LOWER MINNESOTA RIVER
WATERSHED DISTRICT

March 2024

Seminary Fen Stewardship Plan

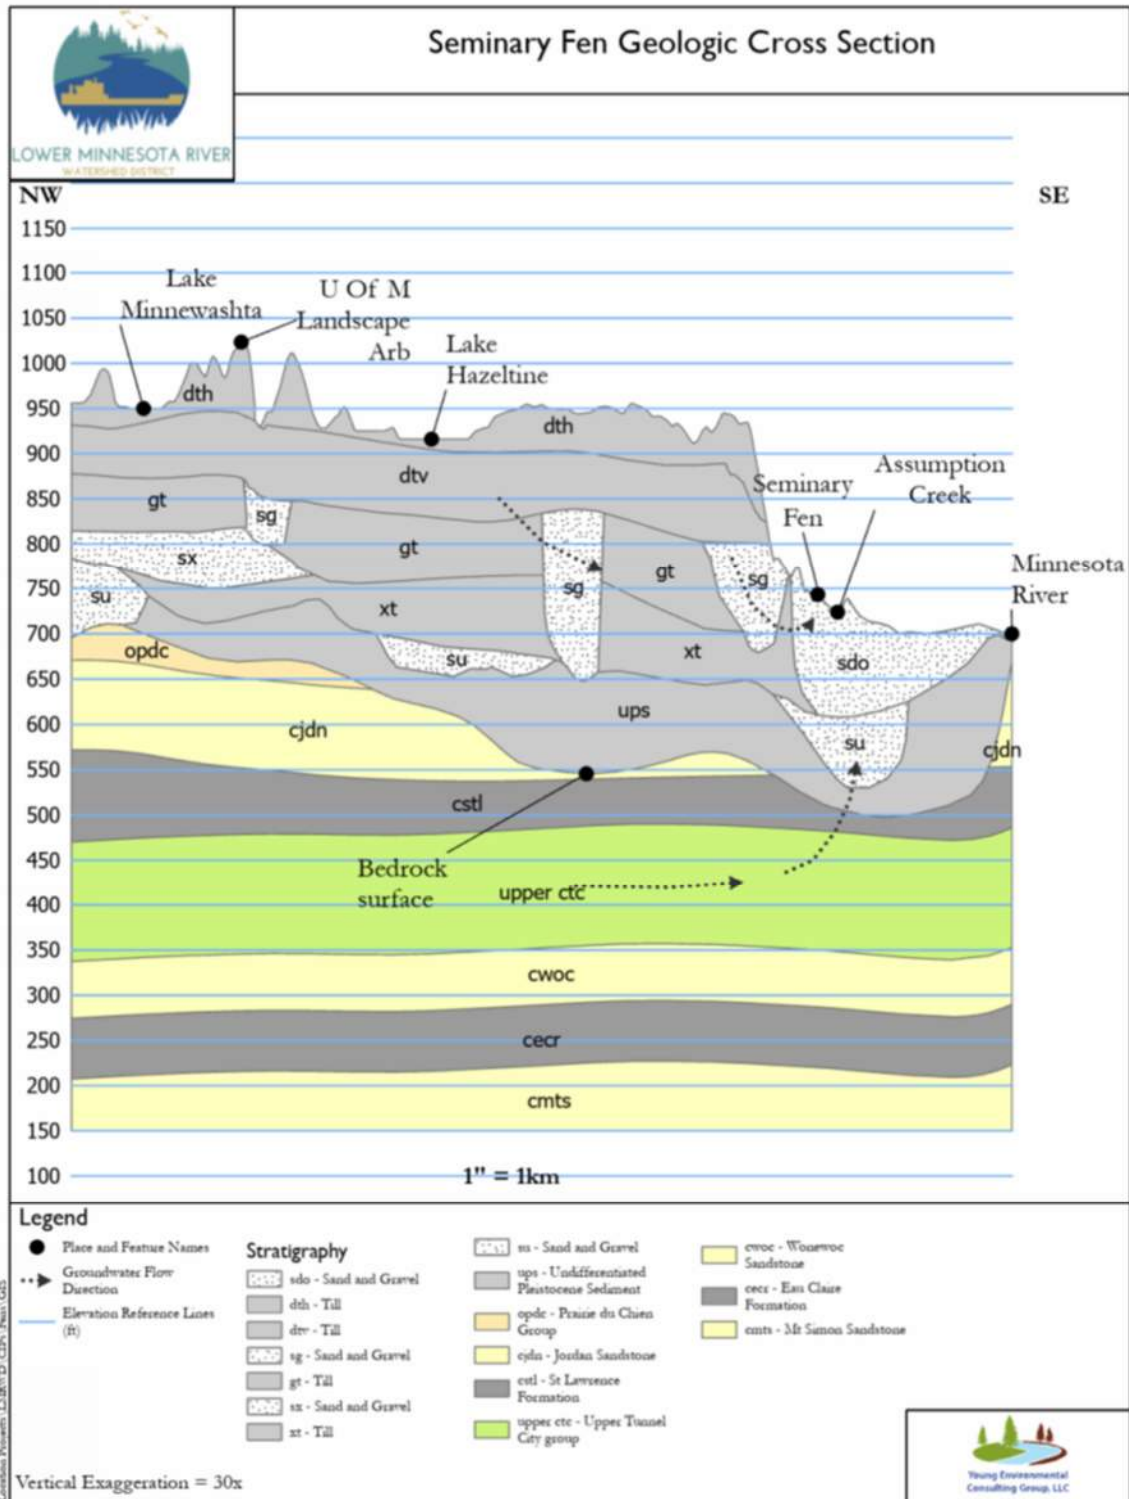
Figure 3. Geologic Cross Section Showing Hydrogeology Associated with Seminary Fen

Figure 3 shows the aquifers that supply groundwater to the SFWC. Water recharged on the upland bluffs infiltrates multiple layered aquifers that flow toward the Minnesota River. The deeply incised Minnesota River Valley exposes many of these aquifers, resulting in springs and seeps that discharge at various levels and feed Seminary Fen, Assumption Creek, and other water features above the river level. The water table is not shown but is slightly below the ground surface.

Figure 3 also illustrates the extent and thicknesses of aquifers and aquitards in the area, groundwater flow directions, and helps define groundwater recharge and discharge areas. Seminary Fen is fed by groundwater discharging from a shallow local aquifer named sg, and from the deeper Upper Tunnel City regional aquifer.

The shallowest buried sand and gravel aquifer, labelled sg, is shown on the Figure 3 cross section as partially exposed to the surface along the edge of the Minnesota River valley. This partial exposure allows surface water to infiltrate and discharge locally to the nearby Seminary Fen area. Figure 4 is a recharge and pollution sensitivity map of the sg aquifer (Peterson, 2009). The warm colors indicate that a portion of the sg aquifer near Seminary Fen provides some local recharge to the area.

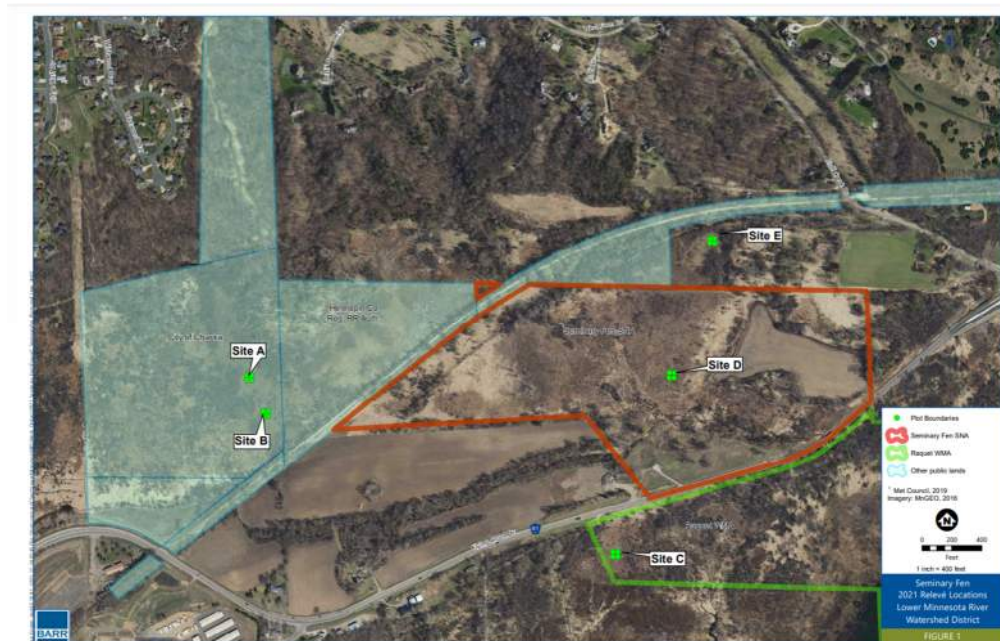
Figure 8. Location of Vascular Plant Relevés in and near the Seminary Fen Scientific Natural Area (Tix & Anderson, 2021)

Prior to 2021, the most recent documented vascular-plant-based vegetation survey was conducted in 1995, so the Gaps Analysis recommended completing a new survey, given that the vegetation in the fen might have changed in response to environmental influences. Young Environmental collaborated with Barr Engineering to complete a vegetation survey of the SFWC during June and August of 2021. These relevés documented the occurrence and distribution of vascular plants within five 100-square-meter (10 meter by 10 meter) plots throughout the SFWC, as established by the assessment team for subsequent monitoring and reassessment. Locations were selected using guidance from the MNDNR and placed in high-quality areas of the plant community.
