February 2024

Gun Club Lake Fens Stewardship Plan

**Lower Minnesota River Watershed District
Chaska, Minnesota**

**Young Environmental
Consulting Group, LLC**

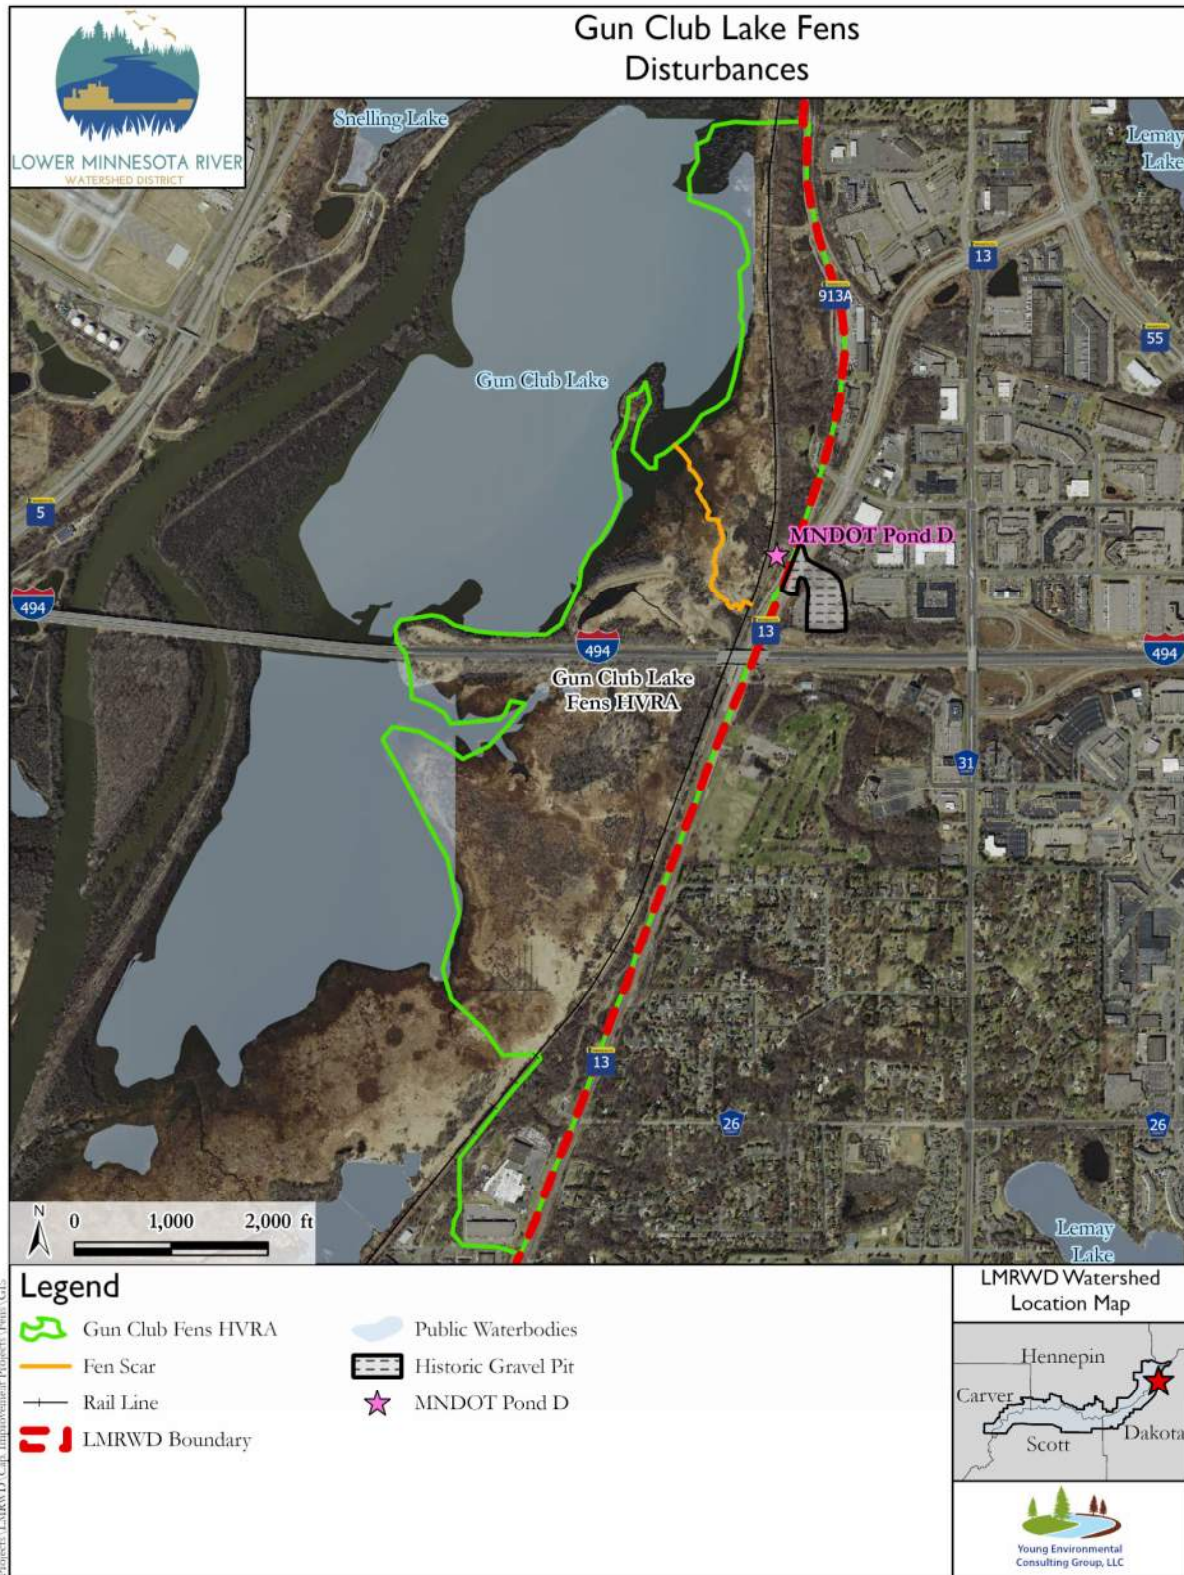
Figure 2. Disturbances to the Gun Club Lake Fens

Residential, commercial, and industrial developments are located east and upgradient of the Gun Club Lake Fens. Although the fens themselves are protected from development as a part of Fort Snelling State Park, nearby development has impacted the fens by changing the area hydrology. Figure 2 highlights these disturbances.

Known disturbances within the fens began in the 1860s with the construction of the railroad that borders the fens to the east (Schmidt, Pratt, Vermeer, & Bradley, 2007). Around the time of railroad construction, the land use in the area was largely agricultural (Young Environmental, 2022a). In the early 1900s, drainage alterations and ditching occurred throughout the watershed and near the current location of I-494, likely for agricultural purposes. In the mid-1900s a gravel pit was constructed east of the fens, and flow was diverted away from the northern portion of the fen to the southern portion. Construction of I-494 in 1982 completely divided Gun Club Lake Fens into the North Fen and South Fen.

A channel that has eroded into the North Fen has been evident in aerial imagery dating back to the 1940s, although it likely formed following the construction of the railroad (Young Environmental, 2022a). Railroad construction channelized flow from the east under a railroad bridge, and subsequent watershed development has increased imperviousness and runoff volumes. The railroad bridge is located at the outlet of the Minnesota Department of Transportation's (MnDOT) Pond D that collects flow from nearby highways. Evaluation by Young Environmental indicates that the channel in the North Fen has not yet stabilized and will continue to erode if not addressed (Young Environmental, 2022a). The 2022 Gun Club Stormwater Intrusion Study (Young Environmental, 2022a) provides potential management strategies to reduce ongoing erosion of the channel, such as flow dispersion within the fen, providing upstream storage to reduce runoff rates and volumes and channel stabilization. Because the MNDNR is uncertain of the long-term viability of the North Fen, no action has yet been taken to address the channel, and stewardship actions are not proposed in this plan (Young Environmental, 2022a).

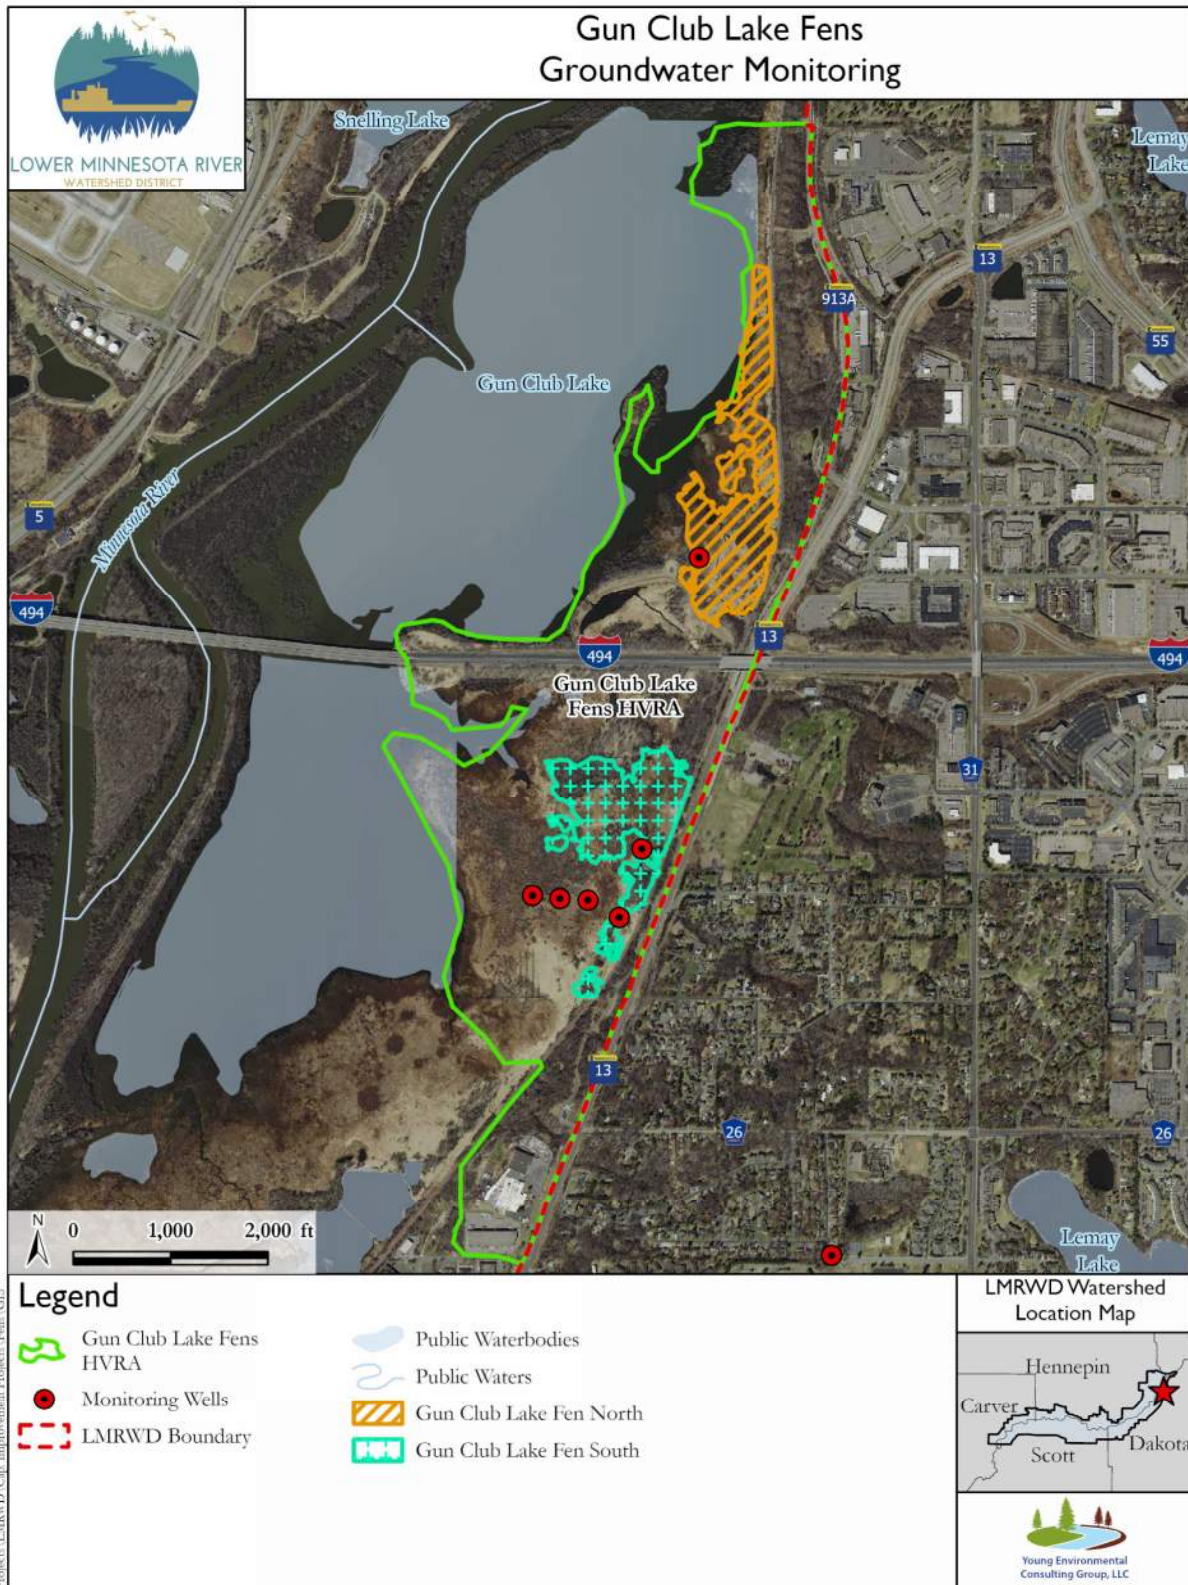
Figure 4. General Location of Monitoring Wells in and near the Gun Club Lake Fens

Figure 4 shows the monitoring wells within and around the Gun Club Lake Fens. Two wells are located in the North Fen, and thirteen wells are located in the South Fen. Because most of the monitoring wells are located in the South Fen area, the majority of the groundwater analysis is focused on the South Fen.

As shown in Figure 4, the South Fen has reasonably good groundwater monitoring well coverage. Groundwater levels are measured in and around the fen by both the MNDNR and the Dakota County SWCD (Young Environmental, 2021). Both datasets are uploaded to the Cooperative Groundwater Monitoring Network. The LMRWD supports the ongoing efforts by the Dakota County SWCD at the thirteen wells (Dakota County SWCD, 2021). Some of these wells are outfitted with data loggers. Groundwater elevations are manually measured monthly, and records are shared with the LMRWD annually.

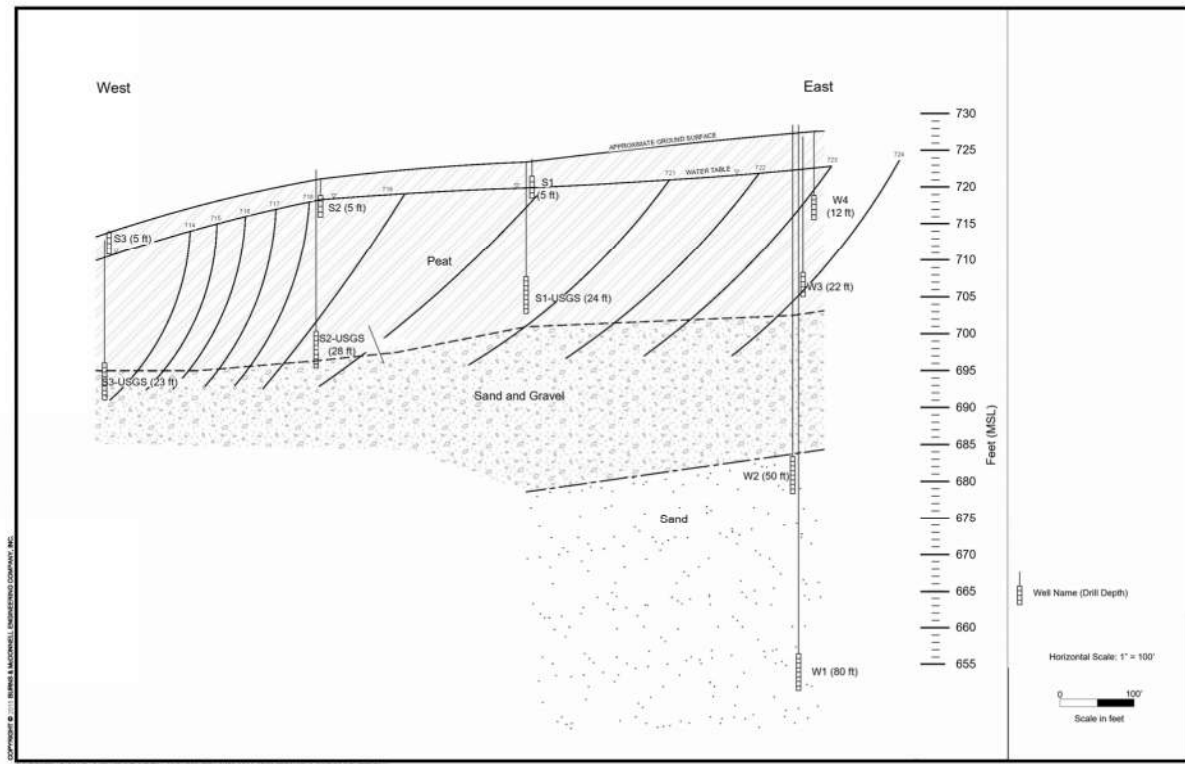
Figure 6. Gun Club Lake South Fen Cross Section Adapted from Burns and McDonnell (2015)

There are thirteen groundwater monitoring wells within and around the South Fen. Figure 6, adapted from Burns and McDonnell (2015), shows the cross section of four sets of paired shallow and deep wells in the

South Fen. Wells are located in and west of the South Fen. Soil borings taken near these wells provide further insight into the geology under the South Fen and informed Figure 6. Well records indicate an upward vertical gradient of groundwater, typical of healthy fen systems. Deeper water travels upward through alluvial sands and into peat before upwelling to the surface. Although all the wells were installed in 1992, routine monitoring of groundwater elevations did not occur until the late 2000s (Young Environmental, 2021).

Figure 9 provides a cross section of the most recent groundwater elevations taken within the South Fen for wells shown in the Figure 6 cross section. Groundwater elevations were measured in November 2022 or March 2023 (MNDNR, 2023). The groundwater elevations, representative of the potentiometric surface of the groundwater, are near the ground surface level at all locations. The deep wells show a potentiometric surface above that of the shallow wells, which results in an upgradient of groundwater that pushes water upward. The elevations of the groundwater generally are at or below the ground surface. This condition is not consistent with a healthy fen, which relies on the upward movement of groundwater to sustain the fen.

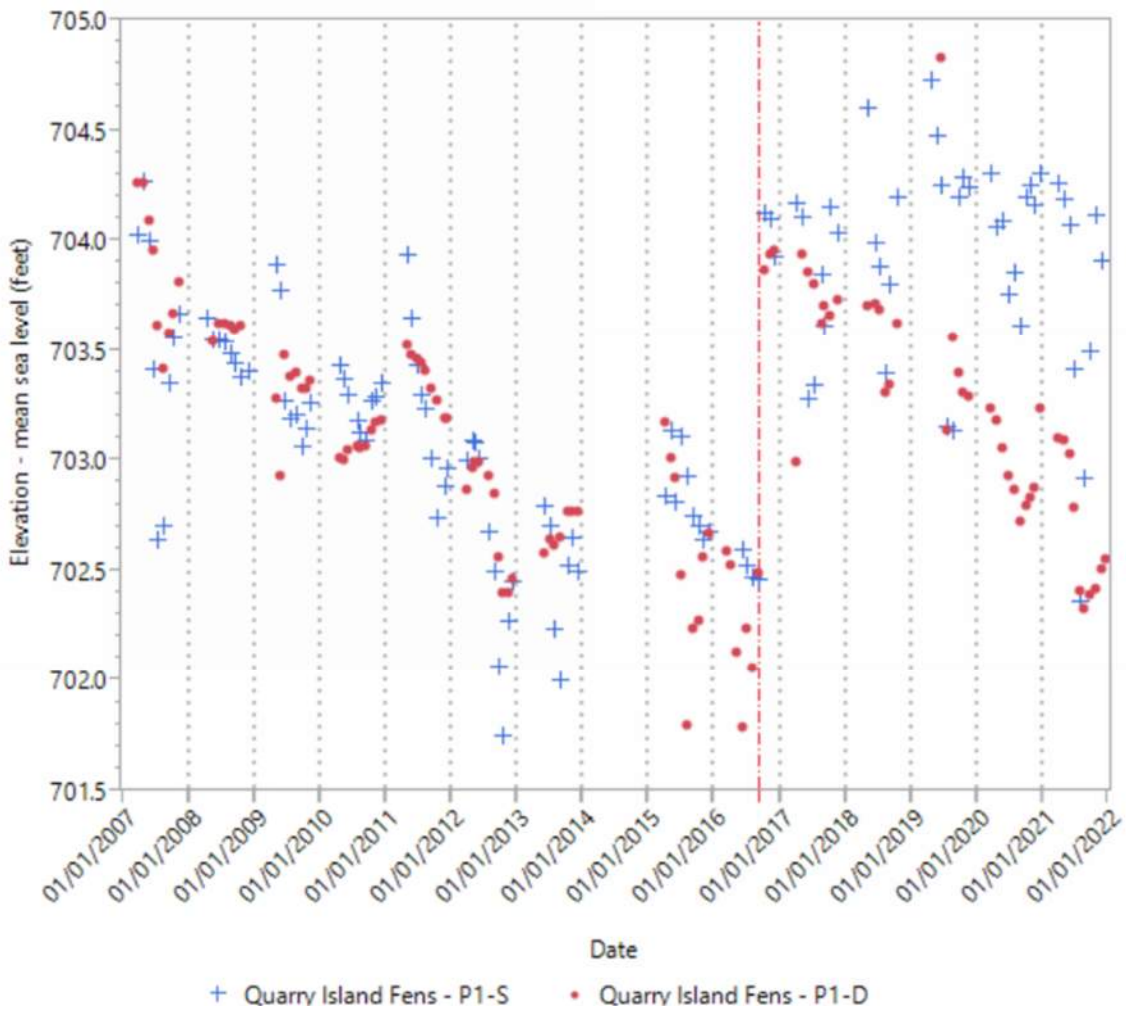
Figure 7. Groundwater Elevations in Gun Club Lake North Fen from Dakota County SWCD (2021)

elevation decline is unknown. The most recent data measured in late 2022 show groundwater elevations of 704.14 feet in P1-S and 702.23 feet in P1-D (MNDNR, 2023). Both elevations are below the estimated ground surface elevation of 705 feet and suggest a lack of upward groundwater gradient (Burns & McDonnell, 2015). This indicates that the fen land surface near these wells may be dry, leading to desiccation of important fen vegetation.

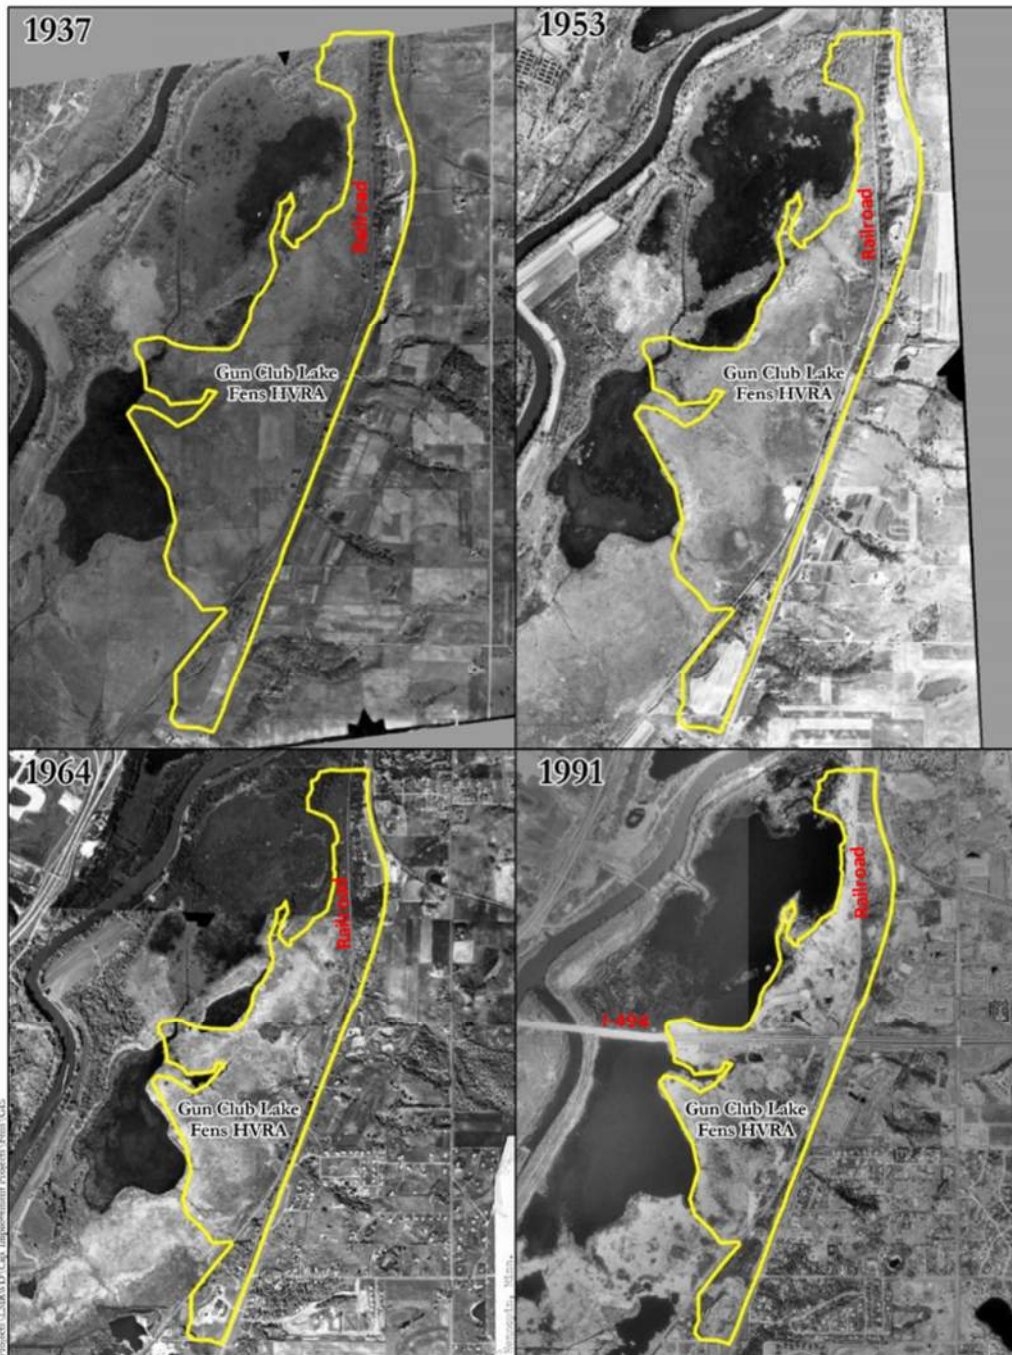
Figure 11. Historical Aerial Imagery of Gun Club Lake Fens High Value Resource Area

Imagery spanning from 1937 to 1991 shows a clear progression in and around the HVRA from rural agricultural use to urban development. The image from 1937 shows a few developments and roads within and around the Gun Club Lake Fens HVRA. Less than twenty years later, the image taken in 1953 shows a greater quantity of roads west of the HVRA. The image from 1964 shows a great increase in development to the east within the cities of Eagan and Mendota Heights. The southernmost portion of the HVRA area has also experienced minor development. The image from 1991 shows another jump in development, more densely in the City of Eagan. It was between the 1970s and 1990s that the City of Eagan experienced its most rapid development (WSB & Associates, Inc., 2008); however, imagery between the 1960s and 1990s in this region was not found. The 1991 image shows nearly complete development within both the City of Eagan and the City of Mendota Heights. Most notable is the construction of I-494, which divided the North and South Fens.
