LOWER MINNESOTA RIVER
WATERSHED DISTRICT

Nicols Meadow Fen Stewardship Plan

February 2024

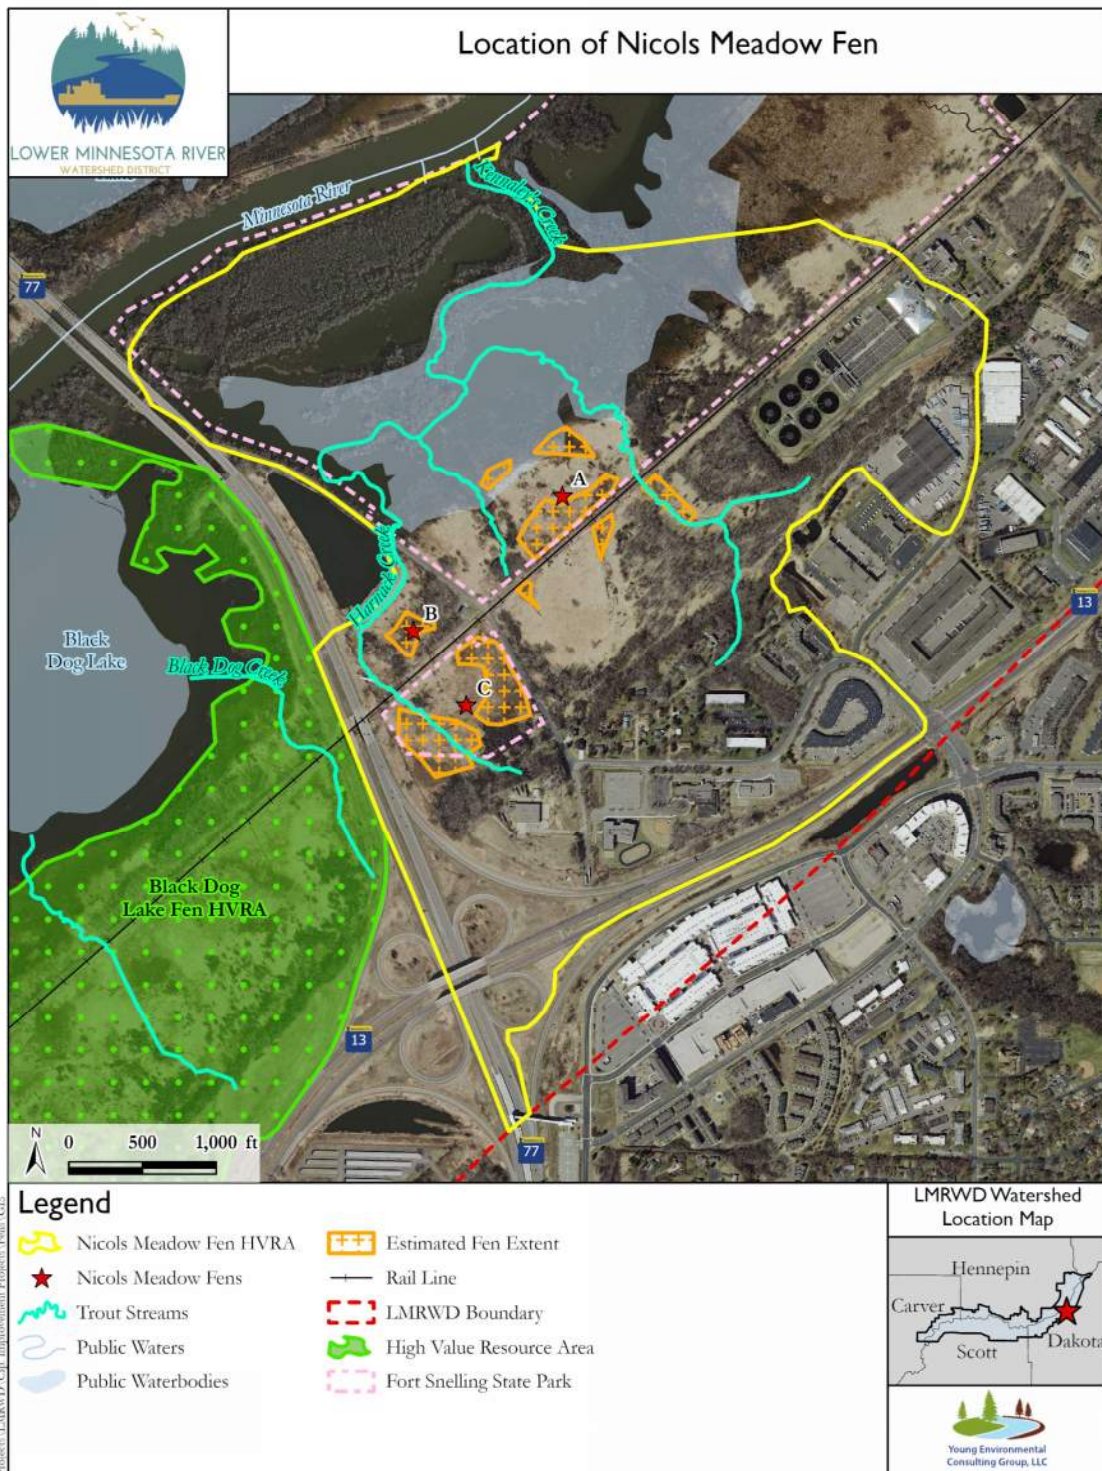
Figure I. Nicols Meadow Fen Location

Nicols Meadow Fen, composed of three clusters of unique wetlands classified as calcareous fens, is situated southeast of the Minnesota River, northeast of Trunk Highway 77, northwest of Trunk Highway 13, and southwest of the Seneca Wastewater Treatment Plant in Dakota County. The three clusters of wetlands that make up the fen are named Nicols Meadow Fen A, B, and C (Figure 1).

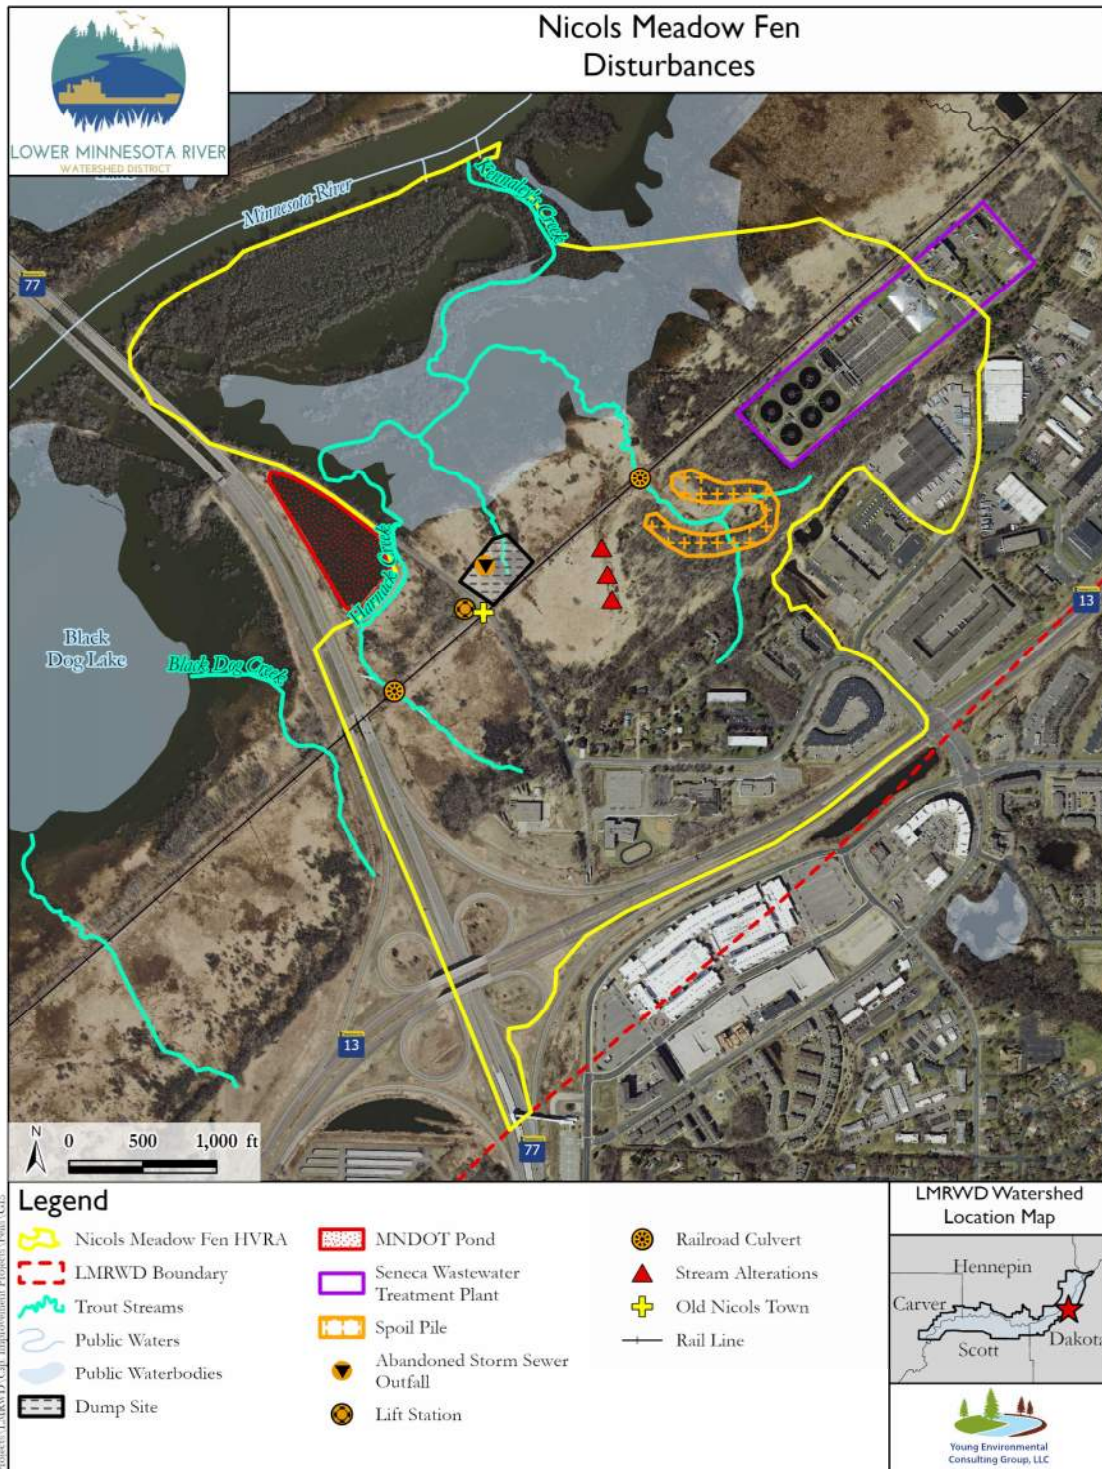
Figure 2. Disturbances within Nicols Meadow Fen

Nicols Meadow Fen is in the Minnesota River Valley at an average ground surface elevation of 720 feet mean sea level (MSL), above the 714.6 feet MSL 100-year flood elevation of the Minnesota River. The valley was created when glacial River Warren drained glacial Lake Agassiz after the last period of glaciation (Young Environmental, 2022a). Almendinger and Leete (1998a) estimated the age of nearby fens as over 10,000 years old. However, because of observed degradation within Nicols Meadow Fen, age-dating tests were not done on the fen as they would not be representative of a typical calcareous fen. Nicols Meadow Fen has a long history of disturbances and alterations. Figure 2 highlights these disturbances.

As the Twin Cities Metropolitan Area developed, greater city services were required. In 1959, the City of Eagan constructed a storm sewer outfall directly to Nicols Meadow Fen (WSB & Associates, Inc., 2008). A large storm in 2000 caused severe erosion at the outfall, creating a cavity approximately 20 feet deep and 30 feet in diameter at the surface (Young Environmental, 2021). The eroded cavity was subsequently restored, the outfall was abandoned, and the storm sewer was rerouted away from the fen (WSB & Associates, Inc., 2008). The most rapid development of the City of Eagan occurred from the 1970s to the 1990s, changing much of the fen's recharge area to industrial, commercial, and residential land uses. To accommodate this development, construction to upgrade TH 77 was started in 1977. It is believed that Nicols Meadow Fen and Black Dog Lake North Fen, which is on the southwest side of TH 77, may have been part of the same fen complex prior to the construction of TH 77.

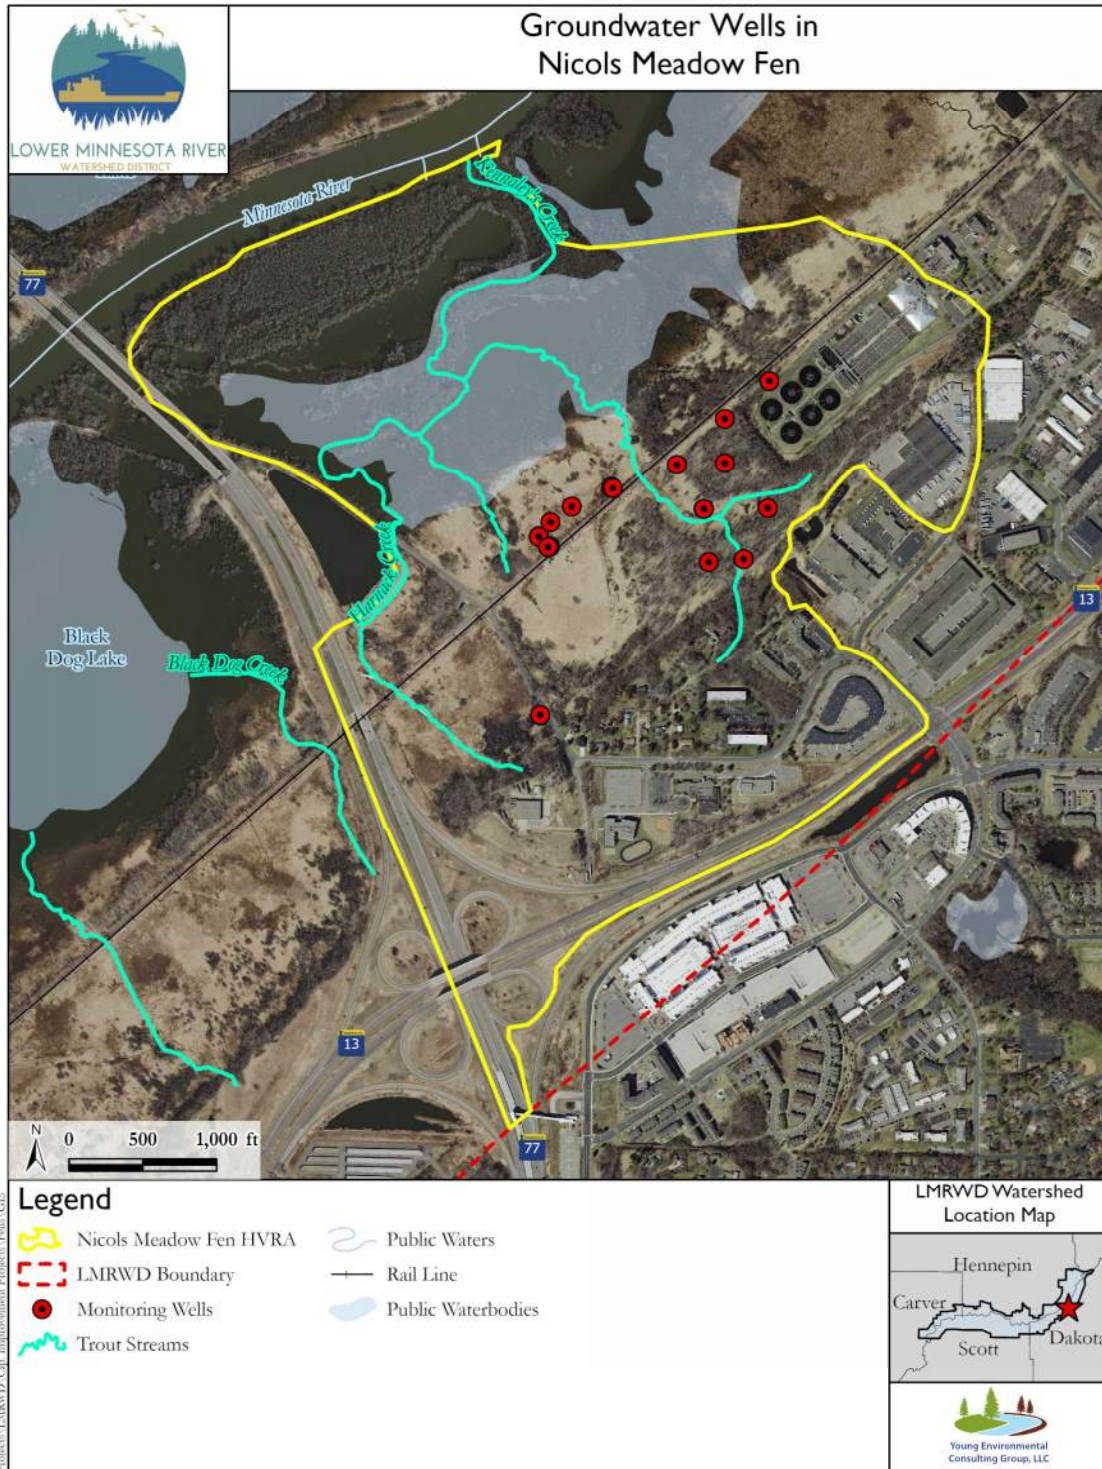
Figure 4. General Location of Monitoring Wells in and near Nicols Meadow Fen

On a more local scale, both the Metropolitan Council Environmental Services (MCES) and Dakota County SWCD have been collaborating with the MNDNR and the LMRWD for several years to monitor groundwater elevations associated with Nicols Meadow Fen. The Fen Gaps Report (Young Environmental, 2021) provides detailed information about the wells located in Nicols Meadow Fen.

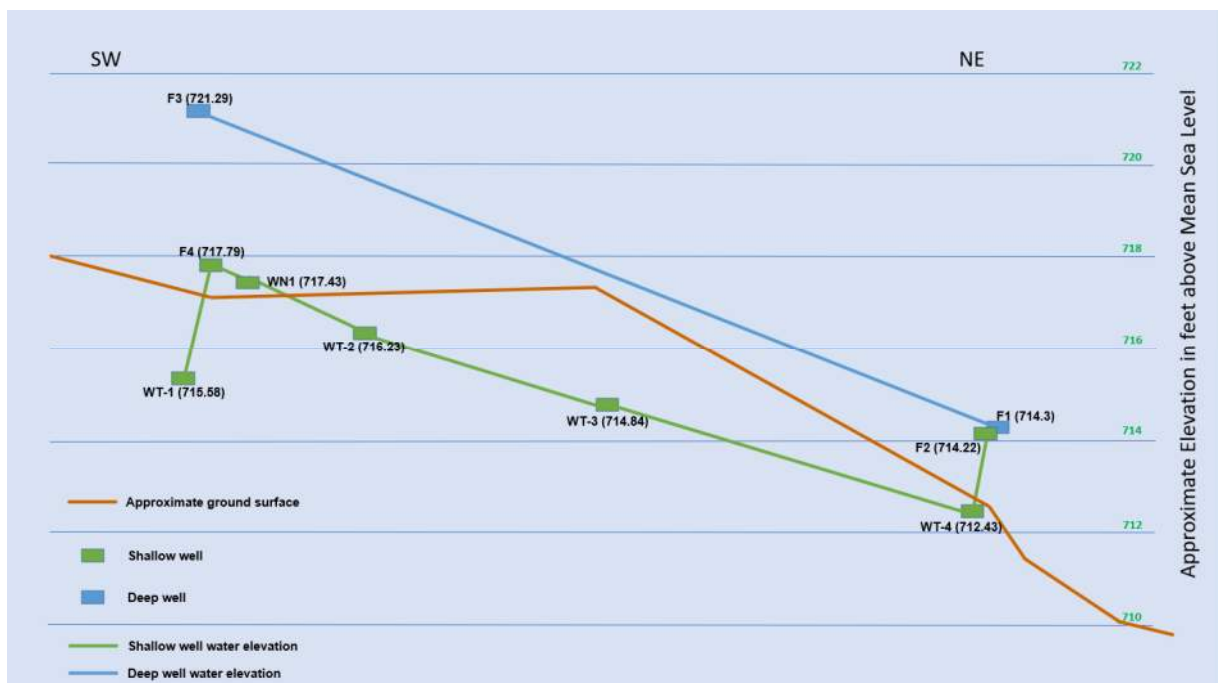
Figure 6. Cross Section of Recent Groundwater Elevations in Nicols Meadow Fen

The water level, representative of the potentiometric surface of the groundwater, is above the ground surface at several locations. The deep wells show a potentiometric surface above that of the shallow wells. This results in an upgradient of groundwater that pushes water up to saturate the land surface. This saturation is necessary to sustain the fen. These effects are seen to a greater extent farther from the Minnesota River and the Seneca WWTP. Unfortunately, groundwater elevations in all the water table wells shown are below the ground surface, indicating that portions of the fen land surface may be dry. This could cause the desiccation of important fen vegetation.

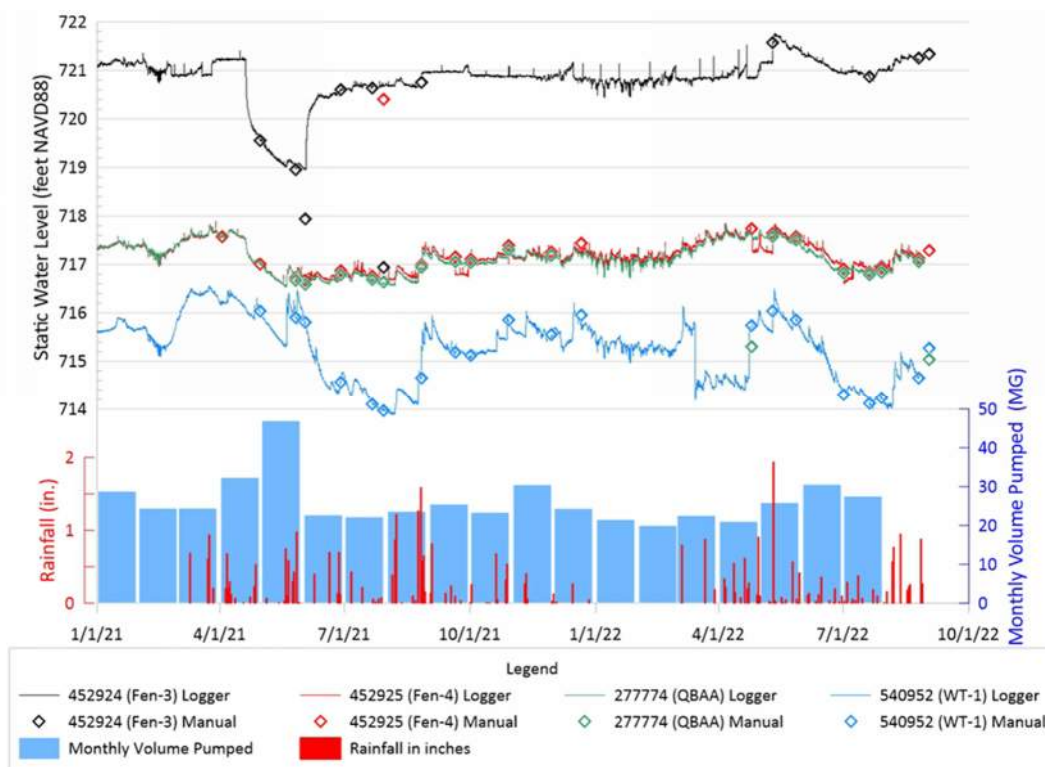
Figure 7. 2021–2022 Groundwater Elevations, Measurable Rainfall, and Water Extracted from Well 1 Taken from Seaberg (2022)

A groundwater technical review on Nicols Meadow Fen was completed in 2022 by John Seaberg, a groundwater specialist at the DNR, because of decreased groundwater elevations observed in 2021. Groundwater elevations within the fen showed a significant drawdown in the spring of 2021. Simultaneously, normally flowing wells were found to be below the ground surface and springs were dry. It was later discovered that the Seneca WWTP had conducted extended dewatering for maintenance of its westernmost clarifier. Measured groundwater elevations remained low throughout this maintenance period and recovered following a return to normal pumping. Additionally, smaller increases in dewatering during May and June 2022 show similar decreases in groundwater elevations. These two incidents indicate that pumping at the Seneca WWTP affects the groundwater that supplies the fen. Figure 7 from the report shows the decreased groundwater elevations and increased pumping at Seneca WWTP Well 1 associated with Permit 1991-6073.

Due to potential dewatering effects on the fen, the MNDNR will be coordinating intensive groundwater monitoring at increased frequencies with the Seneca WWTP in addition to creating a calcareous fen management plan (Andrews & Skancke, 2023). As such, MNDNR representatives

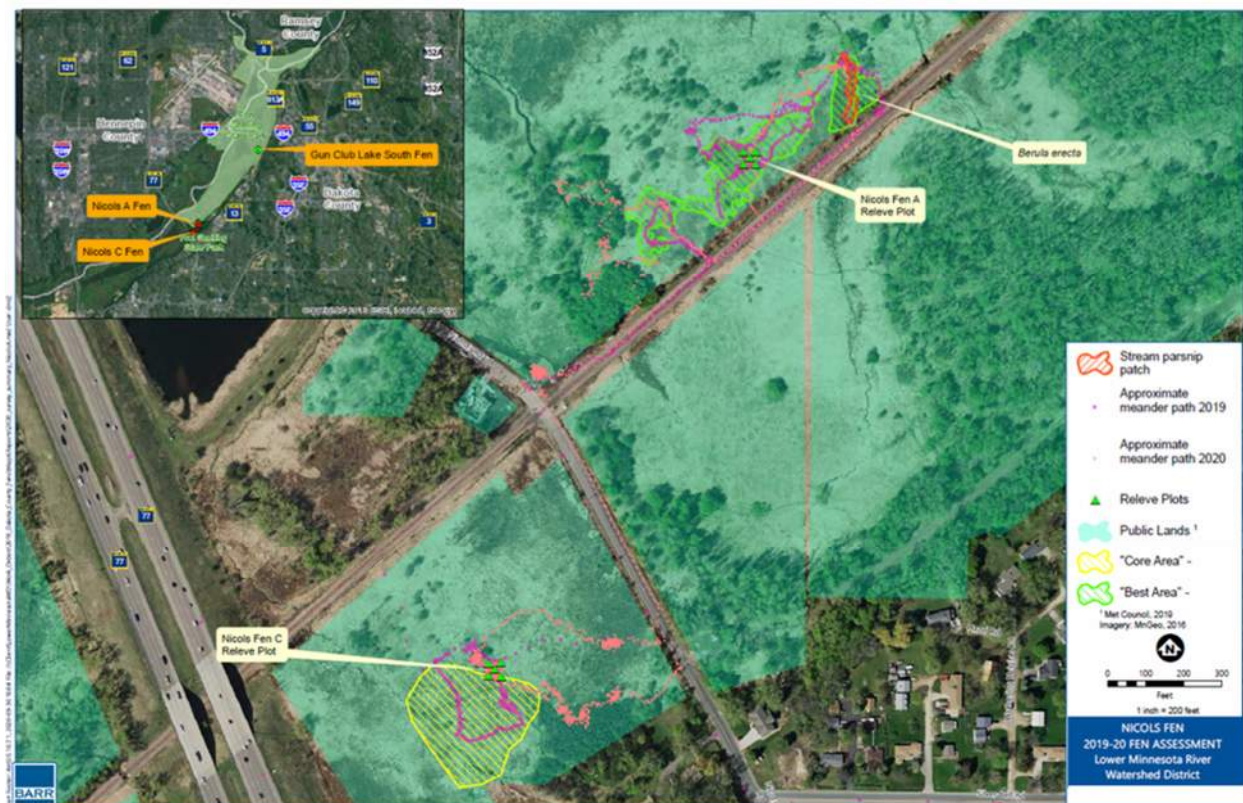
Figure 8. Location of 2019–2020 Nicols Meadow Fen Vegetative Surveys Adapted from Tix (2020)

Several formal and informal vegetation surveys of Nicols Meadow Fen have been conducted since the 1980s. The results of these surveys are described by Young Environmental (2021). Briefly, early surveys identified several indicator species and healthy fen vegetation. Follow-up surveys show a decline in calcareous fen indicator species and increases in undesirable plant species as well as increasingly dry peat. Several surveys in the early 2000s note an overabundance of invasive reed grass, *phragmites*. Young Environmental contracted Barr Engineering (Barr) on behalf of the LMRWD to conduct late and early season vegetative surveys in August 2019 and July 2020, respectively. Relevés were conducted in Nicols Meadow Fens A and C (Tix, 2020). Plots were established in 2019 and returned to in 2020. In addition to the formal relevés, Barr completed meander surveys in the area to document any additional species not seen in the plots. Figure 8 shows the location of the relevé plots and meander surveys.

Nicols Meadow Fen A and C were both surveyed on August 30, 2019, and July 8, 2020. A total of 73 species were found within each fen cluster. However, only two calcareous fen indicator species were found. Fringed brome (*Bromus ciliata*) was found in both clusters. Fen A also contained stream parsnip (*Berula erecta*) while Fen C contained porcupine sedge (*Carex hystericina*). Unfortunately, because of the lack of calcareous fen indicator species observed, neither Fen A nor Fen C meet the requirements for calcareous fen classification. Instead, area vegetation is consistent with a native Seepage Meadow/Carr–Tussock Sedge subtype. Only one state-listed threatened plant species was found during the relevés—cut-leaf water parsnip found on the eastern side of Nicols Meadow Fen A.

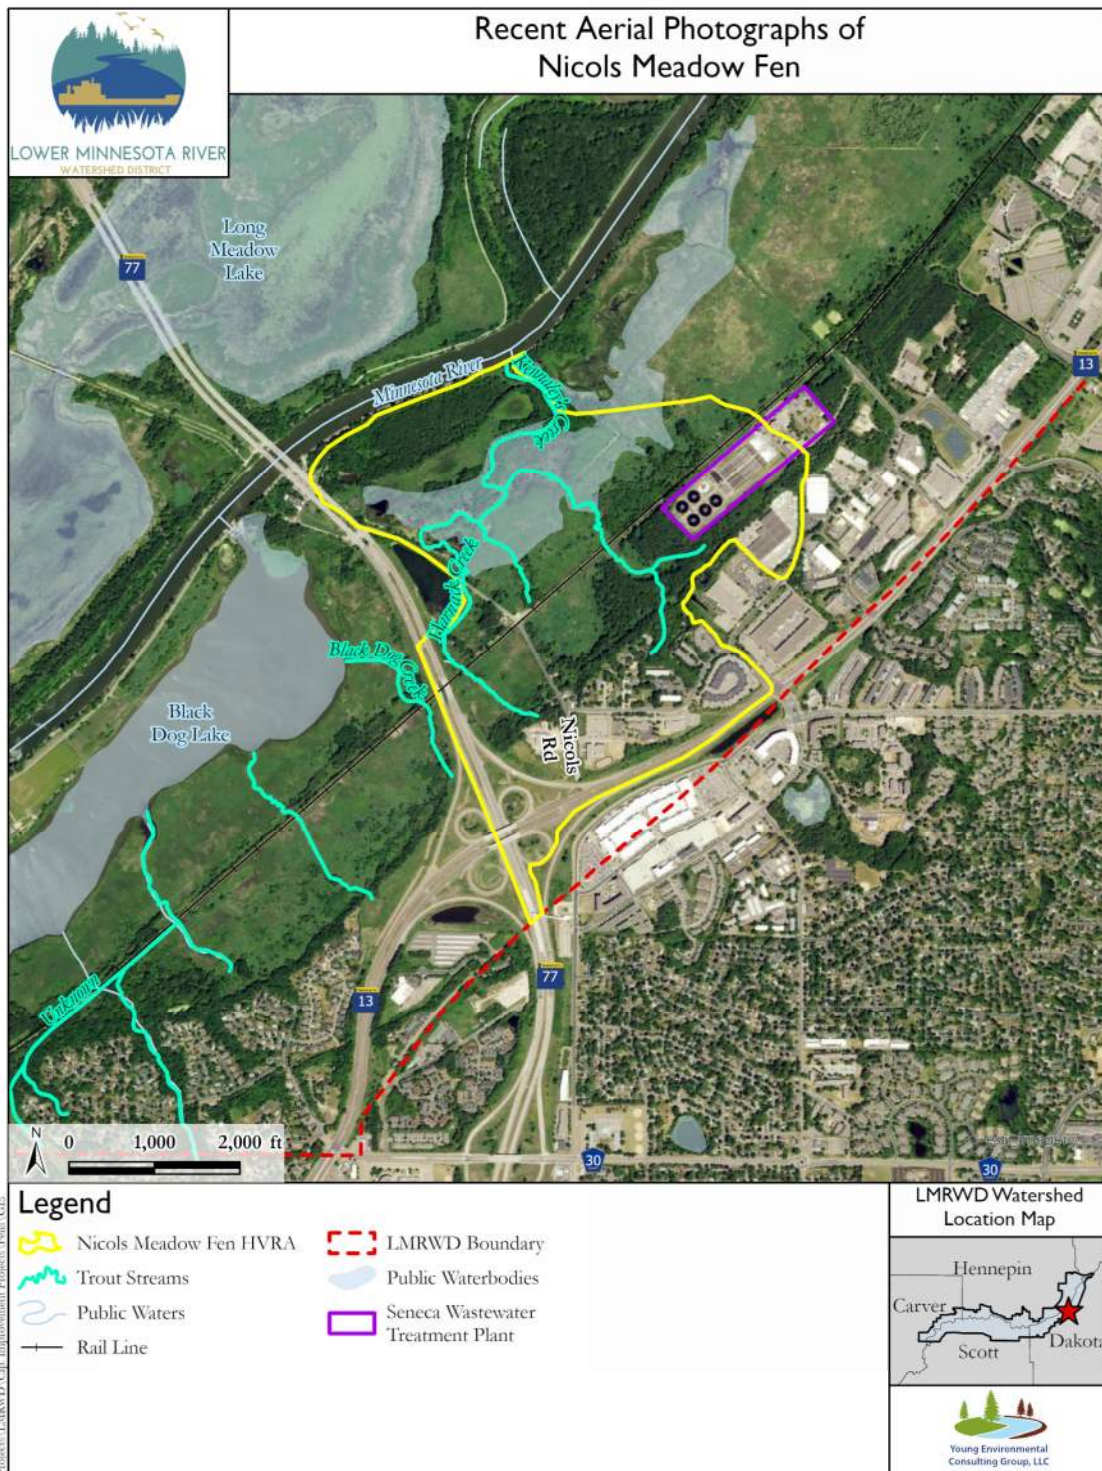
Figure 10. Recent Aerial Imagery of Nicols Meadow Fen and the Surrounding Area

Figure 10 provides a recent aerial image taken in 2019. The image shows significant changes to the area south and east of Nicols Meadow Fen. Undeveloped areas are nearly nonexistent, replaced by a mix of industrial, commercial, and residential land uses. Although development has expanded, it should be noted that it has not yet encroached on the fen northwest of the railroad.
