Groundwater Monitoring Strategy Final Report

Lower Minnesota River Watershed District

November 2005

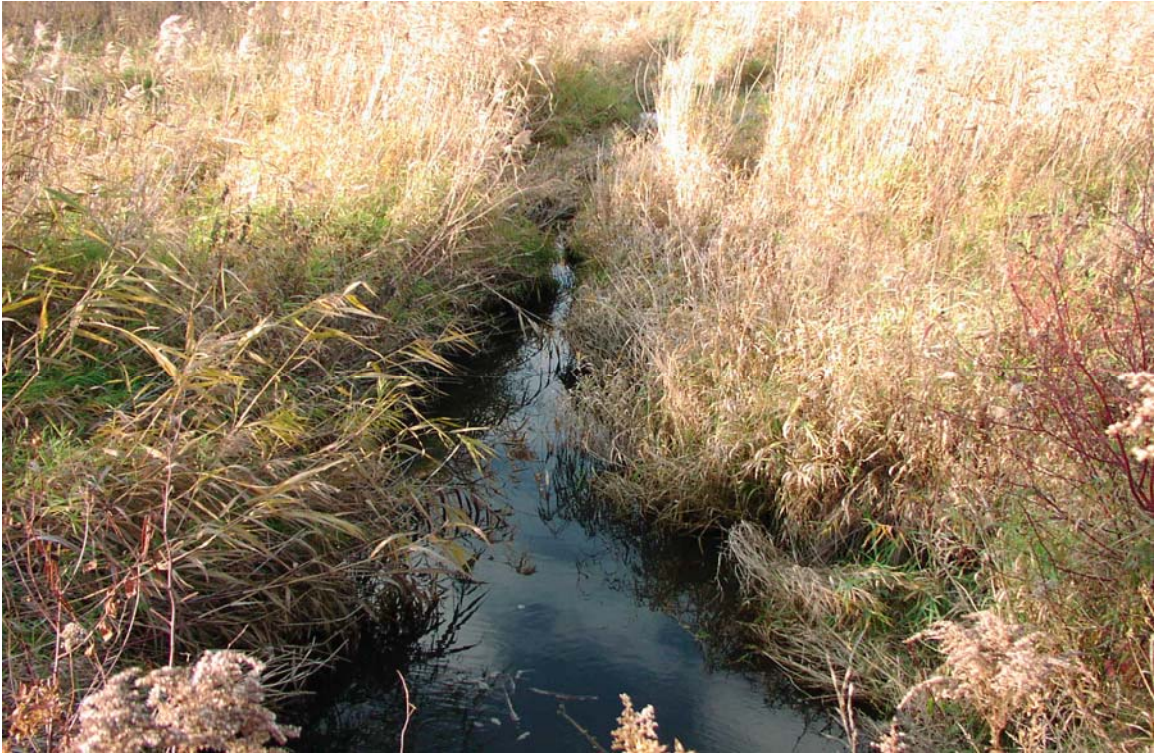
Figure A-1
Kennaley Creek (Photos taken October 2005)

Looking downstream from RR crossing

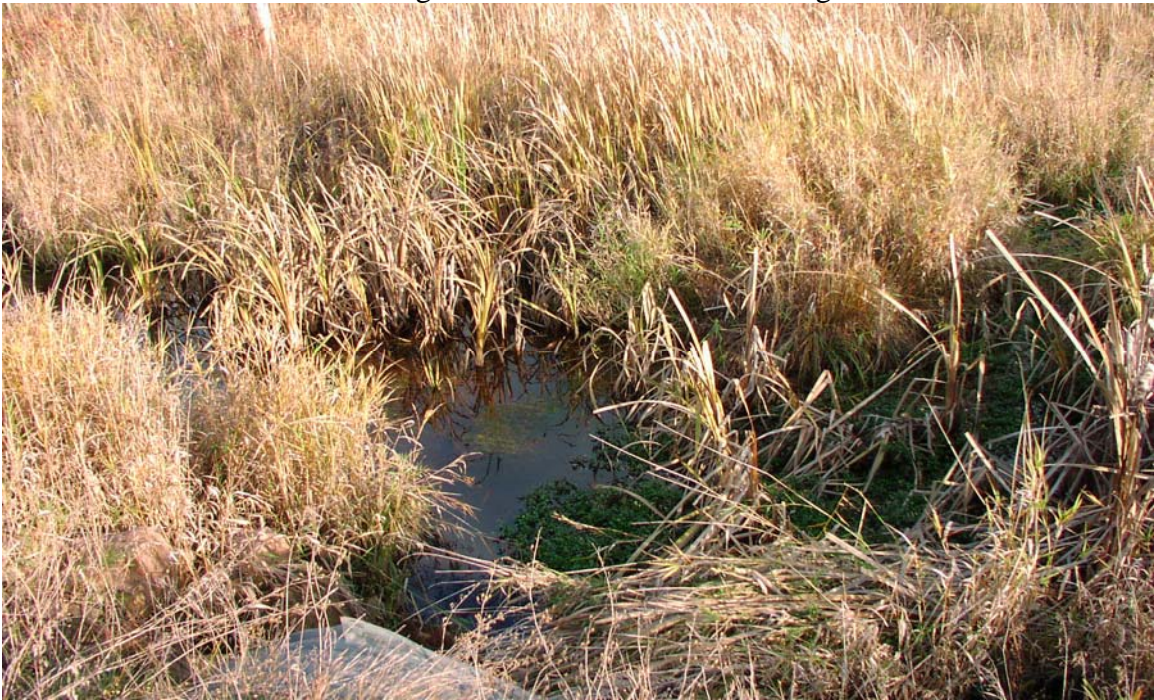
Looking upstream from RR crossing

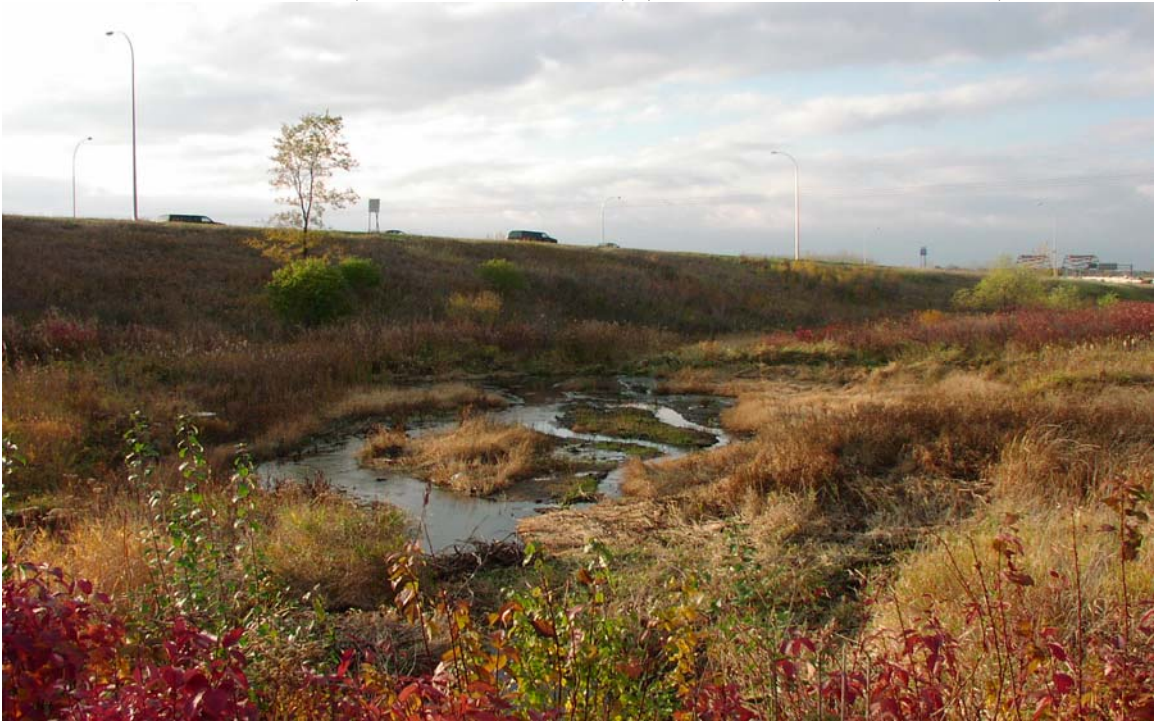
Figure A-3
Harnack Creek (Un-named Steam #1) (Photos taken October 2005)

Looking downstream from RR crossing, TH 77 in background

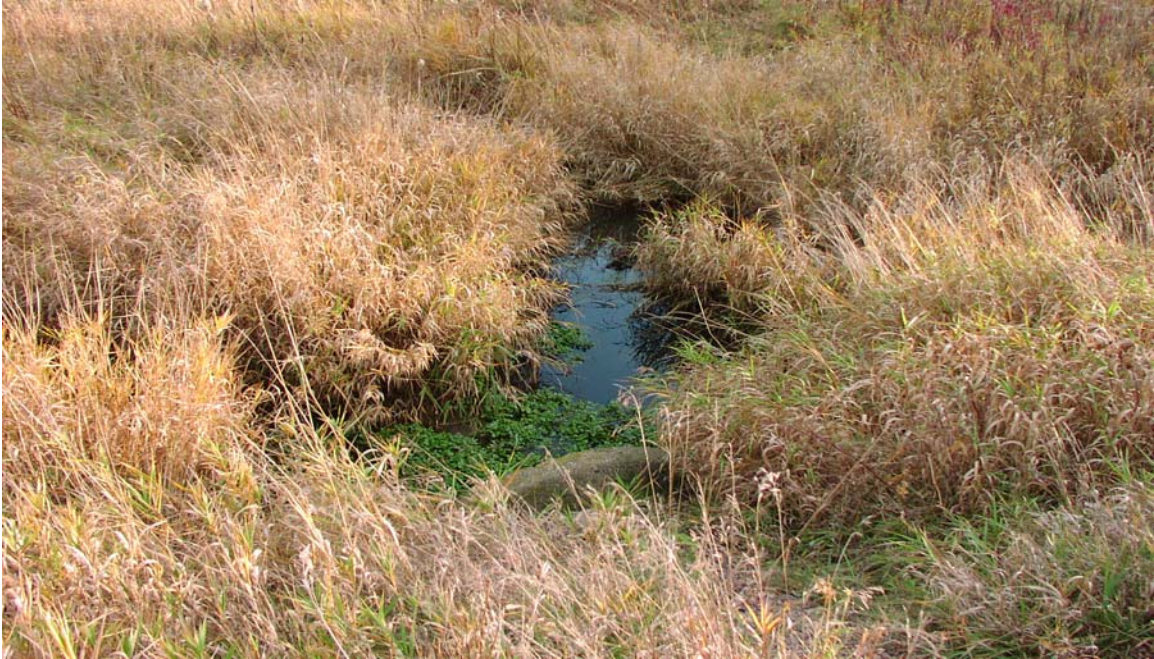
Looking upstream from RR crossing

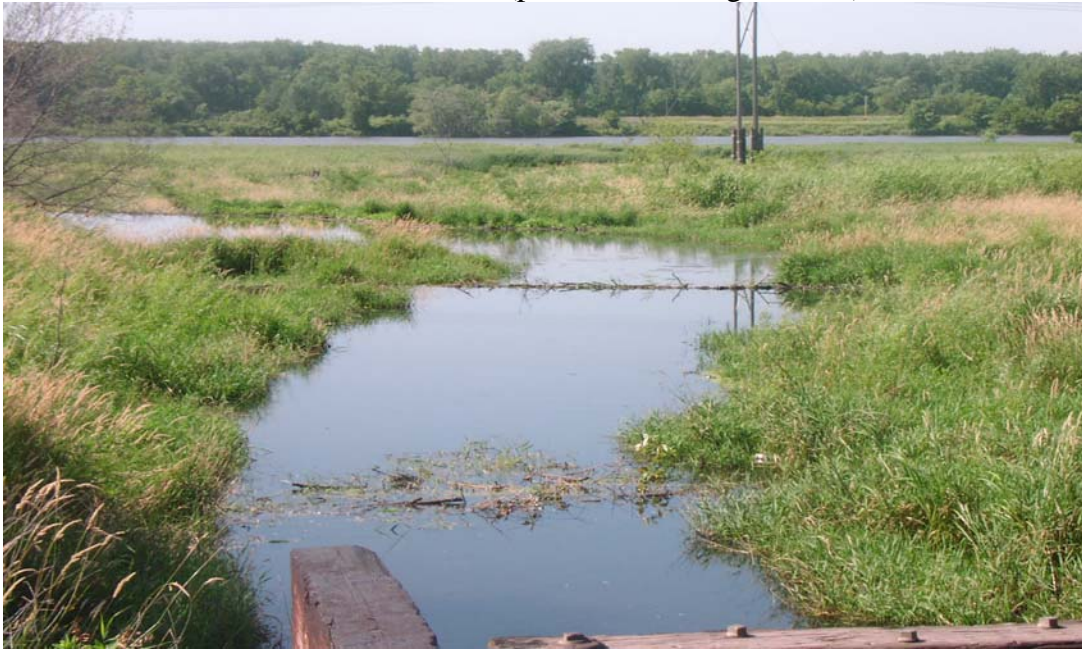
Figure A-5
Un-named Stream #4 (photos taken August 2005)

Health of the Resource: No trout have been sampled in this stream since 1982 when one adult brook trout was found, presumably from a 1980 stocking effort. Most recent stream survey was conducted by MnDNR in August 2000. Due to low base flows, storm sewer discharges that eventually reach the stream, high flood loss potential for trout, and high beaver activity (especially in the vicinity of the railroad crossing), MnDNR feels the stream has limited potential to support trout.

Looking downstream from RR crossing, note beaver dam

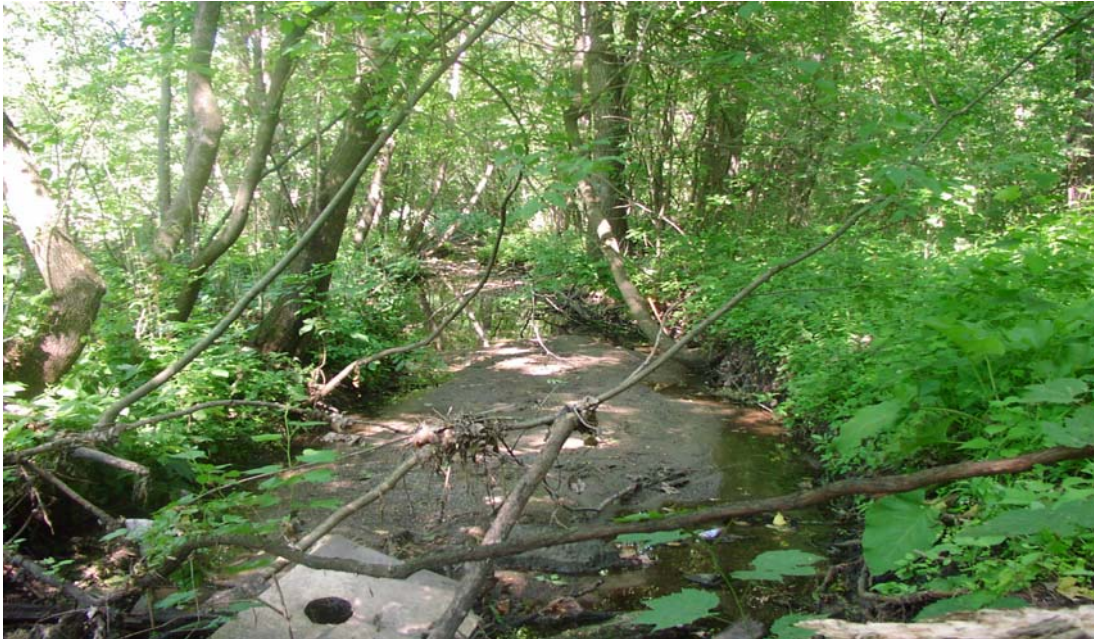
Existing Studies/Monitoring: The latest MnDNR fisheries survey was carried out in August of 2000. In 2003, the City of Burnsville conducted thermal monitoring of the stream between 5/30/03 and 10/30/03 at the locations shown in Figure A-6. The City of Burnsville provided the data and graphs of the monitoring results but there is no formal report showing the monitoring results. A cursory review of the data show temperature peaks during July and August in the lower reaches of the stream in the mid to upper 70° F range. This is well above the optimum temperature range for brook trout as well as the macroinvertebrates on which they would feed and may be a consequence of urban runoff inputs and/or beaver dam activity.

Channel upstream of RR crossing showing scour from storm sewer discharges

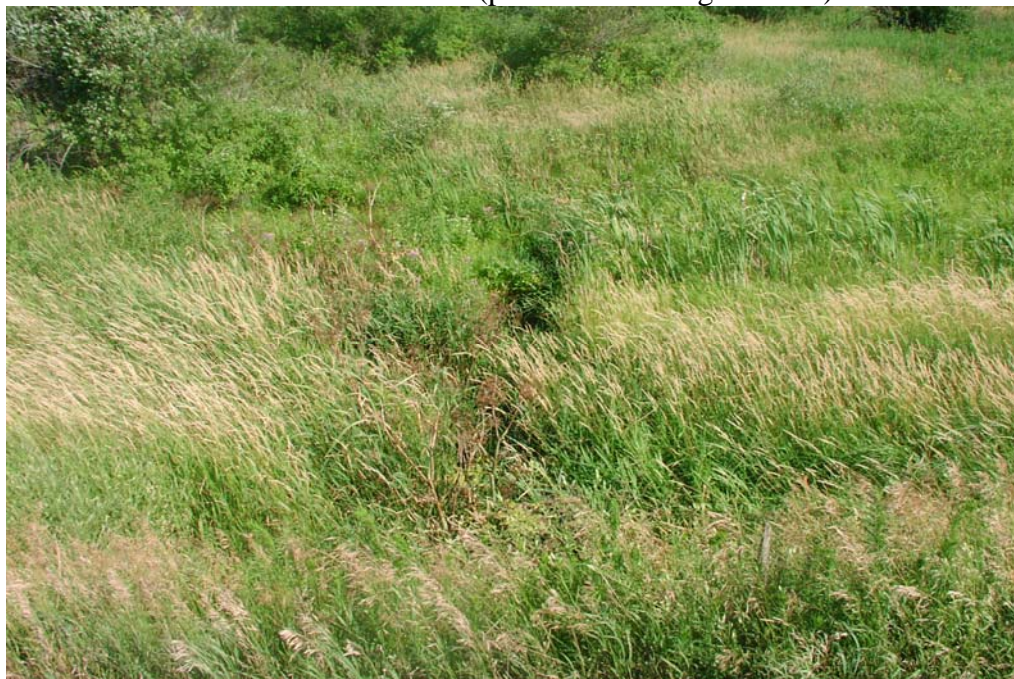
Figure A-7
Un-named Stream #7 (photos taken August 2005)

Health of the Resource: Virtually no recent data or studies have been conducted for this resource. Based on a field visit to the area in July 2005, the stream is very small (less than 3 feet wide at the railroad crossing) and almost completely hidden by riparian grasses. The discharge observed was clear, cold water typical of a groundwater fed stream but flow was well under 1 cfs. The banks in this vicinity were well-vegetated and stable, with none of the signs of instability typical of water that receives large amounts of urban stormwater runoff. The area on top of the bluff above the stream is fully developed for commercial and industrial, but surface water runoff must be routed somewhere other than this drainage. The stream is of very limited value as a potential trout fishery because of its small size.

Looking upstream from RR crossing

Recommendation: Install a temperature recorder in Un-named Stream #7 near the railroad crossing. While the stream is small and access is very limited, it appears to be largely intact. This monitoring effort could help establish baseline conditions for future protection of this unique area at minimal cost and could be of value in characterizing the un-impacted condition of similar resources elsewhere in the District.

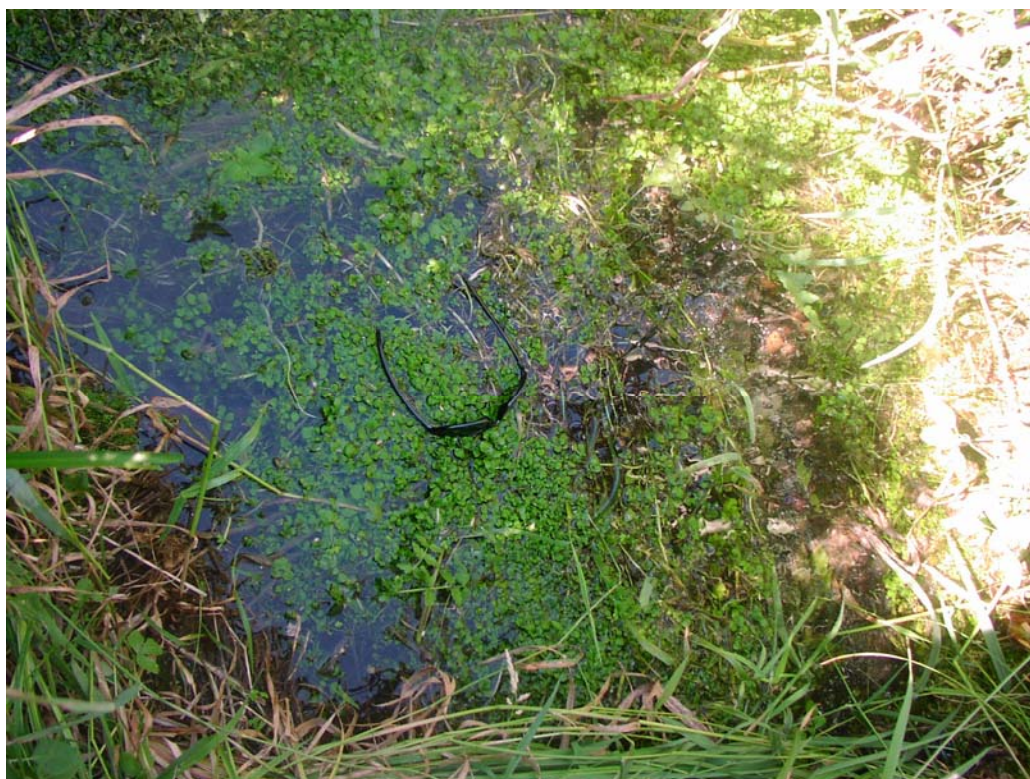
Channel just upstream of RR crossing with water cress

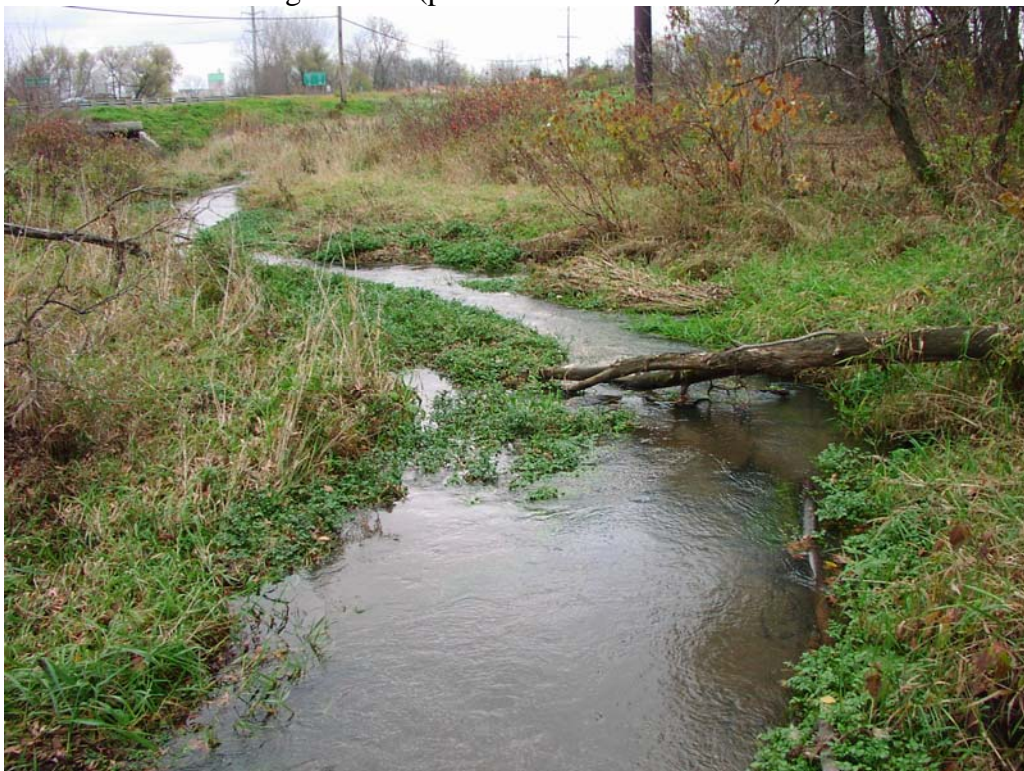
Figure A-9
Eagle Creek (photos taken October 2005)

Looking downstream from wooden bridge just above Highway 101

Recommendation: Install a temperature recorder in Eagle Creek near the Highway 101 crossing. While the stream is well-monitored, information from MnDNR indicates that some of the best habitat and trout populations lie near the Highway 101 crossing, well below the WOMP station. This monitoring effort could inexpensively help establish habitat conditions in this reach of the stream and provide data that indicate whether urban runoff from Highway 101 is having an impact on the stream.

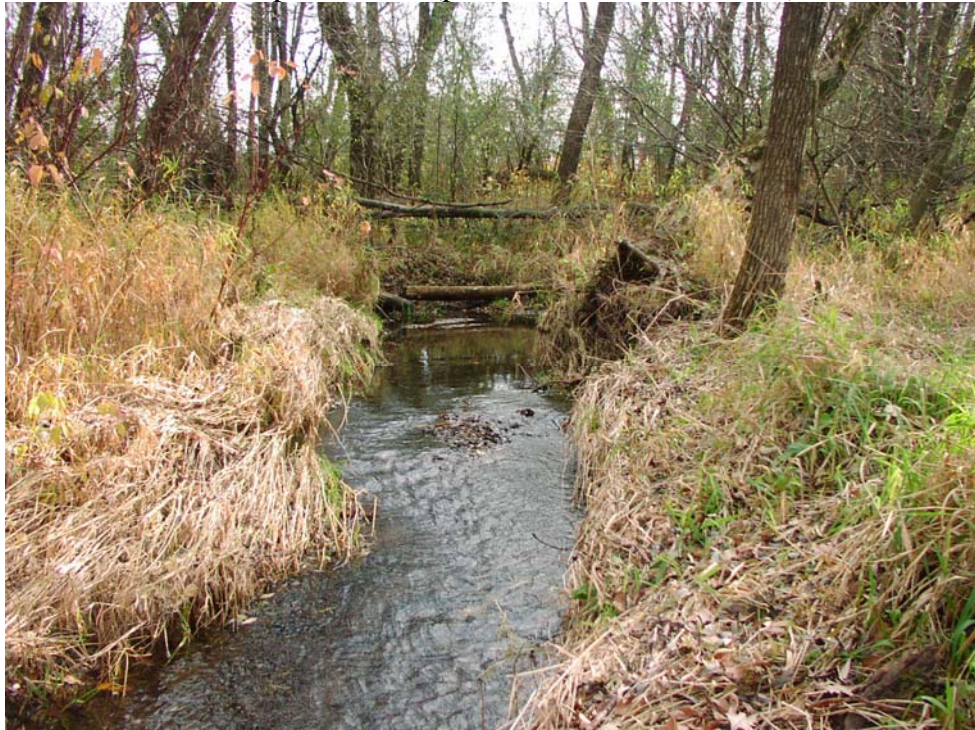
Figure A-11
Assumption Creek (photos taken October 2005)

Health of the Resource: MnDNR staff indicates that they believe the stream is heavily impacted above the fen and is dry in some places, but is in good to excellent condition between the fen and the Minnesota River. Development of the watershed represents a potential danger to the Creek because of increased urban runoff. Also, MnDOT is looking at this vicinity as a potential re-routing alternative for TH 41, but most of their work to date has centered on the impact of that project on Seminary Fen and not the Creek.

Creek just downstream of Highway 212 crossing

Recommendation: Install water level recorders and temperature recorders at two locations in Assumption Creek (probably on mainstem near Highway 212 and on west fork). For reasons cited in the previous write-up on Seminary Fen, this is an important coldwater resource for which relatively little monitoring data has been collected.

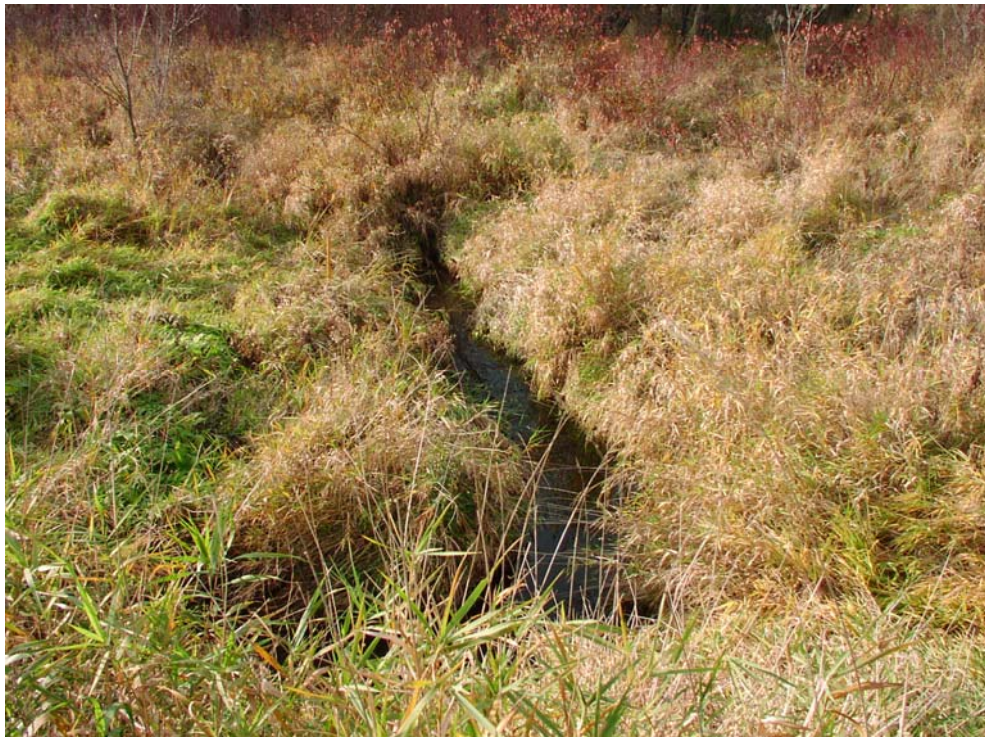
Creek just above Highway 212 crossing
