Assumption Creek at Seminary Fen and US Hwy 212

Purpose: The purpose of this monitoring project was to determine and document stream flows at three locations in Assumption Creek, a Minnesota DNR designated trout stream, between the abandoned rail bed/regional trail and US Hwy 212, near Seminary Fen.

Lower Minnesota Watershed District
Monitoring Station Locations
Assumption Creek
2005 Aerial Photo
December 2006

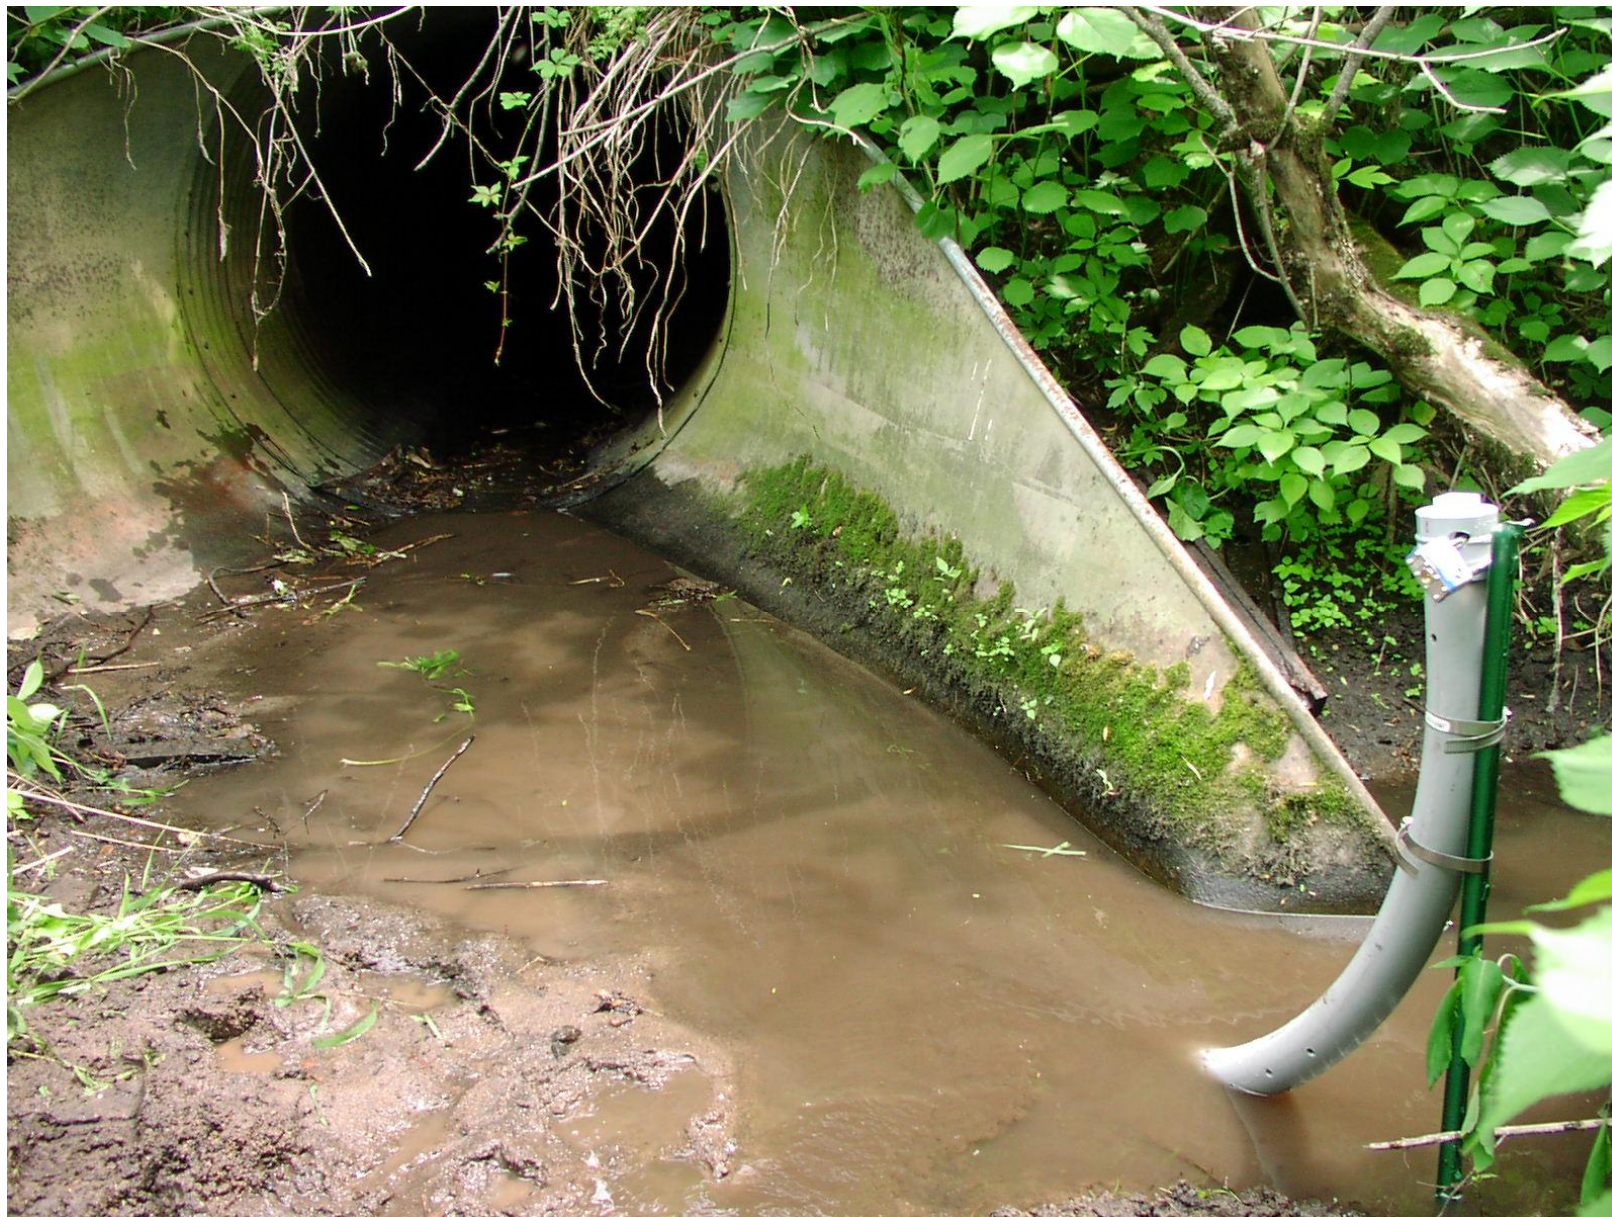
Assumption Creek Sta 1 (view DS)

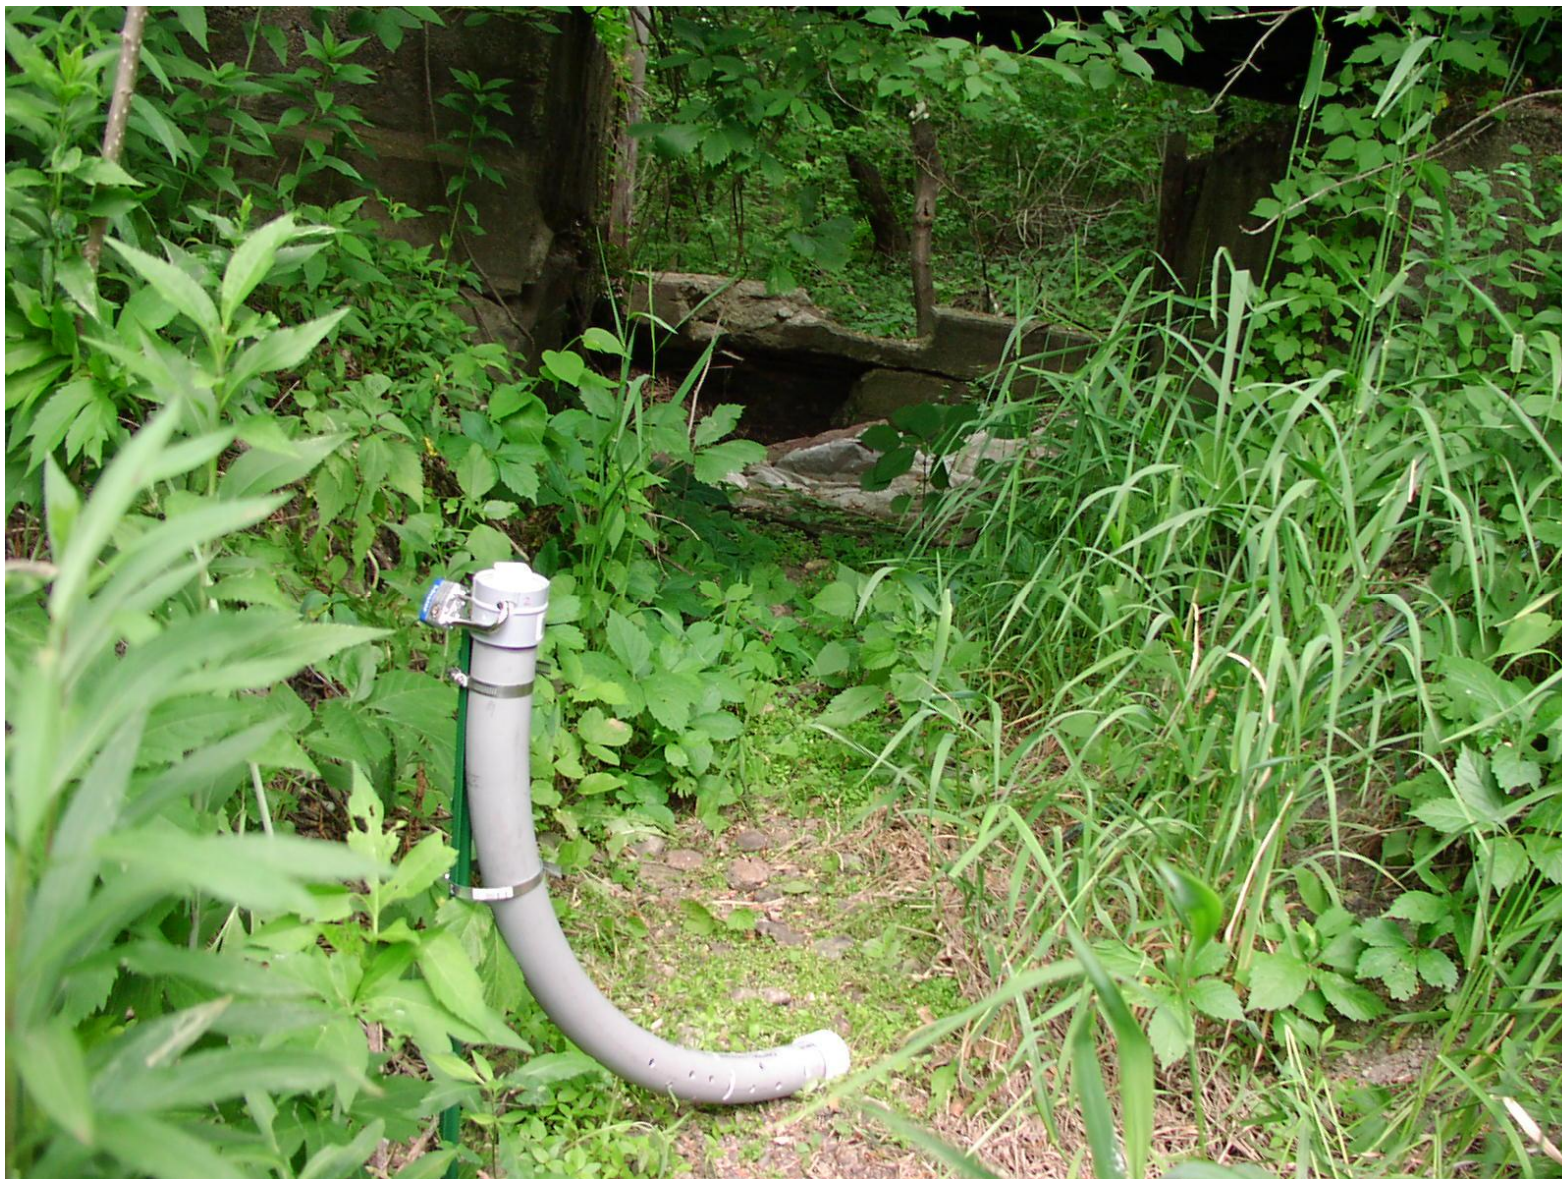
Assumption Creek Sta 2 (view DS at weir)

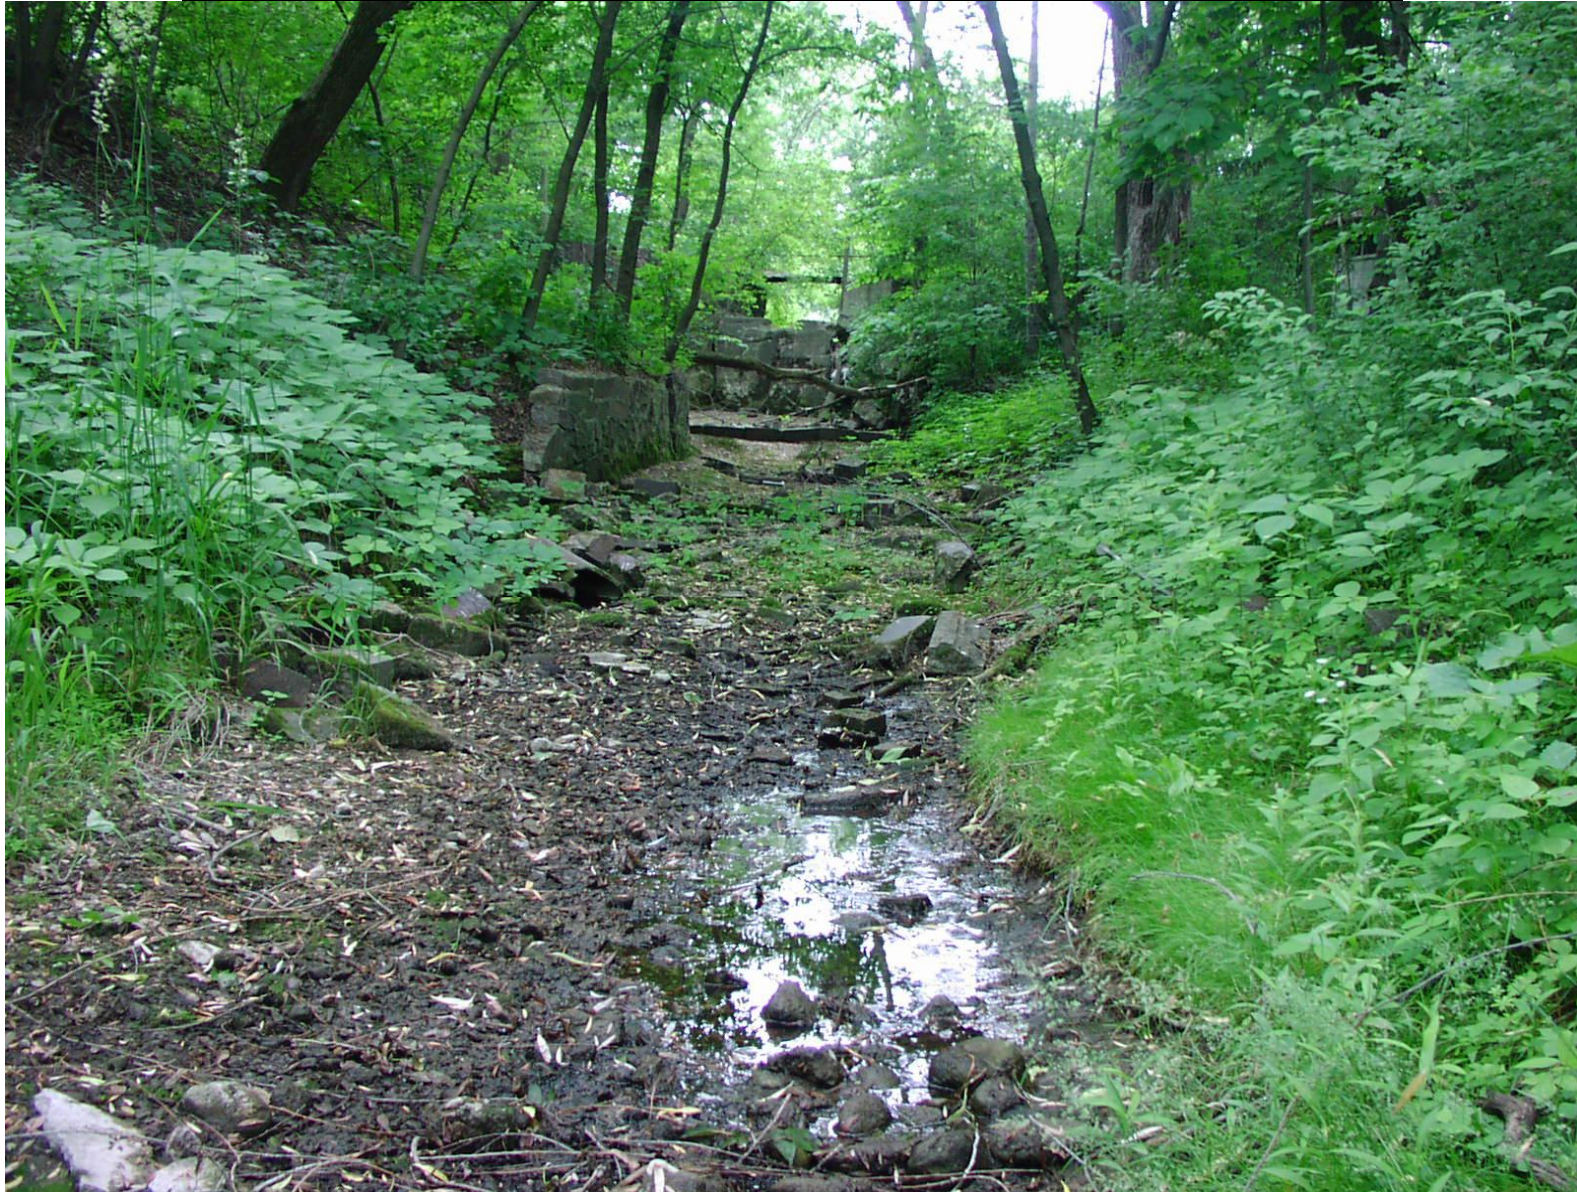
Assumption Creek 100 ft below Sta 2 (view US at structure)

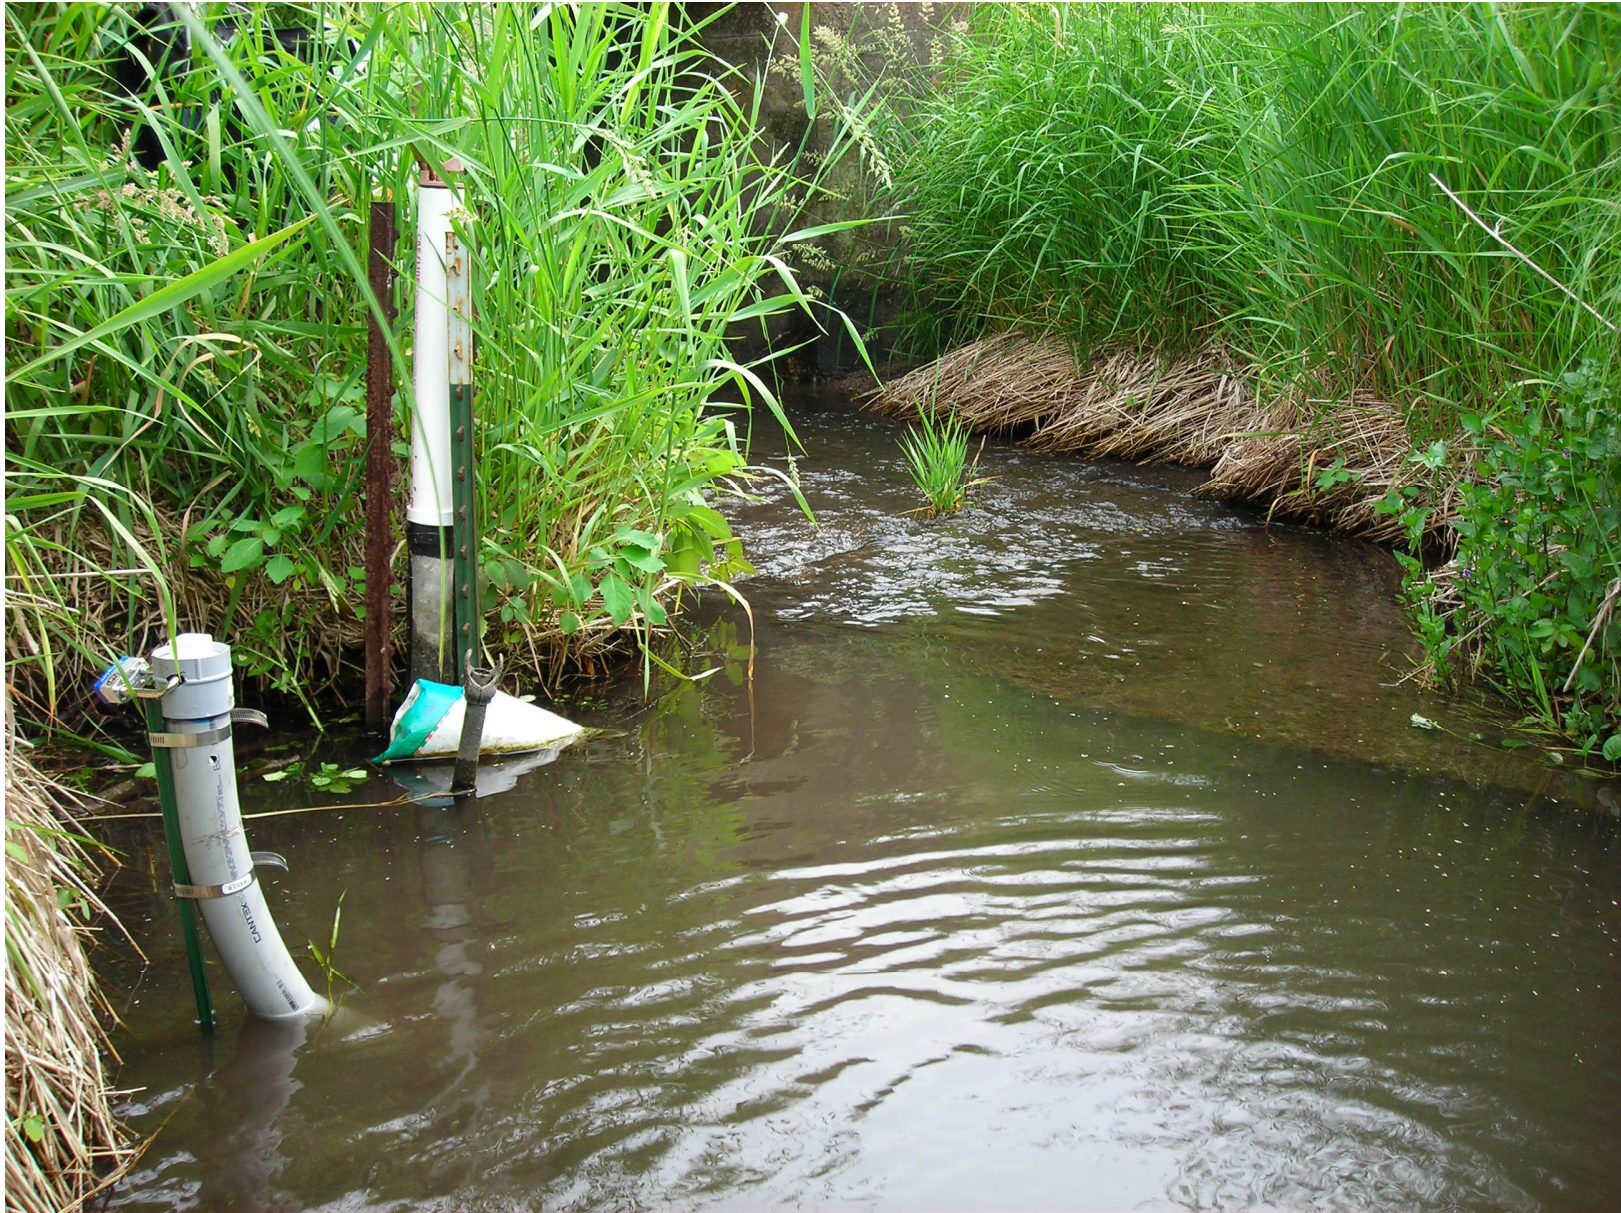
Assumption Creek Sta.3 Hwy 212 (view DS)

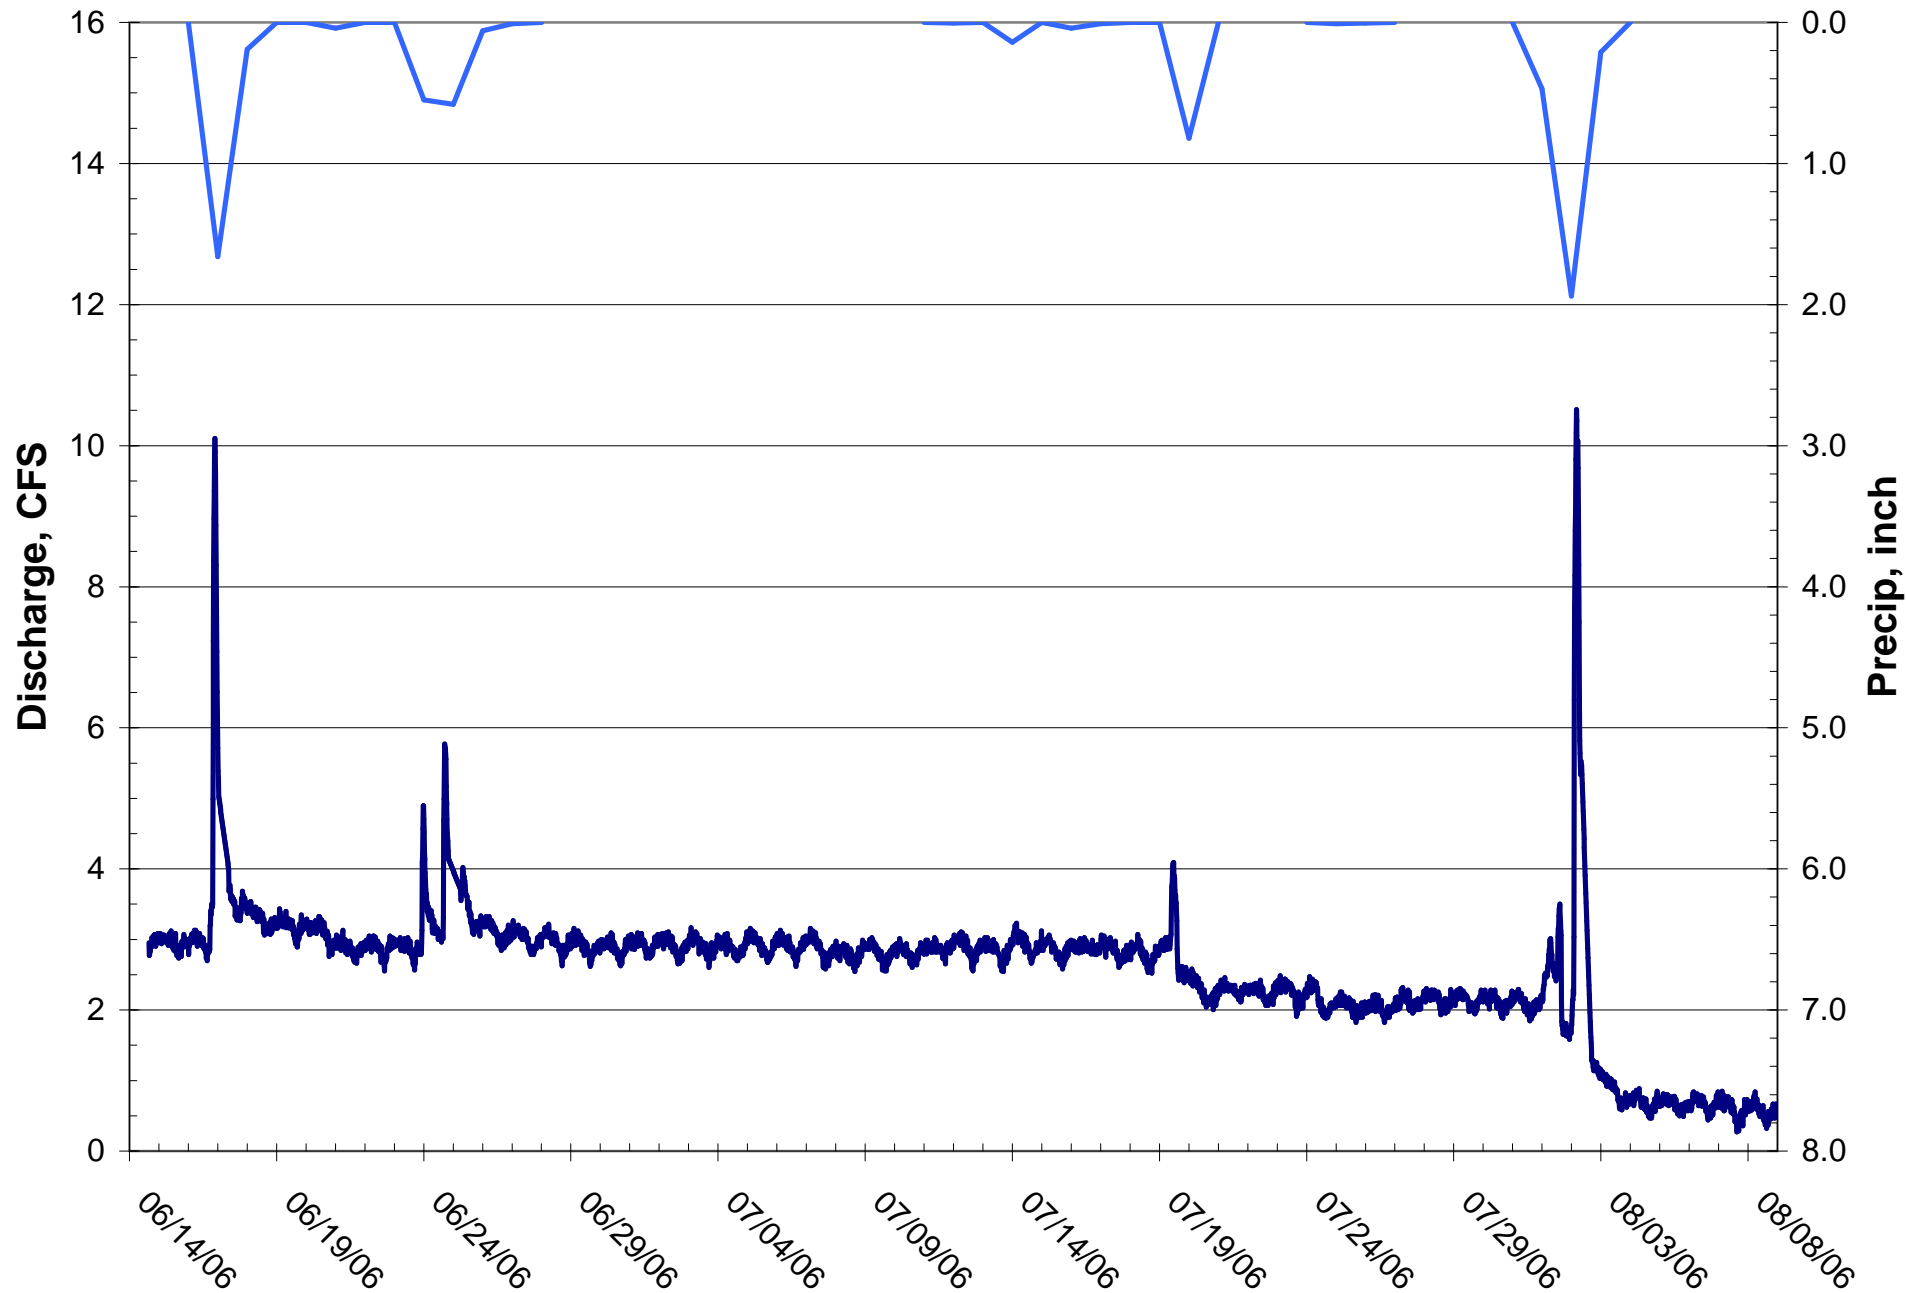
**Assumption Creek
Station 3
Calibrated Discharge and Precip**

The loggers sampled at a 15 minutes per measurement interval for the entire monitoring period. The monitoring was conducted from June – November 2006. However, due to debris in the culvert at Station 1 and a flow obstruction (beaver dam) at Station 3, data were only considered for June – August 2006
