East Chaska Creek Site #2 Upstream behind Brandondale (EC 2)

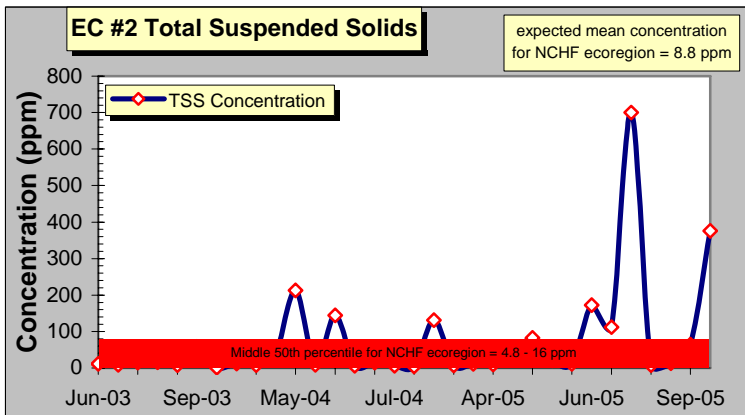
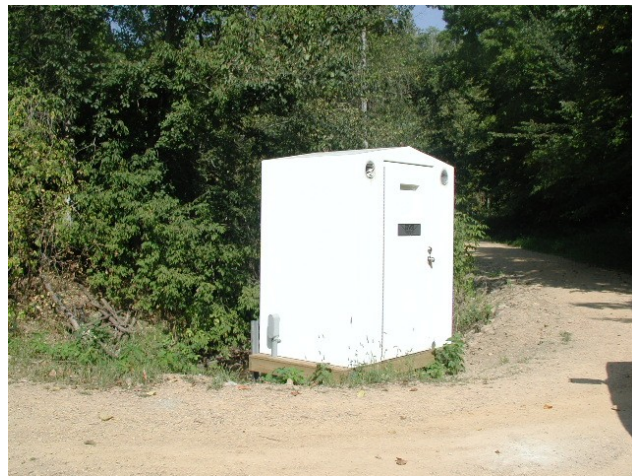
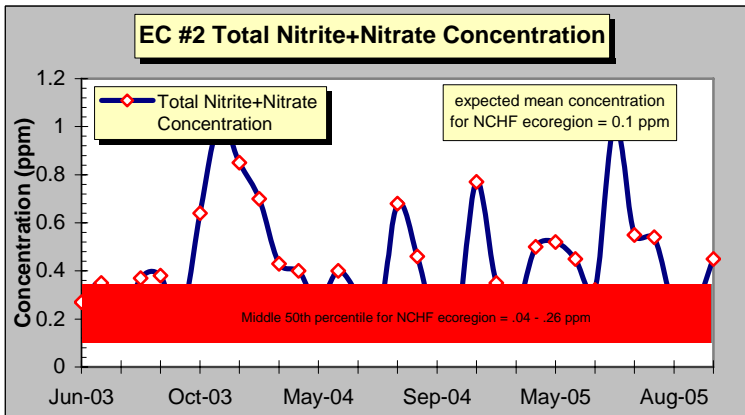
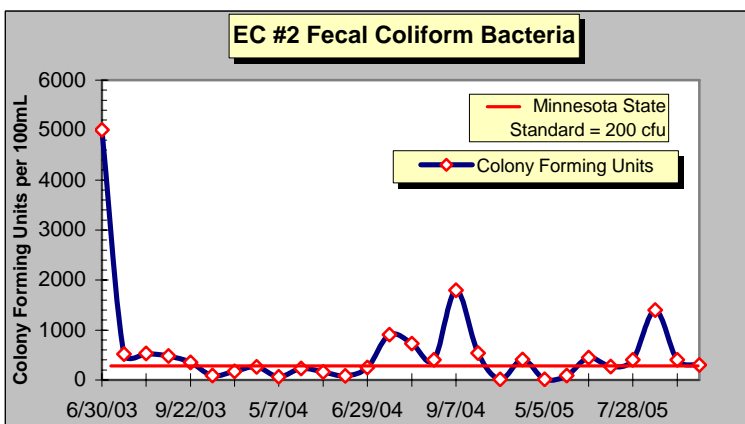
Water Quality Summary:

- Total phosphorous concentration samples were near or below the expected ecoregion average.
- Approximately half of the nitrite + nitrate concentration samples were above the NCHF ecoregion average.
- A majority of total suspended solid sample concentrations were within or below the middle 50th percentile for the ecoregion.
- Although more data is needed, Fecal Coliform Bacteria levels at the site appear to be a problem at the site.
