Seminary Fen/Chaska Ravine Restoration Project

Final Report

July 2016

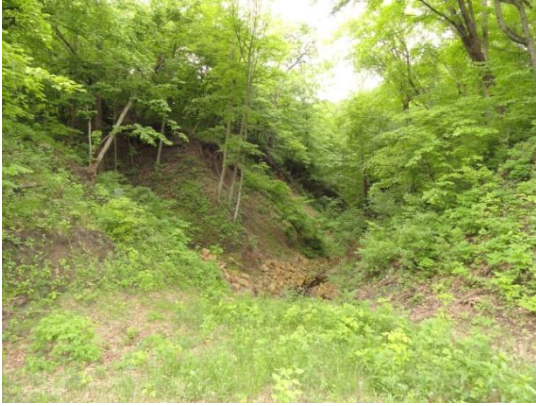
Minor erosion from historic flows and lack of herbaceous vegetation along slopes

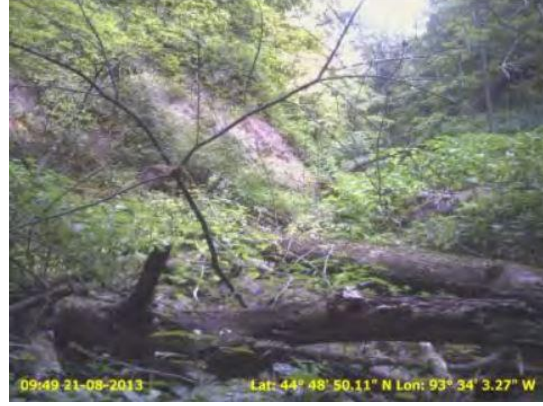
Unstable channel bottom and fallen trees cause toe of slope erosion and slope failure

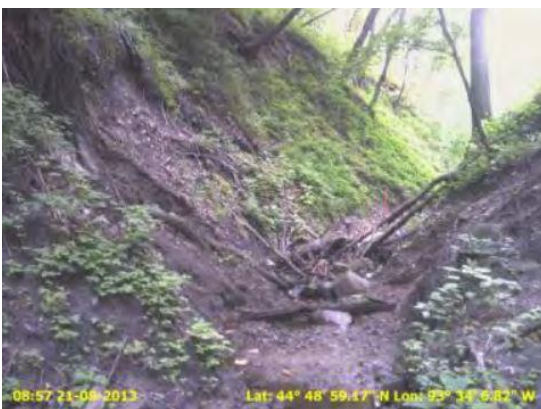
Loss of channel bottom and toe erosion cause slope failure

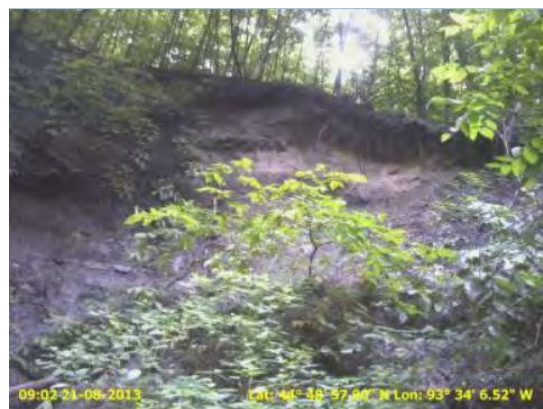
Side hill seeps cause slope instability

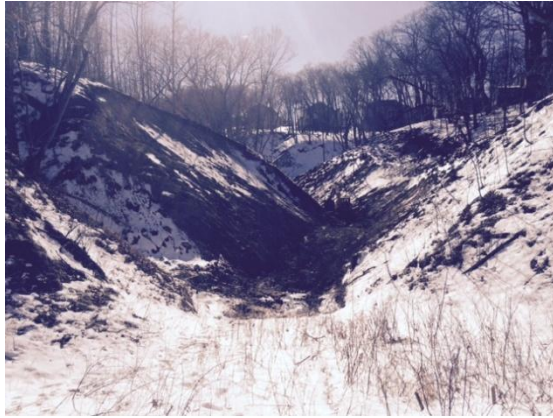
Construction occurred in December 2015

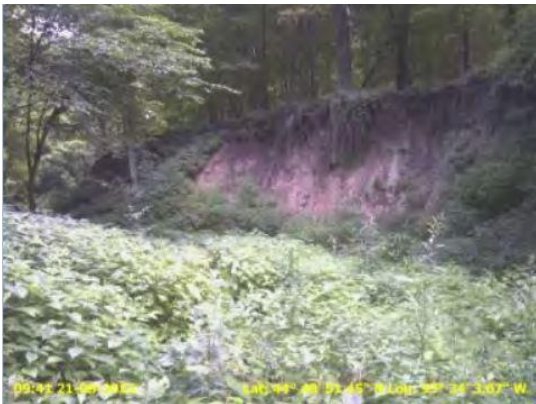
Channel migrating to the steep bluff slope and a loss of access to the floodplain has caused toe erosion and slope failure.
