# ANNUAL MONITORING REPORT 2018

Savage Fens summer of 2018

Prepared for:  
**Lower Minnesota River Watershed District**

By: SCOTT SWCD  
Jordan, MN

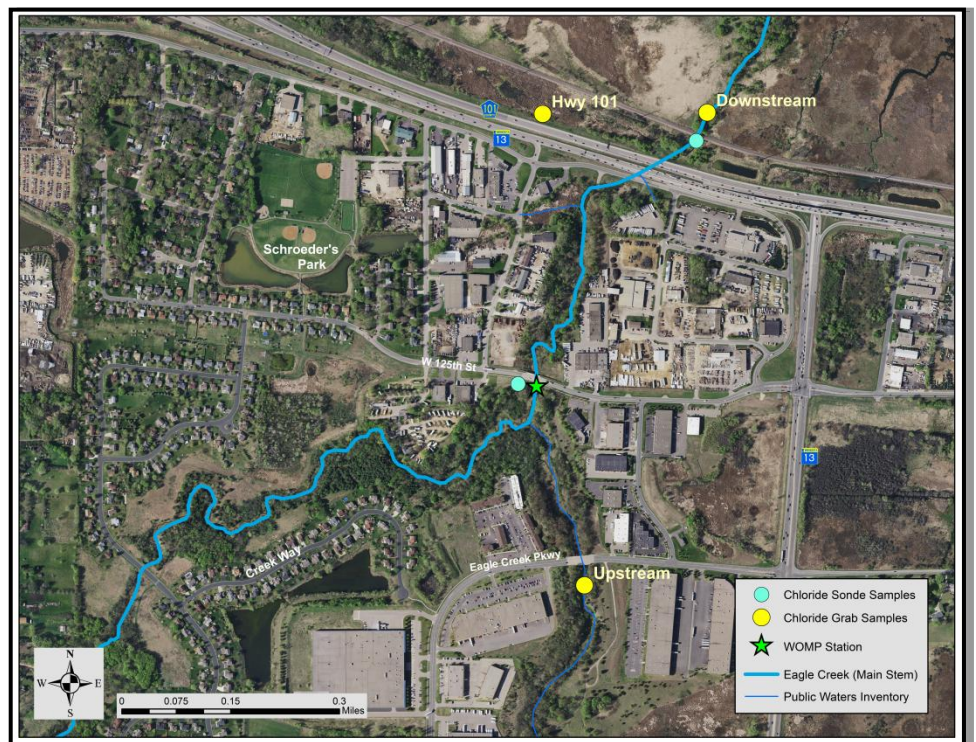
**Figure 7.** Map depicting the locations of the grab samples and sonde readings for the 2018-2019 chloride analysis.

New monitoring to trace potential chloride inputs began in early November of 2018 and is scheduled to conclude at the beginning of May 2019. Samples are collected in three targeted areas around the watershed to capture baseline and runoff chloride concentrations to see if there are areas that are susceptible to higher levels of chloride pollution during the winters (Figure 7). The selected locations will divide the watershed into sections that can help identify areas with the highest inputs. Chloride and *Escherichia coli* (E. coli) samples are collected bi-weekly along with up to eight additional event samples. The event samples are dictated by two consecutive days of above freezing ambient temperatures (32°F). This will capture the greatest potential for chloride runoff into the creek. During each sample run in a sonde reading will be collected at each sample location along with additional sonde sample sites. The goal is to relate chloride concentrations to conductivity levels and translate the correlated chloride values to the sonde only measurements. In addition to chloride, E. coli samples are also collected to help isolate the source of historically high levels observed during the winter months.
