# Geomorphic and Habitat Assessments of Trout Streams in the Lower Minnesota River Watershed District

August 2019

Prepared For: The Lower Minnesota River Watershed District

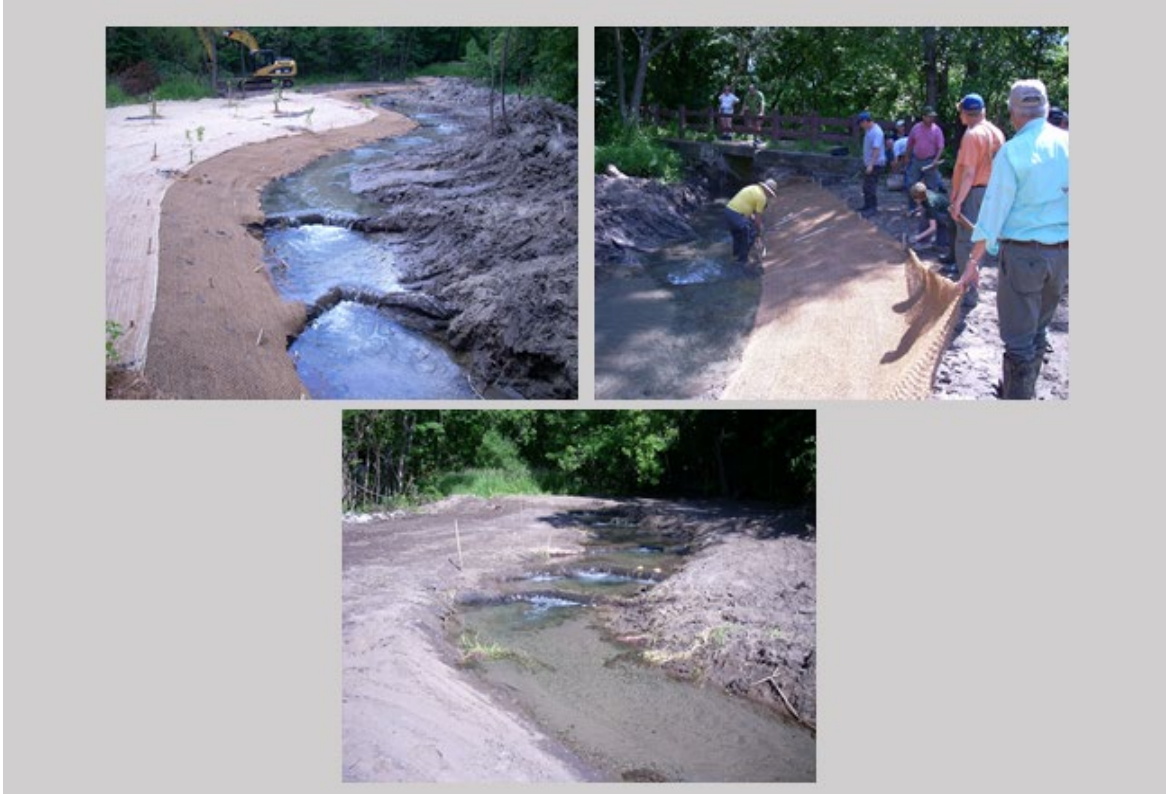
In 2014, Brenda DeZiel, Research Scientist at the University of Minnesota, visited Eagle Creek and completed a habitat assessment. At that point, she rated channel stability as high and depth variability as excellent. She came back in 2019 to show the team how to properly perform a habitat assessment, and observed that there had been major differences in the stream since 2014. More areas of aggradation are apparent today throughout Eagle Creek, but channel stability and depth variability mostly maintained their 2014 scores ([see figure A.2 in Appendix A](#)).

Figure A.2. Eagle Creek in 2014 on left and picture of increased aggradation in 2019 on right. Brenda DeZiel (2014). Kirsten Haus (June 2019).
