Erosion Stabilization Study

Study Area 3 Final Report

Prepared for the
City of Eden Prairie

Prepared by
SRF CONSULTING GROUP, INC.
SRF No. 0076205

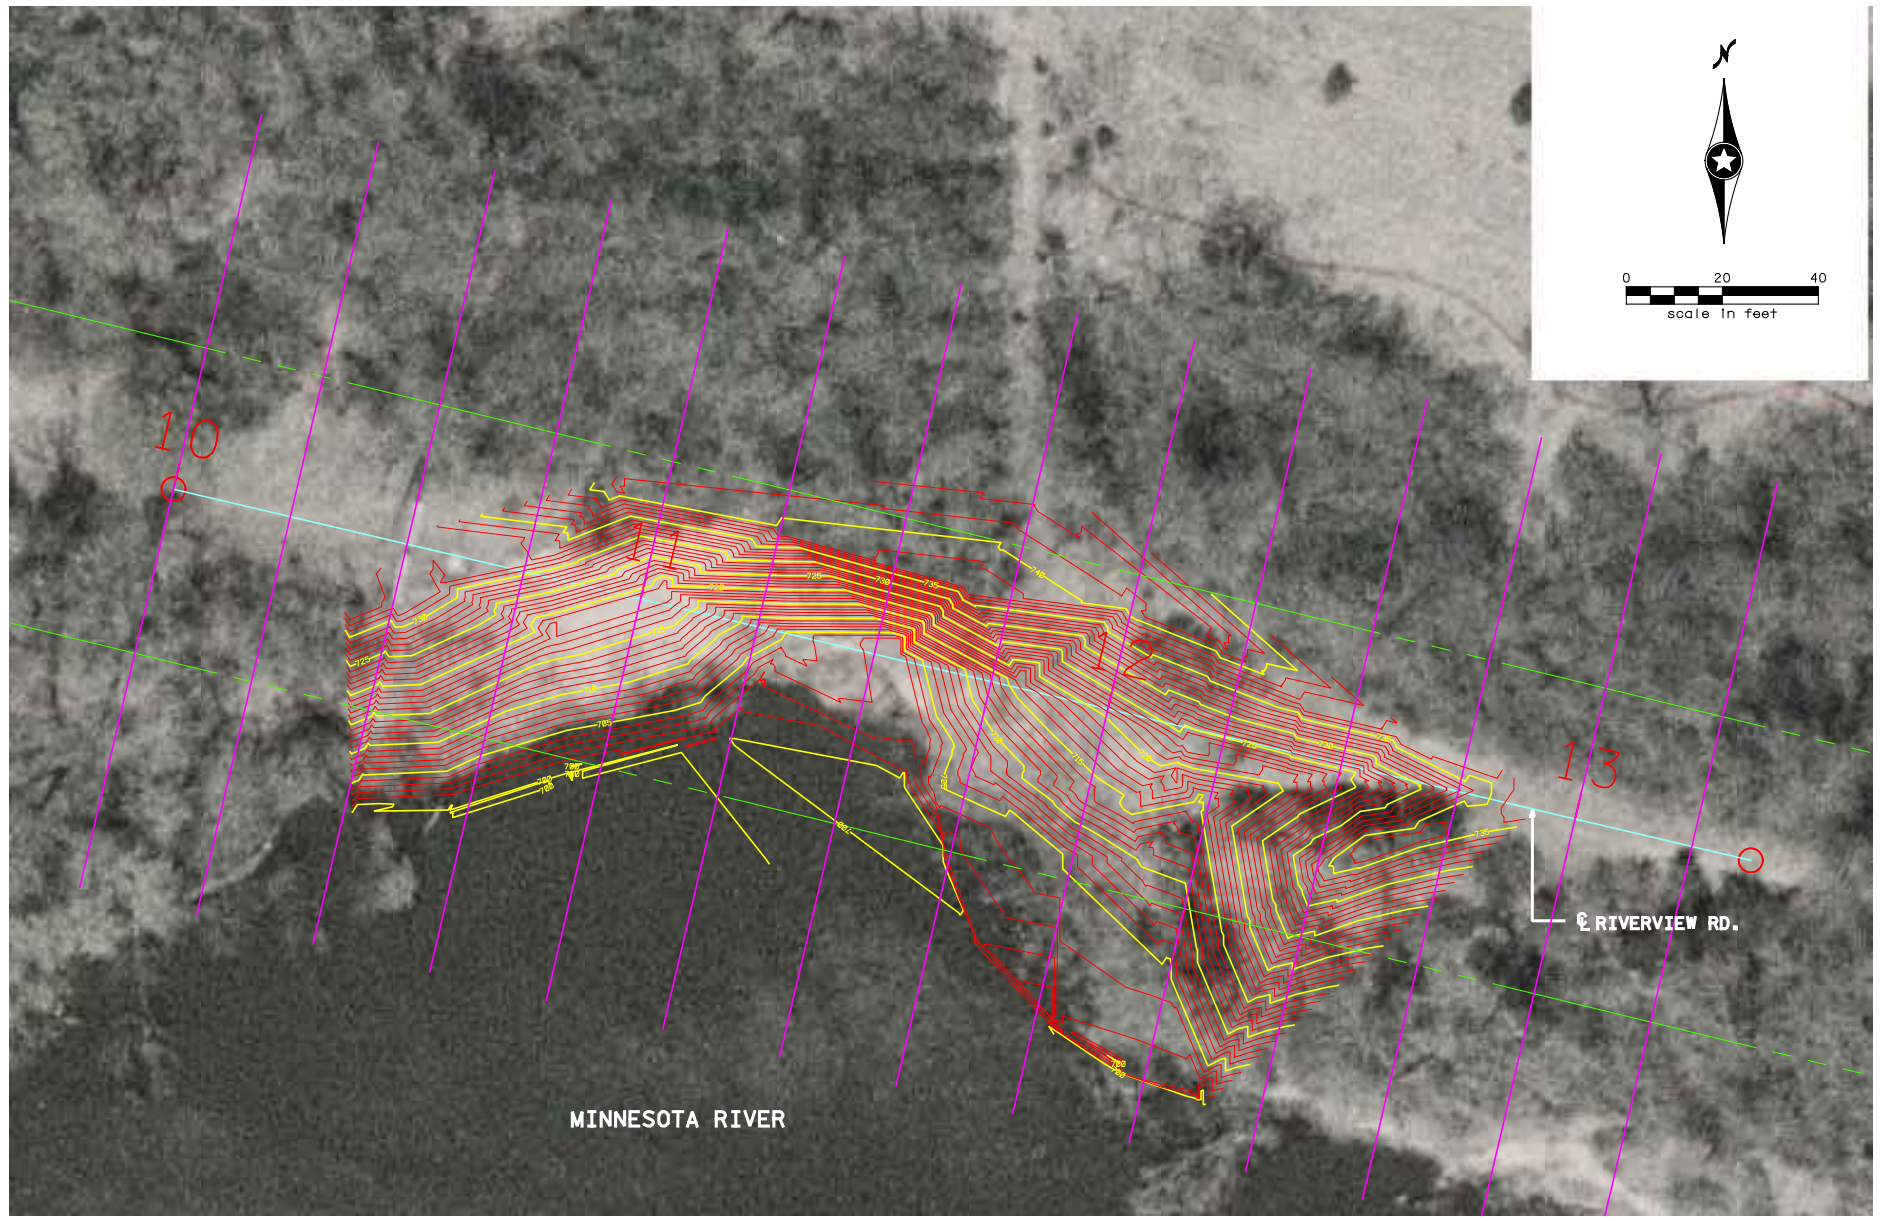
Appendix B: Study Area 3 Cross Section Layout (Existing Conditions)

As noted earlier, a series of springs emerge from the bluff between five and ten feet (vertical) above the water surface (as measured on May 16, 2008). Several cross sections within the most severely eroded area (station 11+25 through station 12+00 in Appendix B) show that sloughing above this elevation is somewhat more evident than in other sections.

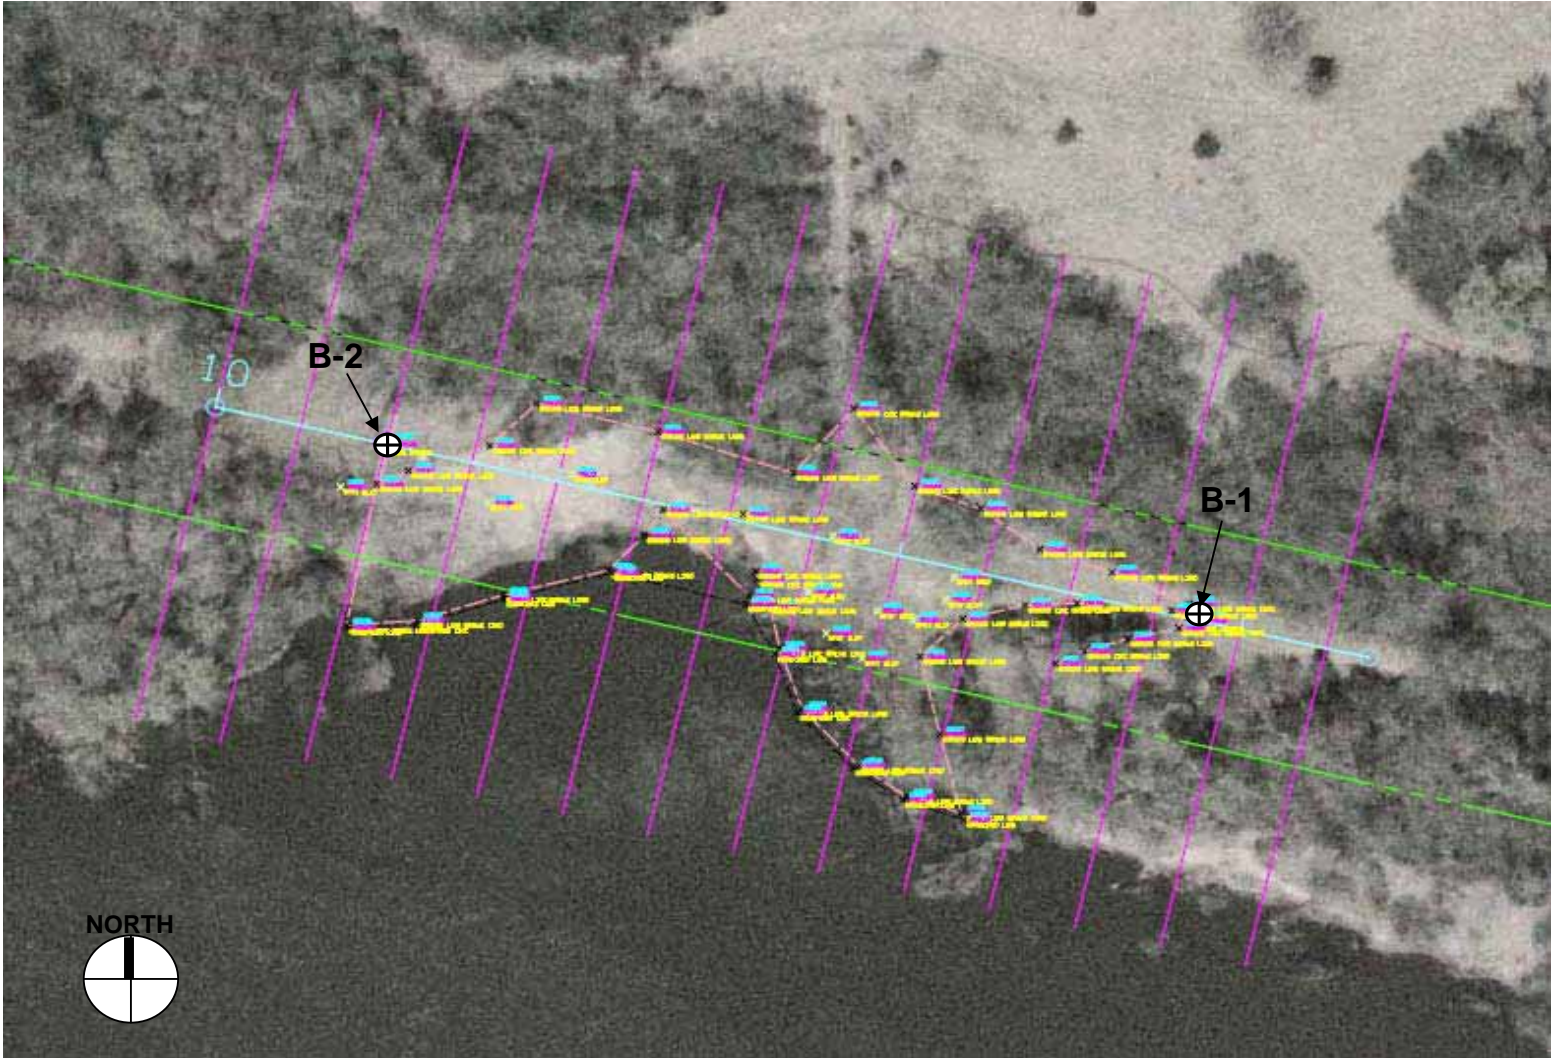
PROJECT	Eden Prairie Erosion Stabilization Study Area 3	SHEET NO.	1
SUBJECT	Soil Boring Location Diagram (taken from original provided SRF)		
DATE	June, 2008	BY	BAT
		GTE PROJECT NO.	95333

In general, the soil borings indicate the slope soils to comprise of approximately 20 to 35 ft of loose to medium dense silty sands with a little to trace gravel overlying approximately 30 to 35 ft of medium dense to dense silts. Below the silt layer, boring B-2 identified dense fine to medium and medium coarse sands.

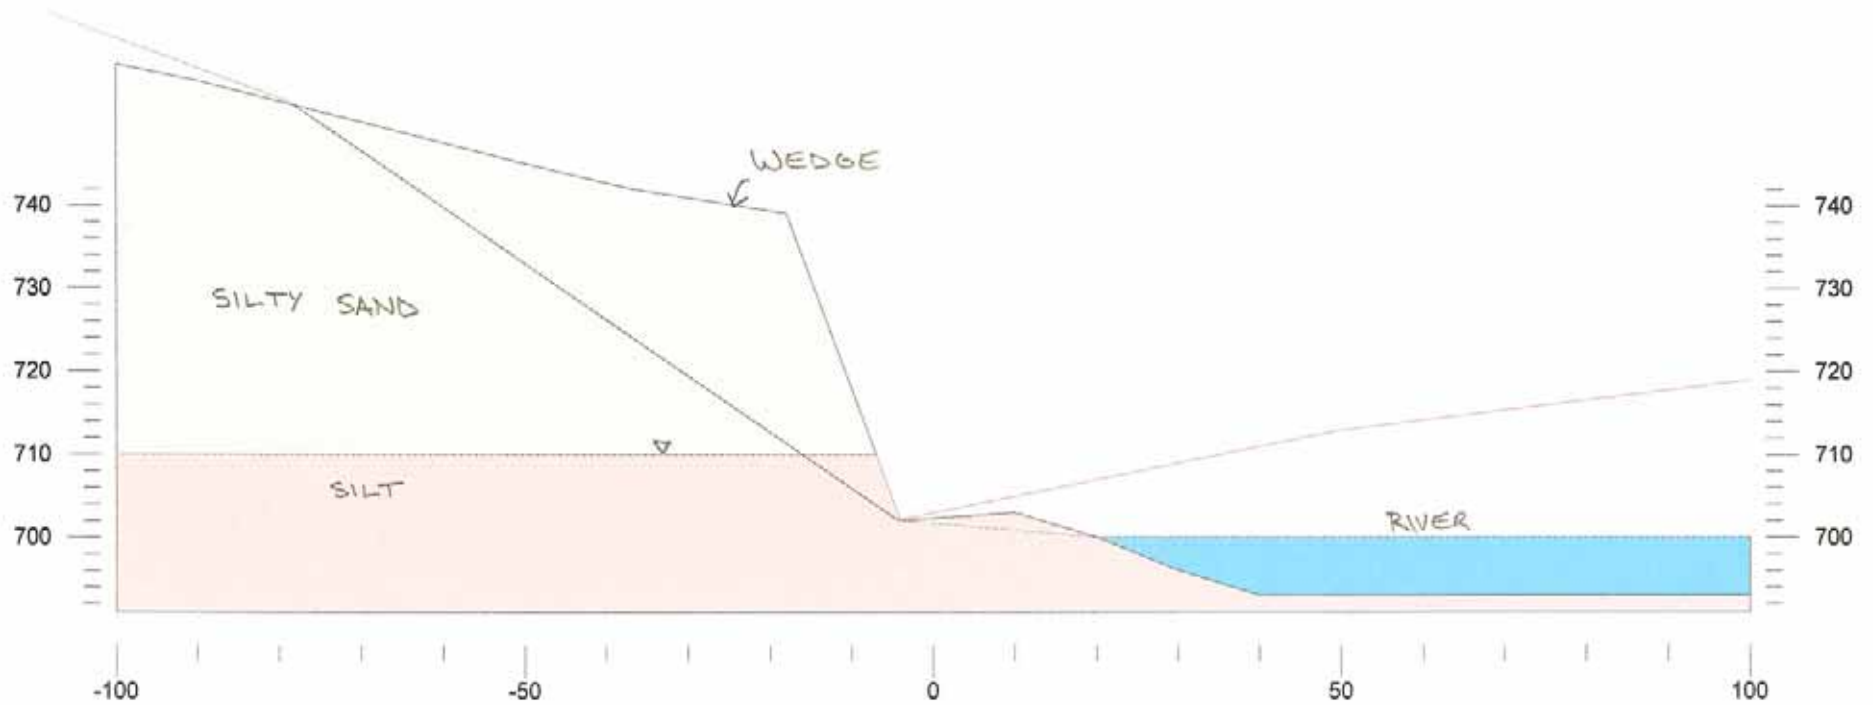
Eden Prairie Stabilization - Area 3
 Gale-Tec Engineering, Inc.
 June, 2008
 Station 11+50, Wedge Failure
 Assumed Conditions for Limit Equilibrium (FS=1.0)
