Technical Memorandum

To: Linda Loomis, Administrator
Lower Minnesota River Watershed District

Re: Area 3 Slope Stability Project Update

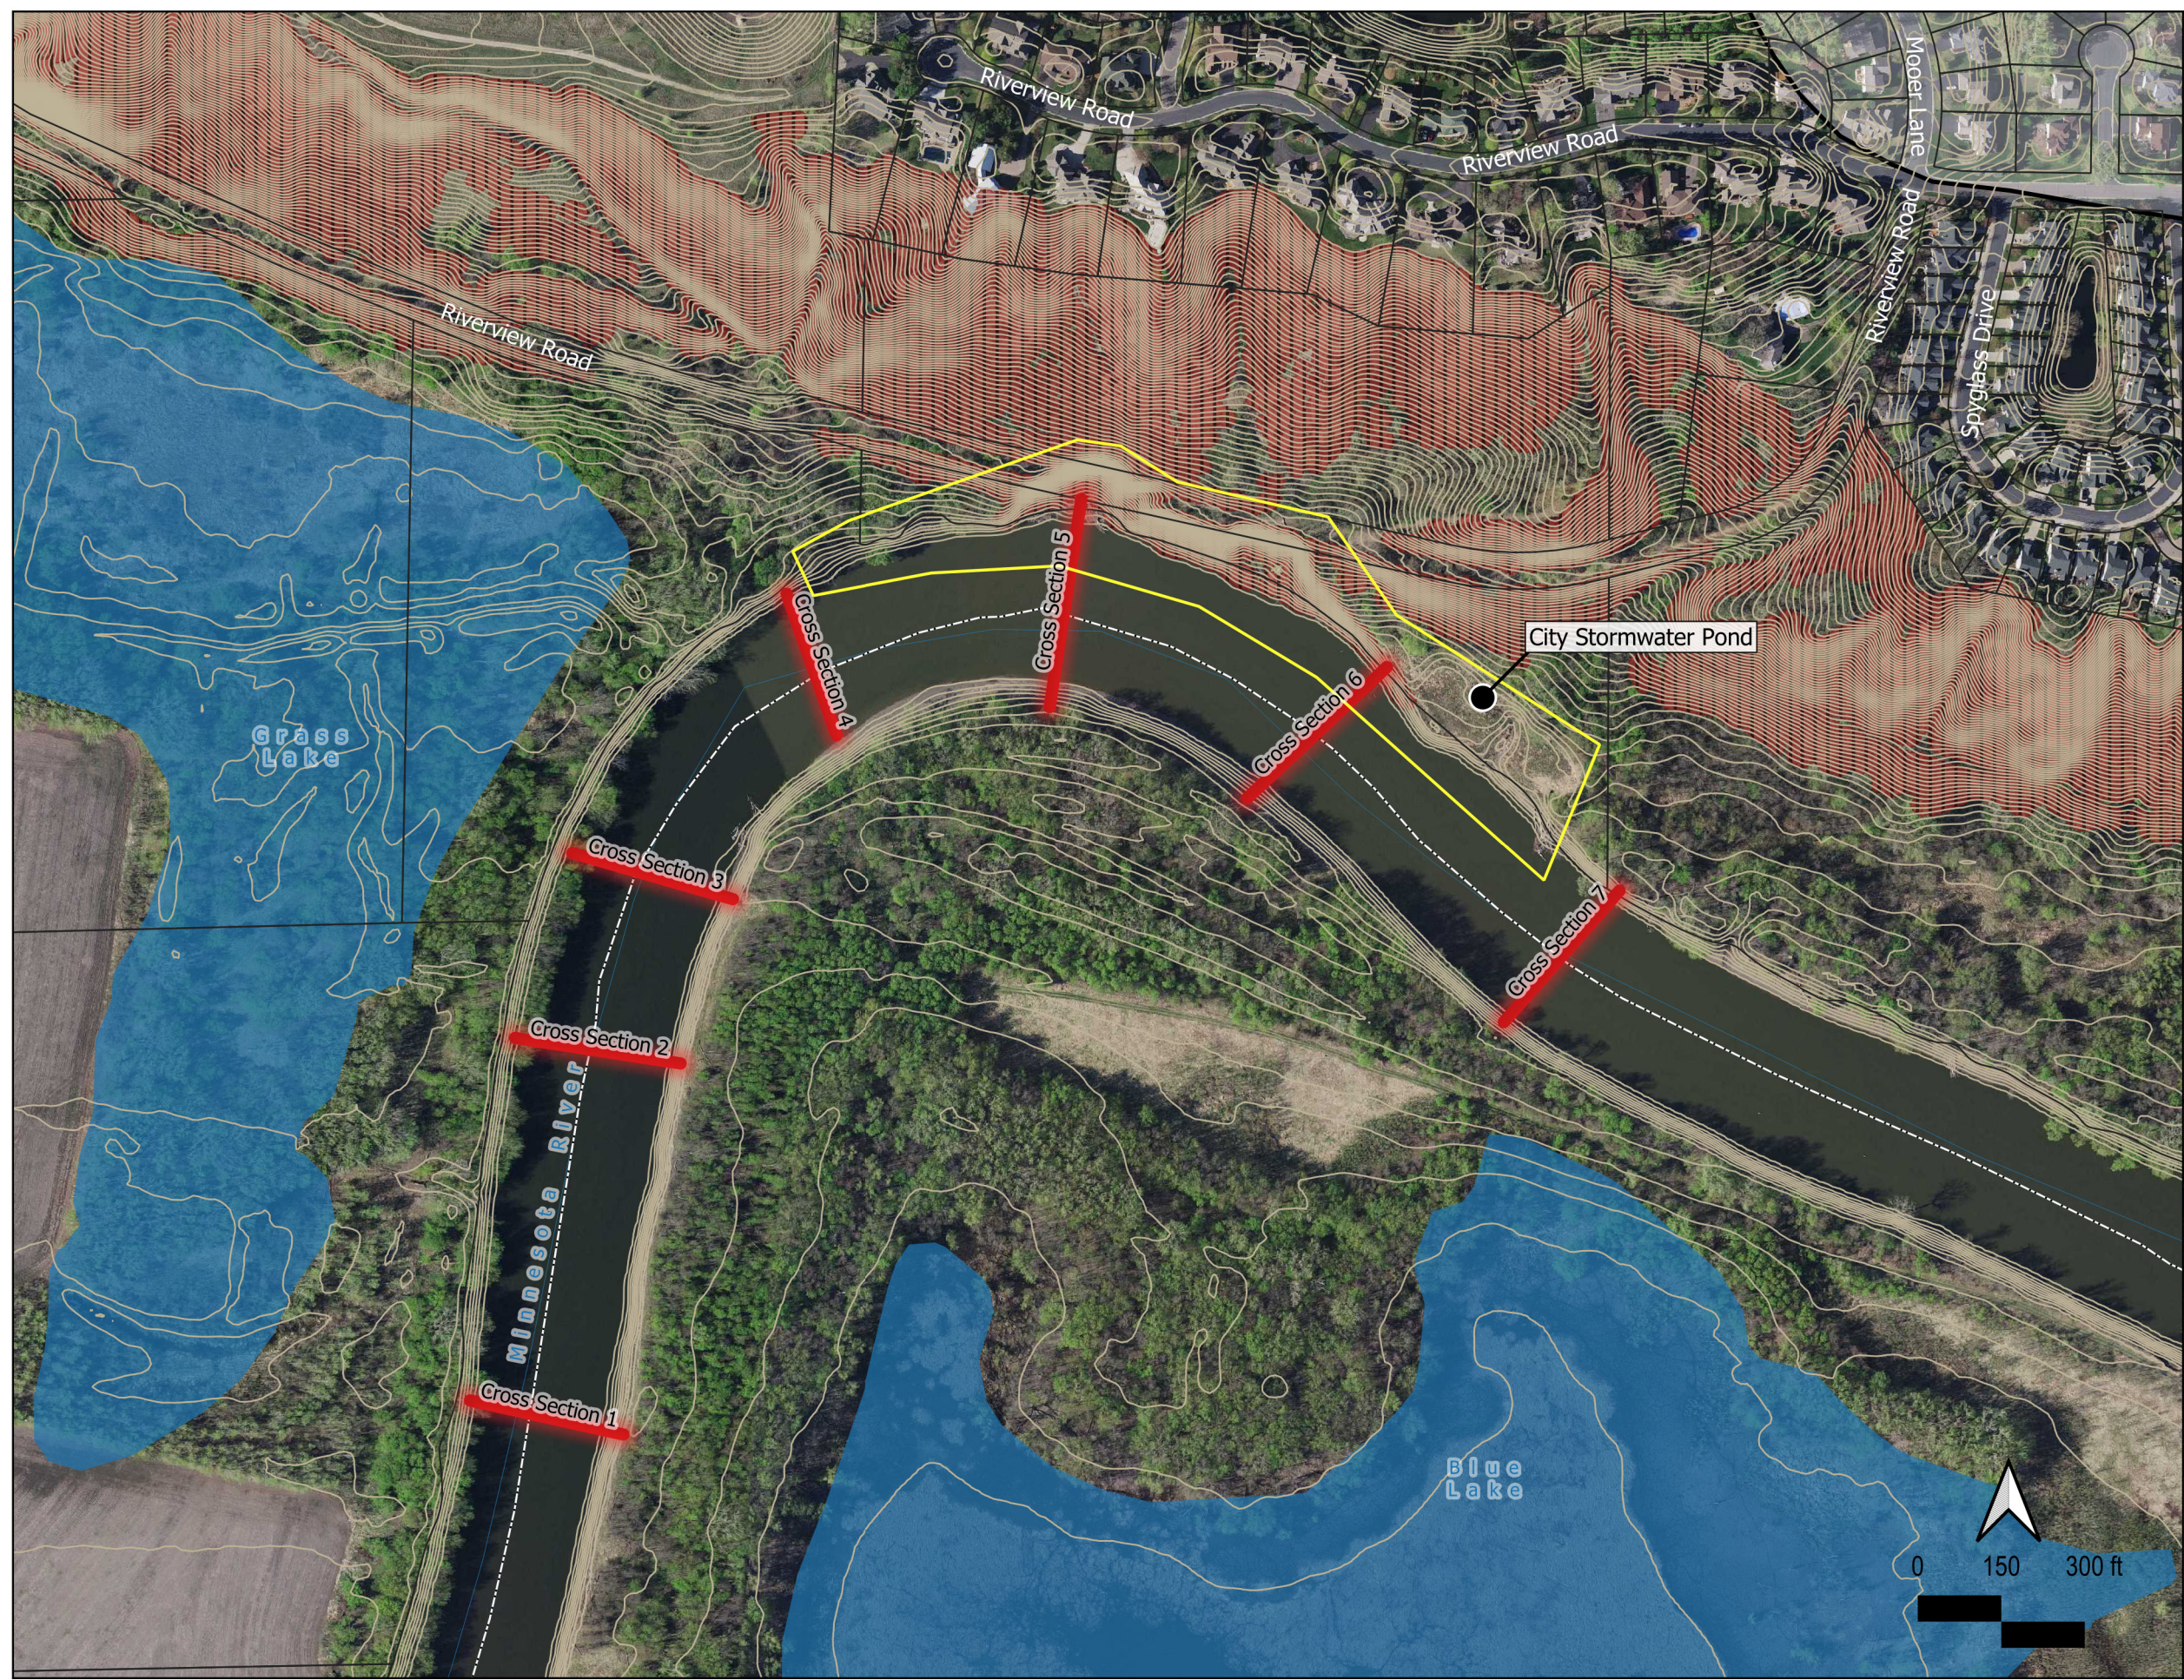
**Figure 1:
River Cross-Sections**

Barr conducted a bathymetric survey of the six cross sections surveyed in 2009 on September 3, 2020 (**Figure 1**). The cross-sectional data was compared to the 2009 data by aligning the horizontal stations and elevations at the survey (**Figure 2**).

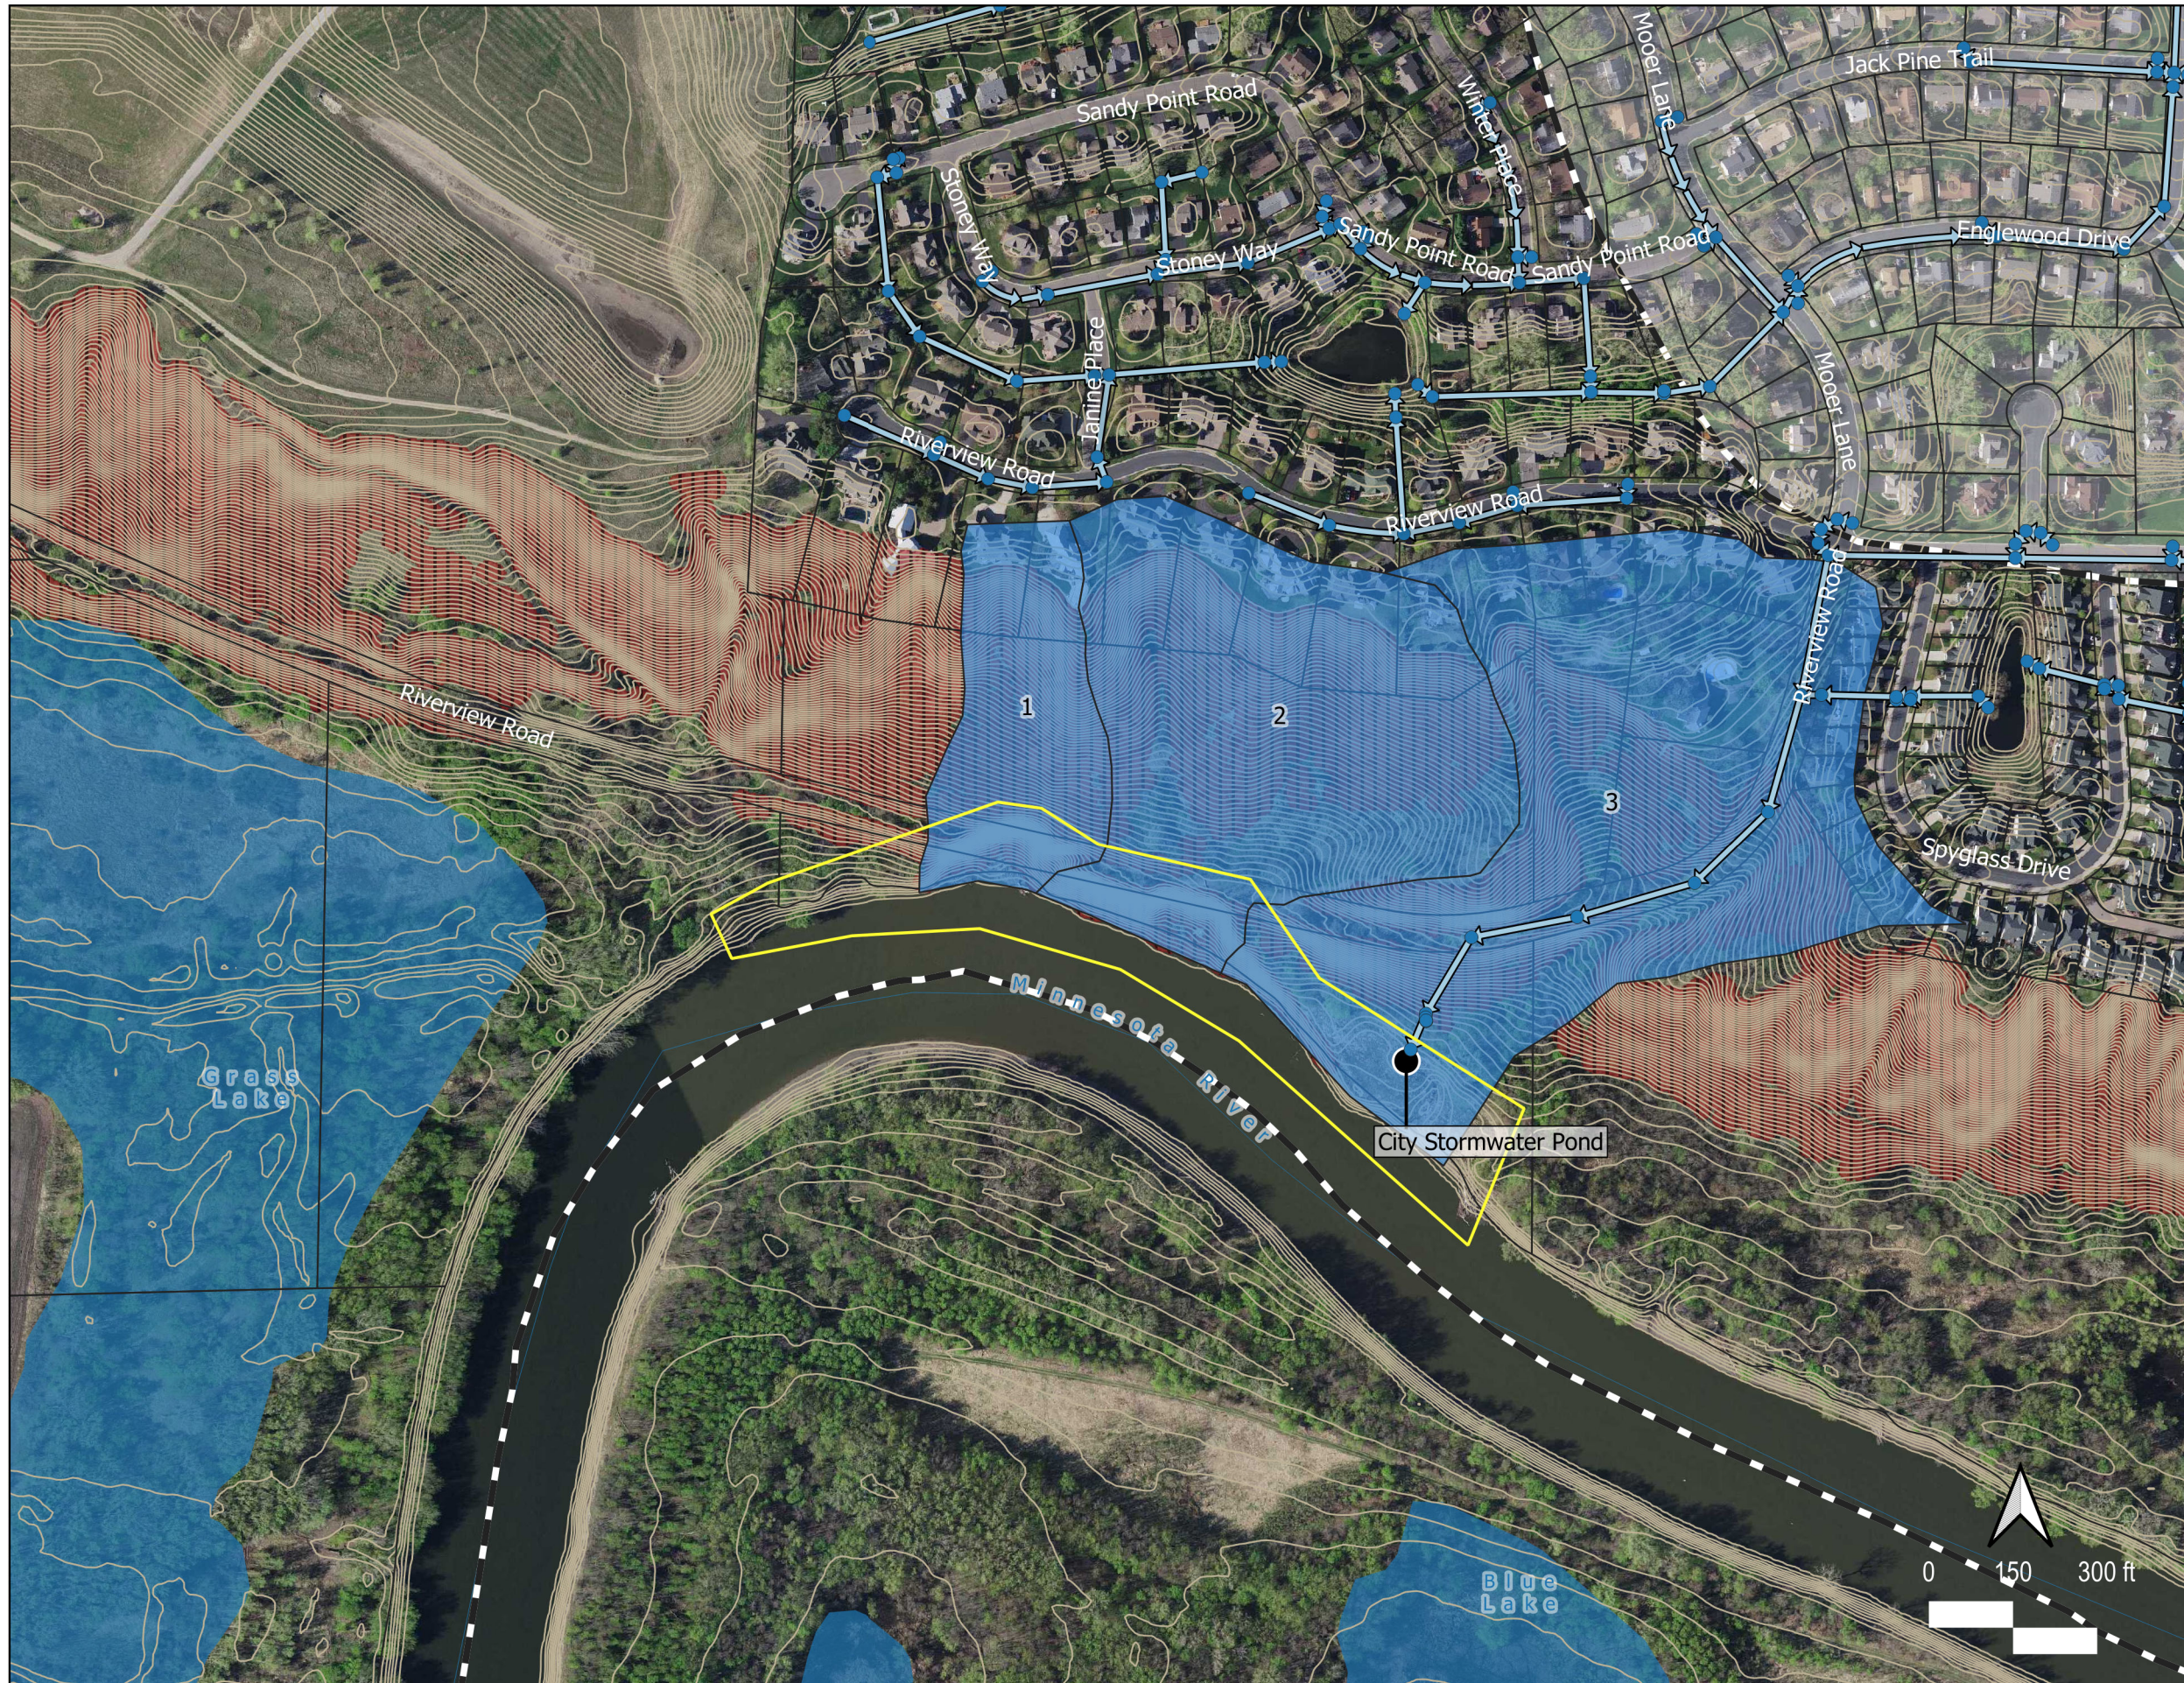
**Figure 6:
Area 3 Watershed
Delineations**

Using the City’s storm sewer network and the MnDNR LiDAR data, three sub-catchments were delineated to the locations where gullies flow into the Minnesota River from the Area 3 embankment (**Figure 6**). This delineation confirmed that there are no major storm sewer outfalls into the gullies from Riverview Road. The gully drainage areas appear to be limited to the areas directly connected to the gullies. The sub-catchments are relatively small (3.3–16.2 acres) and predominately open space, with a small amount of single-family residential development at the top of each subcatchment.

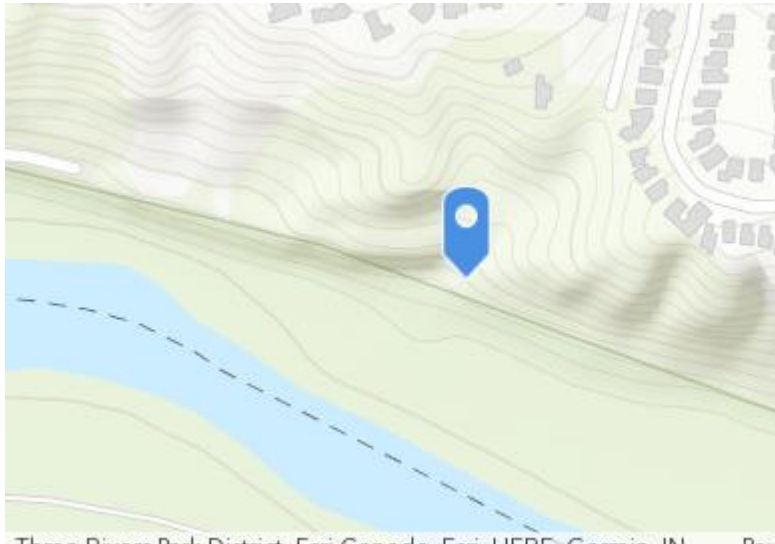
GULLY ID: 999-166

WATER LEVELS	Low, Fast
SEEP	Yes
APPARENT CAUSES:	Seep/groundwater, Slope
ADDITIONAL NOTES: Rated high erosion potential because there is deep incision from the groundwater seep area and most of the banks are overhanging. Headcut is actively eroding from a large, bare soil groundwater "bowl" Gully widens out after about 20 feet and appears to stabilize, but then quickly incises again due to u stable stream channel Invasive Species? Low Type: Common Buckthorn

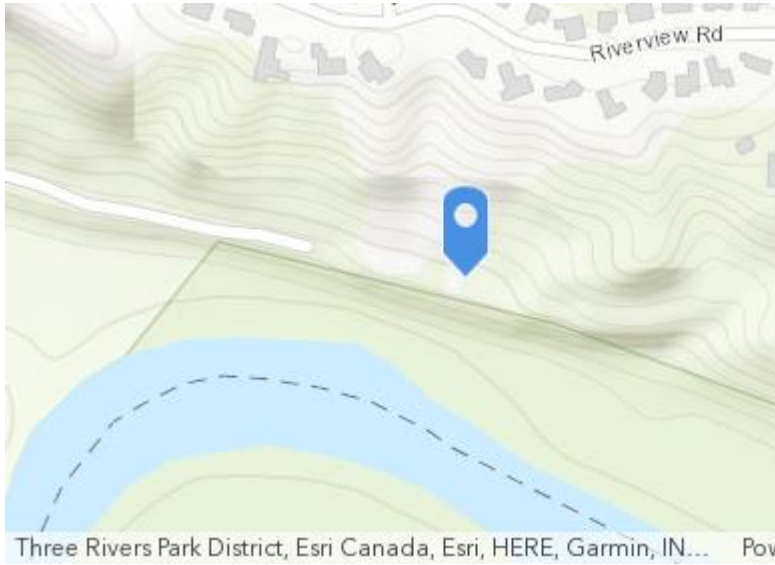
GULLY ID: L275

PREVIOUS WAYPOINT ID: 1263	
SURVEY DATE: 07/28/2020 2:04 PM	
LOCATION: Eden Prairie	
TYPE OF SITE: Gully	
SITE SUMMARY: Partly Cloudy Rain in previous 24 hours: No Off of Walking Trail Short: <50' gully. The problem indicators were: Flattened and/or slumping banks (widening), undercut or overhanging banks (lateral scouring), pistol-butted or leaning trees	Gully Head UTM Estimation: 4962322N 465478E, Observation Point correction, if applicable: Connections to other points, if applicable:
GULLY INFORMATION	
EROSION POTENTIAL:	High
GULLY DEPTH:	Deep: >15'
BOTTOM WIDTH:	Wide: >5'
TOP WIDTH:	Wide: >10'
BANK CONDITION:	Bare Soil
BOTTOM CONDITION:	Bare Soil
CHANNEL SLOPE:	Steep
GULLY SHAPE:	Bowl shaped slump
GULLY MATERIAL:	Sand
WATER LEVELS	Low, Slow
SEEP	Yes
APPARENT CAUSES:	Seep/groundwater, Unstable drainage feature entering system , None/Unknown
ADDITIONAL NOTES: Not really a gully, more of a very large slump along the left bank of the MN River 2007 report noted a spring and a pipe outfall. Spring was located near the river. Pipe outfall located near the left bank of the slump, but unable to assess due to steep slope. All of these features are included in a gully sheet because of the severe erosion and inability to assess pipe. Invasive Species? None Type: None

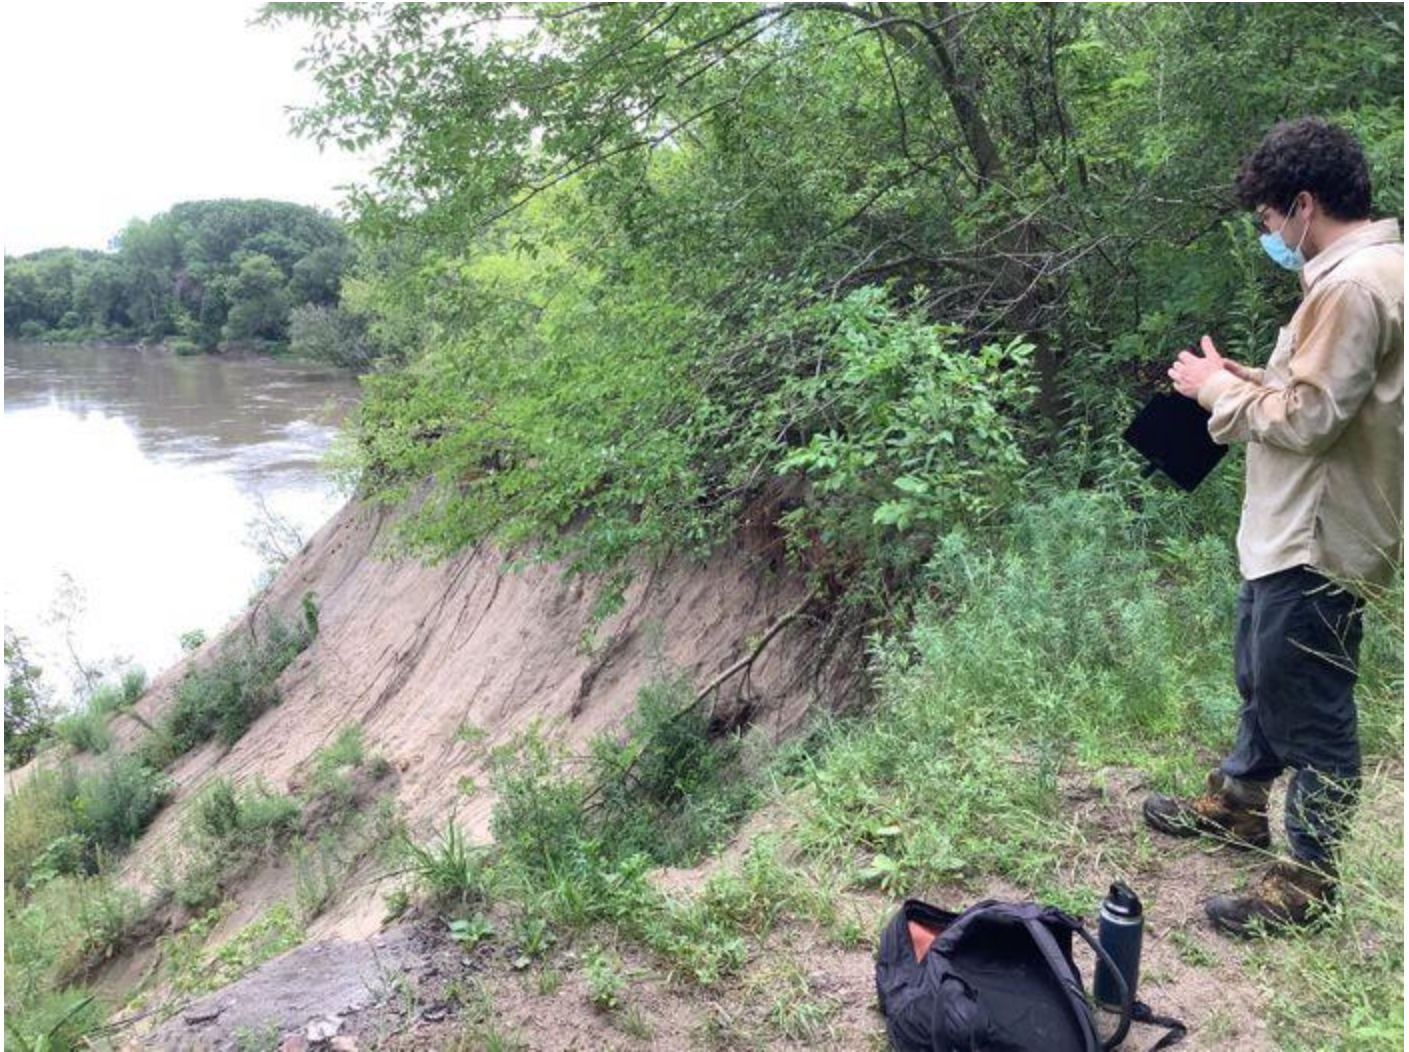
Looking u/s to the headcut area, scale

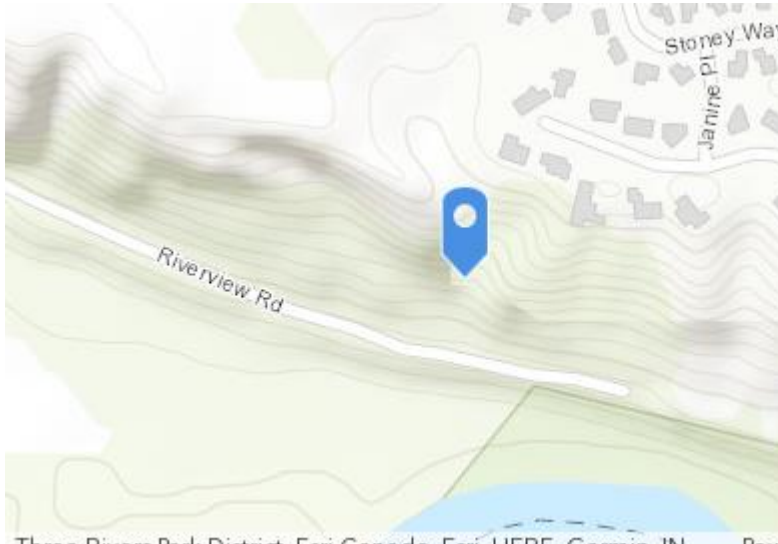
GULLY ID: L277

SEEP	Yes
APPARENT CAUSES:	Seep/groundwater, Slope, Channel Incision
ADDITIONAL NOTES: Gully is very active with signs of recent slumping and erosion through the reach. Steady base flow from seepage at headcut. Significant erosion since 2007. Because of this we conclude it has high erosion potential. Invasive Species? Medium Type: Common Buckthorn

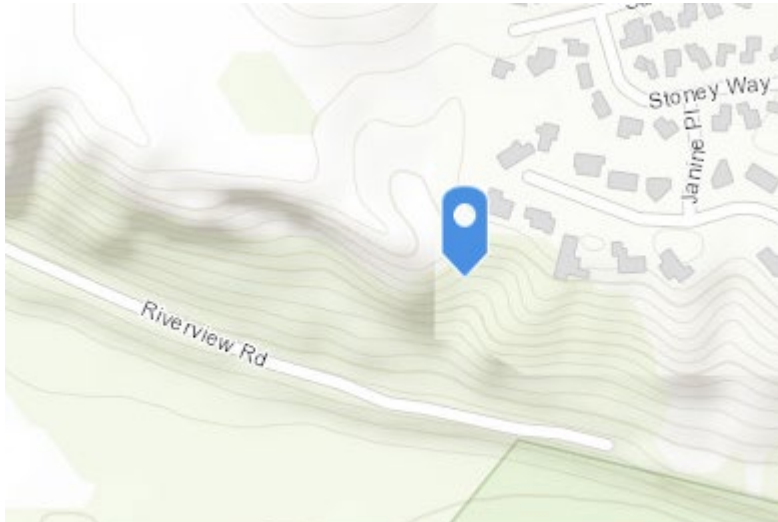
GULLY ID: L278

BOTTOM CONDITION:	Some Vegetation
CHANNEL SLOPE:	Steep
GULLY SHAPE:	V-shaped
GULLY MATERIAL:	Sand
WATER LEVELS	None, N/A
SEEP	No
APPARENT CAUSES:	Slope, None/Unknown
ADDITIONAL NOTES: Rated as high erosion potential because of steep bank slopes, narrow bottom width, and an actively eroding headcut with overhanging banks. There is little vegetation holding the soil in place along the banks. However, there were no deep slumps or sections of overhang noted along the banks themselves, so this gully is on the moderate end of high erosion potential. Invasive Species? High Type: Common Buckthorn Debris? Tire and some fallen tree

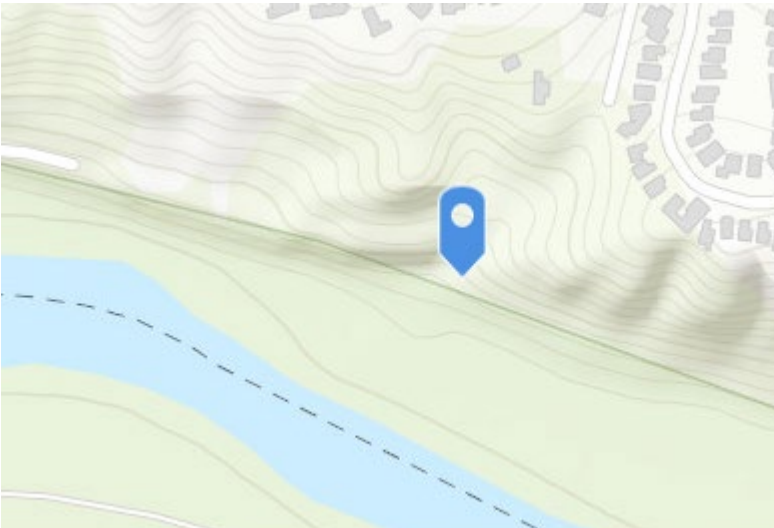
GULLY ID: L279

ADDITIONAL NOTES: High erosion potential with steady base flow as the erosive force. Lots of signs of active erosion. Off shoot gully 999-166 formed from seepage at headcut formed is becoming a higher erosion potential gully as well. Invasive Species? None Type: None

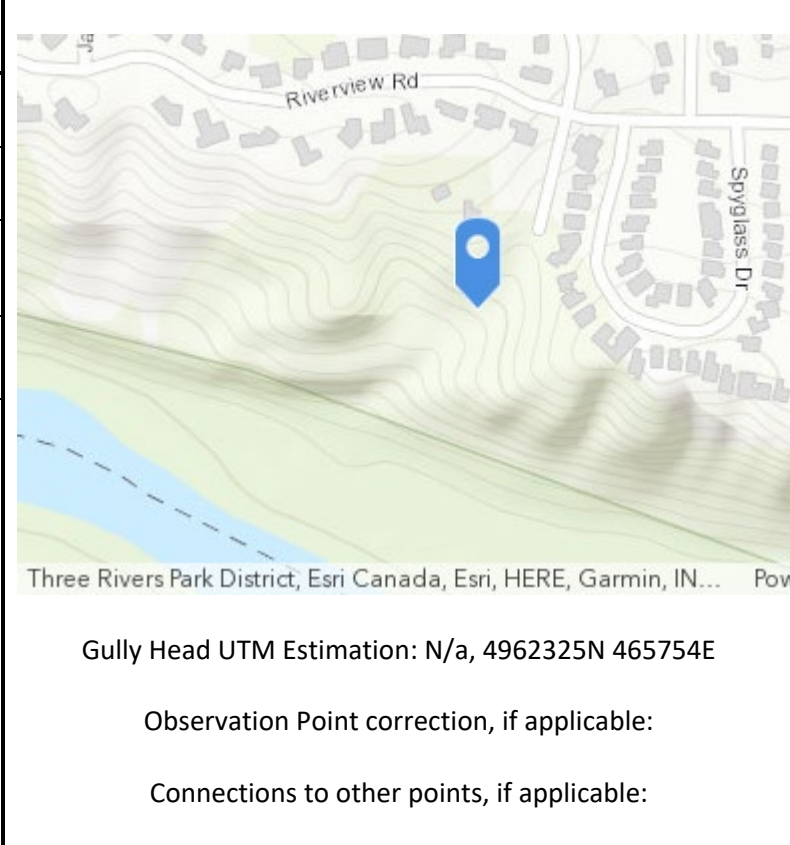
GULLY ID: L280

PREVIOUS WAYPOINT ID: 1273	
SURVEY DATE: 07/28/2020 12:51 PM	
LOCATION: Edén Prairie	
TYPE OF SITE: Gully	
SITE SUMMARY: Sunny Rain in previous 24 hours: No Off of Walking Trail Long: >100' gully. The problem indicators were: None	
GULLY INFORMATION	
EROSION POTENTIAL:	Low
GULLY DEPTH:	Shallow: <3'
BOTTOM WIDTH:	Wide: >5'
TOP WIDTH:	Wide: >10'
BANK CONDITION:	Heavy Vegetation
BOTTOM CONDITION:	Armored
CHANNEL SLOPE:	Steep
GULLY SHAPE:	Trapezoid
GULLY MATERIAL:	Gravel/cobble/ boulders
WATER LEVELS	None, N/A
SEEP	No
APPARENT CAUSES:	None/Unknown
ADDITIONAL NOTES: 2008 Report listed this as a heavily eroded trail, and a small gully was visible. Looks like trail was restored with riprap, it is now a narrow path with heavy vegetation along each side, virtually no banks, and no erosion evident. Invasive Species? None Type: None Debris? None Existing Stabilization? Riprap Success: Yes

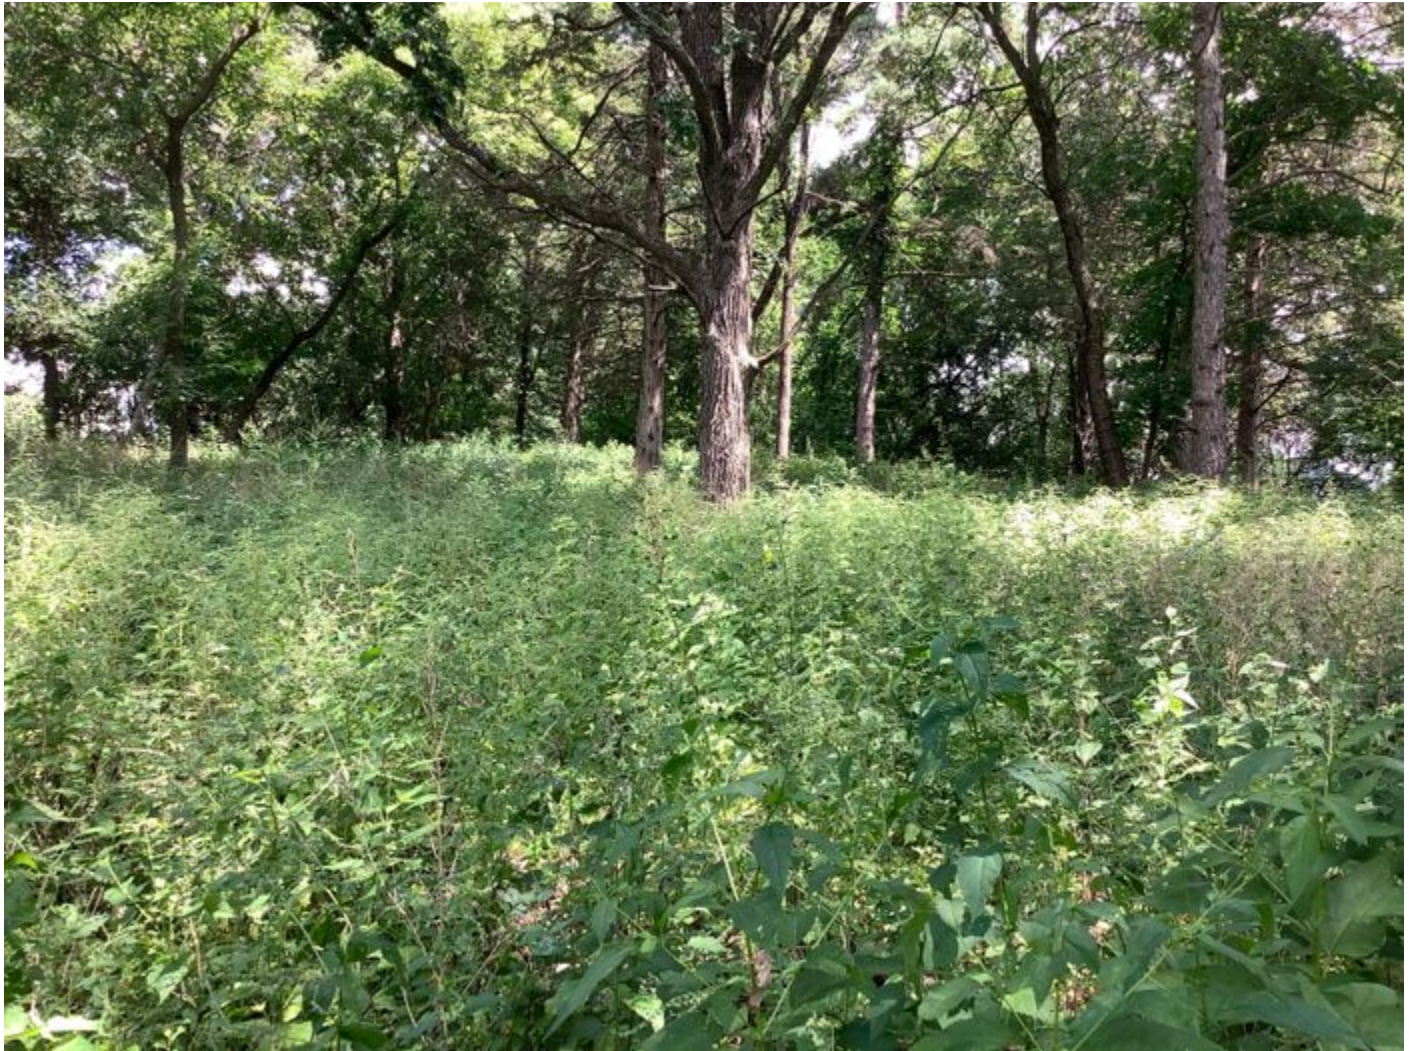
Looking u/s from 2008 waypoint location (site correction listed above). Unsure if this area was also revegetated

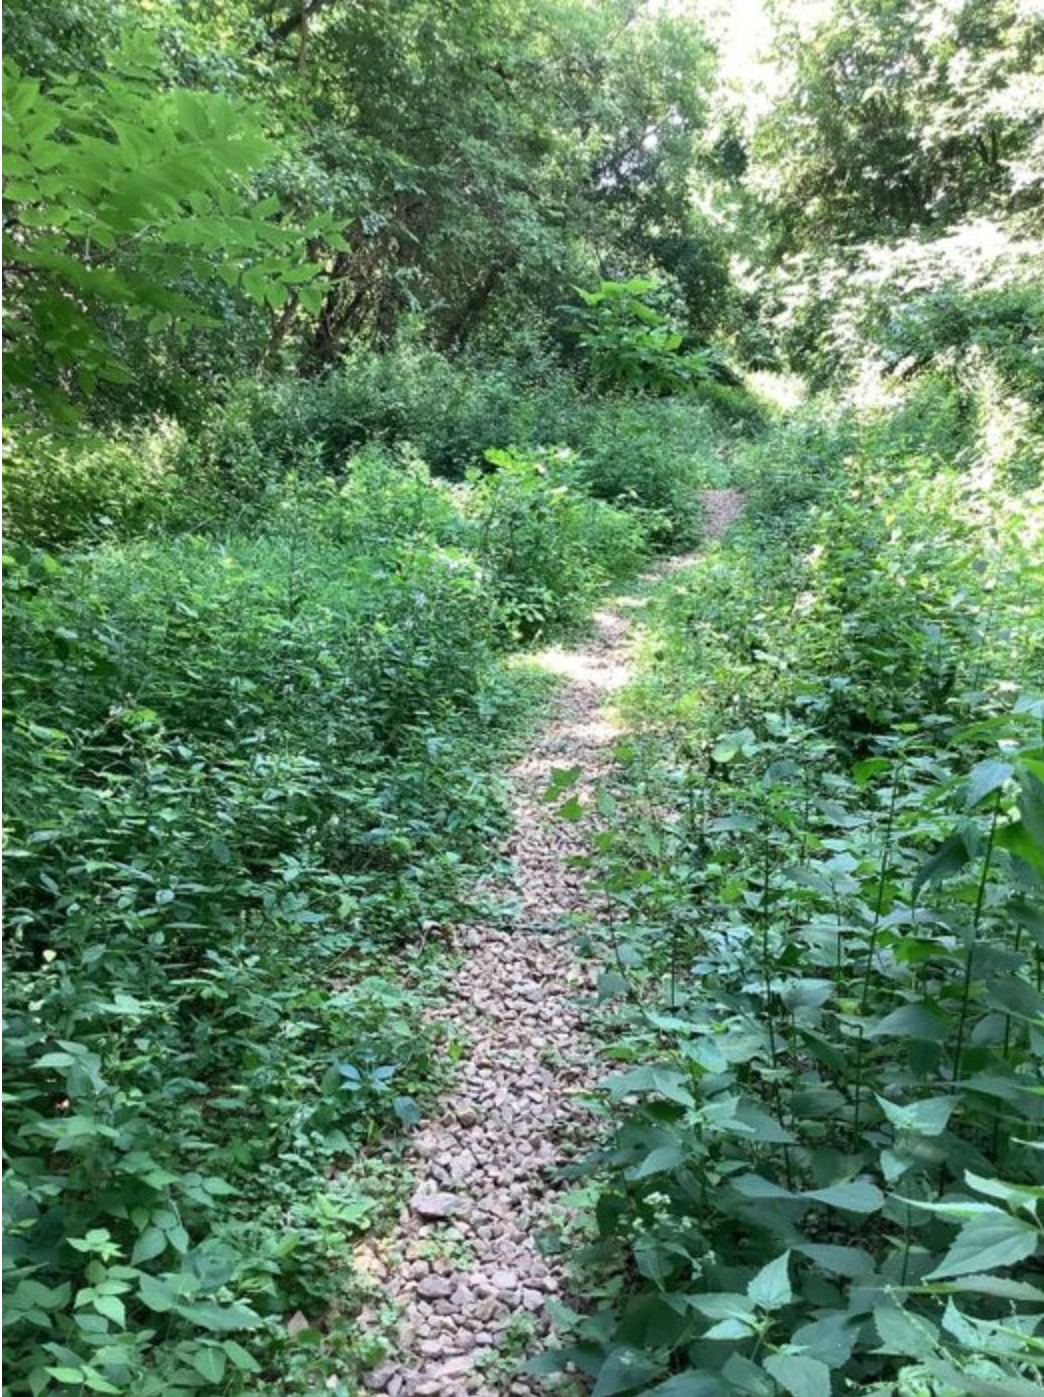
Looking d/s at stable path and heavy vegetation along the sides

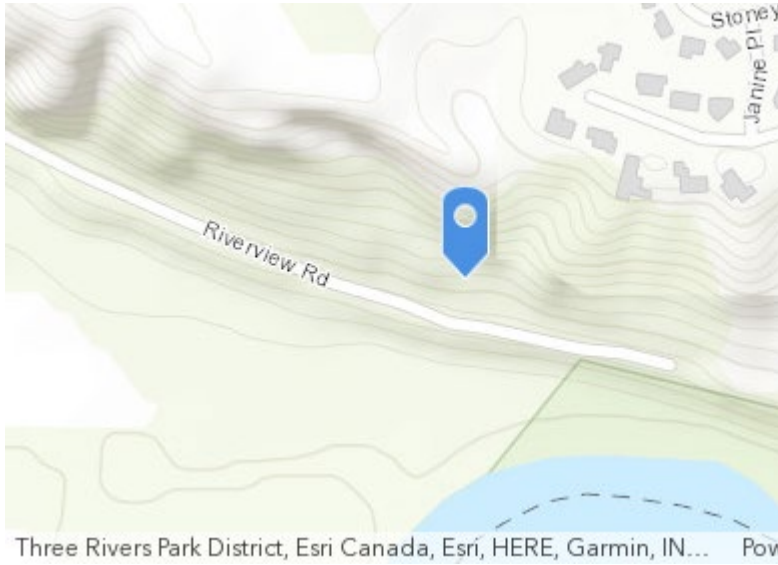
GULLY ID: L485

<p data-bbox="711 829 1315 861">Gully Head UTM Estimation: 4962433 N 465167 E ,</p> <p data-bbox="760 898 1266 930">Observation Point correction, if applicable:</p> <p data-bbox="766 968 1260 999">Connections to other points, if applicable:</p>
PREVIOUS WAYPOINT ID: 1267	
SURVEY DATE: 07/28/2020 4:13 PM	
LOCATION: Eden Prairie	
TYPE OF SITE: Gully	
SITE SUMMARY: Sunny Rain in previous 24 hours: No Heavily Forested Medium: 50'-100' gully. The problem indicators were: Loss of Bank Vegetation, Vertical and/or bare banks (incision), pistol-butted or leaning trees	
GULLY INFORMATION	
EROSION POTENTIAL:	Moderate
GULLY DEPTH:	Deep: >15'
BOTTOM WIDTH:	Narrow/V Ditch
TOP WIDTH:	Wide: >10'
BANK CONDITION:	Bare Soil
BOTTOM CONDITION:	Bare Soil
CHANNEL SLOPE:	Flat
GULLY SHAPE:	V-shaped
GULLY MATERIAL:	Sand
WATER LEVELS	None, N/A
SEEP	No
APPARENT CAUSES:	Channel Incision, Dense Canopy
ADDITIONAL NOTES: Gully is just a flow path that is down cutting on a steep slope. Headcut just is portion of channel where it becomes gradually less incised. Tons of leaning trees and patches of bare soil. Gully appears to be a long term moderate issue. Invasive Species? Low Type: Common Buckthorn Debris? Fallen tree debris Existing Stabilization? No Success: N/A

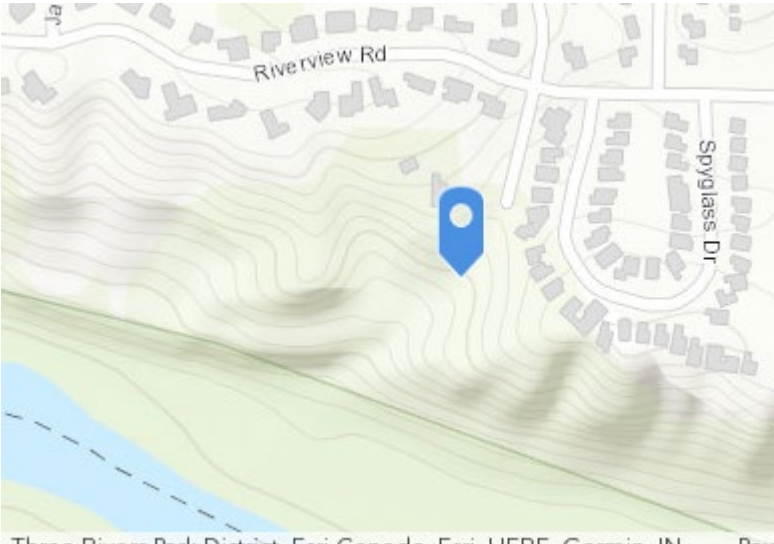
GULLY ID: L490

<p style="text-align: center;">Gully Head UTM Estimation: 4962343 N 465802 E ,</p> <p style="text-align: center;">Observation Point correction, if applicable:</p> <p style="text-align: center;">Connections to other points, if applicable:</p>
PREVIOUS WAYPOINT ID: 1274	
SURVEY DATE: 07/28/2020 12:27 PM	
LOCATION: Edén Prairie	
TYPE OF SITE: Gully	
SITE SUMMARY: Sunny Rain in previous 24 hours: No Off of Walking Trail Long: >100' gully. The problem indicators were: Flattened and/or slumping banks (widening), pistol-butted or leaning trees	
GULLY INFORMATION	
EROSION POTENTIAL:	Low
GULLY DEPTH:	Medium: 3'-15'
BOTTOM WIDTH:	Wide: >5'
TOP WIDTH:	Wide: >10'
BANK CONDITION:	Heavy Vegetation
BOTTOM CONDITION:	Heavy Vegetation
CHANNEL SLOPE:	Steep
GULLY SHAPE:	Trapezoid
GULLY MATERIAL:	Sand
WATER LEVELS	None, N/A
SEEP	No
APPARENT CAUSES:	Slope, Channel Incision, Game Trails
ADDITIONAL NOTES: Some leaning trees and old signs of slumpage but no distinct signs of active erosion. Gully appears to be relatively stable. Invasive Species? Medium Type: Common Buckthorn Debris? Fallen tree debris Existing Stabilization? Fallen tree debris thrown in headcut channel and possible revegetation of gully. Success: Unknown

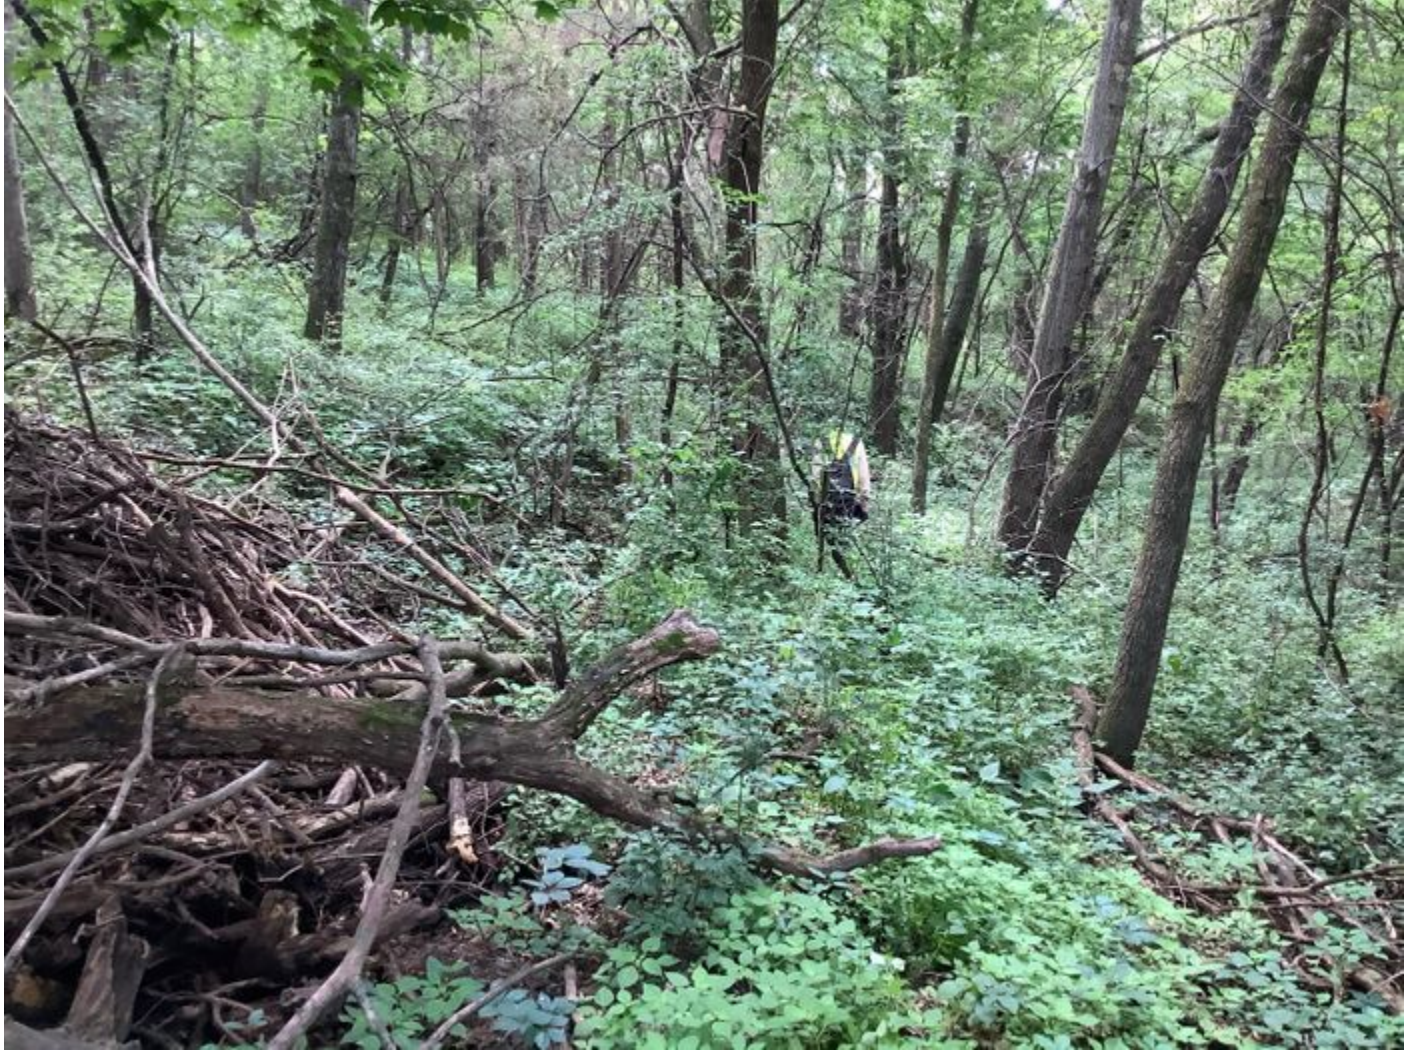
Downstream view from right bank looking at scale and vegetation in the channel.
