3.0 2008 INVENTORY ASSESSMENT AND DATA REVIEW

3.1 2008 Gully Inventory Background

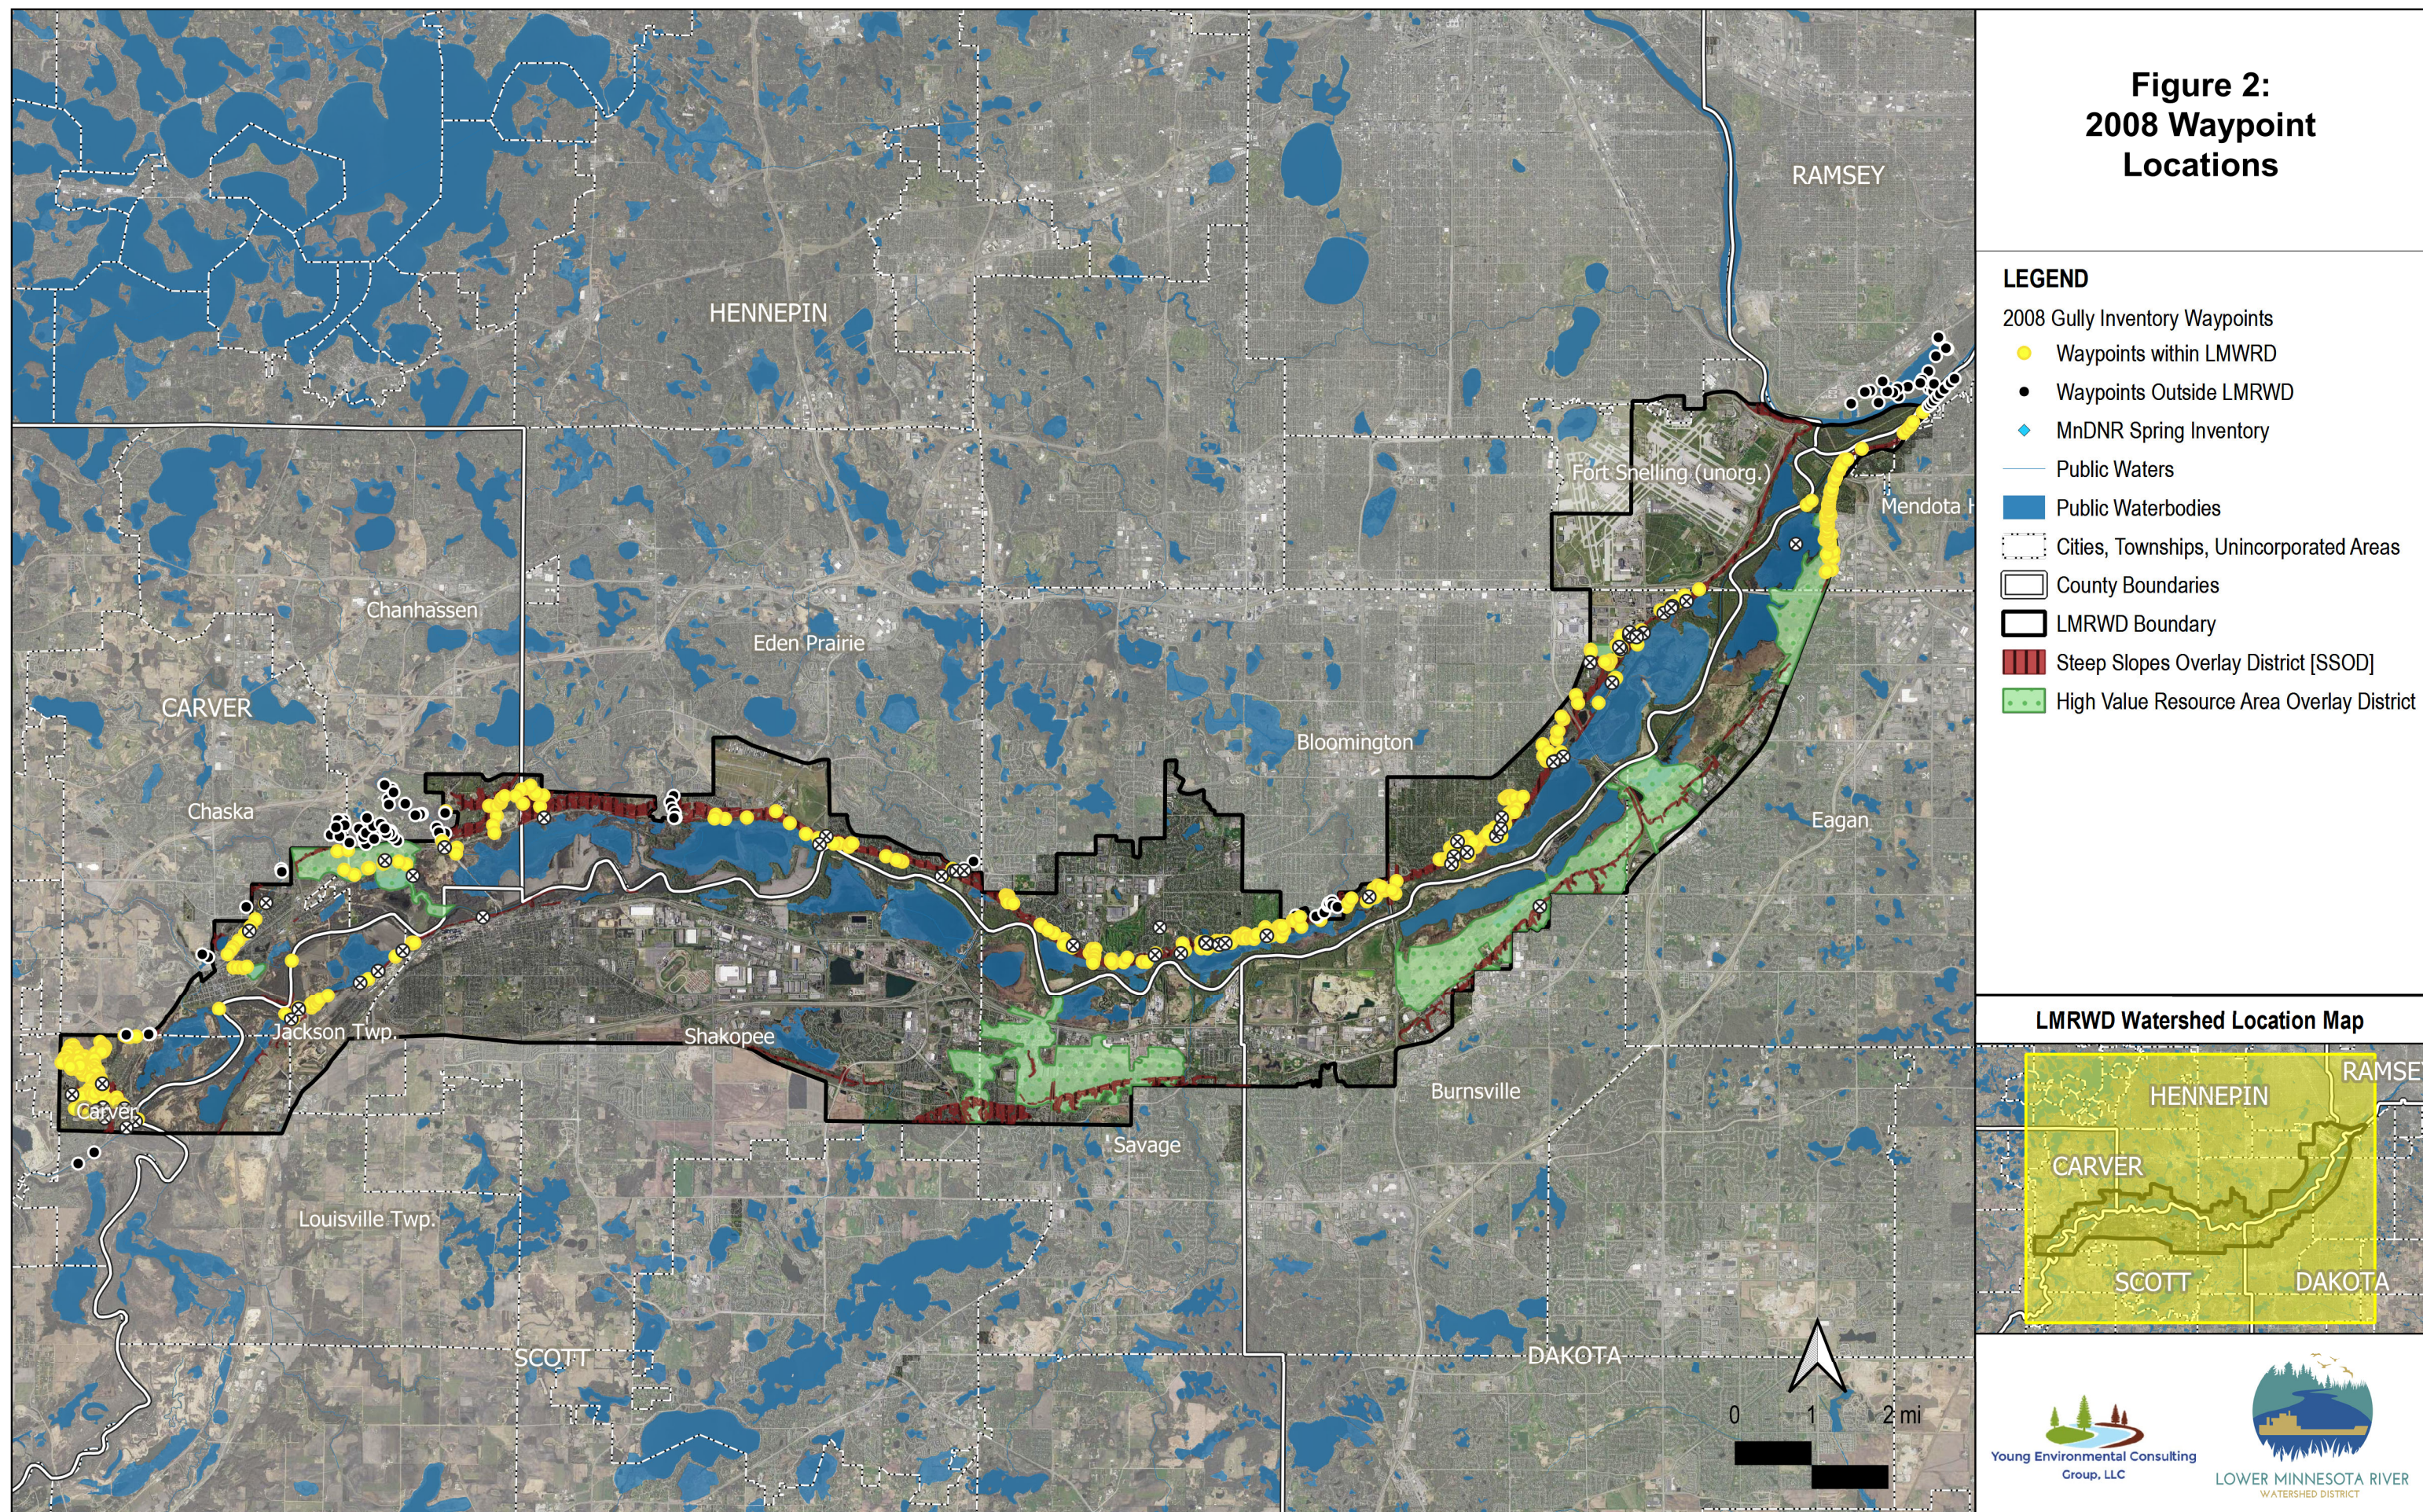
**Figure 2:
2008 Waypoint
Locations**

In review of the 2008 Inventory, the locations of all previous gullies and pipe outfalls were mapped using GIS. It became apparent that there were discrepancies within the original data set. As part of this analysis, waypoints were removed from the data set if they were determined to be erroneous, duplicates, or not applicable (such as points outside of the LMRWD boundary, storm sewer inlets, and trash or dump sites). Only sites that were clearly and conclusively not applicable were removed from the data set and locations that were indeterminate were included in the Project for field confirmation. Of the 604 waypoints in the 2008 Inventory, 113 sites were removed from the data set, and the remaining 491 were surveyed and assessed as part of the Project ([Figure 2](#)). While reviewing the waypoints in GIS, researchers observed some conflicts in the unique waypoint ID numbers. To avoid confusion, new numbers were assigned to all the Project sites. A summary table of the 2008 and 2020 identifiers is included in [Appendix A](#).

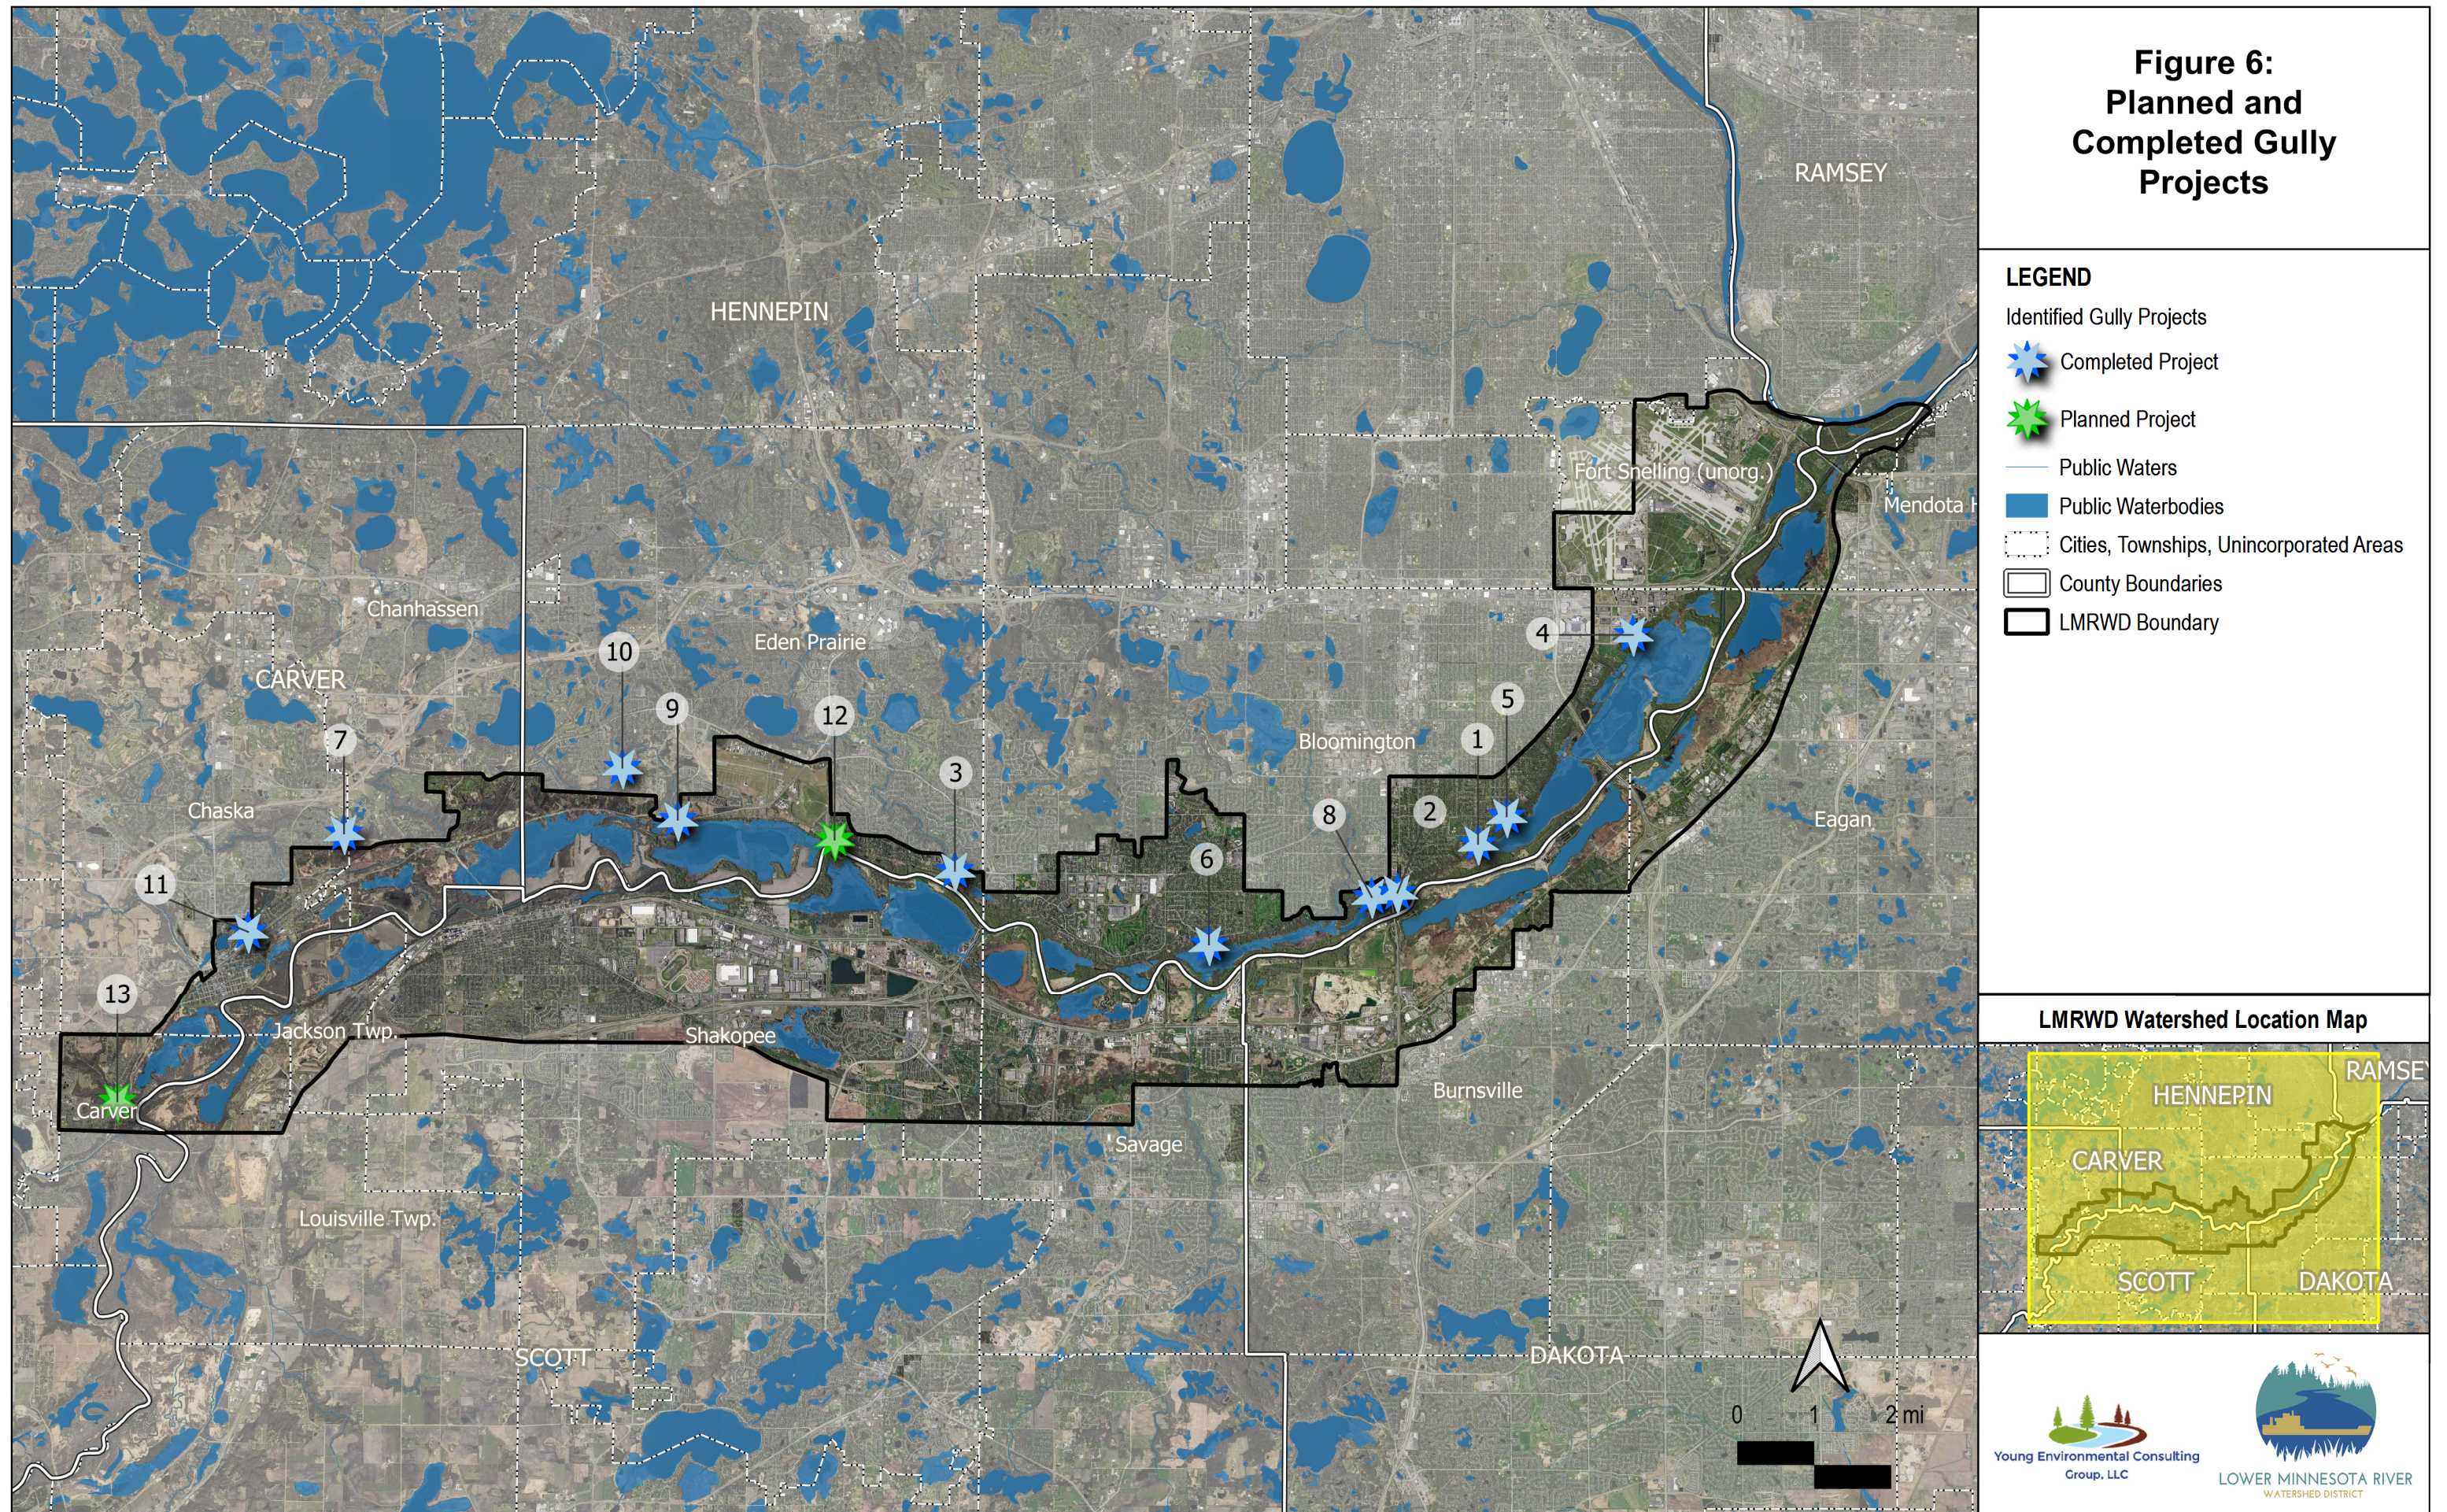
**Figure 6:
Planned and
Completed Gully
Projects**

From the review of the partner community plans, the following restoration projects were identified and appear on [Figure 6](#).

These sites were added to the Project as having been restored or potentially restored to assess the current conditions. The individual project details are provided in city summaries in [Section 5](#).
