5.0 CITY OF BLOOMINGTON

5.4 Bloomington Gully Progression

5.5 Bloomington High-Priority Sites

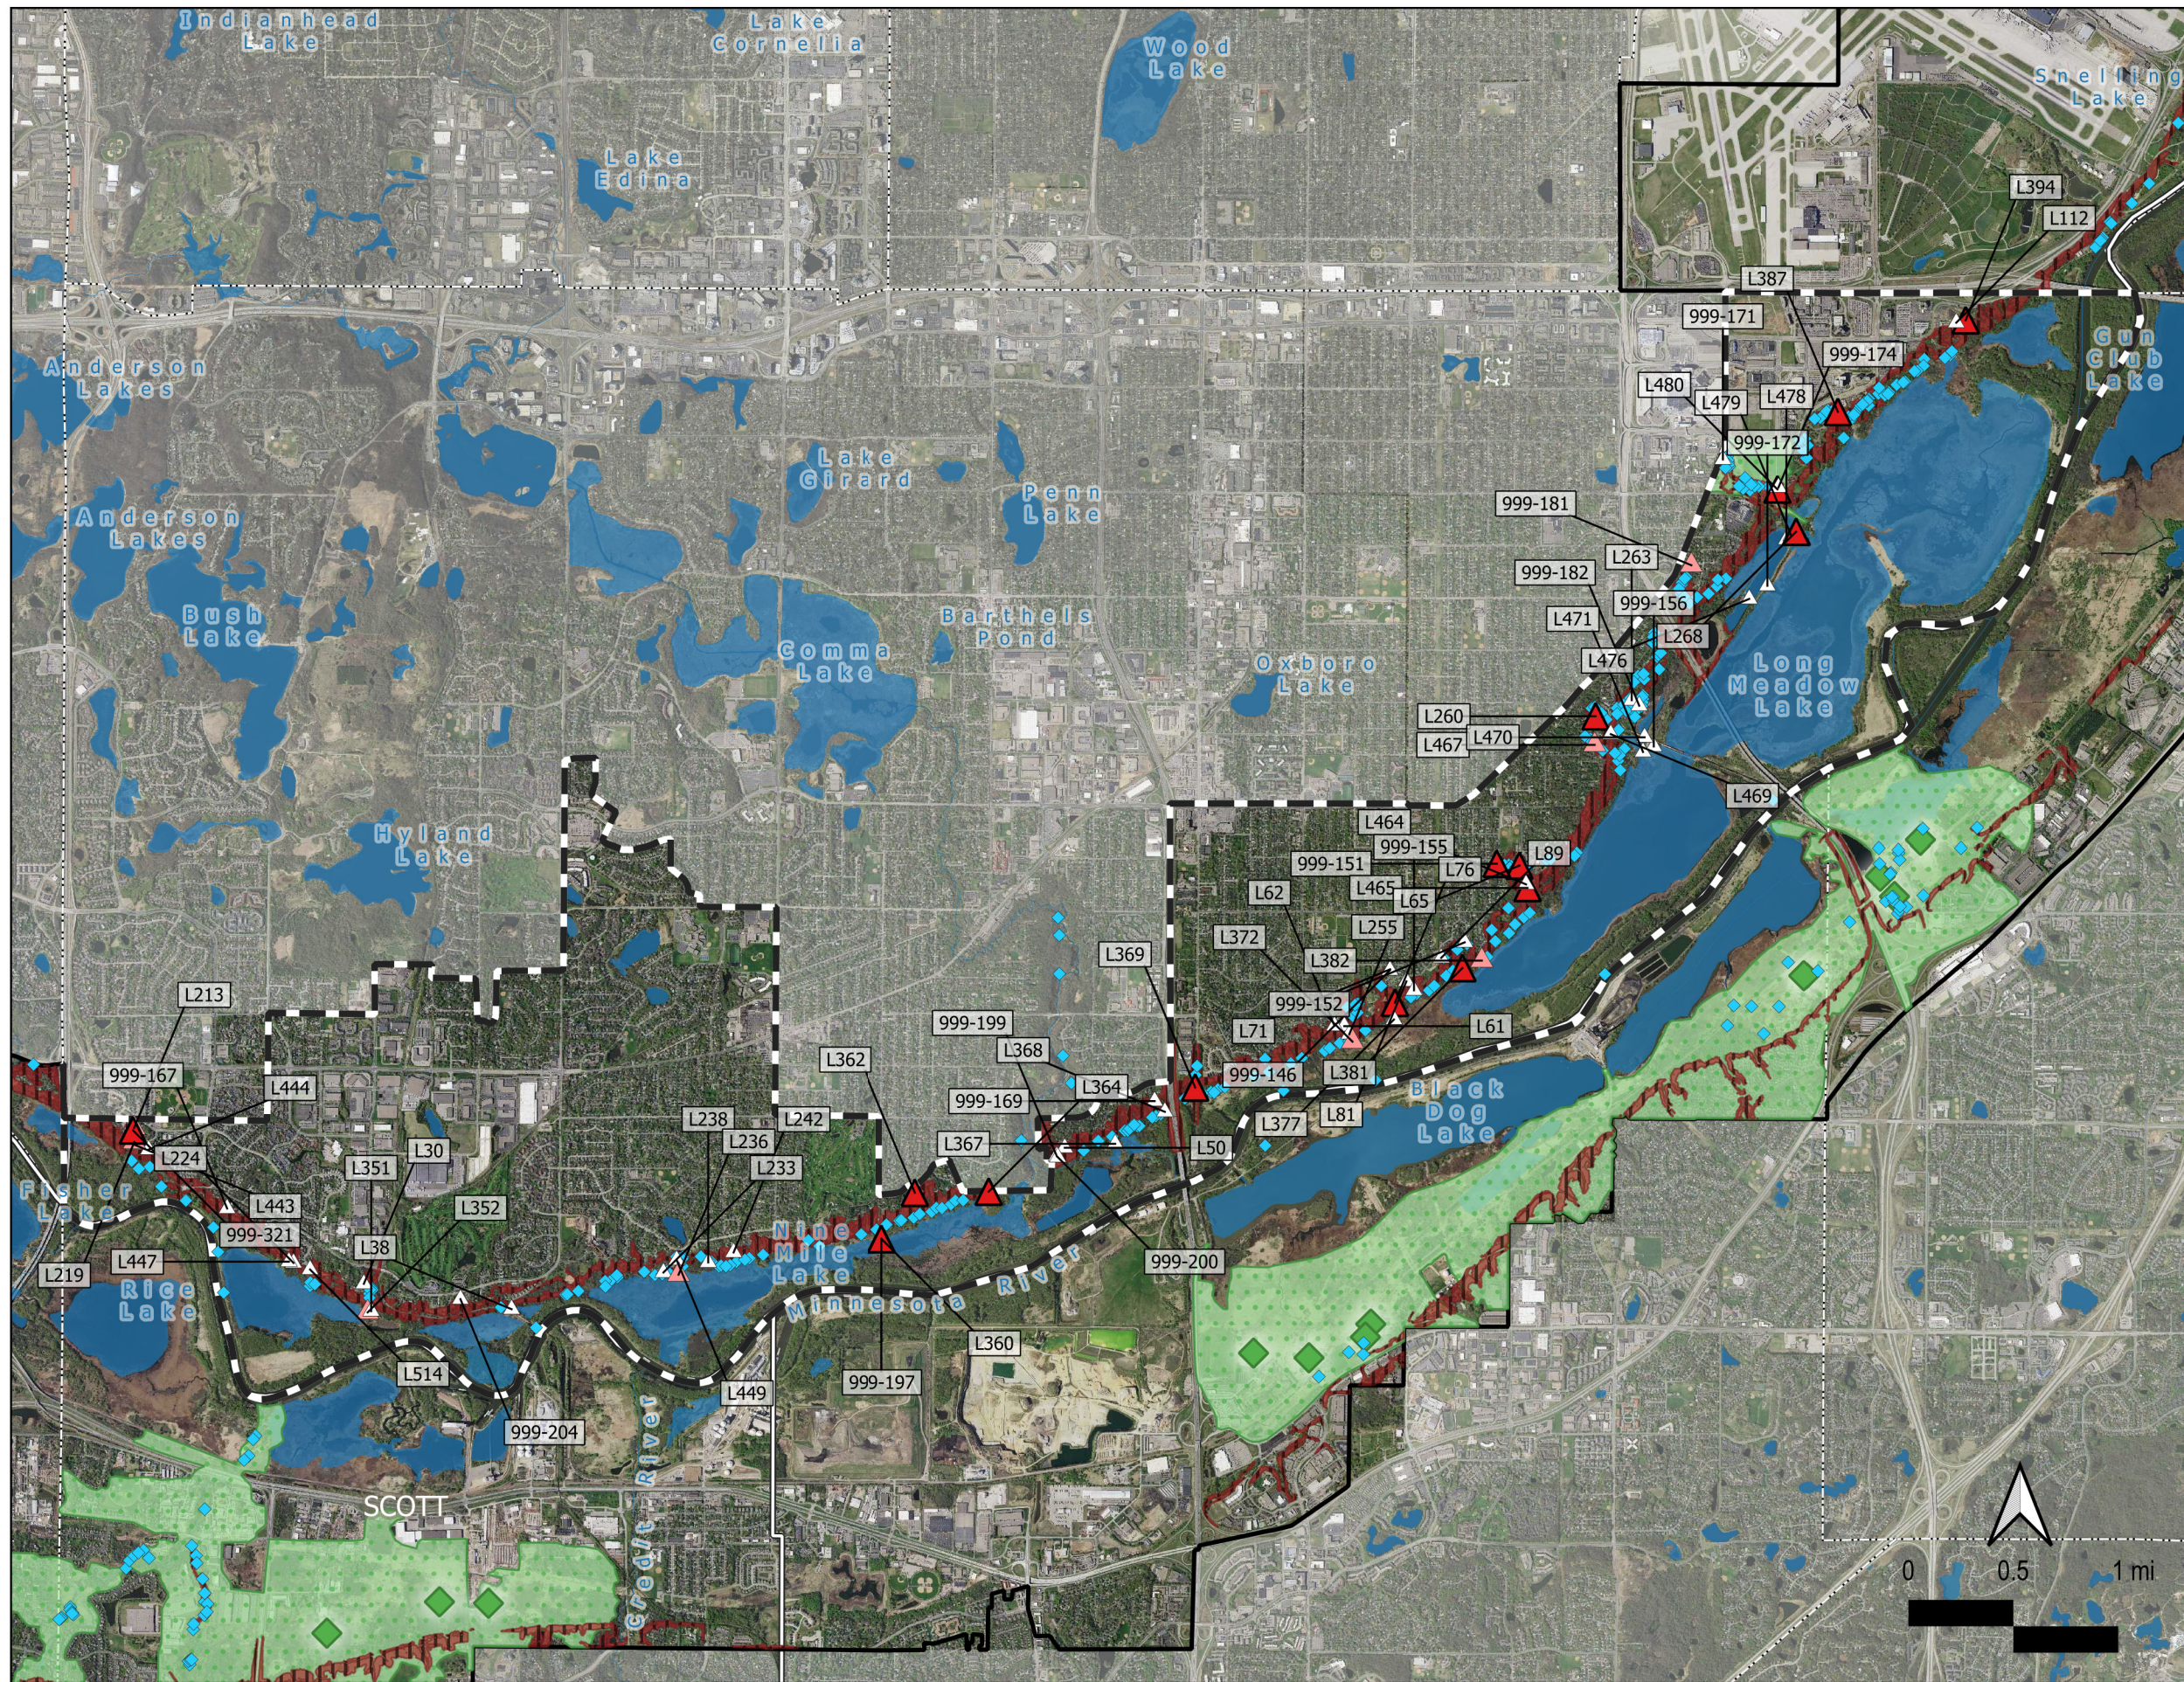
**Figure 12:
Bloomington 2020
Pipe Outfall
Conditions**

Of the 68 pipe outfalls surveyed in Bloomington, there were 16 in need of immediate repair. Within public parks in Bloomington, the field survey captures all types of existing pipe material with a range of sizes from less than 6 inches to over 48 inches. Pipes generally either drained water beneath trails or discharged water into streams, lakes, or the wetlands surrounding the Minnesota River. In Bloomington's residential areas, small pipes were observed in retaining walls at the head cuts of the gullies. Many of these pipes caused little to no channel incision or slumping around their outlet ([Figure 12](#)).

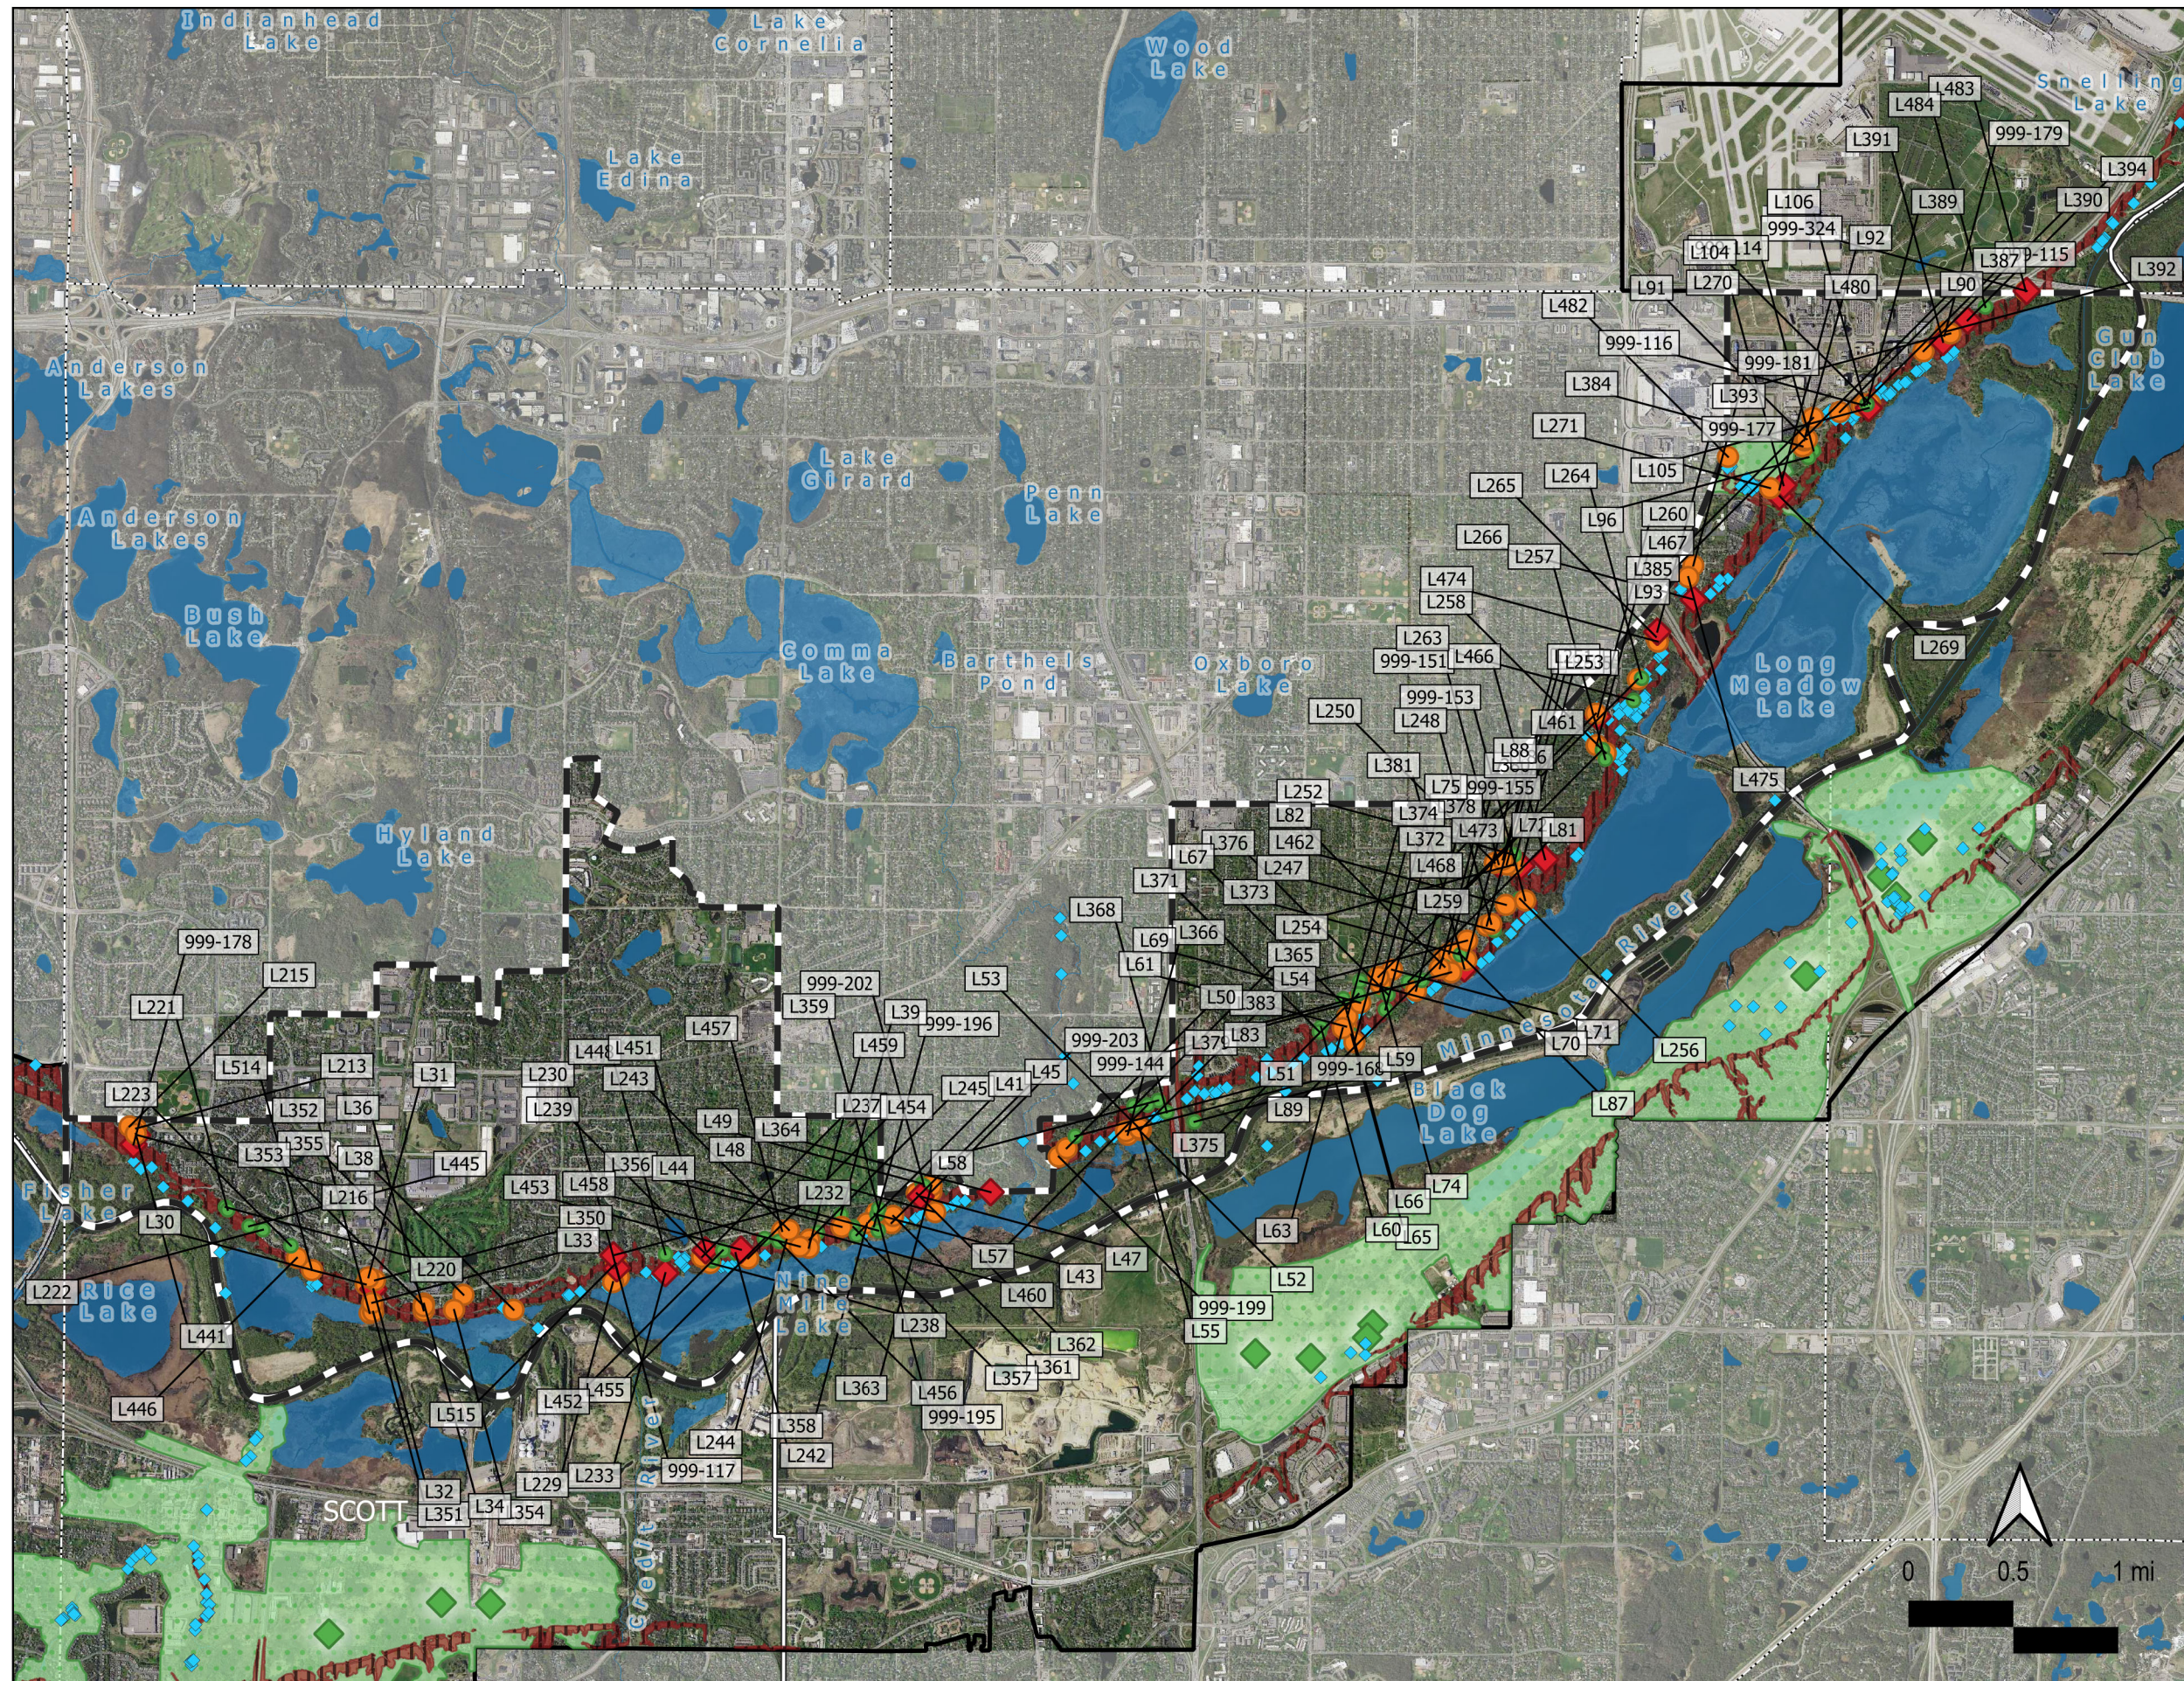
**Figure 13:
Bloomington 2020
Gully Conditions**

Variety in gully erosion potential exists along the Bloomington's hillslopes. Most of the gullies in Bloomington exhibited low or moderate erosion potential and consisted of sandy soils. The most common gully type in Bloomington consisted of a bowl-shaped groundwater seep emerging as the head cut. The groundwater formed a small stream that either destabilized the soil and led to incision and overhanging banks or became vegetated and showed few problem indicators. Sites with high erosion potential did not contain seeps or groundwater and, other than the steepest of slopes, the cause of the severity was unknown ([Figure 13](#)).

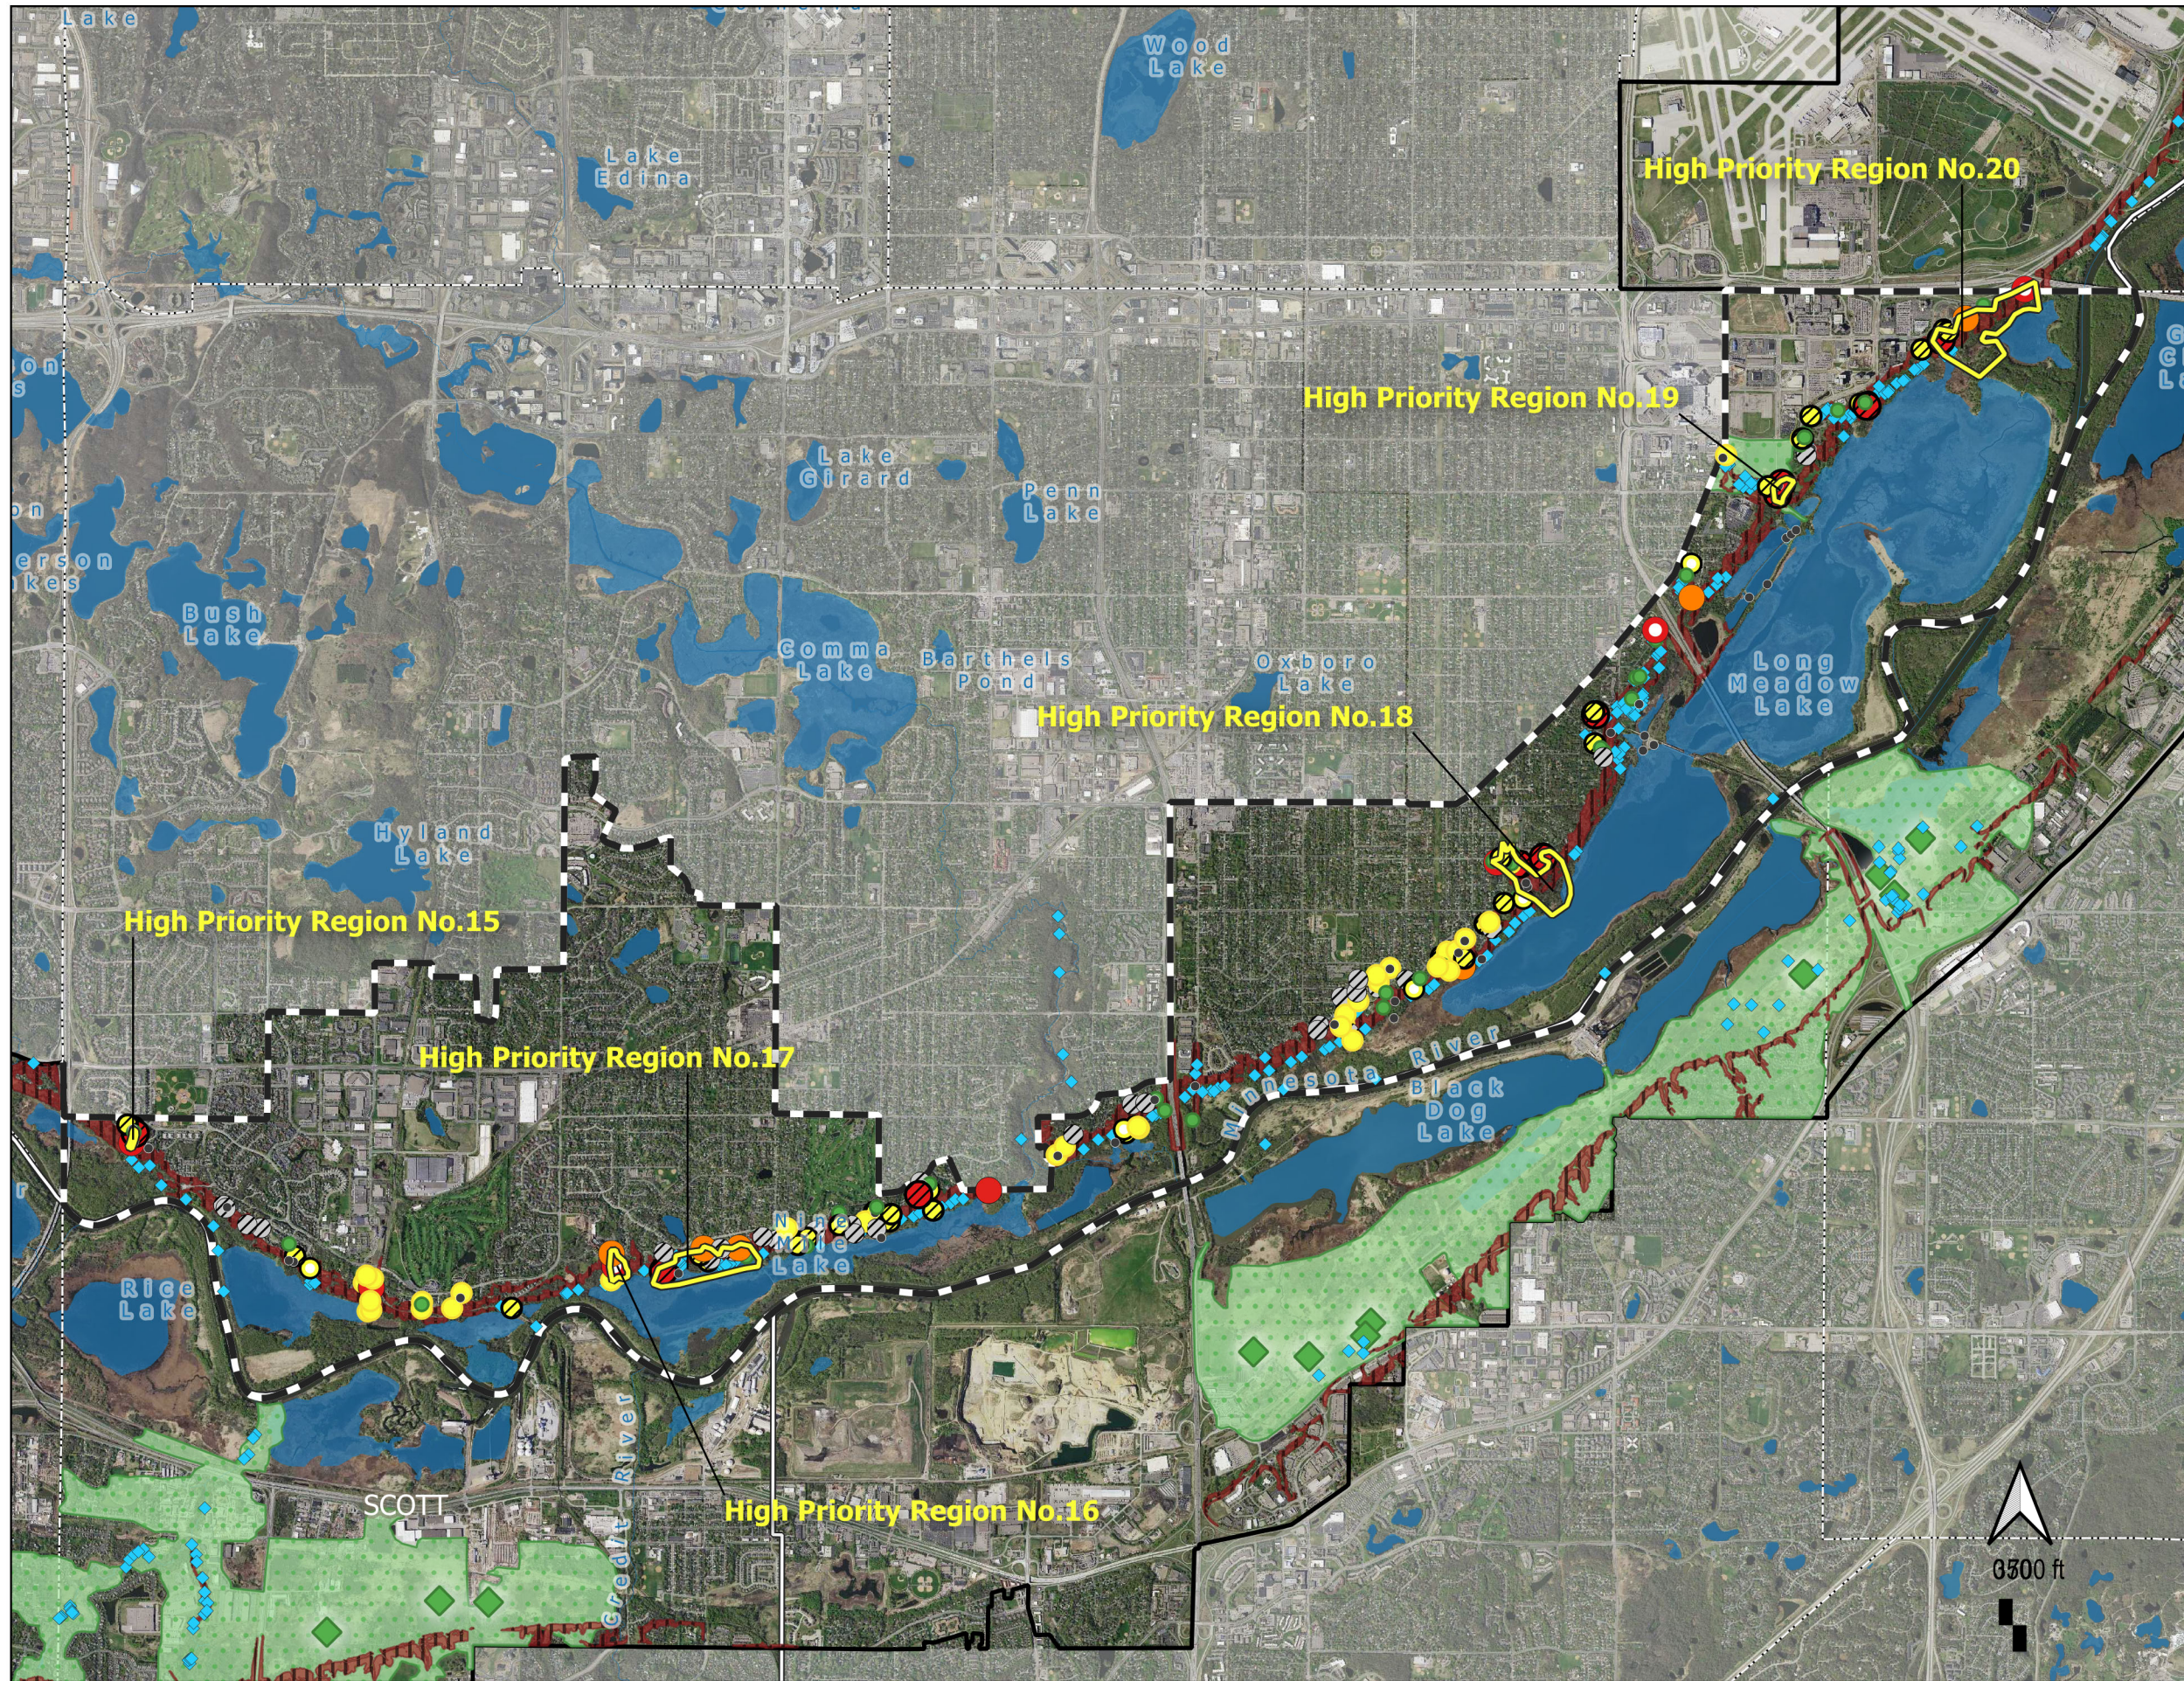
**Figure 14:
Bloomington Erosion
Progression and HPRs**

To better assess the erosion progression of an individual site, the change in erosion potential is mapped in **Figure 14**. Priority was placed on sites that increased in severity, going from low to high or moderate erosion potential. The improved data collected as part of the Project may have also played a role causing sites to have increased severity ratings; those sites are now ranked more appropriately based on more detailed data rather than on any significant progressive change.

Within Bloomington, the high-priority sites stretched across the southern border of the city within or next to the District's Steep Slopes Overlay District. As shown in **Figure 14**, gullies also lay next to known spring sites; groundwater was a principle cause of erosion at many of these sites.

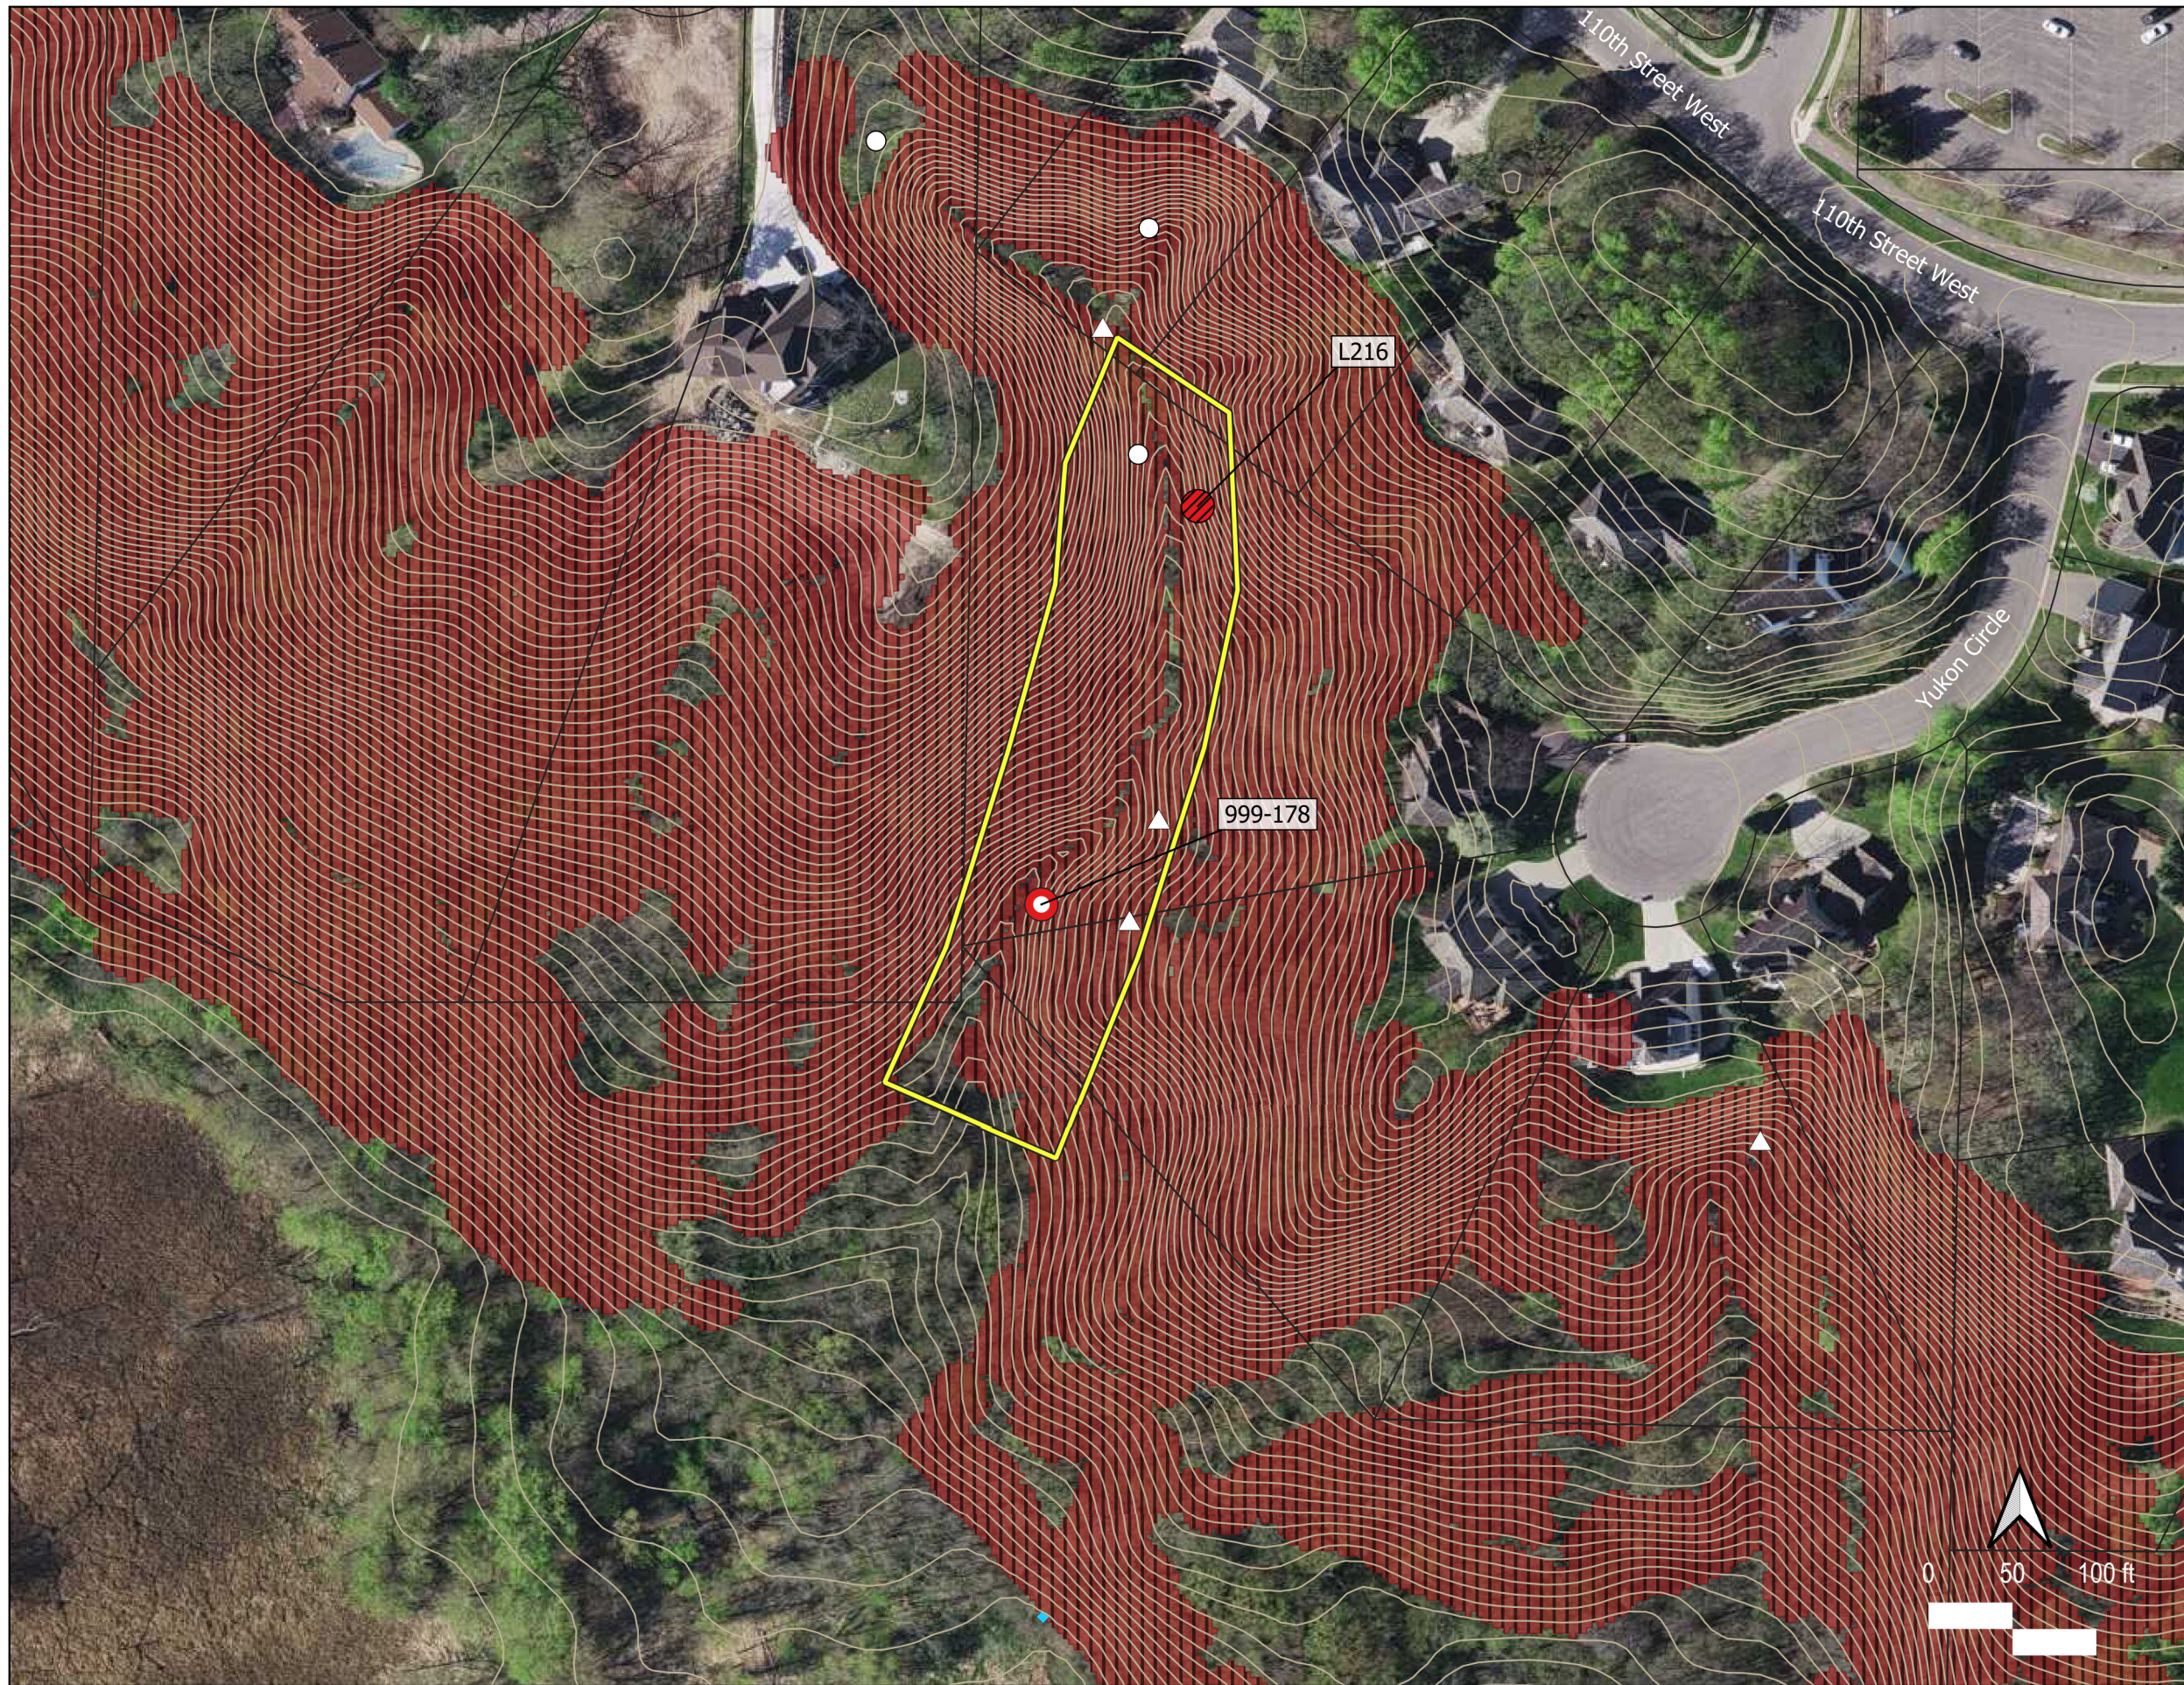
**Figure 15:
Bloomington High
Priority Region No. 15**

HPR 15 is made up of two sites: L216 and L219 (**Figure 15**). The gully system started with groundwater upwelling beginning at L216 that steadily grew to become a stream channel with a low amount of fast-moving water. Further downstream in the channel, a significant knickpoint with a depth over 4 feet formed the head cut of L219. The subsequent erosion along L219 was far more severe than the erosion noted at site L216. Despite the difference in severity, the gullies within the system shared similar problem indicators. Both sites showed evidence of slumping, loss of bank vegetation, and overhanging banks. Although some vegetation was present—especially along the banks of L216—it did not look heavy enough to stabilize the area. The wide bottom width at Site L216 narrowed downstream from the knickpoint, and L219 was characterized as having a V-shaped channel. In addition to the problem indicators at L216, L219 exhibited degradation, incision, and pistol-butted trees.

The cause of the gully system appears to have been groundwater upwelling. Channel incision and slope were found to have contributed to erosion past the knickpoint in L219.

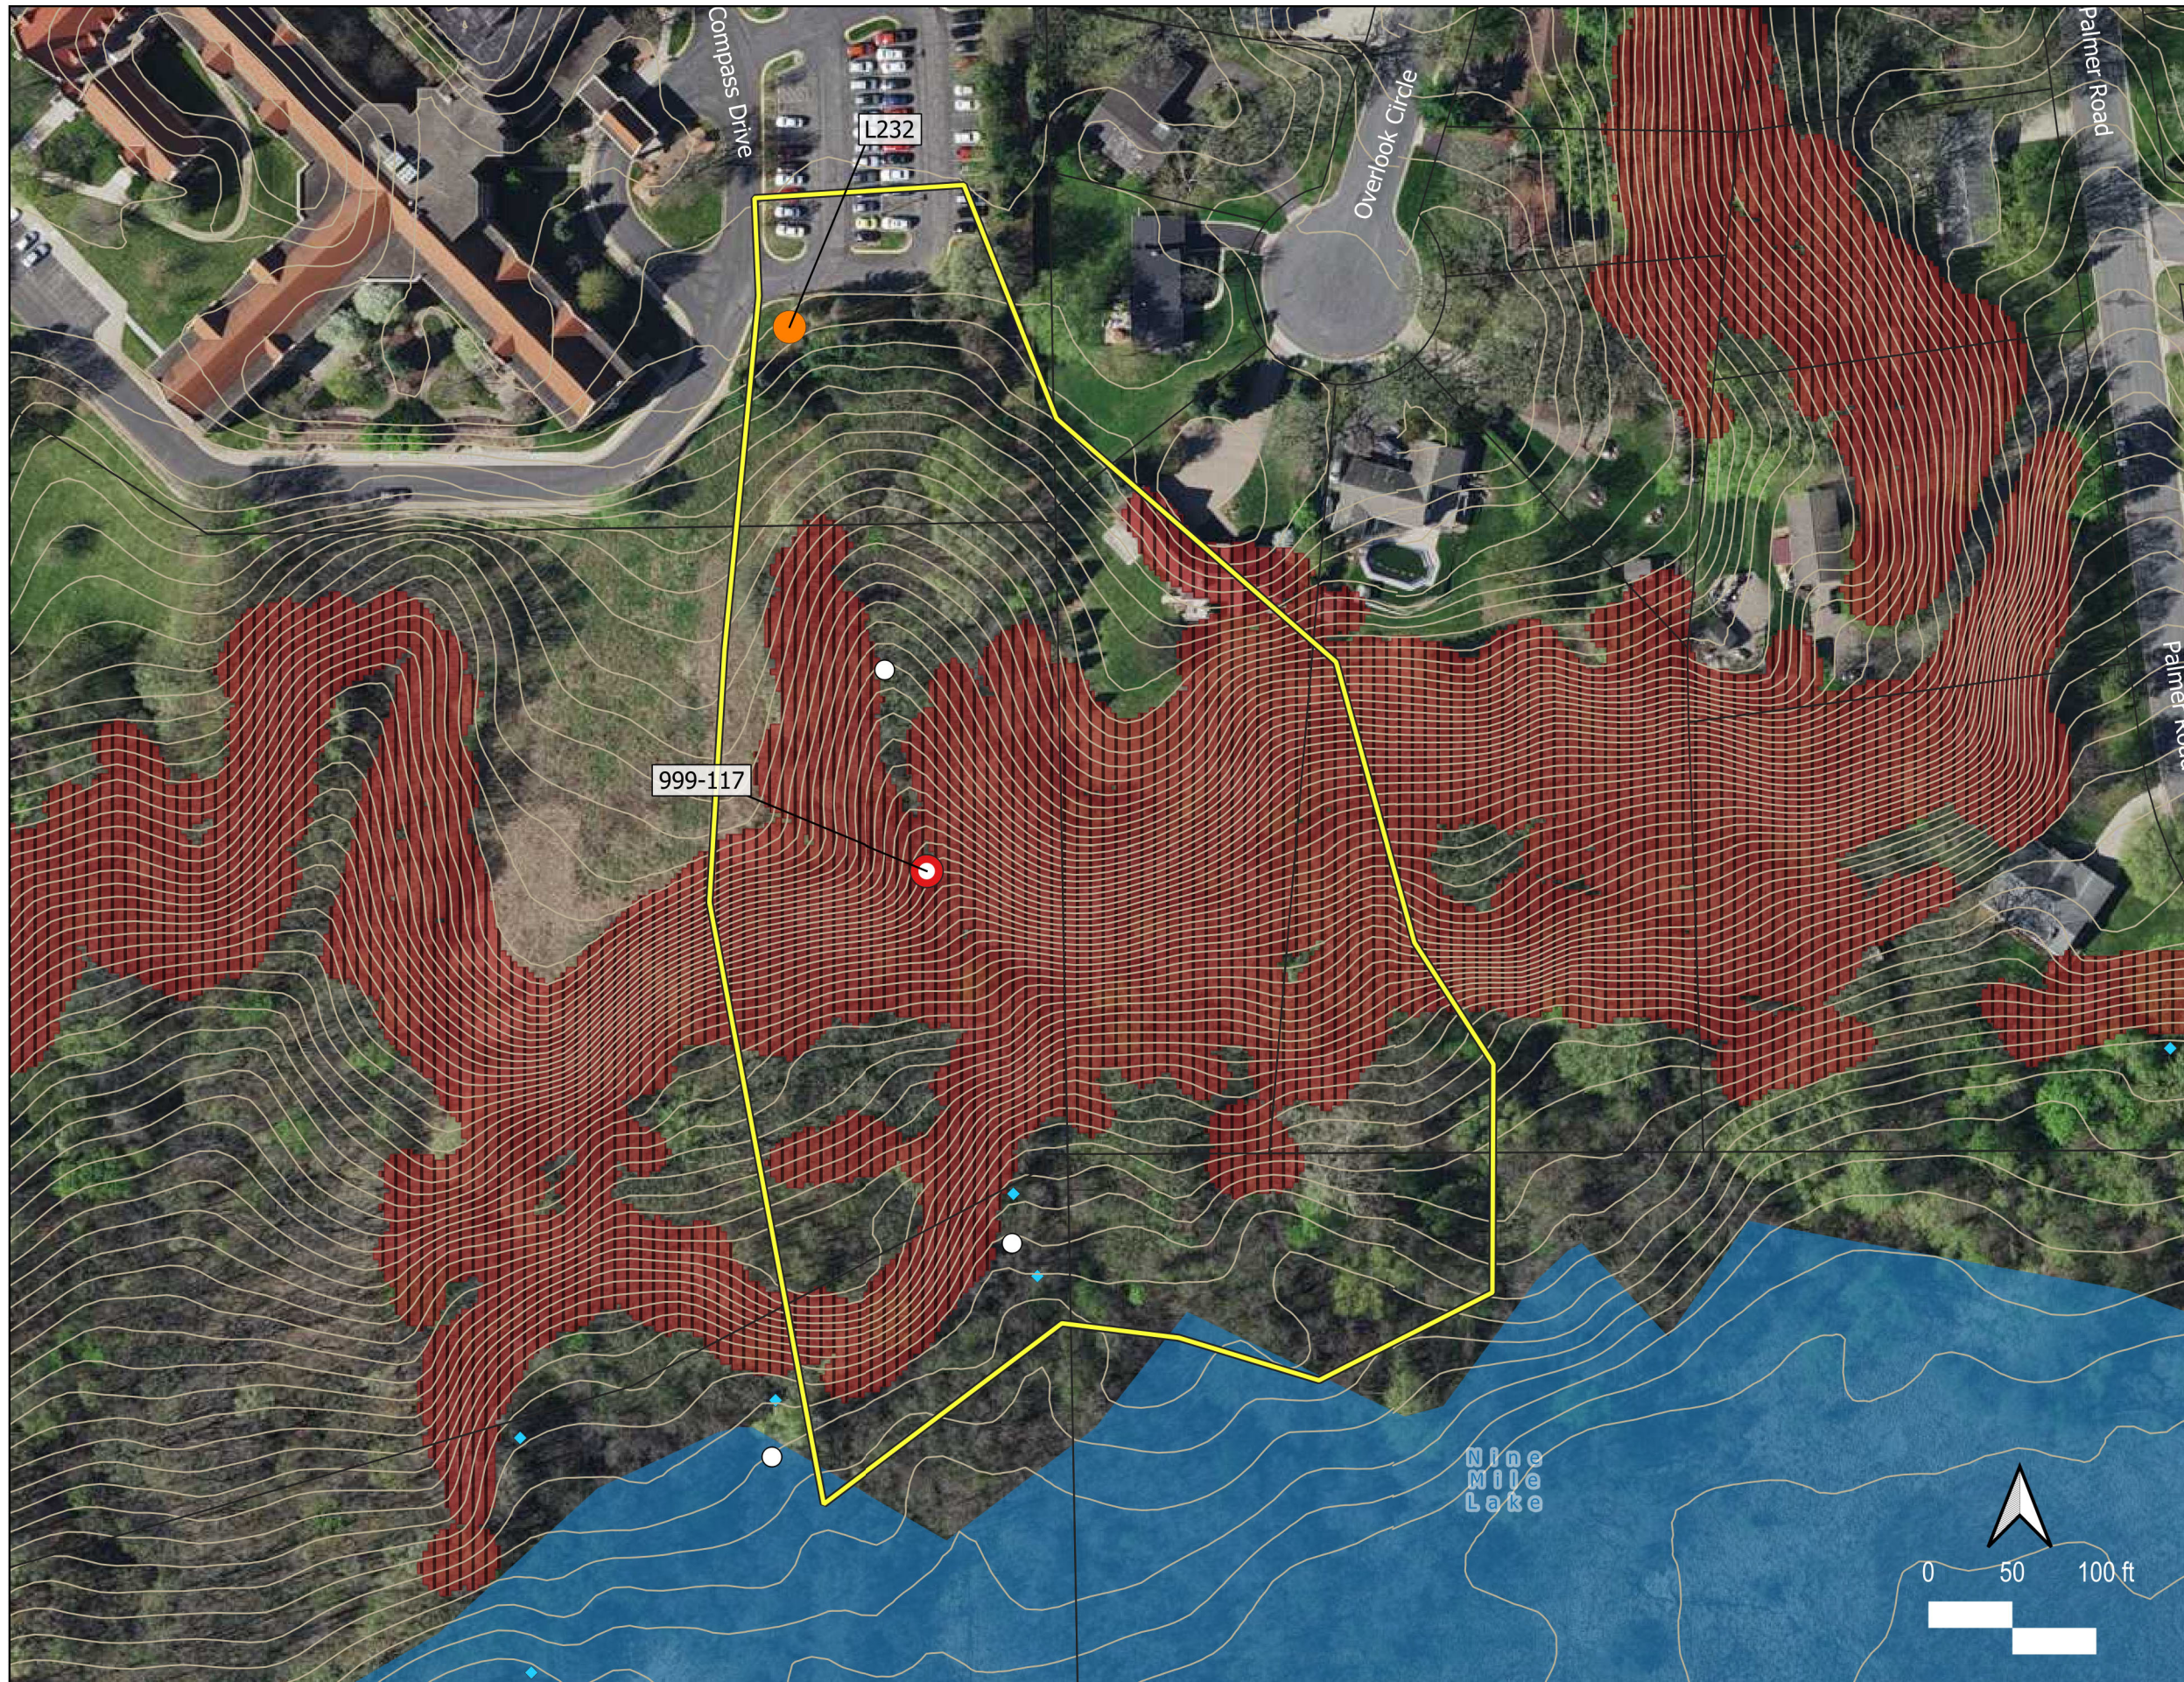
**Figure 19:
Bloomington High
Priority Region No. 16**

HPR 16 includes Gullies L232 and 999-117 (**Figure 19**). The points were both located on the Minnesota Masonic Home property. Both sites are located within the same stream channel. Gully L232 marked the start of the channel and began as a narrow, incised head cut next to a parking lot. The head cut was covered by geotextile fabric and riprap, but active erosion along the incised banks was observed. The gully continued into a forested area, where multiple head cut and finger gullies formed off the main channel, despite evidence of riprap stabilization along some sections of the channel. Dense canopy in the forest and slope of the terrain were noted as possible contributors to the erosion at both sites. No water was observed within either gully during the field survey.

Gully L232 turned into a moderate gully downstream until a large knickpoint formed the head cut of Gully 999-117. At that point, the severity of the gully dramatically increased. Gully 999-117 shared many of the same problem characteristics as Site L232, such as incision, leaning trees, overhanging banks, and bare soil. However, L232 was shallow, while Gully 999-117 was deeper and had a narrower V-shape. Small knickpoints apparent throughout the channel also caused the field team to mark degradation as a problem indicator. Additionally, the trees along the channel of 999-117 were more severely undercut than those along L232. The cause of the deep incision in this gully is unknown. However, as pictured in **Figure 22**, the substrate type switched from sand to clay for one portion of 999-117, with completely bare banks.
