5.0 CITY OF BLOOMINGTON

5.4 Bloomington Gully Progression

5.5 Bloomington High-Priority Sites

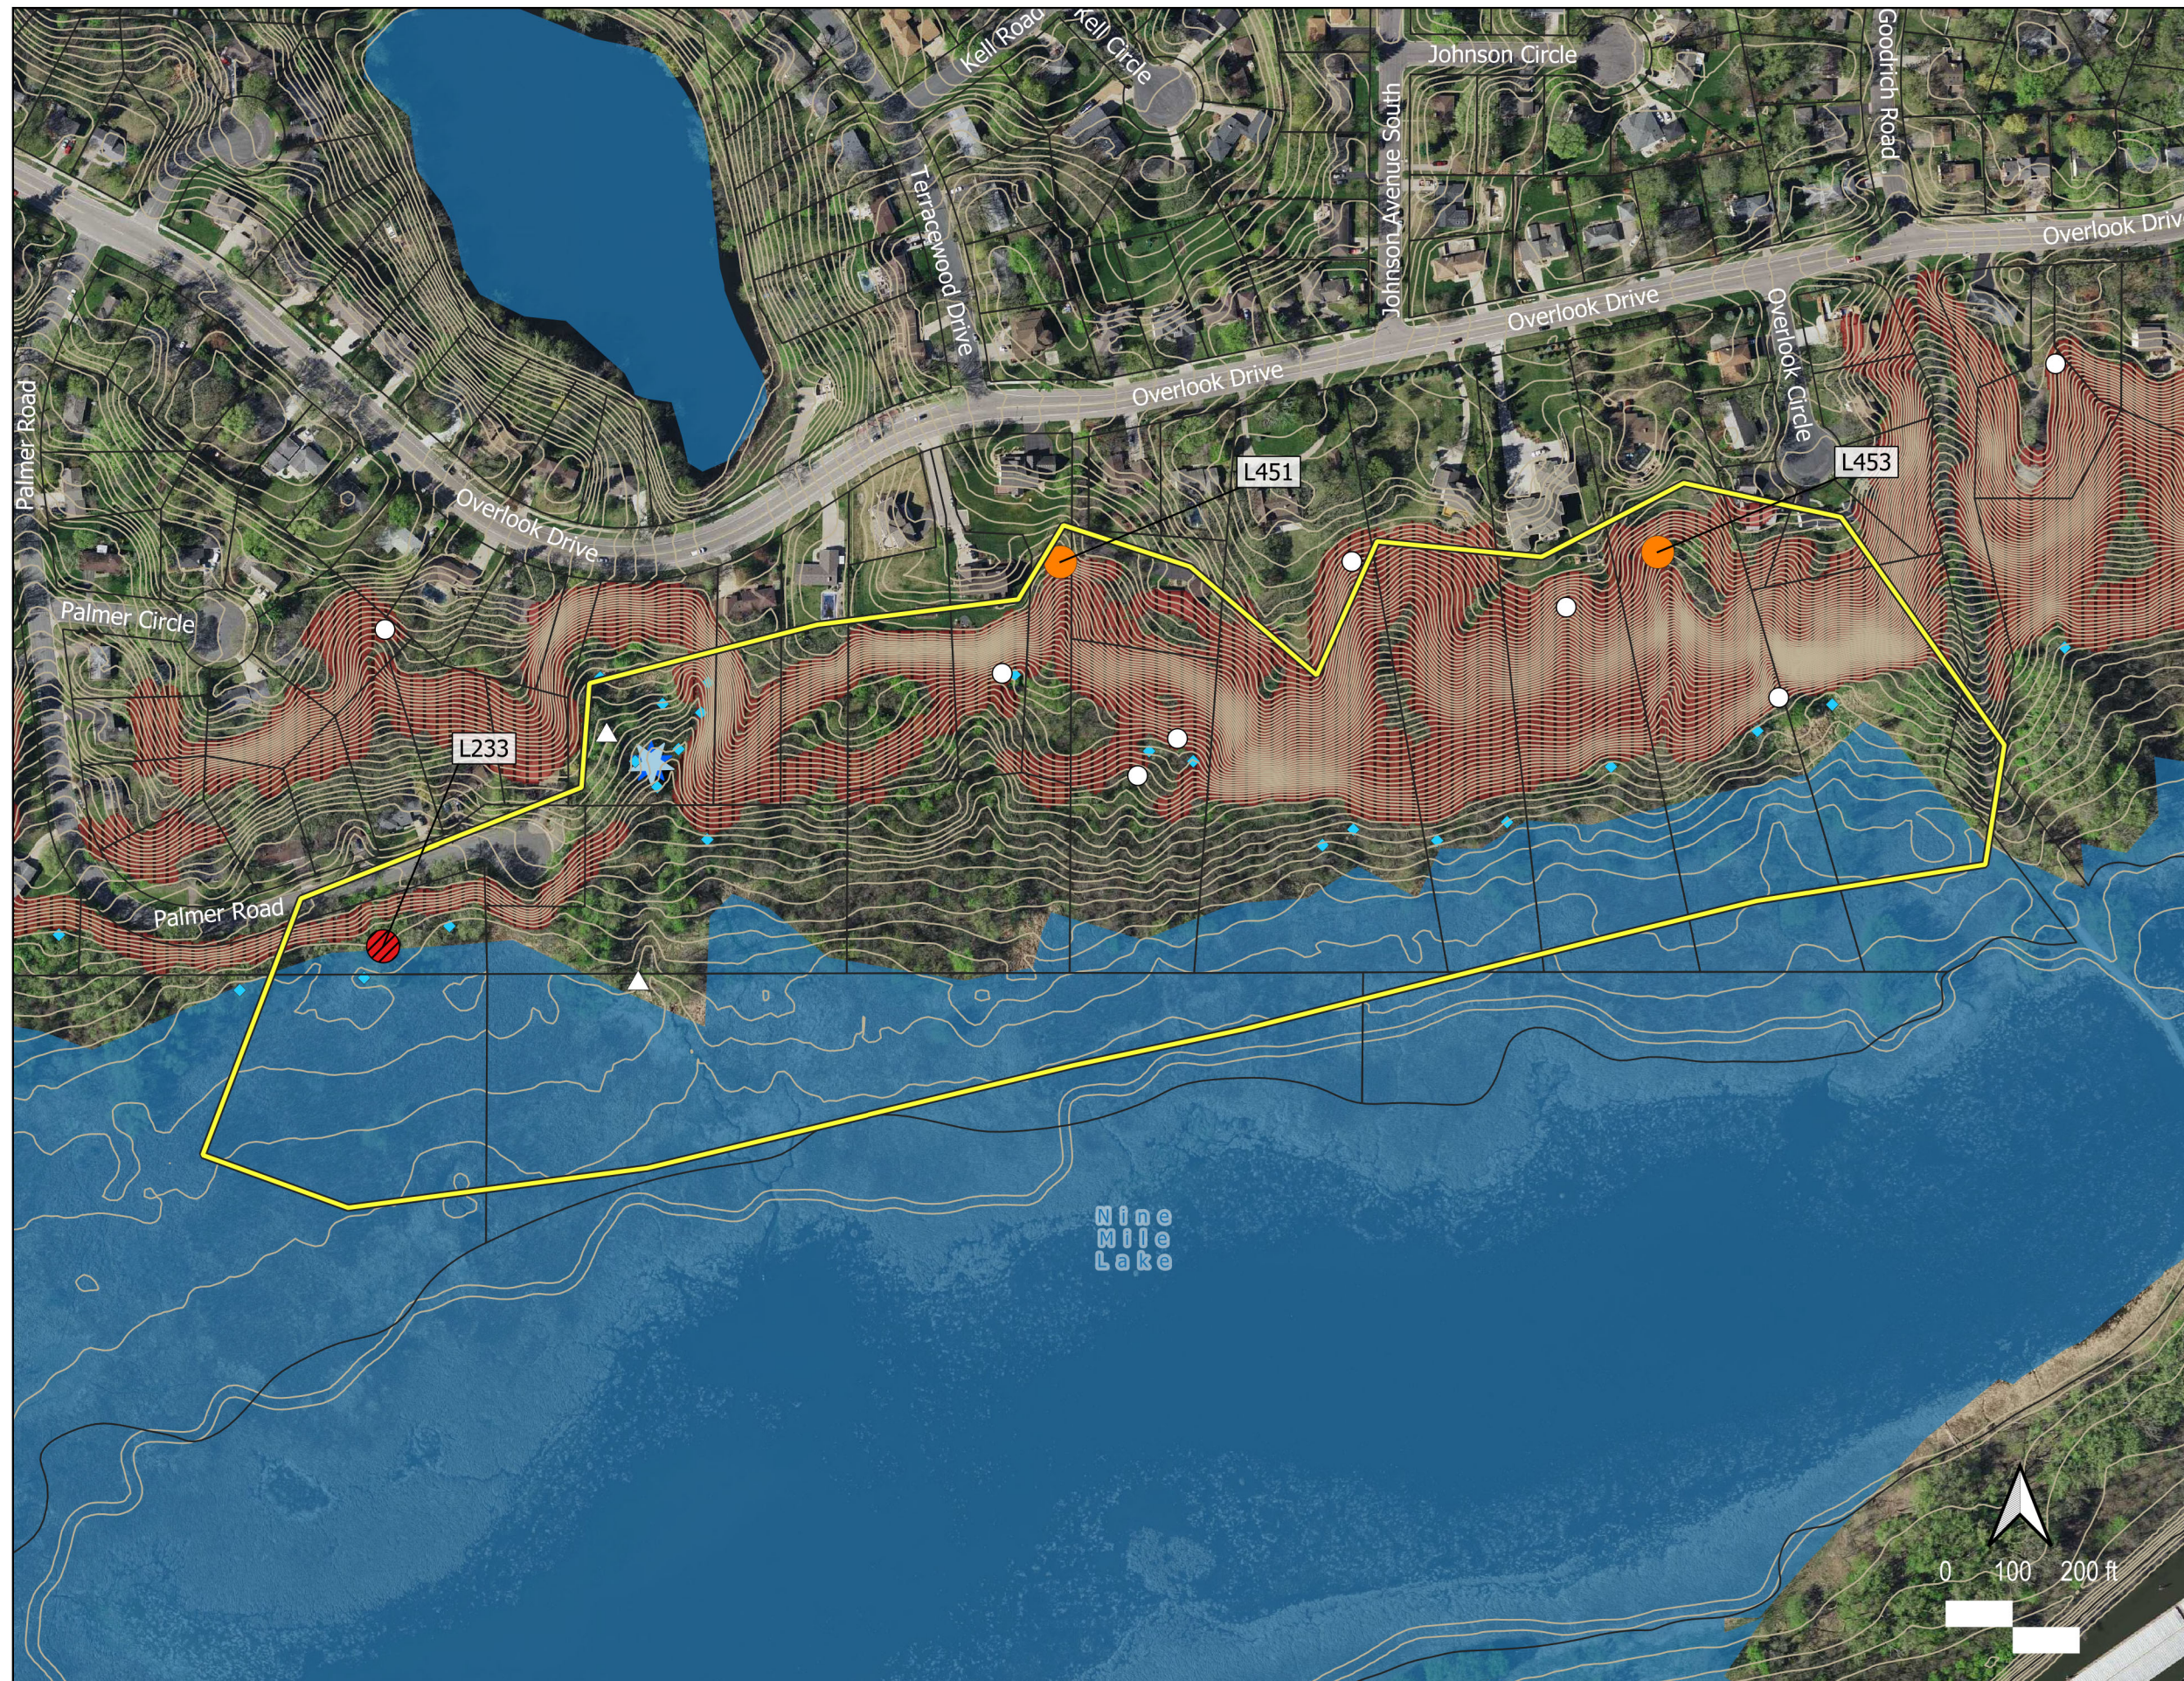
**Figure 23:
Bloomington High
Priority Region No. 17**

HPR 17 consists of Gullies L453, L451, and L233 (**Figure 23**). All three gullies drain down toward the Minnesota River, with head cuts accessible from the road.

Gully L453 was directly behind a residential backyard. The homeowner seemed interested in possible restoration. Gully L453 exemplified one of the most extreme cases of gullies along steep slopes in Bloomington. The gully itself began at a head cut in the backyard and became heavily incised. About mid-gully, the channel slope turned into a 45-degree angle for at least 30 horizontal feet. Along this section, an incised V-shape channel consisting of bare banks, as well as degradation within the channel, was present. The general gully material was sand; fallen tree debris, along with buckthorn, was seen throughout the channel.

No groundwater was observed; any cause other than steep slopes is unknown. Problem indicators included degradation, incision, leaning trees, and a loss of bank vegetation.

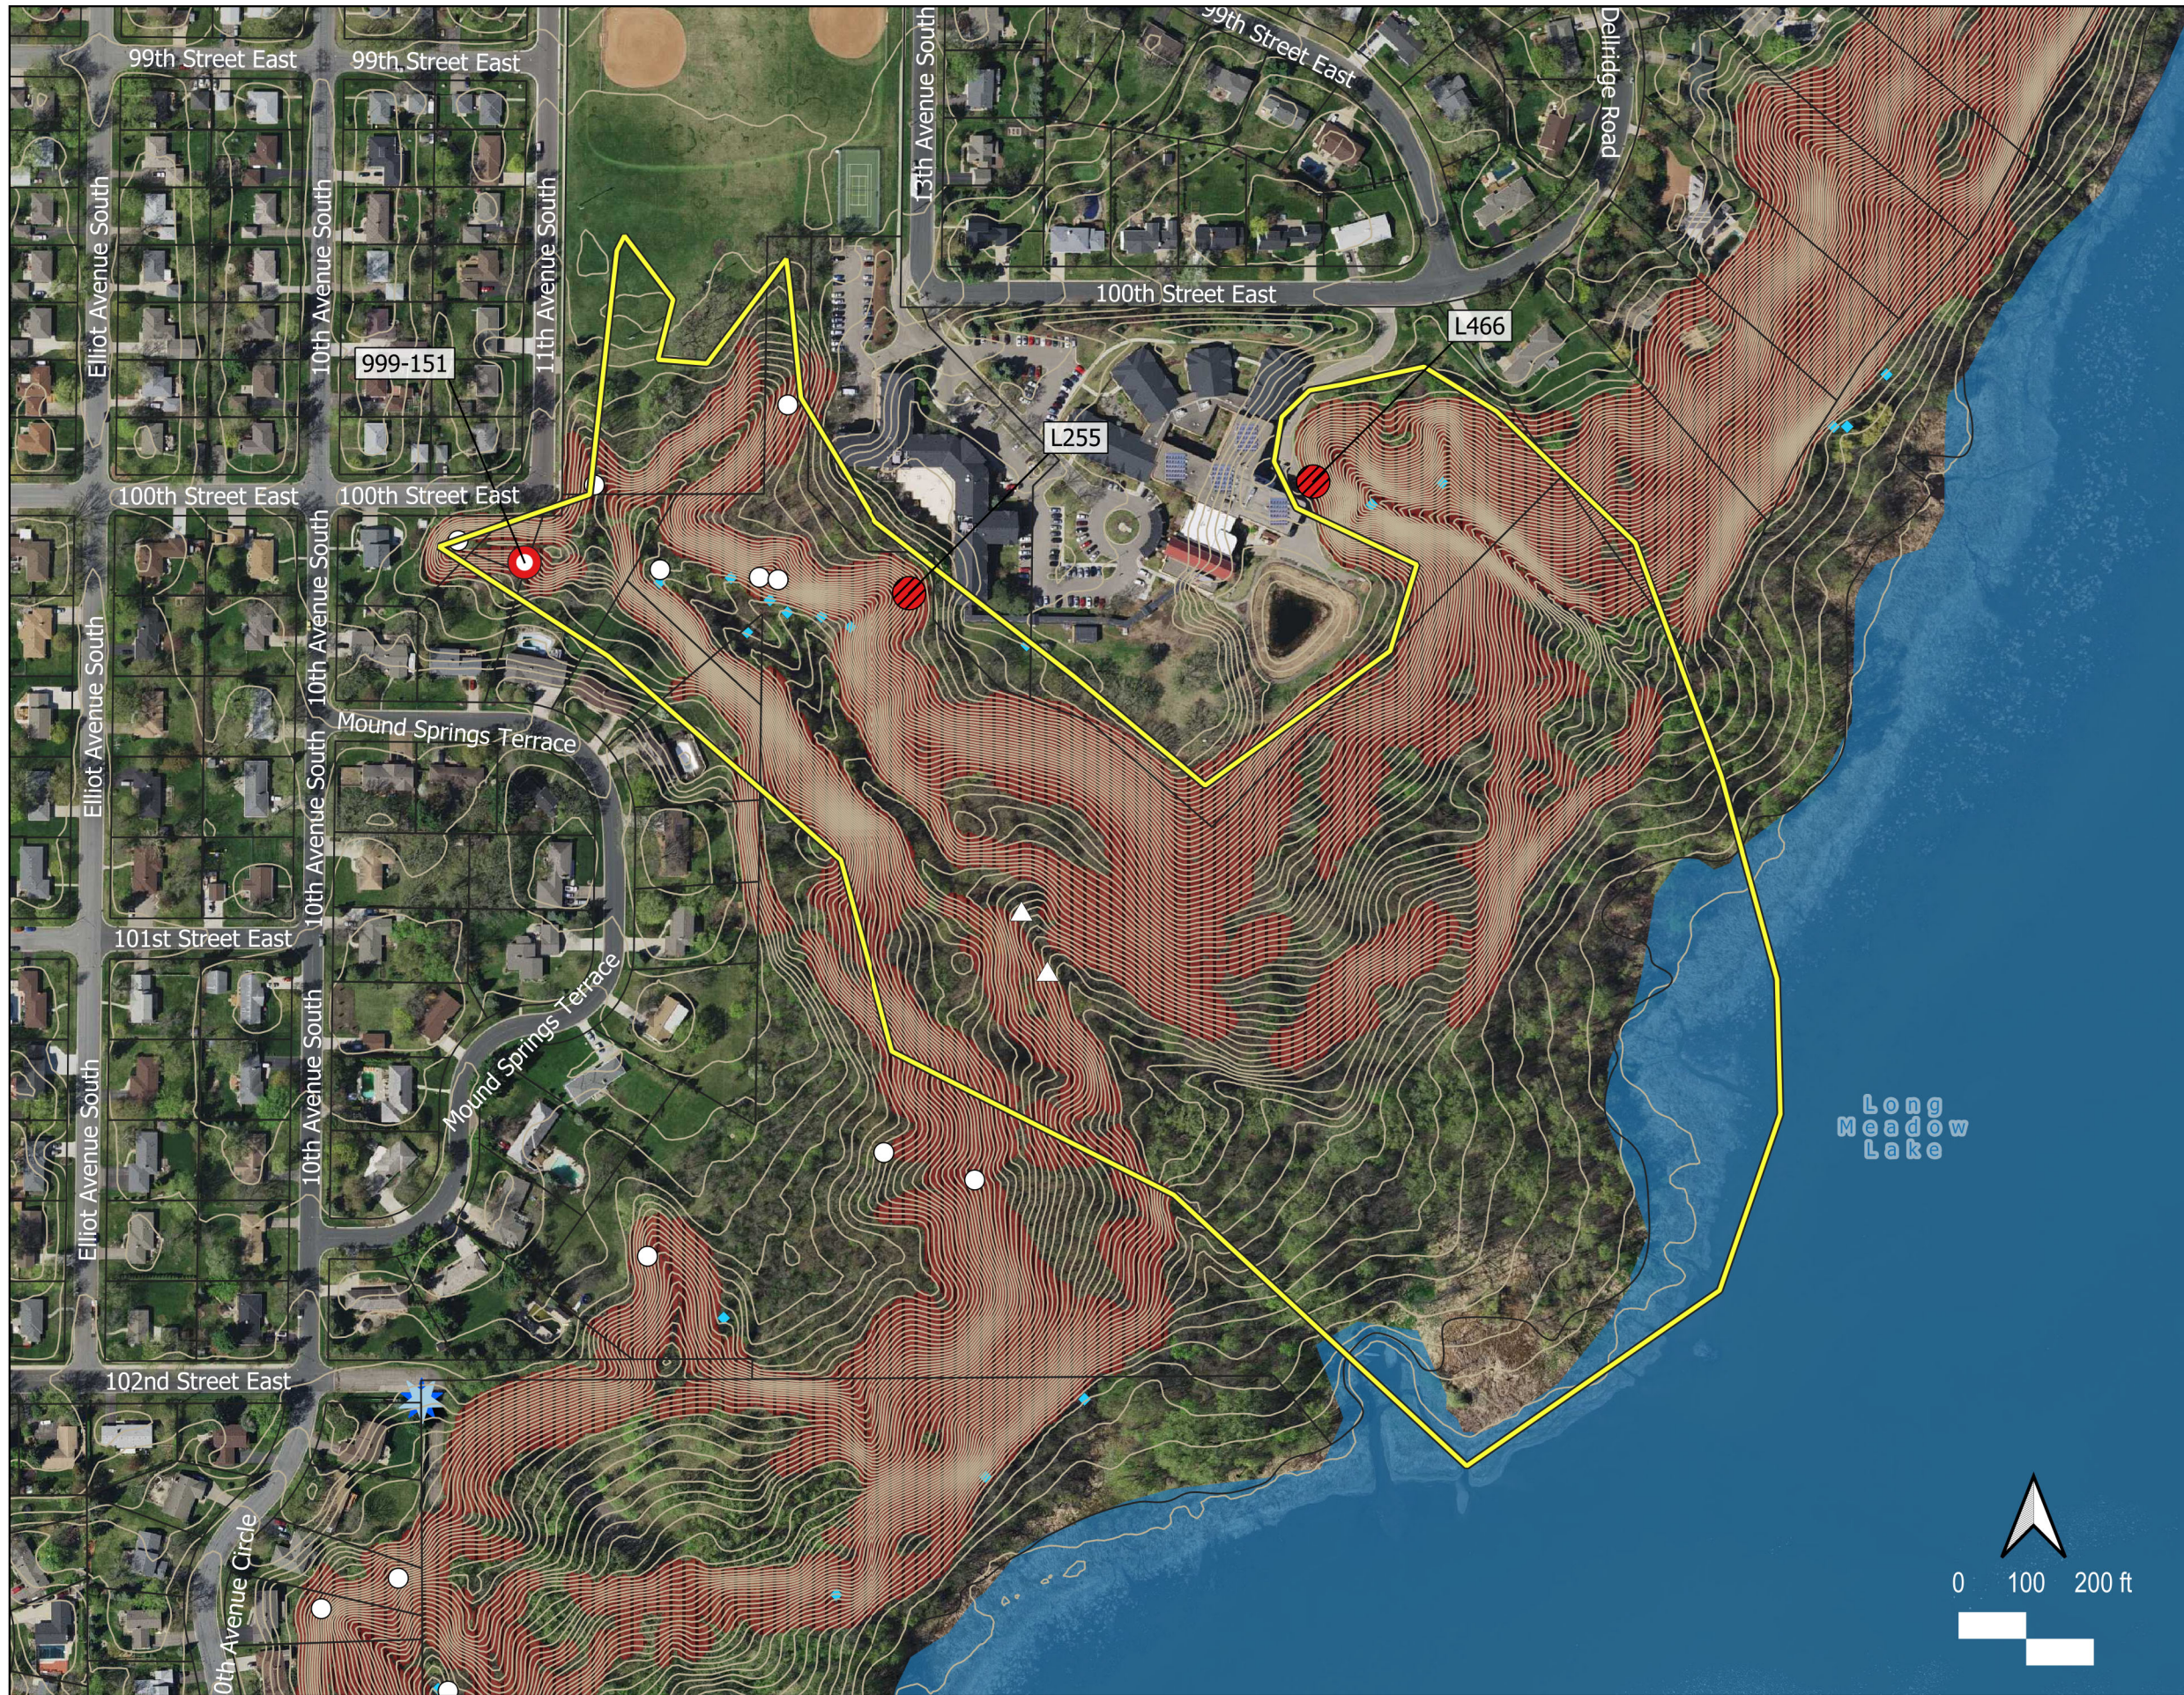
**Figure 31:
Bloomington High-
Priority Region No. 18**

HPR 18 is made up of three sites: 999-151, L255, and L466 (**Figure 31**). All three sites are located within Mound Springs Park.

Gully L255 was benchmarked as having a high erosion potential due to a photo depicting steep banks with bare soil and a description of “severe erosion.” This ranking is consistent with the ranking from the Project. During the 2020 field survey, new knickpoints near the toe of the gully and deeper incision within the gully channel were evident. **Figure 32** shows pictures from the 2008 and 2020 assessments.

Site L466 was located near to the other two sites. The site was described as a “deep gully with severe erosion” in the 2008 Inventory and benchmarked as a high erosion potential site. However, the condition of this deep gully could not be accurately assessed as part of the Project because of heavy vegetation.

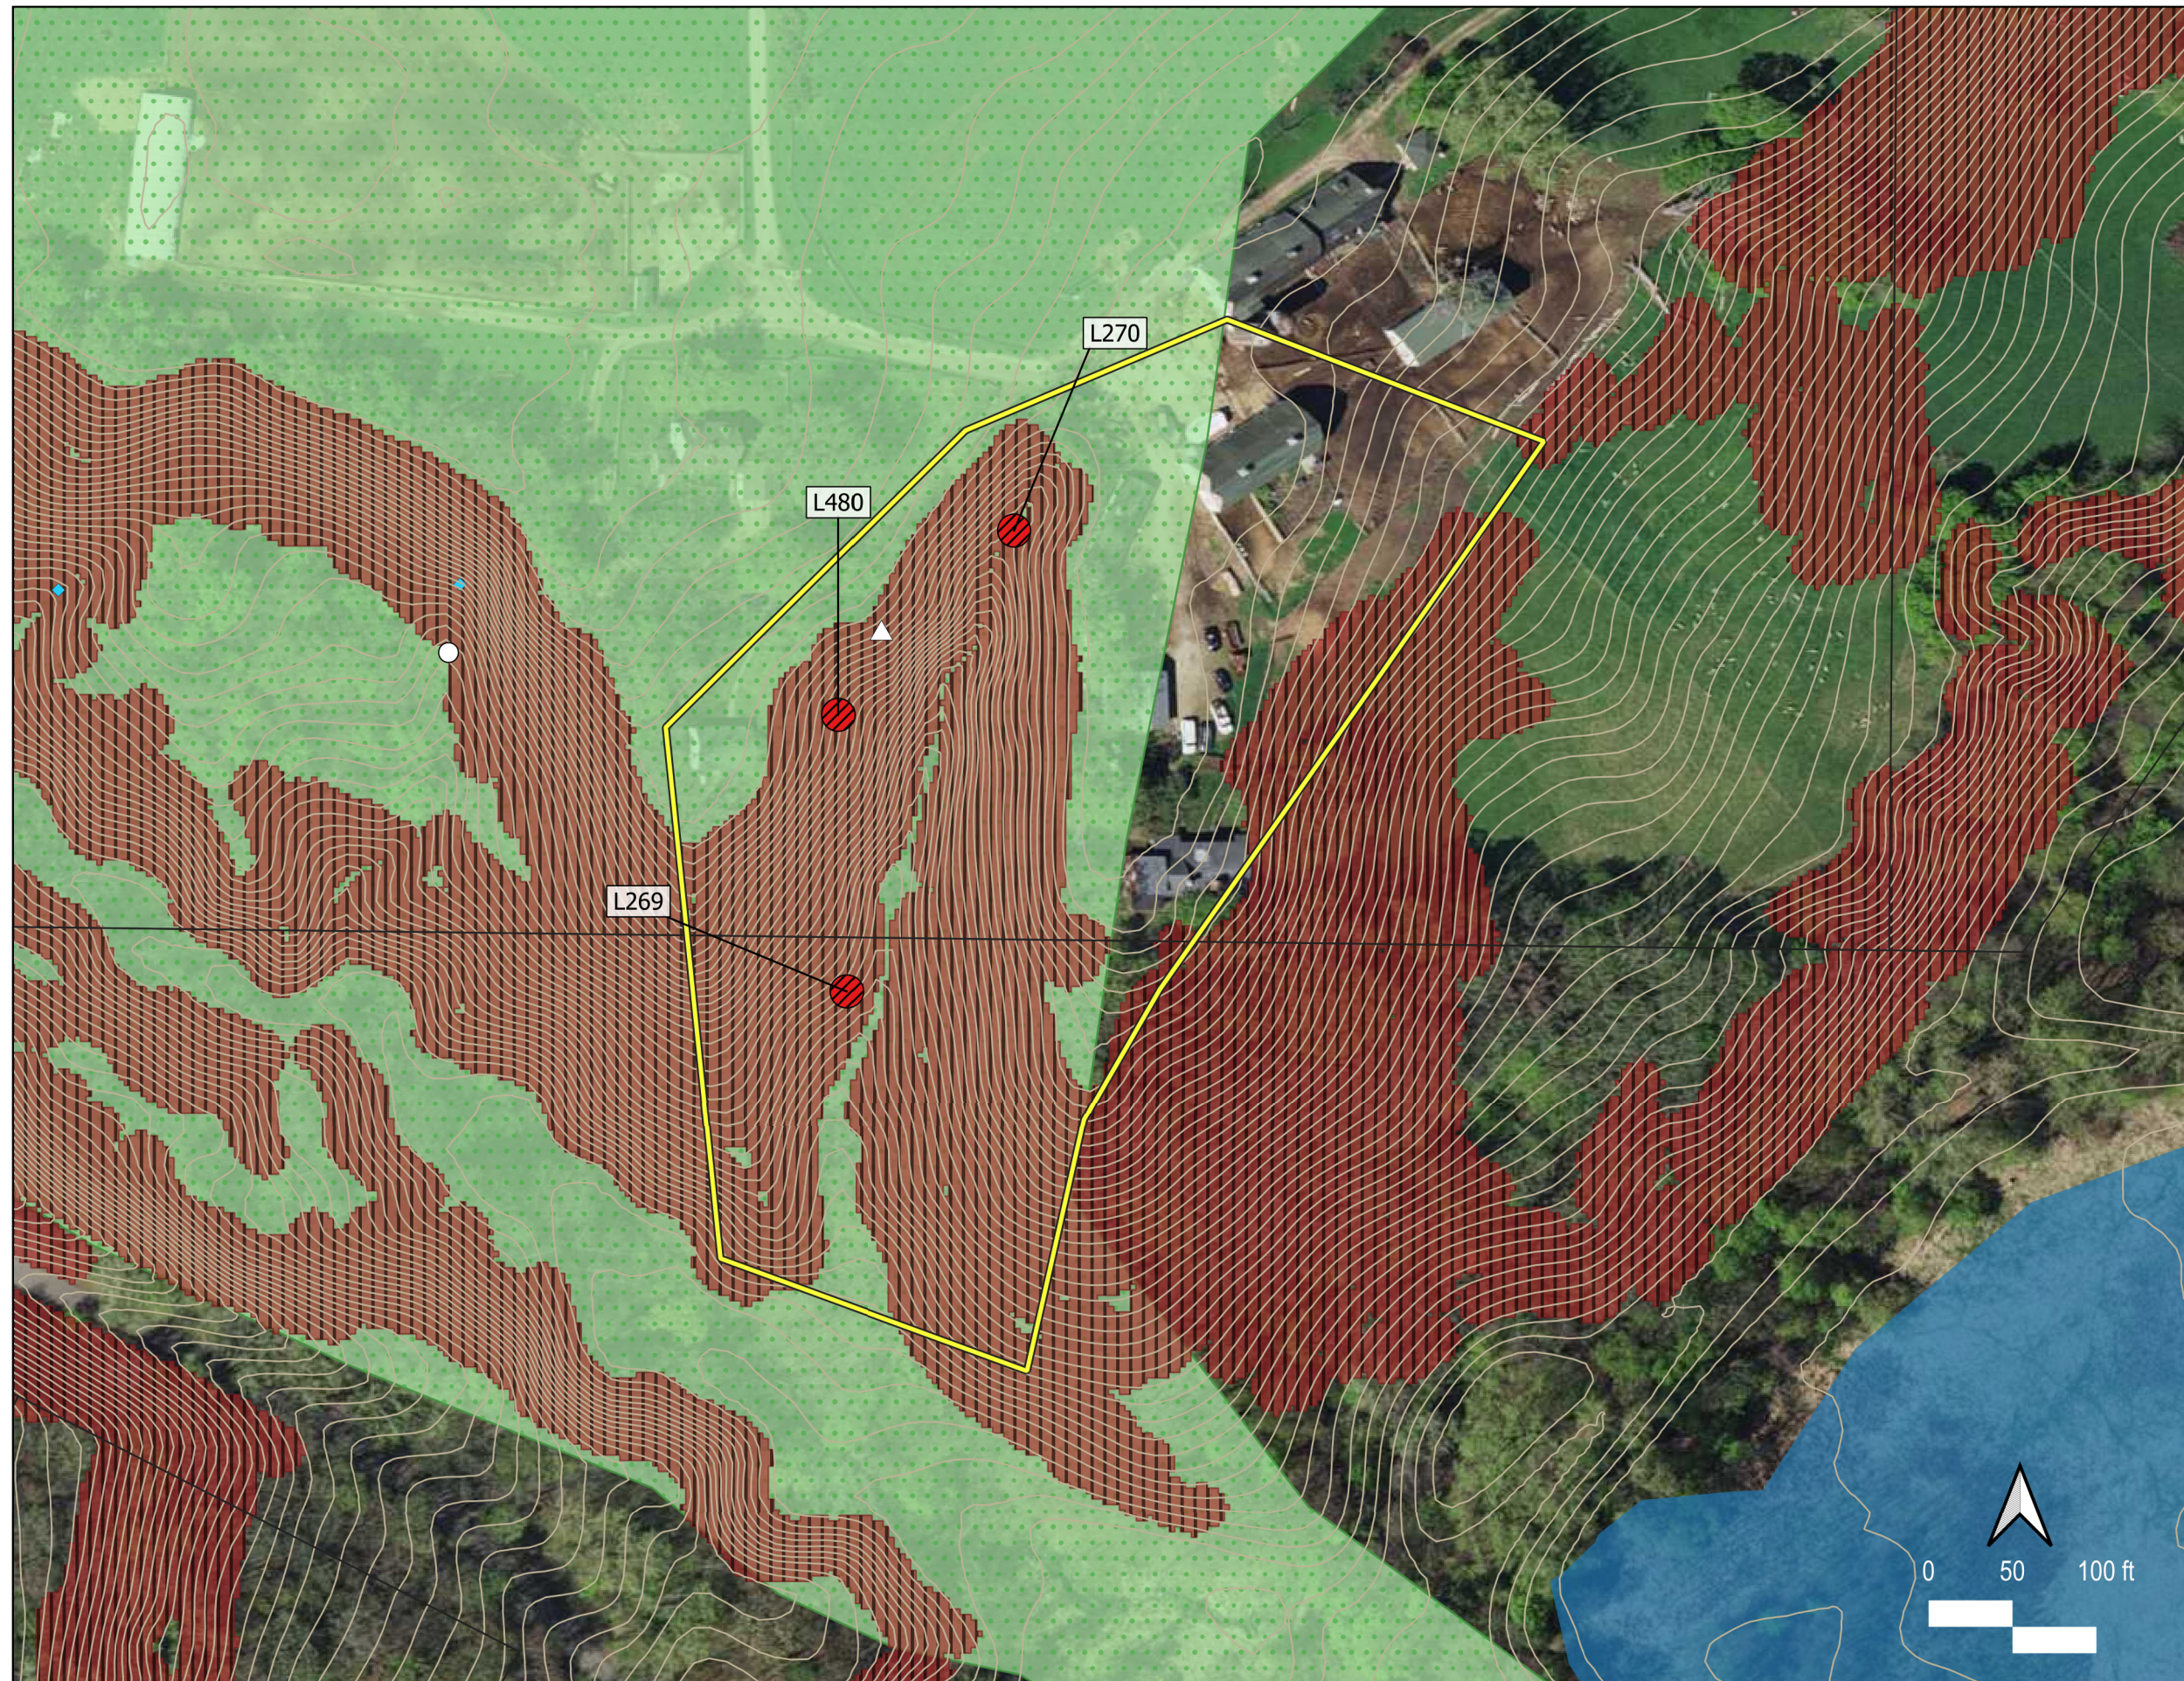
**Figure 35:
Bloomington High-
Priority Region No. 19**

HPR 19 contains gullies L270, L269, and L480 (**Figure 35**). These three sites are all located within a channel perpendicular to Ike's Creek.

In the 2008 Inventory, "extreme erosion" was noted at Site L269, and a head cut with overhanging banks was evident in the L270 site picture (**Figure 36a**). Both L269 and L270 were benchmarked with high erosion potential. The erosion potential appears to have remained consistent between the past and current assessment. No stabilization measures were noted, and compared to the 2008 Inventory photos, both gullies appeared to have deepened. **Figure 36** illustrates a narrower V-shape and larger perimeter of overhanging banks at the head cut of L270 in 2020 than in 2008.

The 2008 Inventory noted L480 as "deeply eroded," benchmarking it as having a high erosion potential. That description remained consistent and the site maintains high erosion potential. The gully appears to have widened without stabilizing. Additionally, the 2008 Inventory did not note a pipe draining into the gully, but the pipe was hanging and exposed.

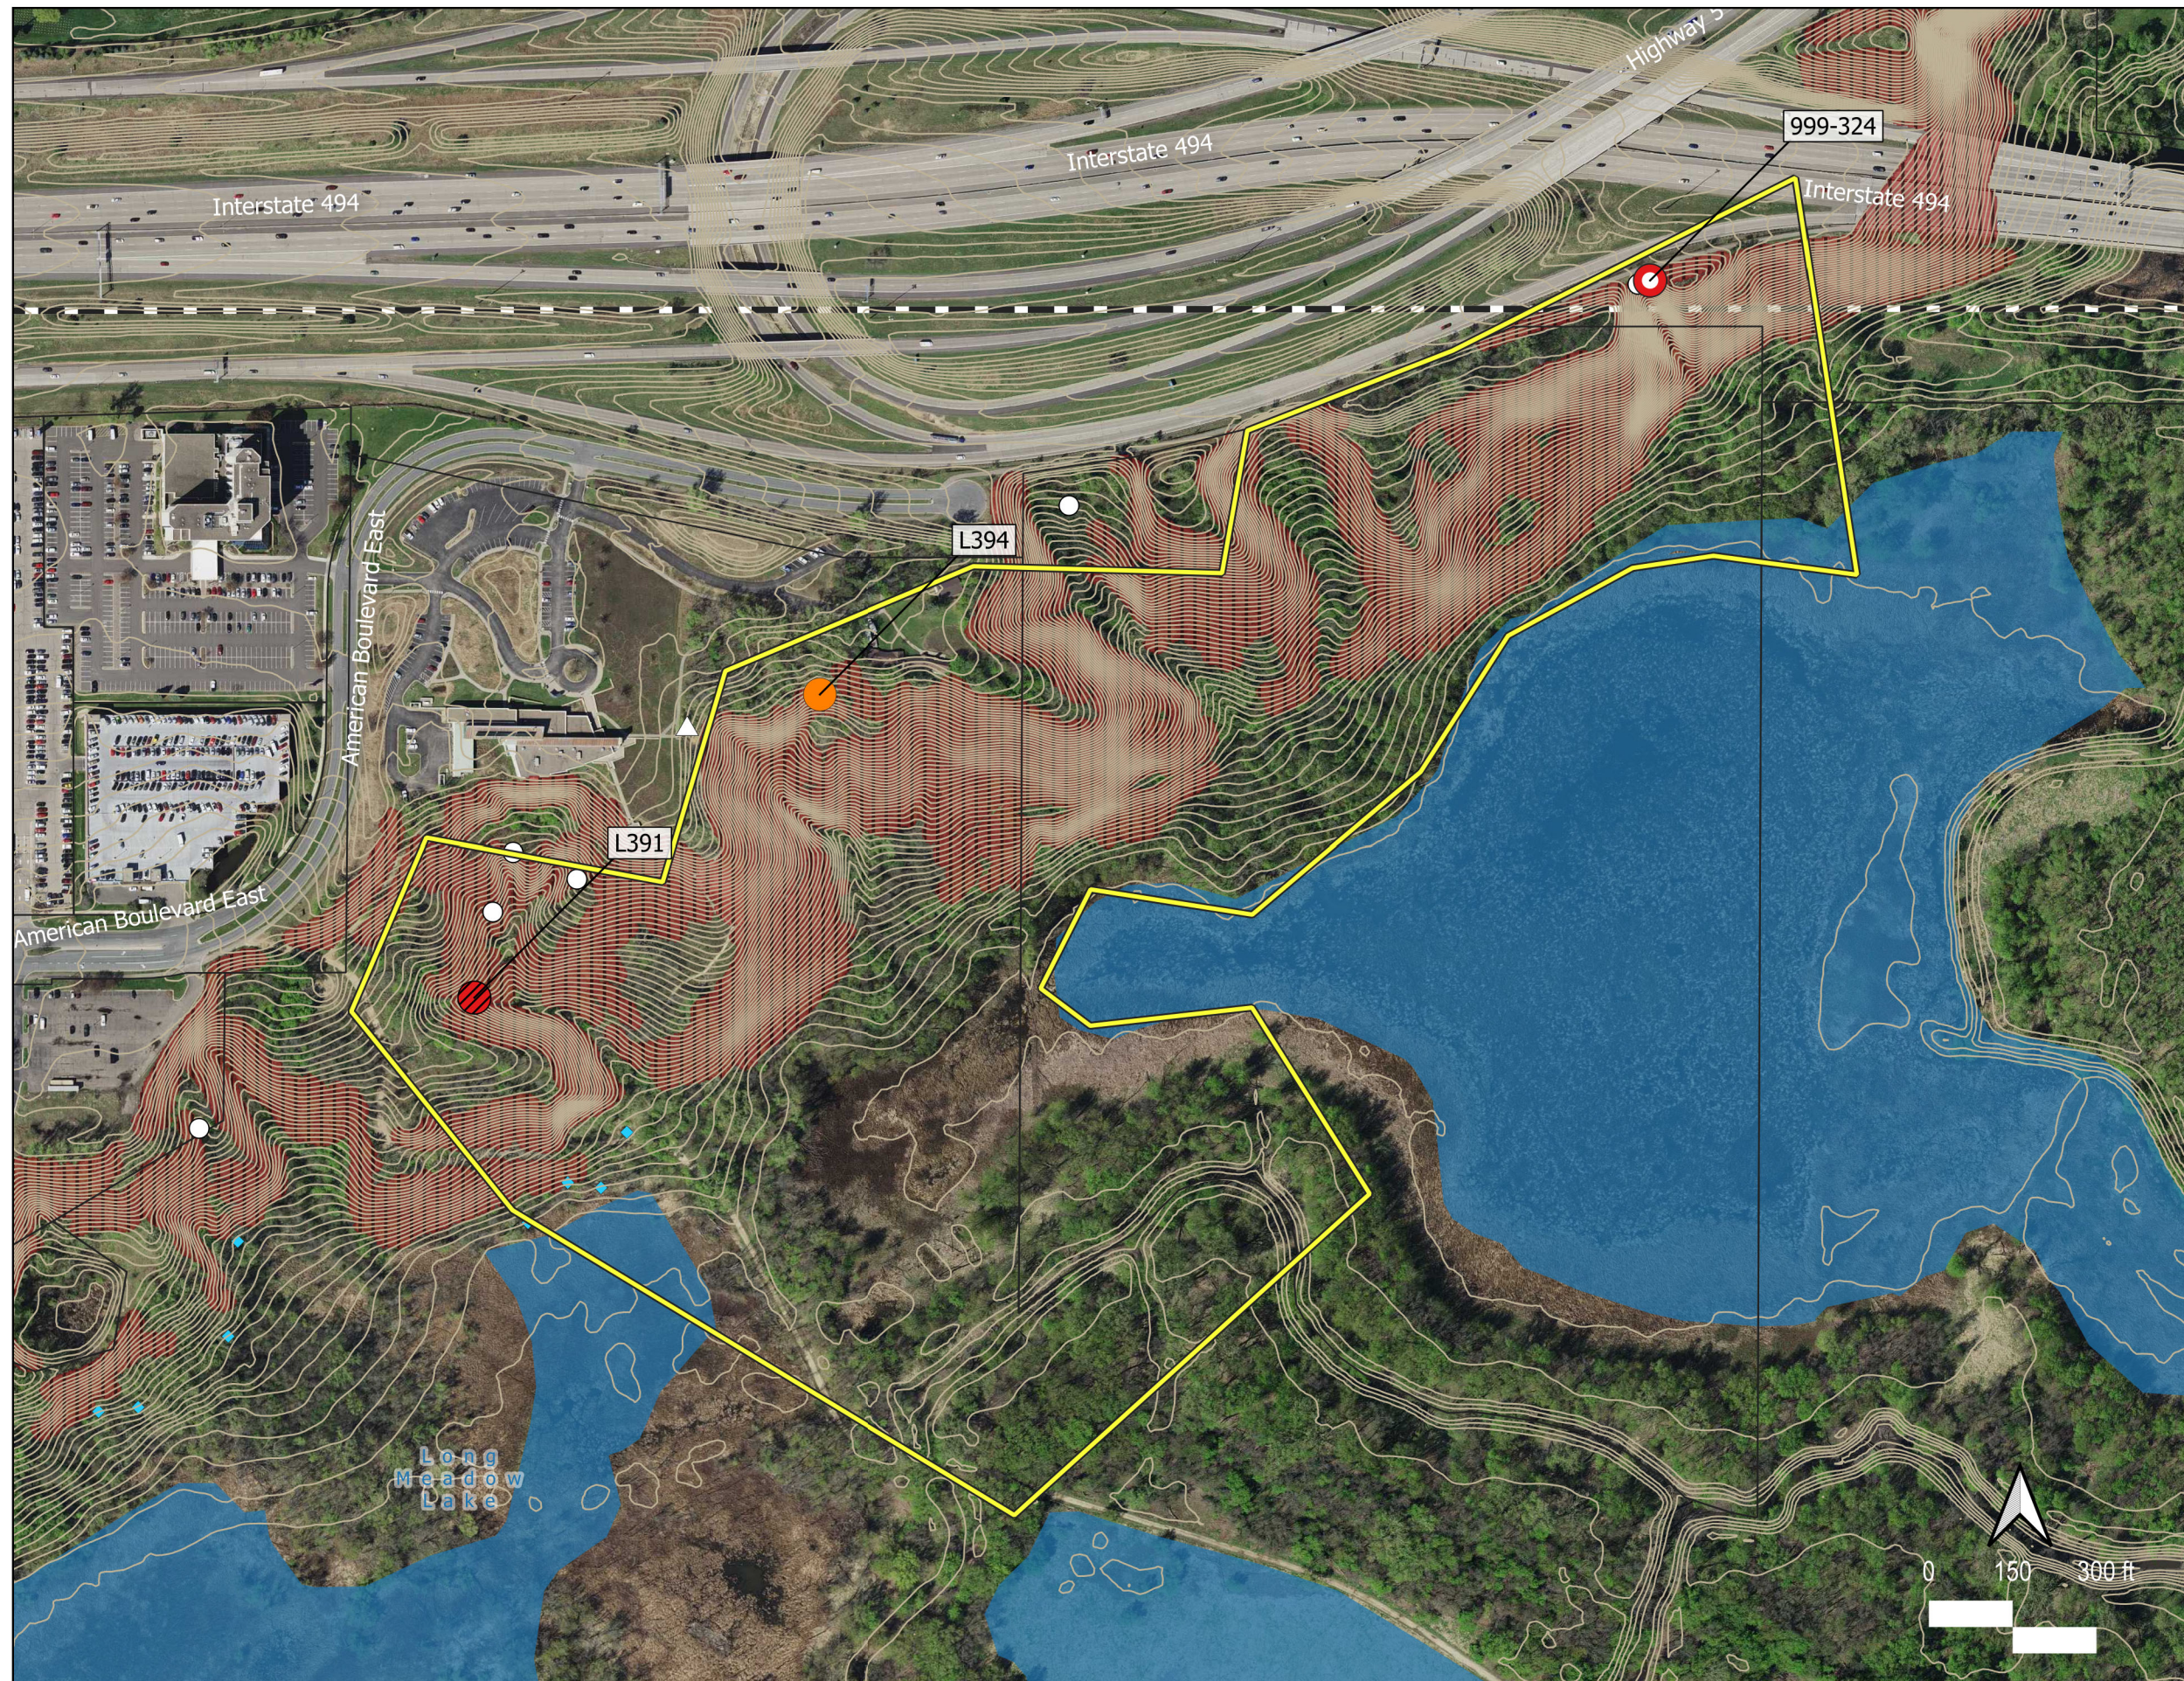
**Figure 38:
Bloomington High-
Priority Region No. 20**

The 2008 Inventory noted an “erosion cut” and concrete debris within the L394 channel. The picture did not seem to show the depth and extent of erosion seen in 2020 and, as such, the site was benchmarked as having a moderate erosion potential. As shown in **Figure 39**, actively eroding banks were observed during the field survey.
