6.0 CITY OF CARVER

6.3 Findings

6.5 Carver High-Priority Sites

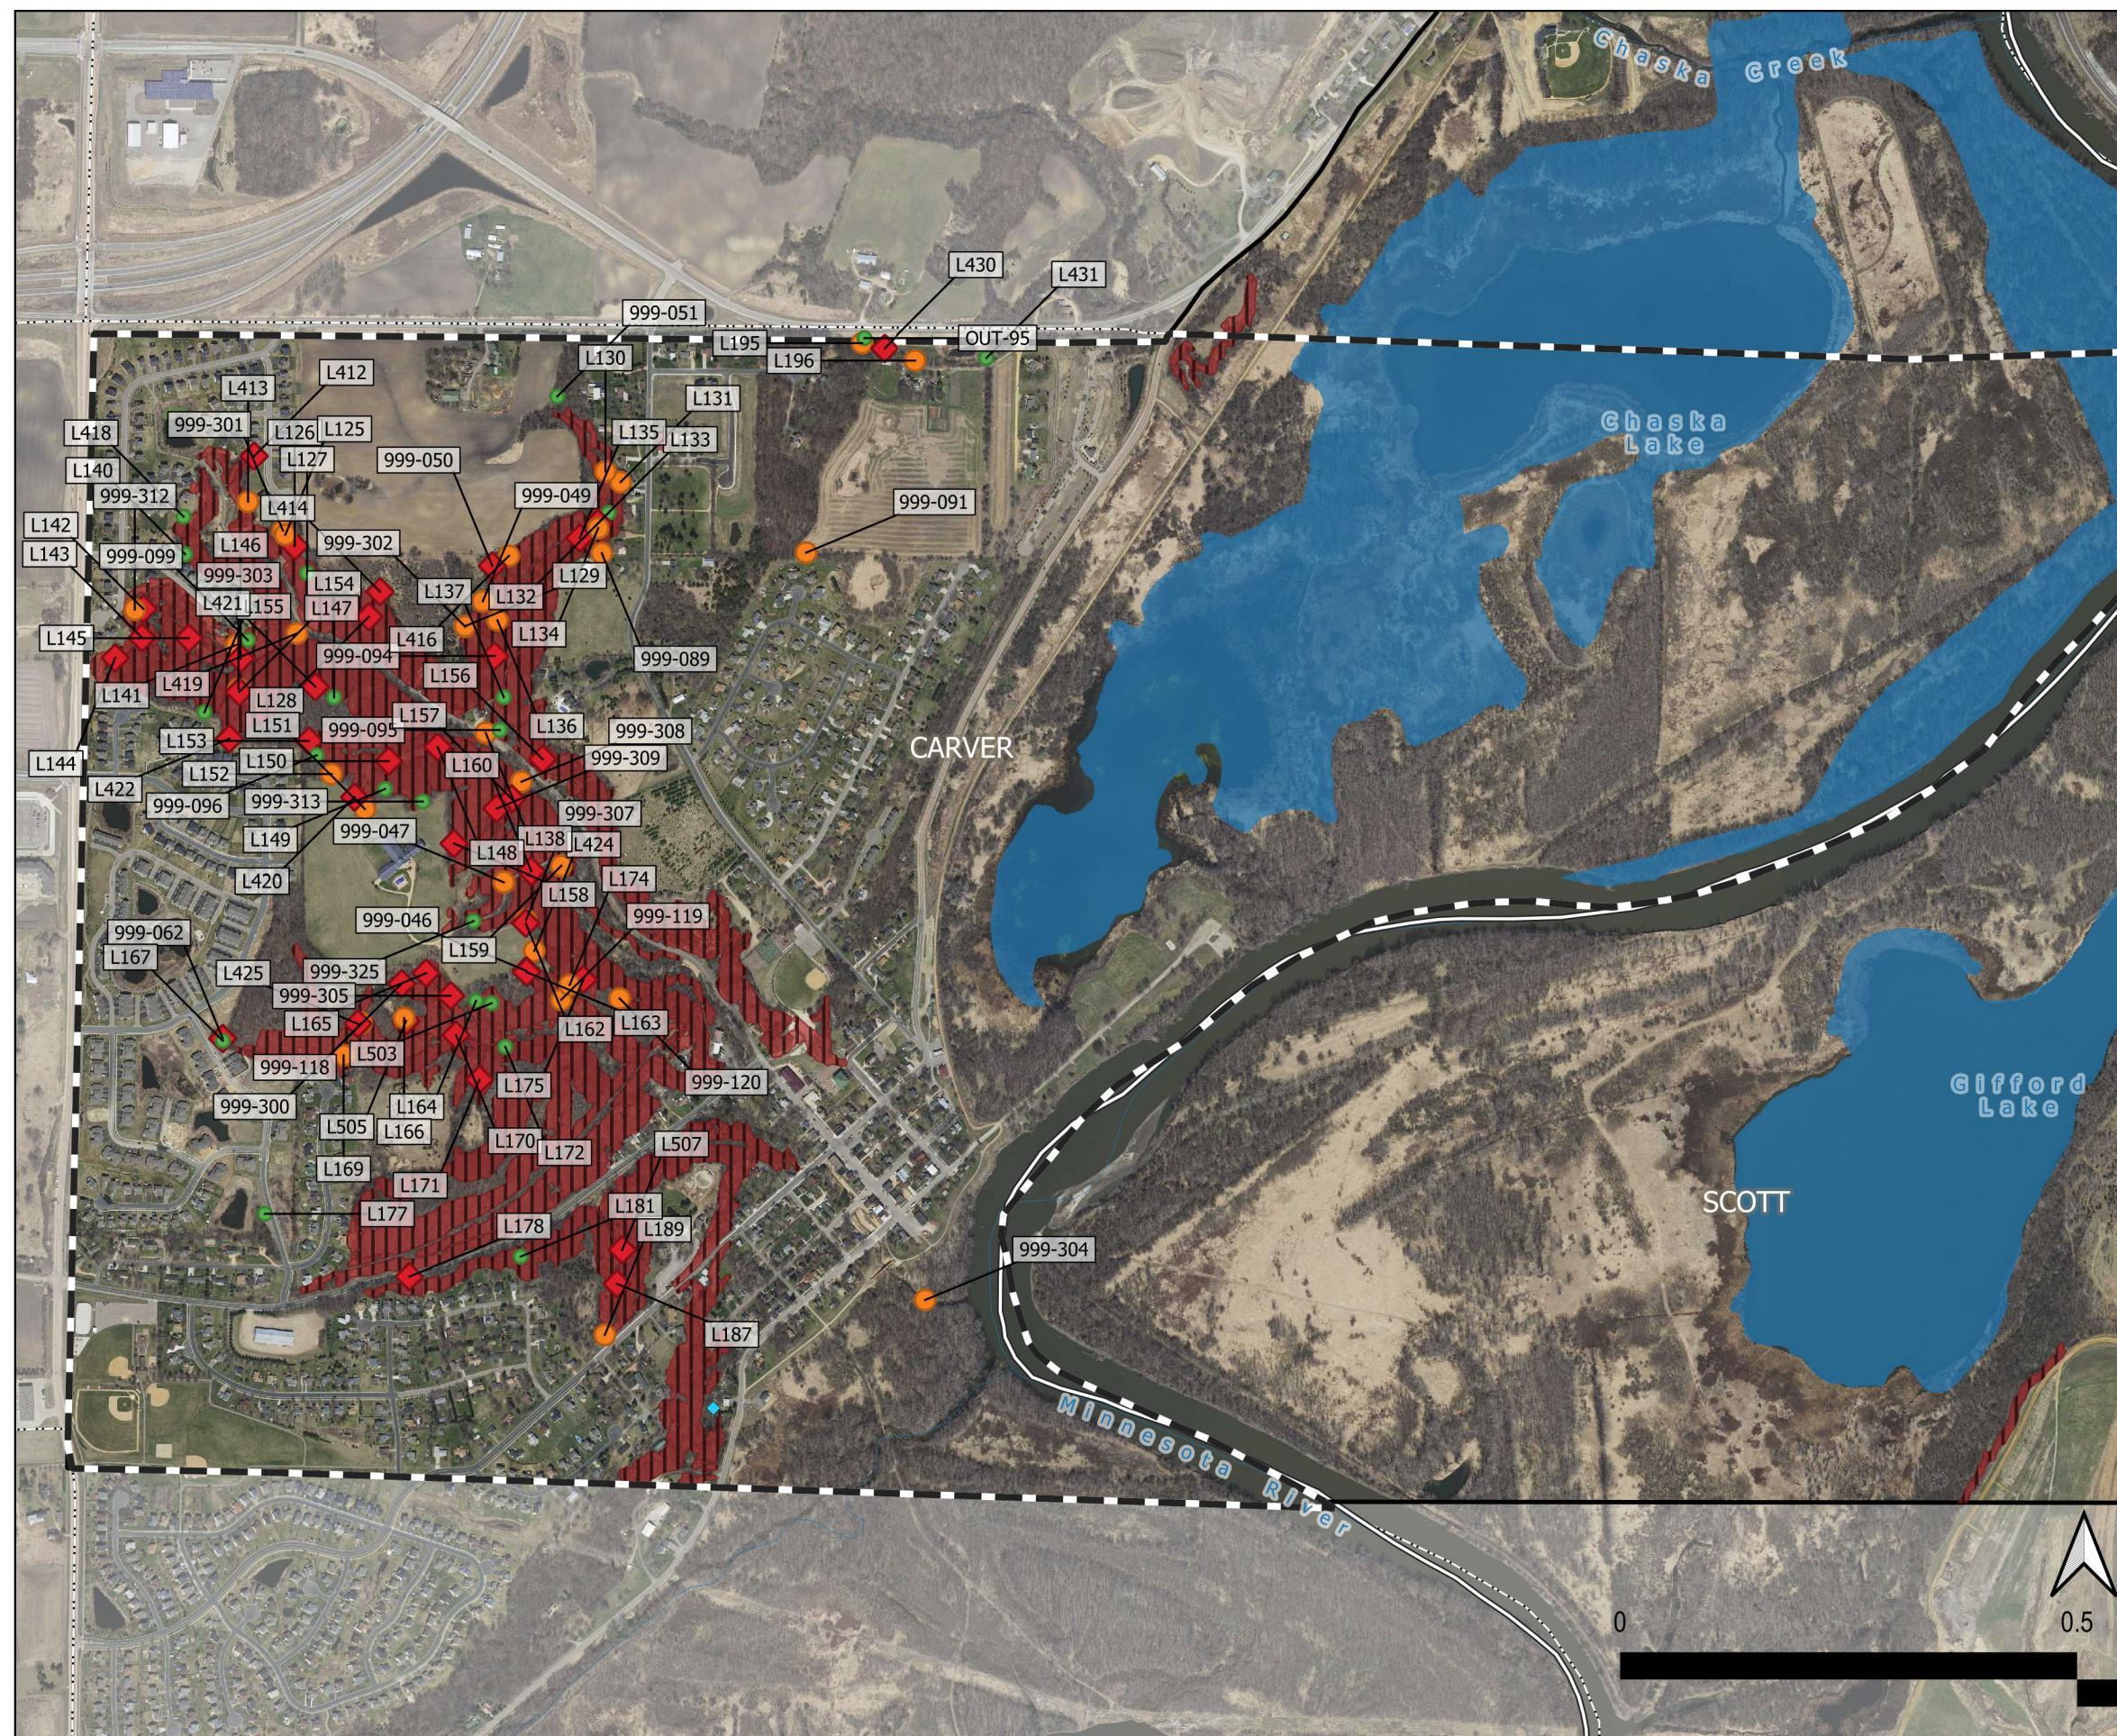
Carver contained some of the deepest gullies and the highest concentration of high erosion potential sites (Figure 43). For particularly long gullies, the team had to complete surveys at multiple locations within the gully system to accurately capture changes. Although drainage pipes contributed to instability, groundwater springs were observed in most locations and many gullies contained groundwater-fed streams with water flowing in the channel. The prevalence of groundwater in Carver was confirmed by the number of observed springs in the MnDNR Spring Inventory. Gullies in Carver branched out and connected at various points, creating branching gully systems, especially along Spring Creek. Many of the heavily eroded gullies consisted of sand, but other substrate types like fine-grained cohesive were present. Boulders and armored stream channels were also prevalent in this area.

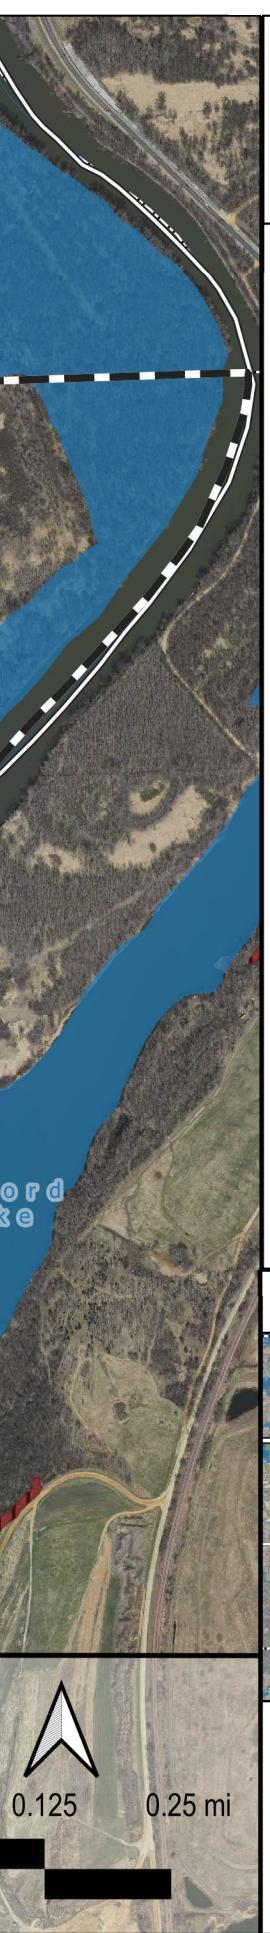
Figure 44: **Carver Erosion Progression and HPRs**

To better assess the erosion progression of an individual site, the change in erosion potential is mapped in **Figure 44**. Priority was placed on sites that increased in severity, going from low to high or moderate erosion potential. In the City of Carver, only 17 sites saw a reduction in erosion potential. The ratings for the sites judged to be less severe in 2020 than in 2008 can likely be attributed to the limited information available from the previous study for ranking determinations. The improved data collected in the 2020 study may have also played a role in the fact that sites were being ranked more appropriately, rather than any significant progressive change that may have occurred.

The high-priority sites within the City of Carver are comprised of nine HPRs and two stand-alone sites shown in **Figure 44**. All the high-priority sites are in the Steep Slopes Overlay District. Each region is primarily grouped around the high erosion potential sites, but there are additional moderate to low priority sites encompassed within each of the regions as well. The rationale for the priority groupings is described below:

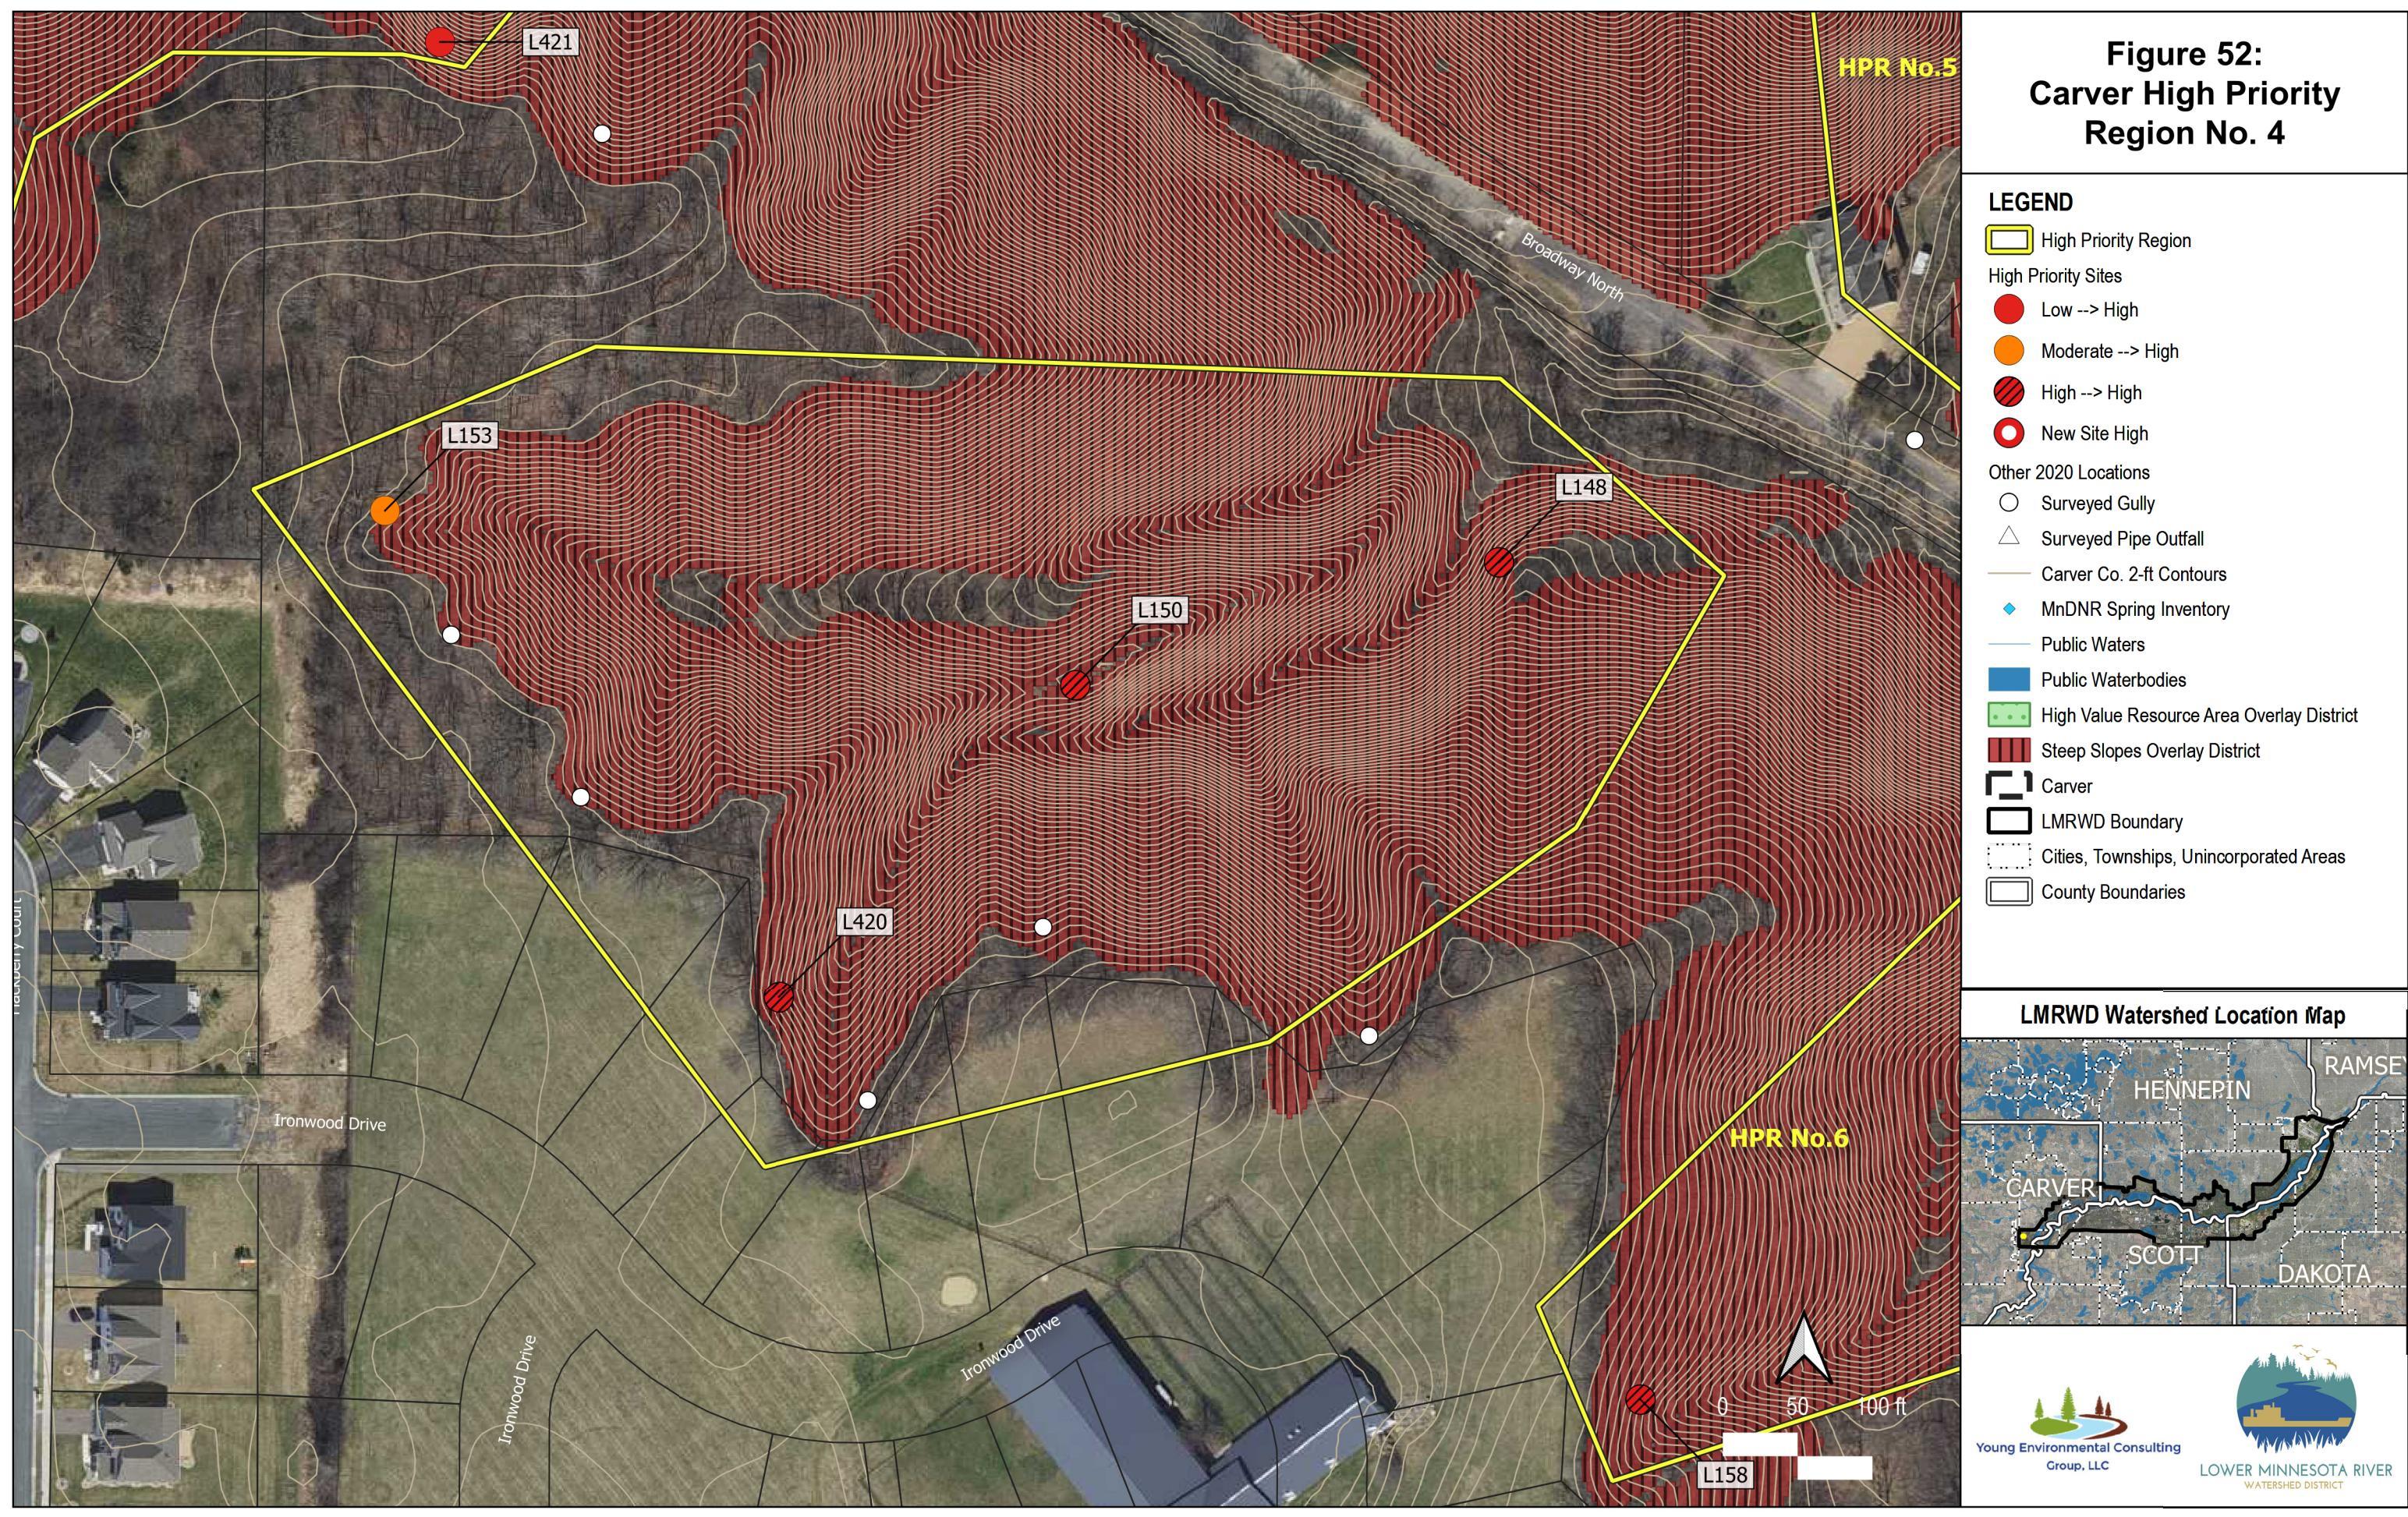
In 2008, the study documented extensive erosion at L420, L150, and L148. **Figure 53a** depicts the channel incision and active erosion seen at L148 during the previous study. At L153, the previous study characterized it as a "fingertip that looks good." The desktop analysis rated L420, L150, and L148 as having high erosion potential and L153 as having moderate erosion potential. The field team confirmed the three high ratings in the field, determining evidence of active erosion and slumping that provided the rational for high erosion potential rankings. **Figure 53b** and **Figure 53c** provide examples of the severe slumping, overhanging banks, and channel incision observed throughout the gully system. L153 was determined to be high erosion in the field, due in part to a second head cut forming off the main channel not previously identified in the 2008 study. Fresh bare soil with exposed roots also provided rationale for the site's high priority ranking.

Figure 53. Photo 'a' is an image of L148's channel and banks taken in 2008; Photo 'b' is an upstream view of L148's channel taken in 2020; and Photo 'c' is an upstream view of L150's channel taken in 2020.

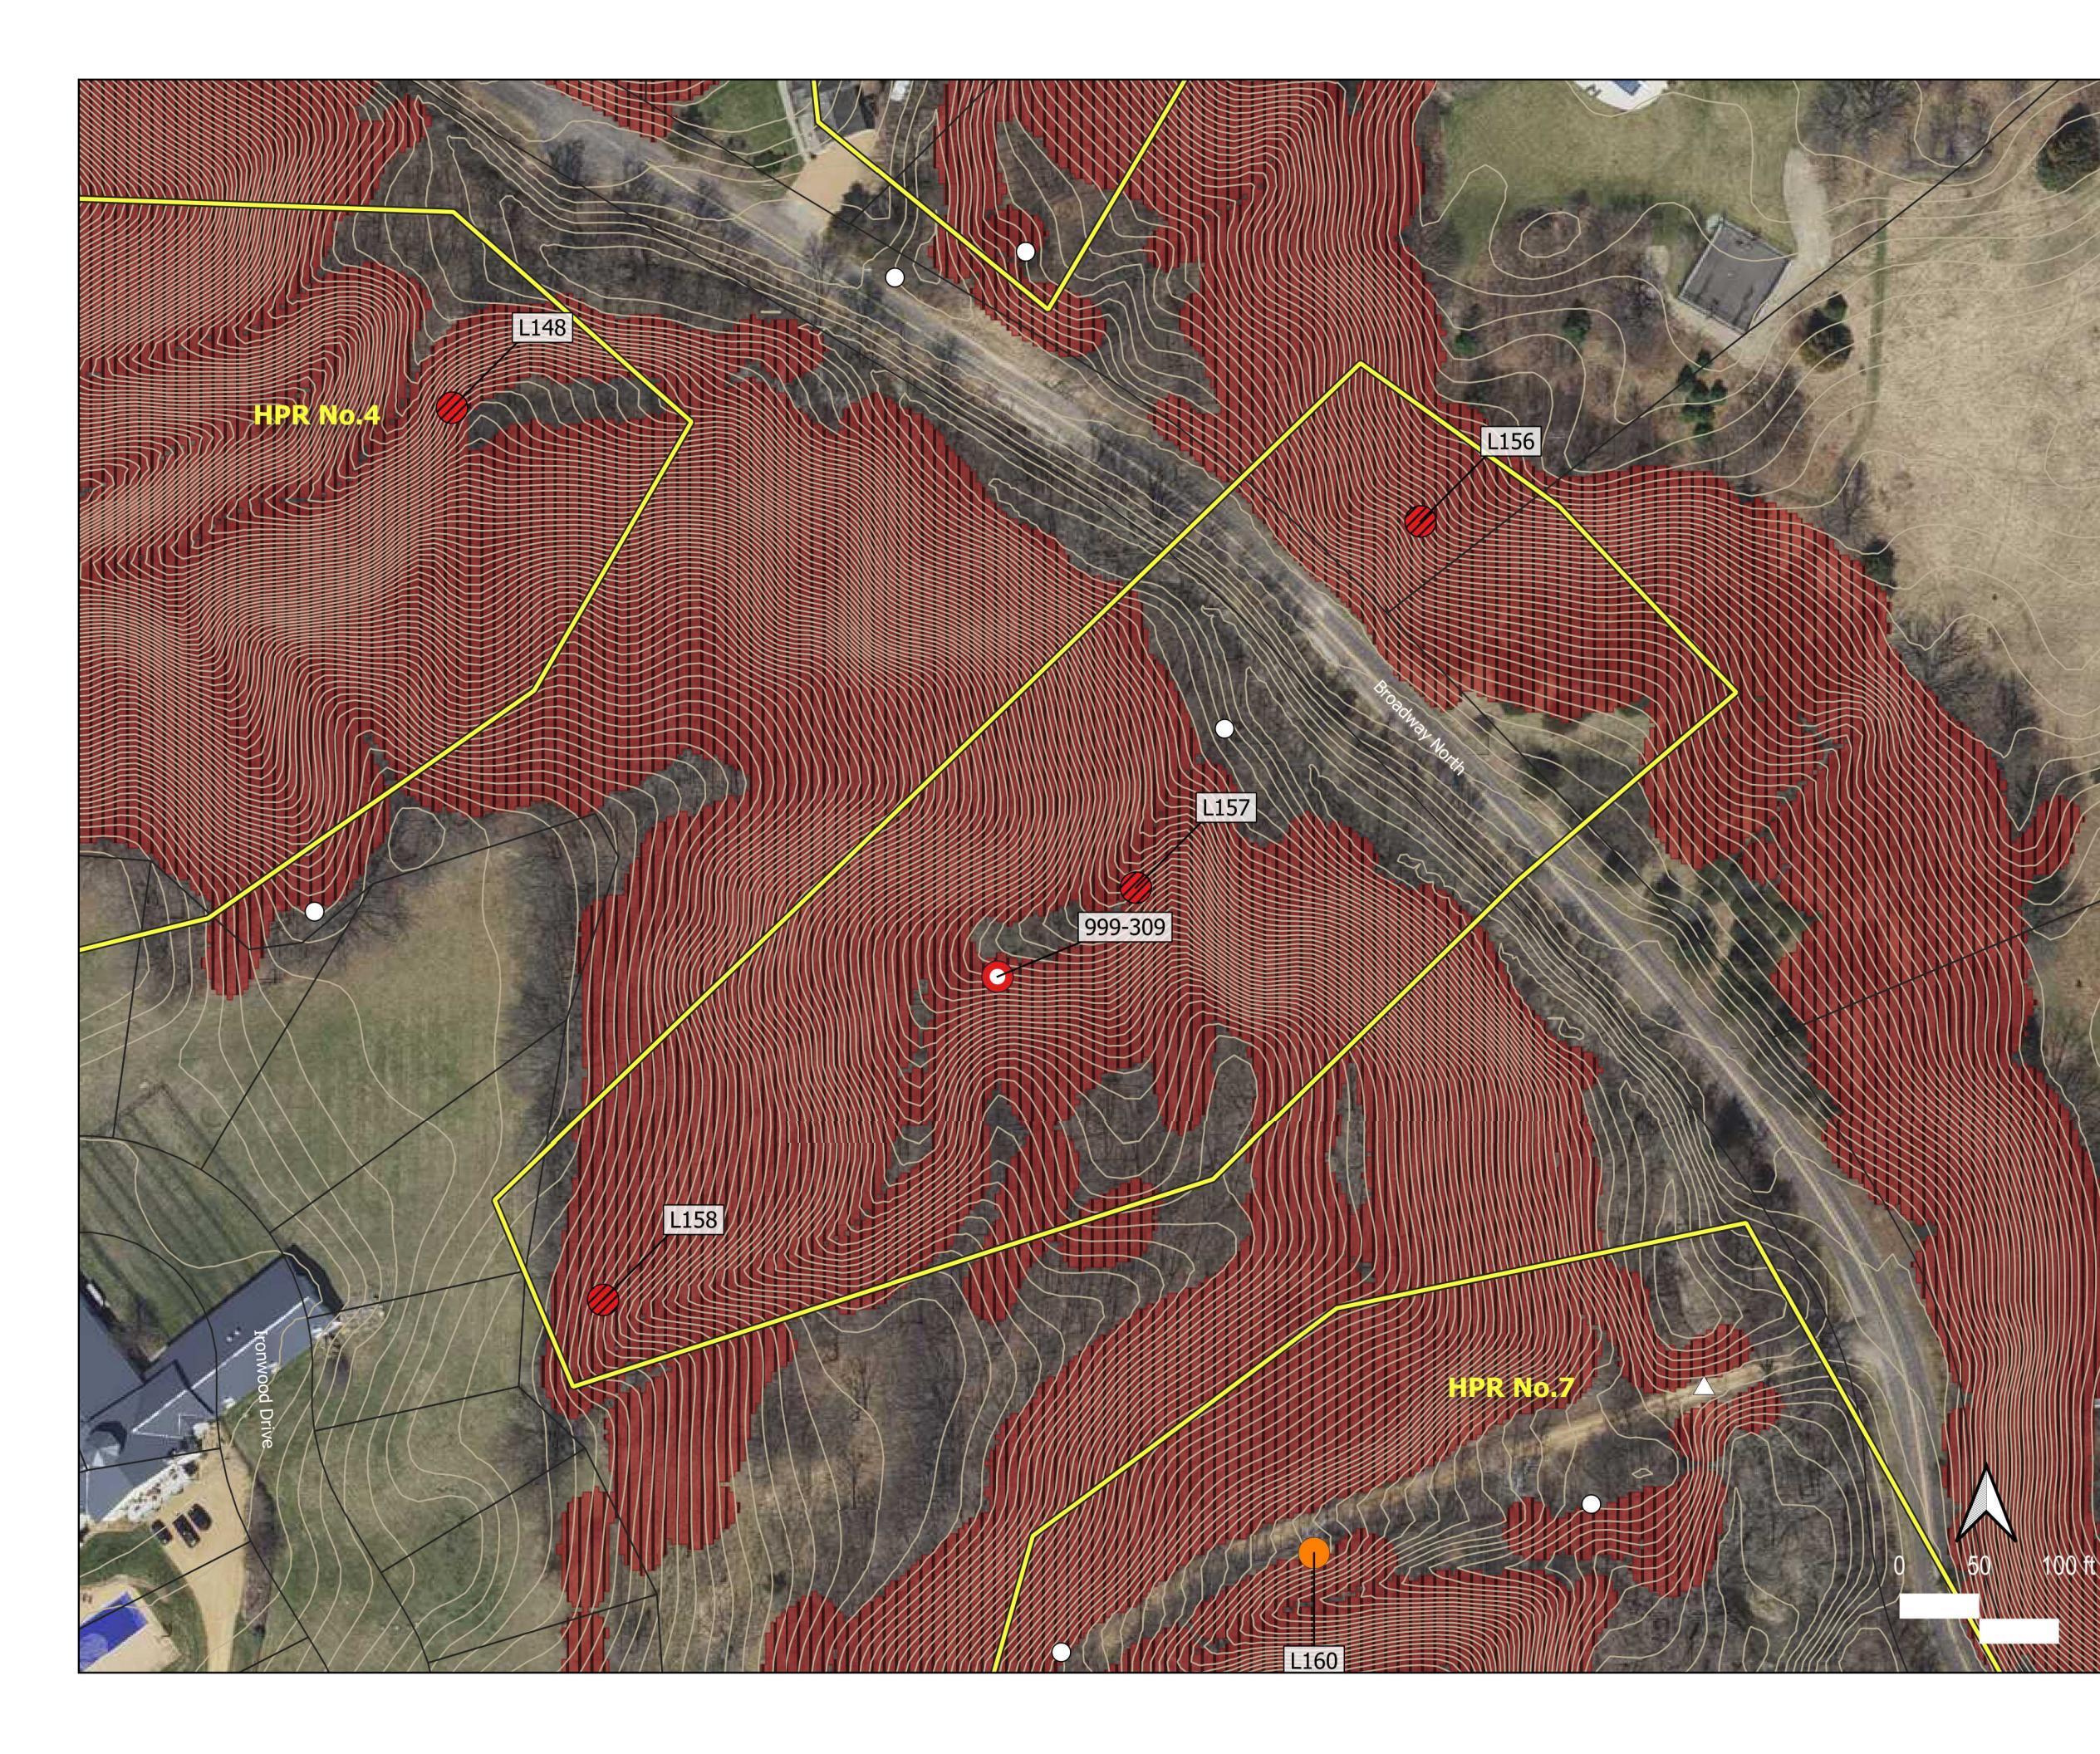
Figure 57: Carver High Priority Region No. 6

HPR 6 consists of Points L158, L500, L157, and L156 (**Figure 57**). Three sites, L158, L157, and L500, form one gully system, with knickpoints constituting the breaks in the reach where a new point was surveyed. At the head cut, the gully channel was found to be deep but grading into a medium depth further downstream. The gully was found to have a narrow bottom width and a V-shape, with a steep slope. The material for the gully system was found to be fine-grained cohesive sediment. The entire gully system was found to be bare soil, and no seep was observed throughout at the time of the visit. L156 was evaluated as a short, medium-sized narrow gully on the hill slope parallel to the main gully system of this region. Common to the gullies in the region, bare soil, steep slopes, and V-shape were noted for L156. Sand was determined to be the predominant material, and no seep was observed at the time of the visit.

Problem indicators throughout the region were observed to be degradation, incision, undercut banks, and loss of bank vegetation. The team noted slumping at the head cut and toe of the main gully system, as well as at L156. Apparent causes for gully formation in the region include slope and channel incision, with dense canopy additionally being noted for the main gully system.

In 2008, L156 was noted as being a small finger gully with "deep cut erosion under trees and all up hillside." The gully was benchmarked as having high erosion potential based on the information provided. The team confirmed this ranking during the 2020 study. The main gully system was described in 2008 as being a finger gully with sizeable erosion throughout. Additionally, it was noted to have deep cut erosion at L157 near the gully toe. The system was ranked as having high erosion potential during the desktop analysis. The ranking was confirmed in the 2020 study, with the whole gully system being ranked as having high erosion potential. The team observed a significant increase in erosion and degradation since 2008, further providing a rationale for its high-priority status. **Figure 58** depicts the increased erosion and degradation that has occurred between the two studies. **Figure 58a** is an upstream view of the main gully system channel taken in 2020, showing the channel incision and erosion near L157. **Figure 58b** is the same upstream view taken in 2020, showing the increased channel incision and erosion that has occurred since the previous study, as well as highlighting the channel shape and incision commonly seen throughout the region.

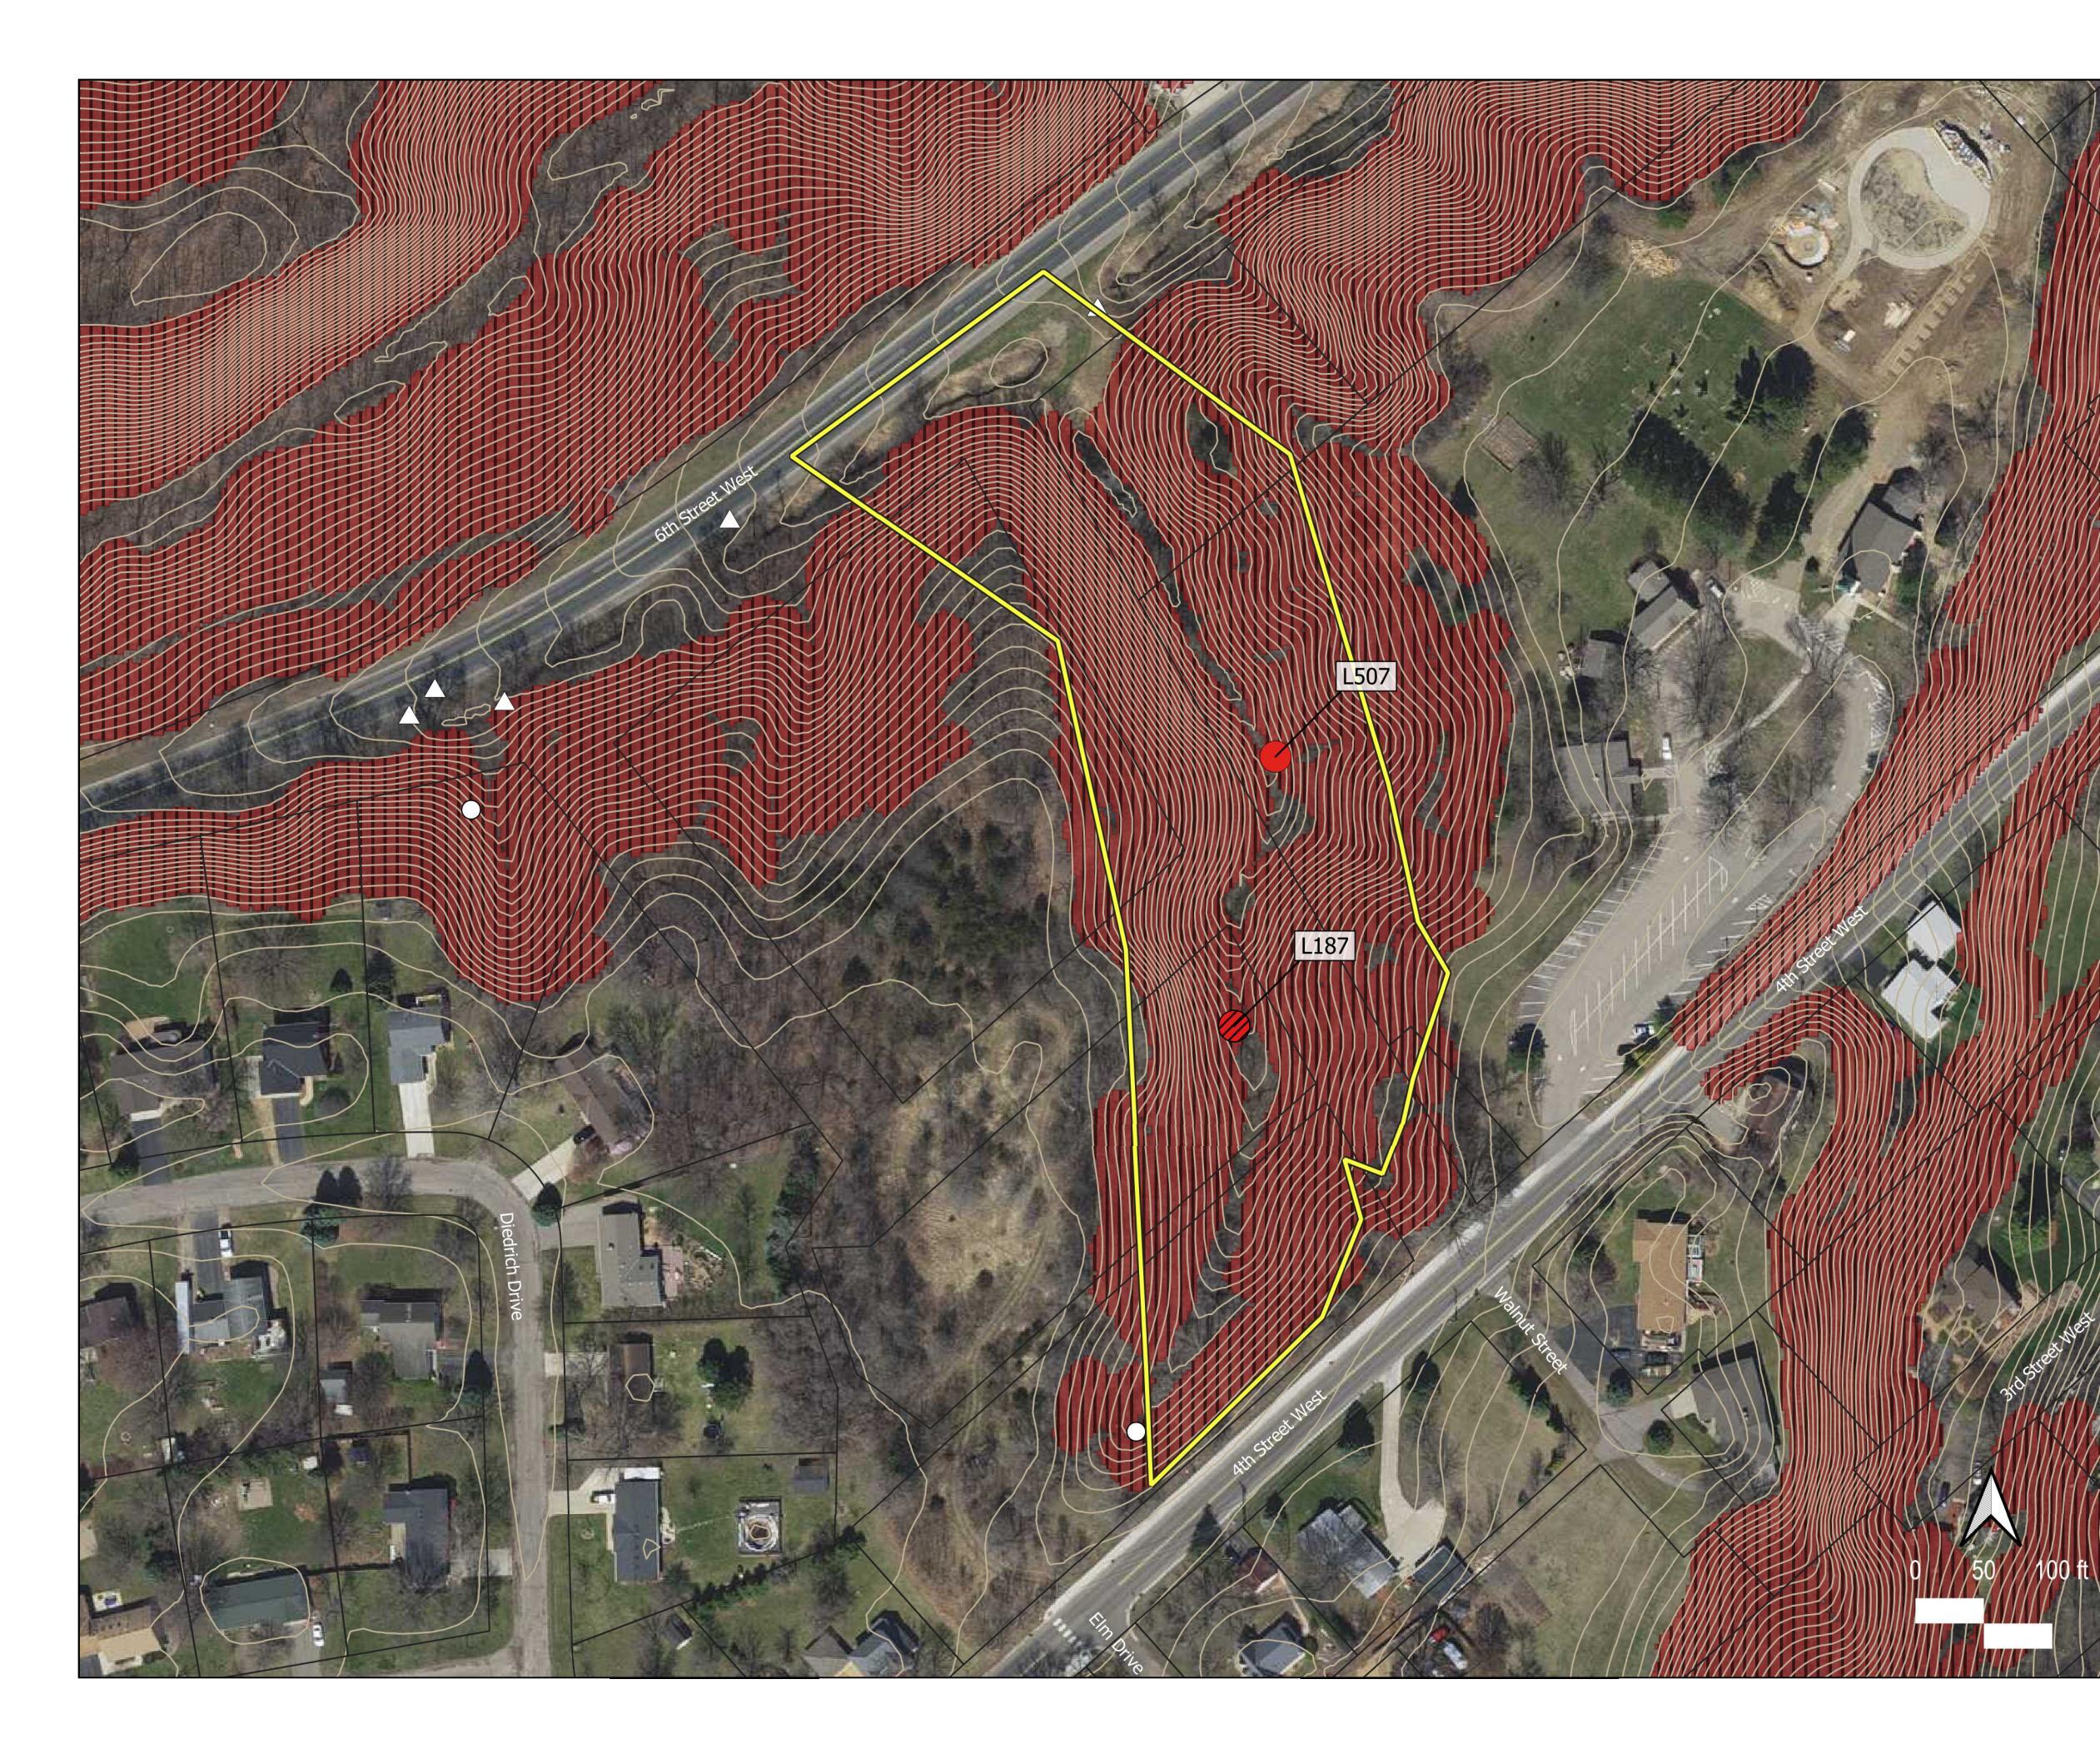
Figure 64: Carver High-Priority Region No. 9

HPR 9 is made up of two sites, L187 and L186, which form one large gully (**Figure 64**). The gully's head cut is formed by a pipe outfall discharge at Site L189. L189 was rated as having moderate erosion potential and is therefore not a high-priority site. It is included in the gully region but not detailed in this section. Both gullies are medium-sized and long, with flat slopes. Channel armoring is common in this region, with some bank vegetation observed throughout. Sand is the predominant gully material in the region. L187 was observed to have a U-shaped channel, whereas L186 was observed to have a V-shaped channel. Seeps were only observed at L186, but no consistent water flow was observed in the gully system.

The problem indicators of the region are degradation, incision, slumping, undercut banks, and leaning trees. New gully head cuts were observed forming within the gully system, and large slumps were seen throughout the region. The apparent causes of L187 were channel incision and an unstable drainage feature. The apparent causes of L186 were an unstable drainage feature, channel incision, groundwater, and a dense canopy.

In 2008, L187 was described as a "washout area." During the desktop analysis, it was determined the site had high erosion potential based on the image and information available. The team in 2020 confirmed this high erosion potential ranking in the field, finding evidence of active erosion throughout the channel and significant slumping. Site L186 was evaluated as a spring at the end of a marsh in 2008 and given a low erosion potential ranking during the desktop analysis, based on the limited information available. The field team determined the site had high erosion potential in 2020, finding evidence of slumping and new head cuts forming from the original channel. Groundwater incision in the channel was additionally noted, providing a rationale for its high erosion potential ranking. **Figure 65** shows the evolution of L186. **Figure 65a** is a downstream image of L186's channel taken in 2008, showing minimal channel incision and erosion. **Figure 65b** is a downstream image of L186's channel taken in 2020, showing severe channel incision, undercut and exposed banks, and erosion in channel.
