7.0 CITY OF CHANHASSEN

7.3 Findings

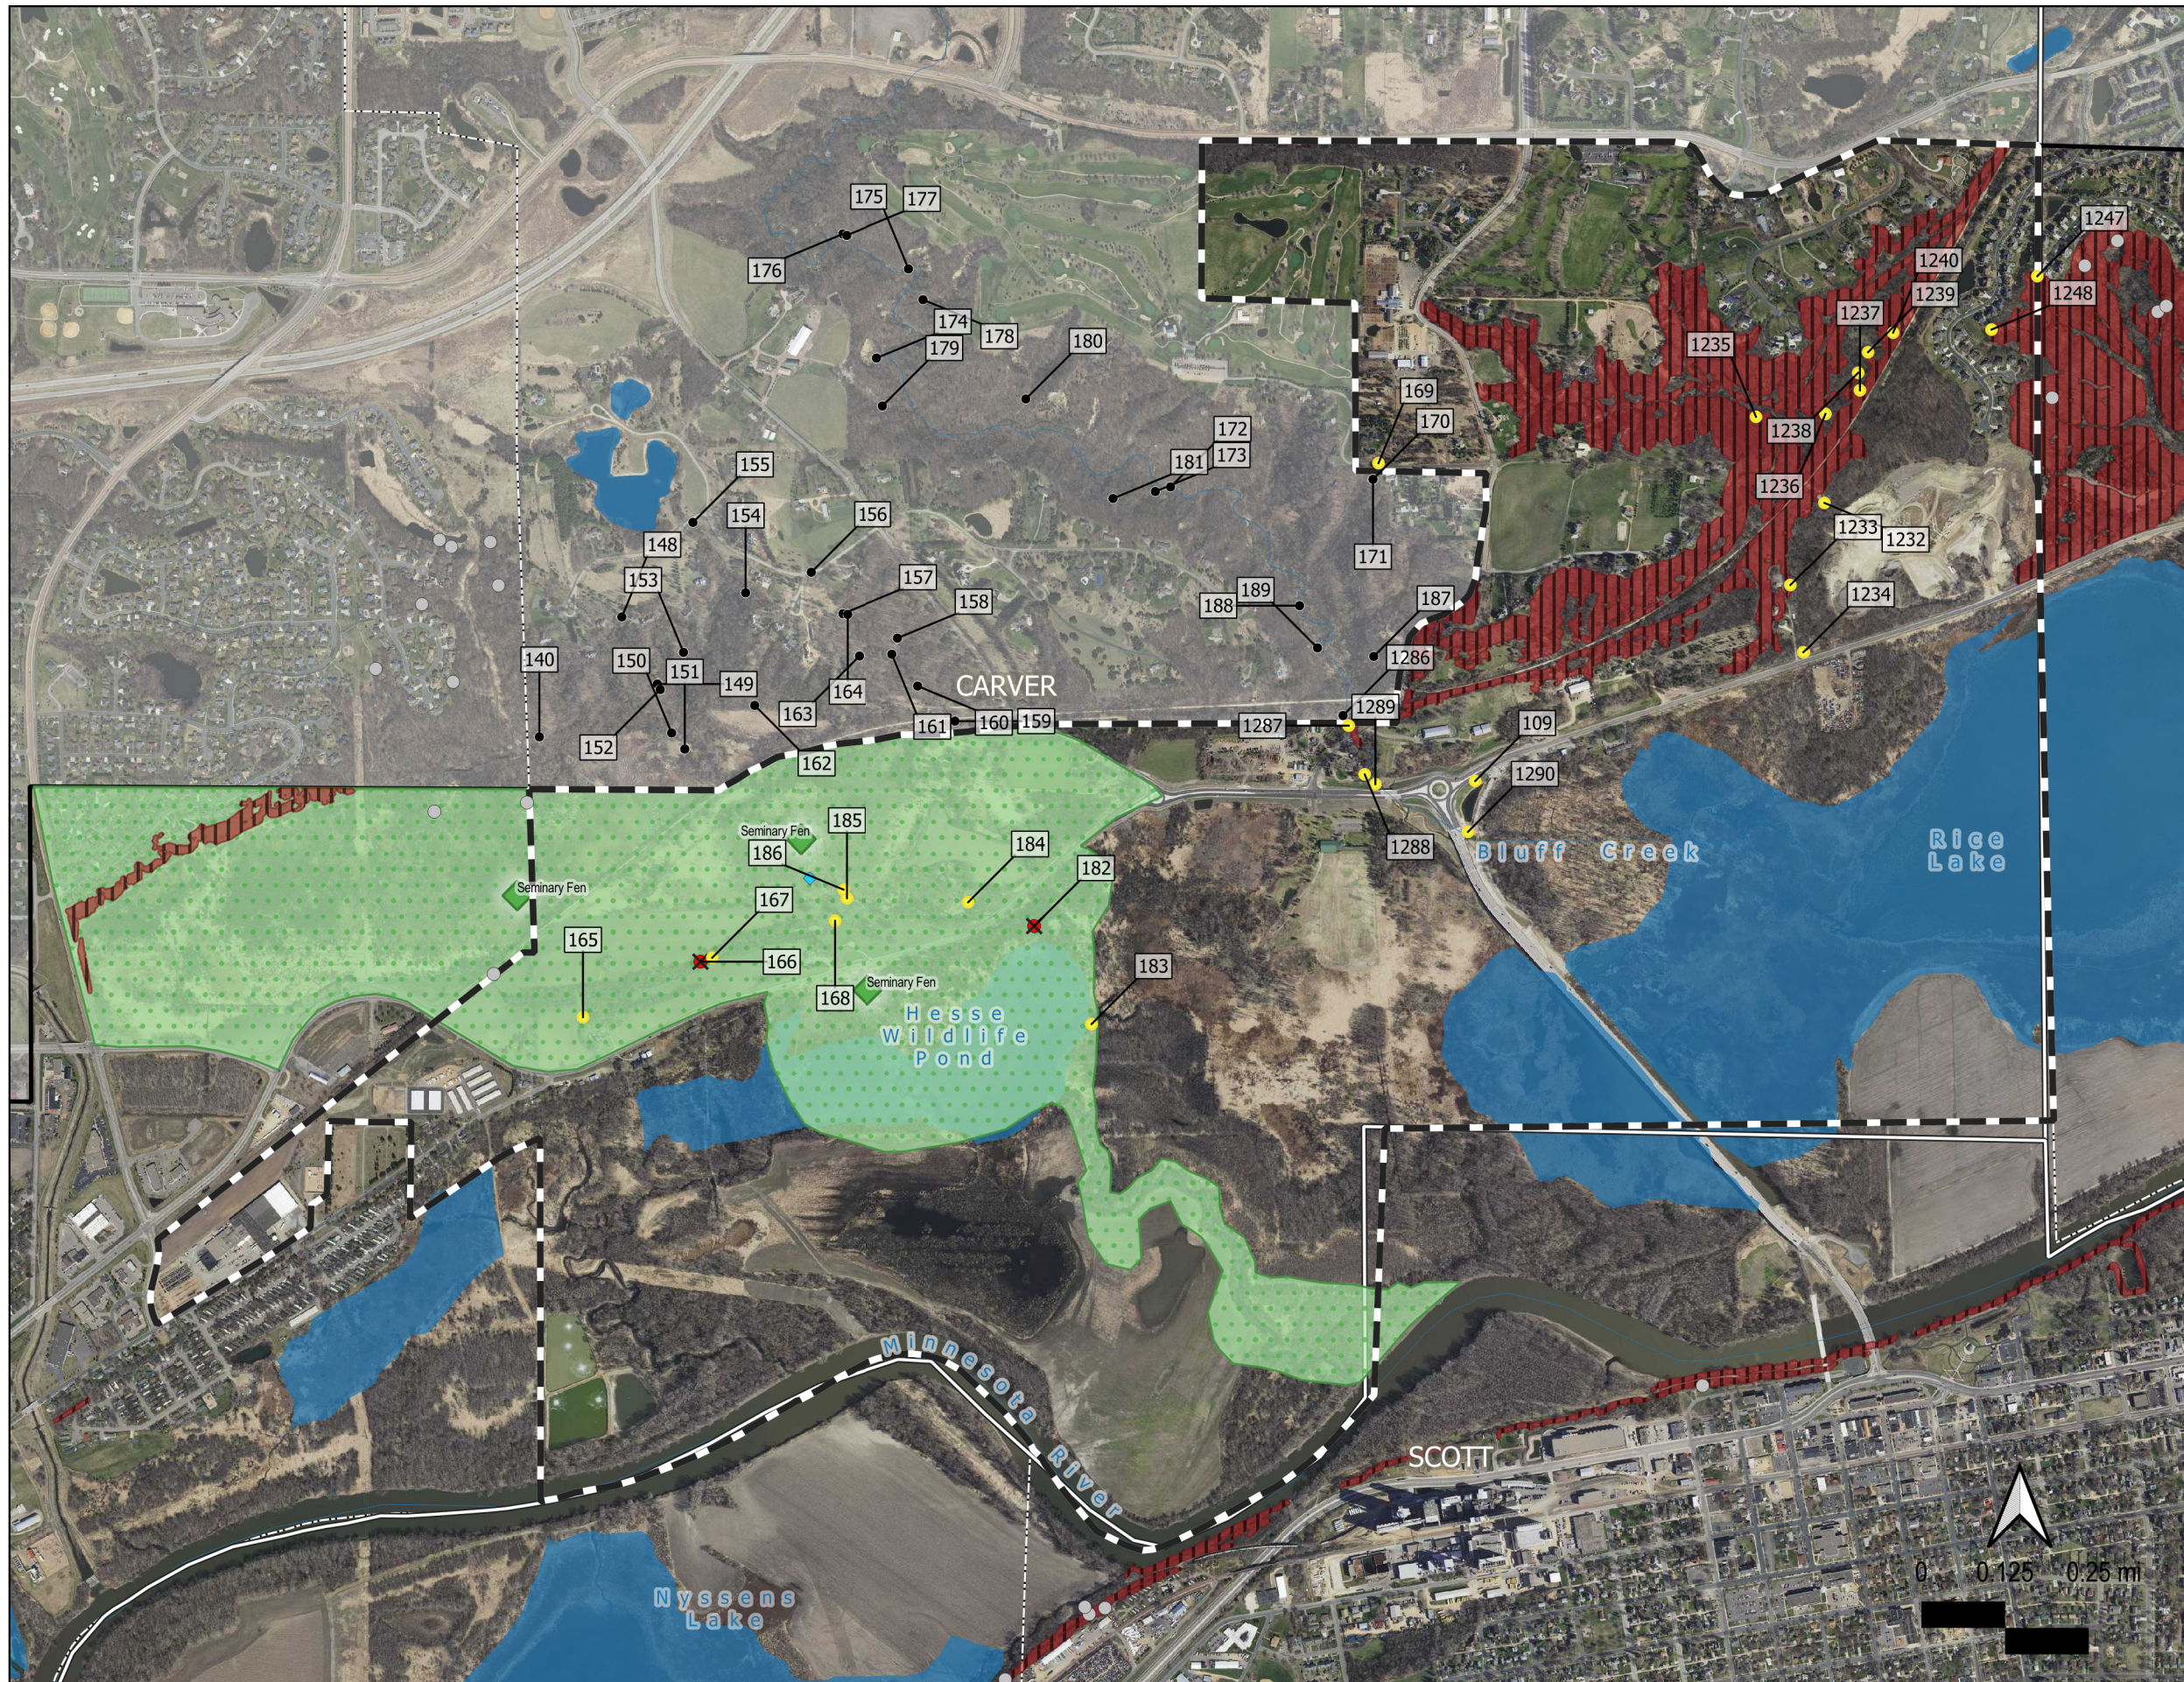
**Figure 68:
Chanhasen 2008
Inventory Locations**

The 2008 Inventory identified 60 gullies within the City of Chanhasen. Upon review of the 2008 data, 34 were determined to be outside the District, and two sites were found to be inapplicable to the 2020 gully condition assessment and removed from the dataset. One of the two N/A sites was a photograph of piezometers and the other site was a photograph of the Assumption Creek bank erosion, not a gully. Of the remaining 24 gully locations, 14 appeared to be pipe outfall locations (**Figure 68**).

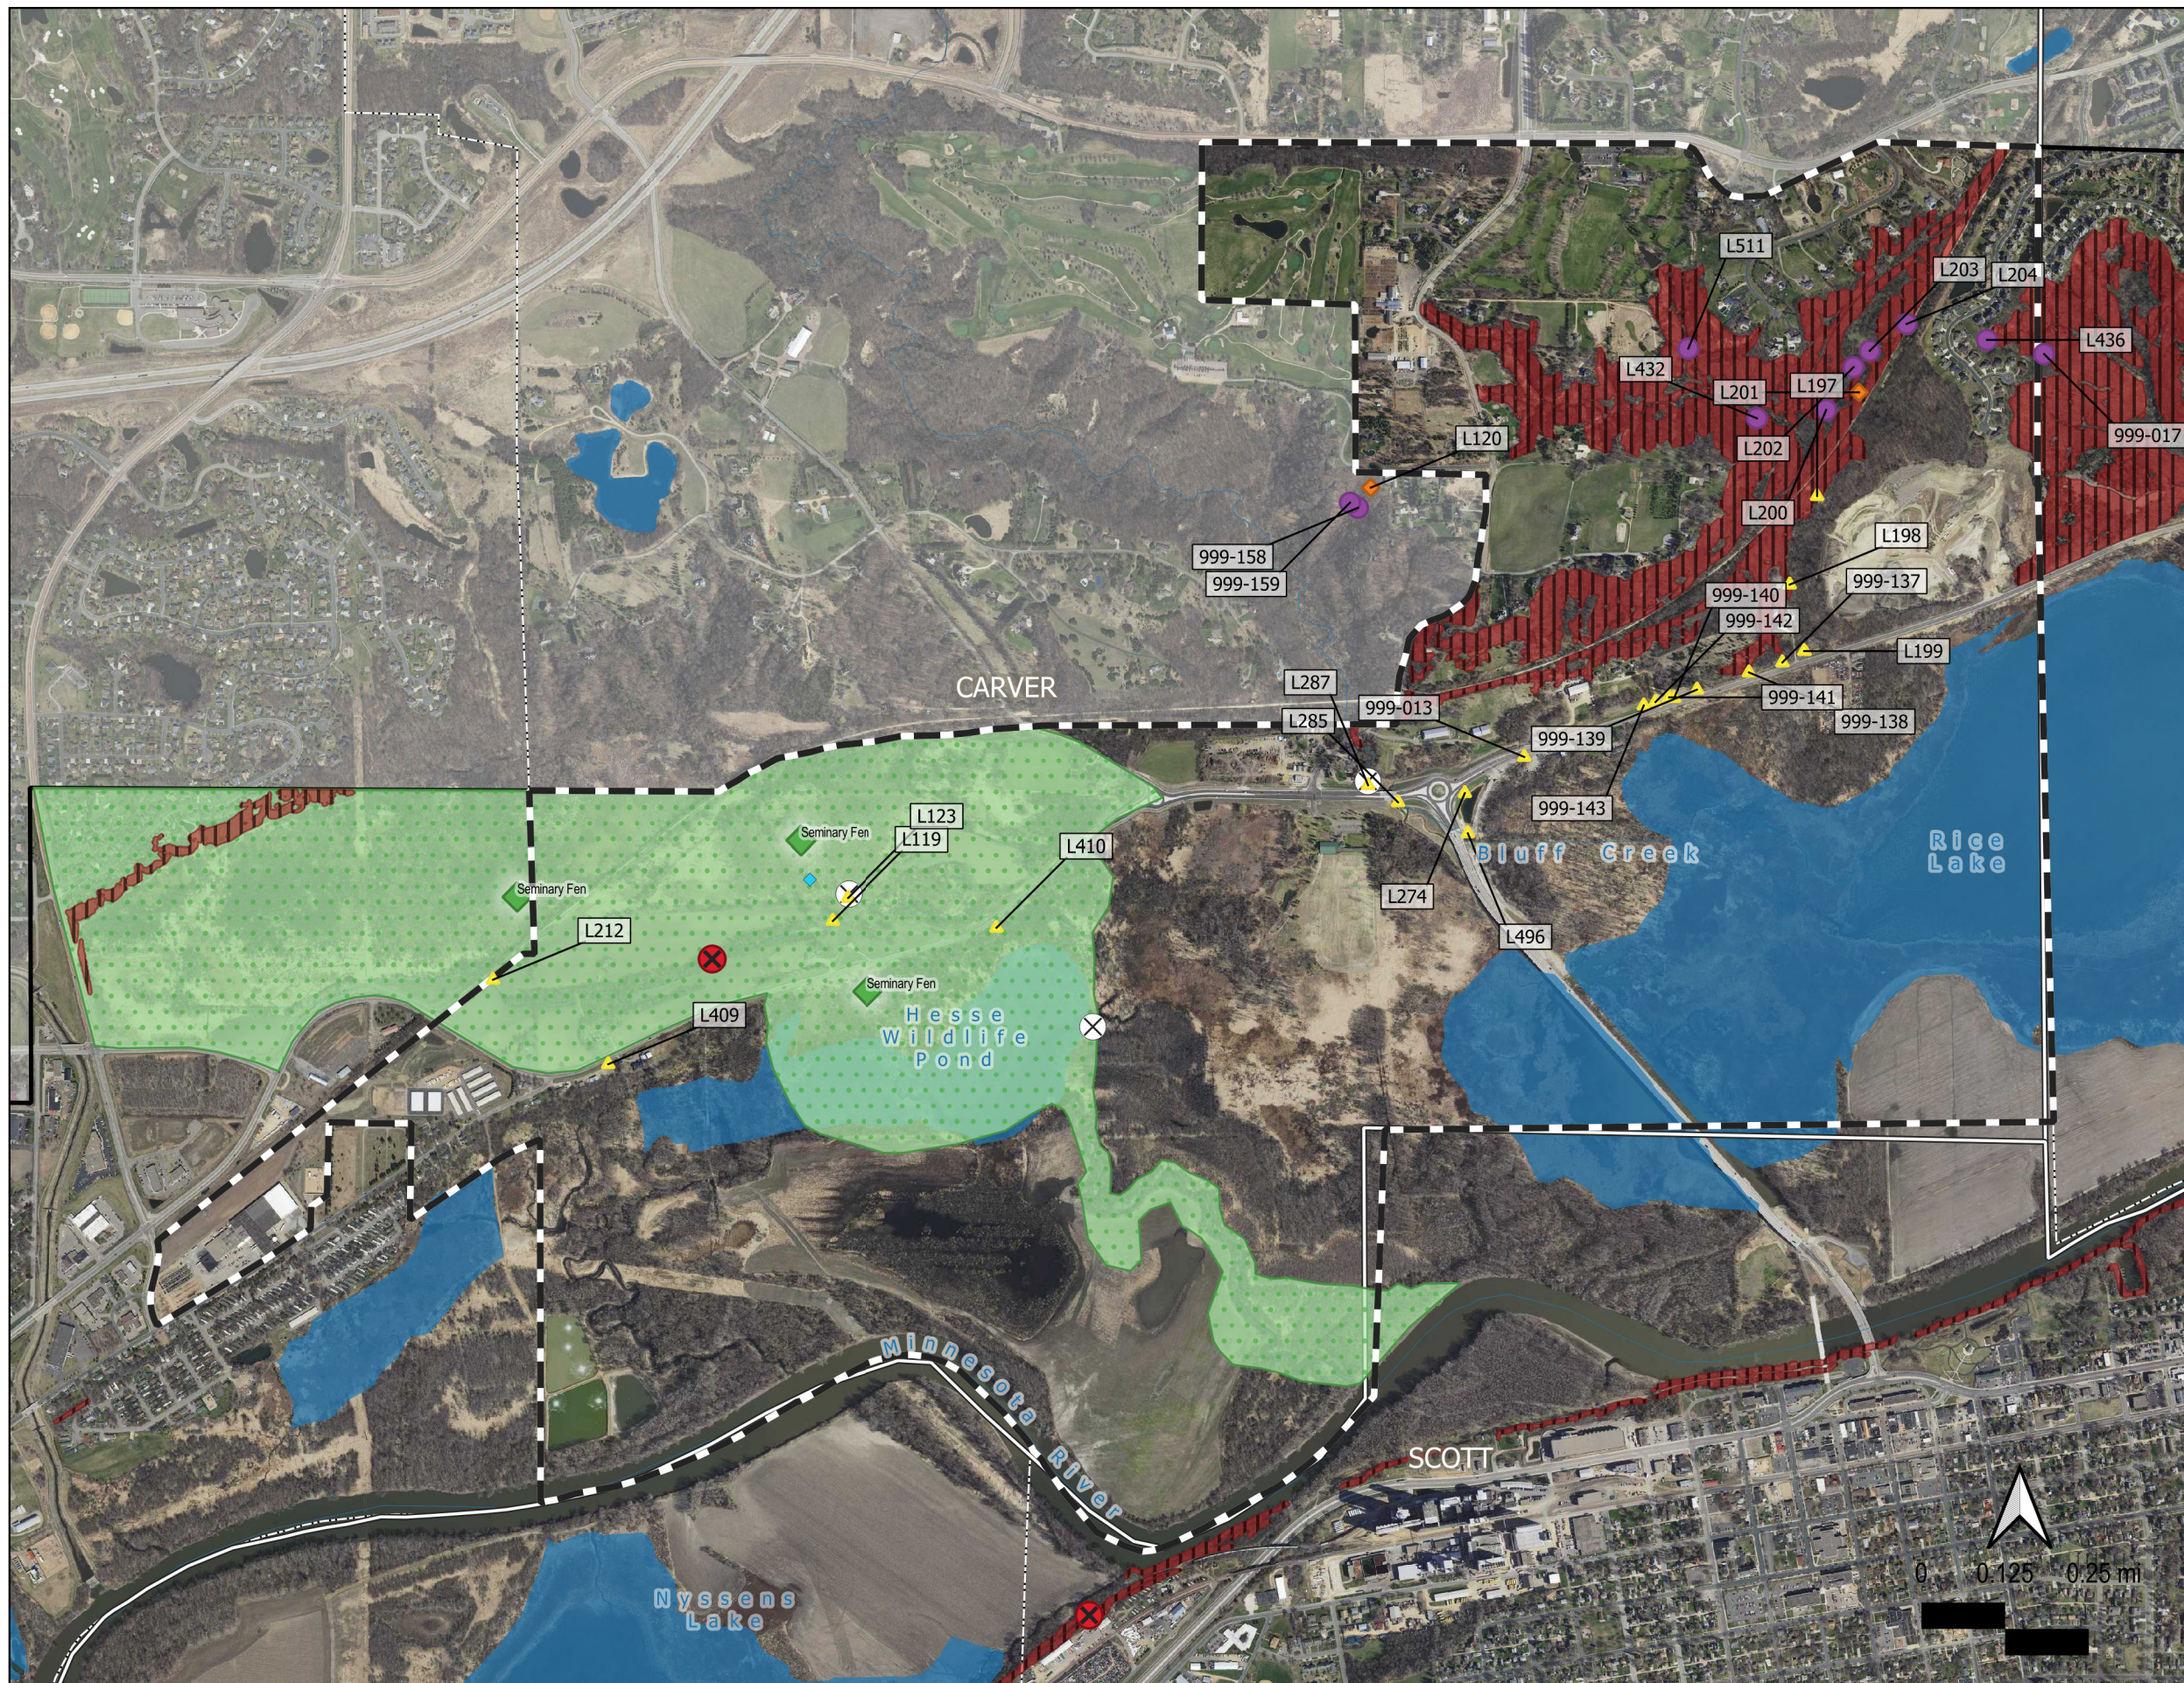
**Figure 69:
Chanhasen 2020
Survey Locations**

During the 2020 field season, the team collected 36 locations within the LMRWD boundaries, including three locations that could not be located and/or accessed and one location (L286) that described caged riprap along a stream but did not correspond to a gully (**Figure 69**).

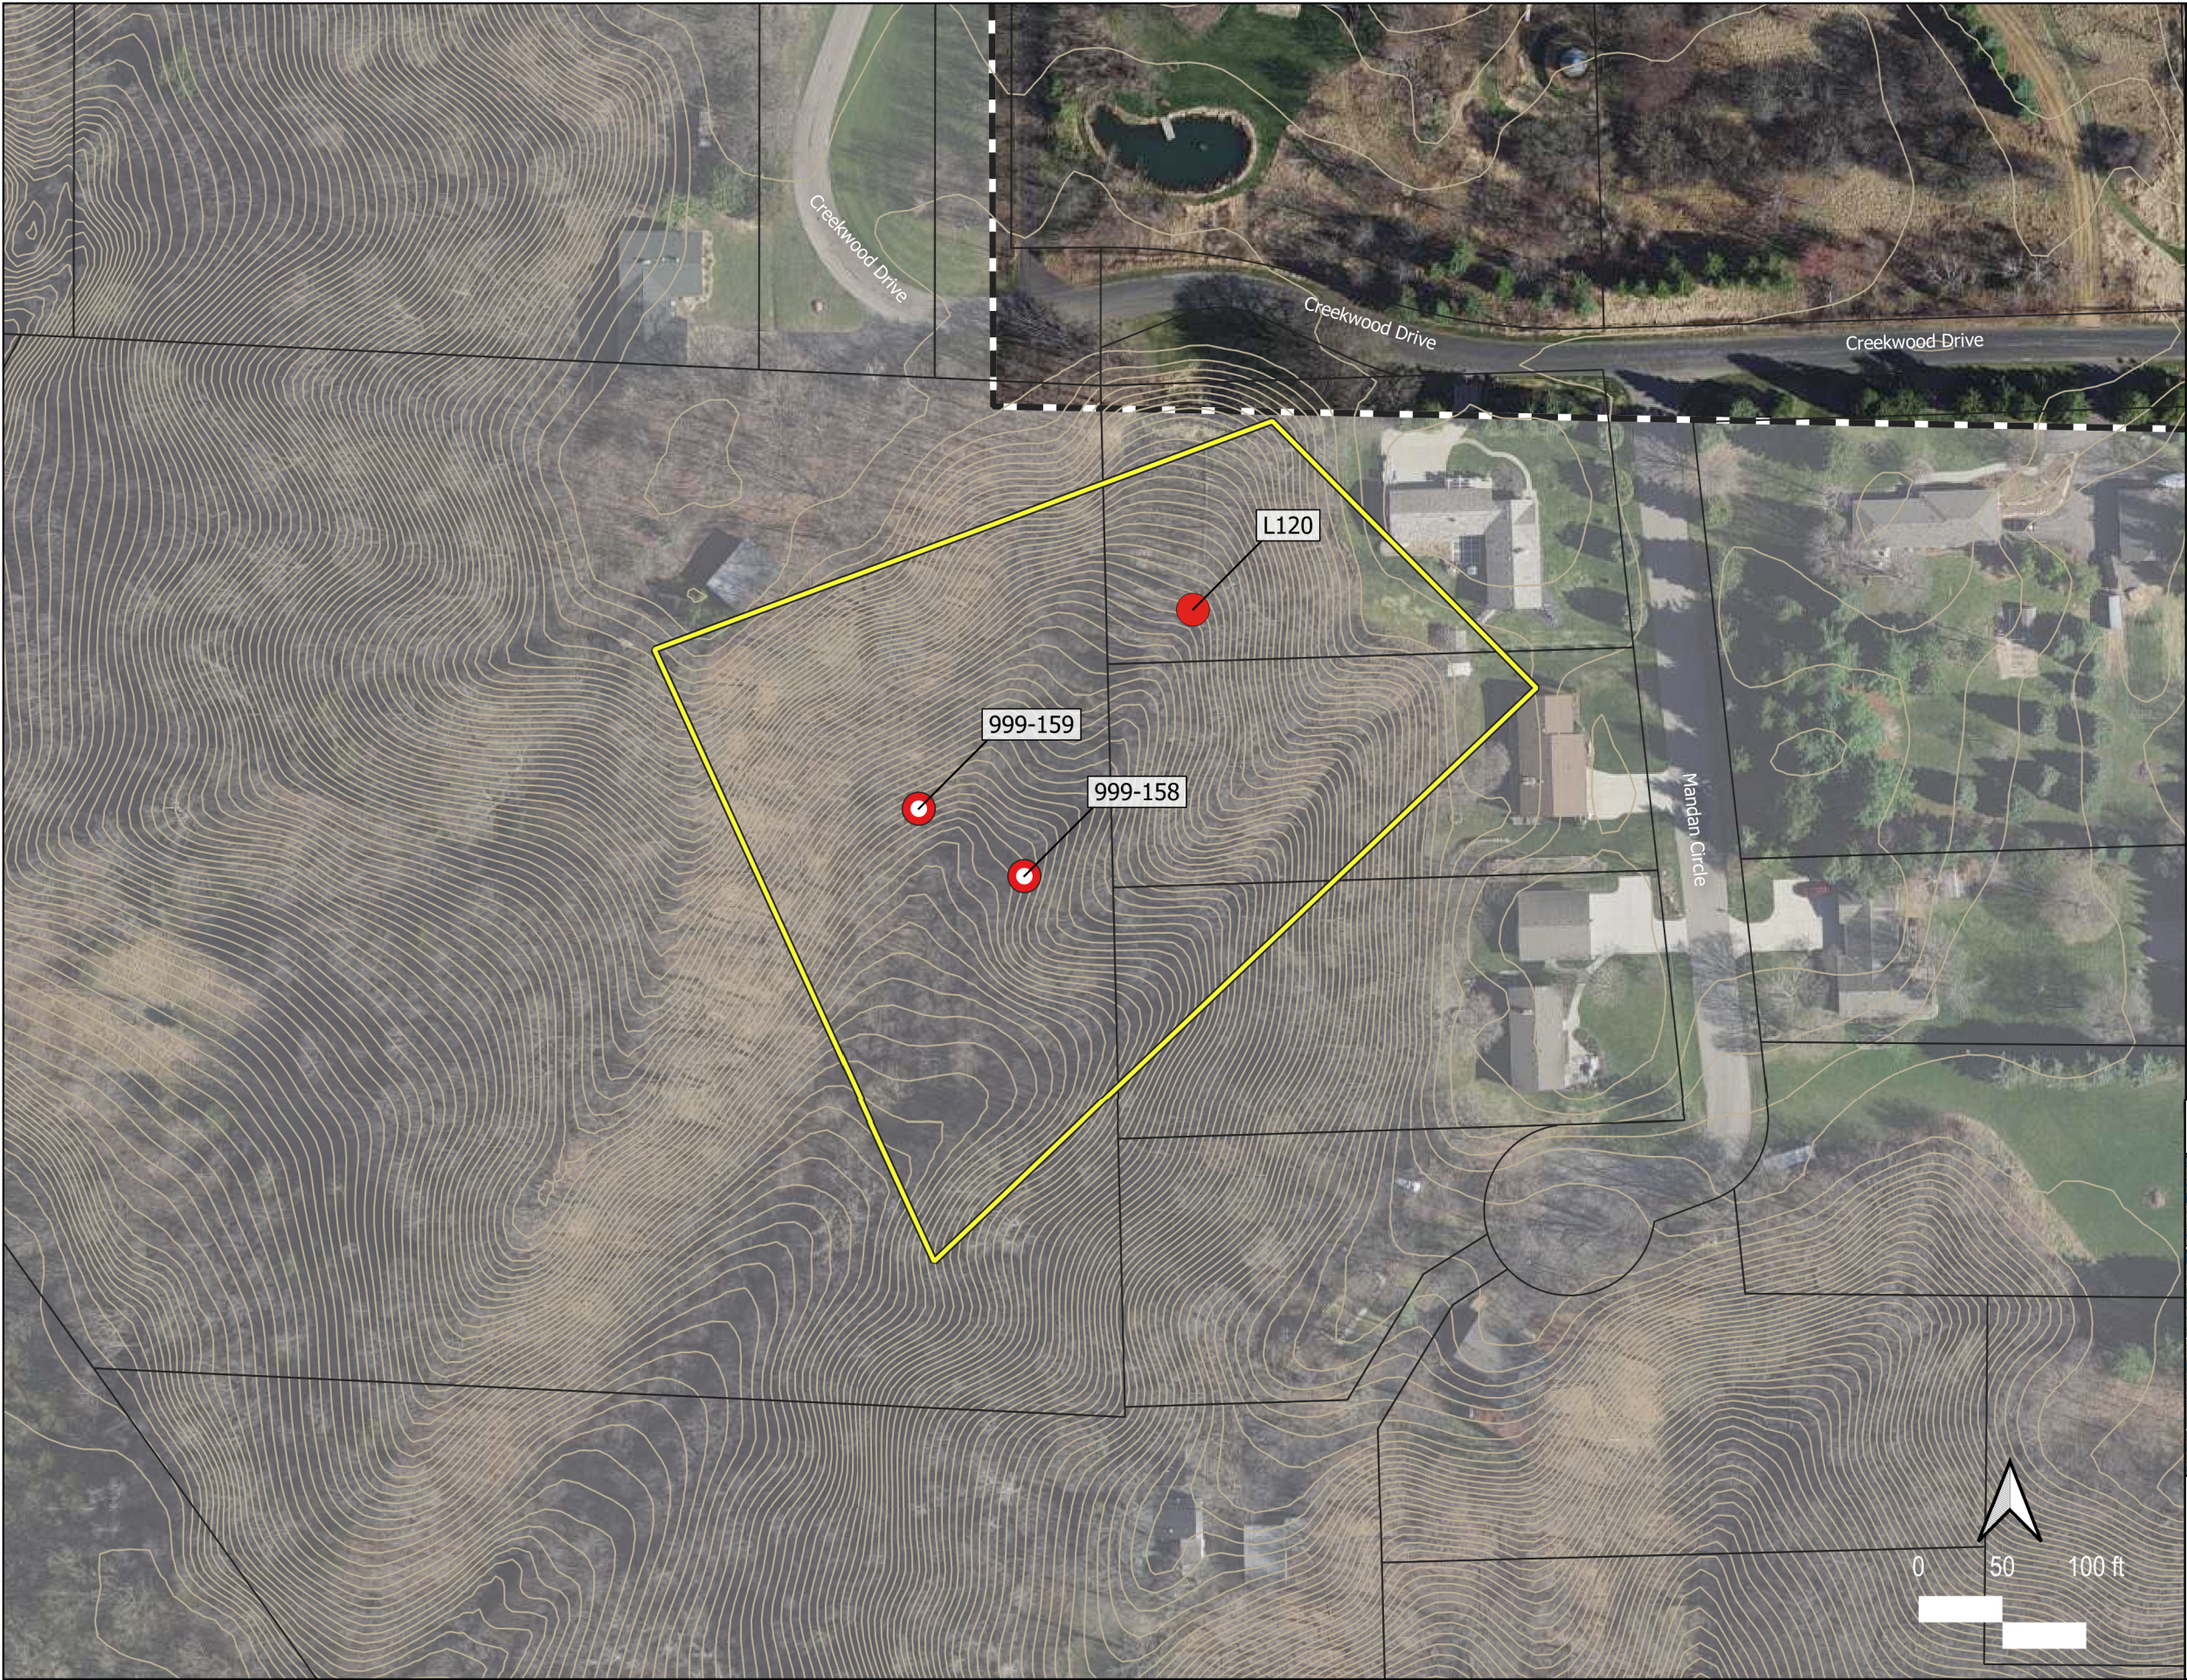
**Figure 73:
Chanhassen High-
Priority Region No. 10**

HPR 10 is located right outside of the LMRWD boundaries along Creekwood Street (**Figure 73**). This region consists of three gullies and one pipe outfall. Gullies 999-158 and 999-159 were not included in the gully count for Chanhassen because they are located out of bounds of the LMRWD. Information on this section is provided and recommended to be given to Riley-Purgatory-Bluff Creek Watershed District, which is the district in which the waypoints are located. Possible collaboration with the LMRWD may help in restoration efforts.

Gully 999-158 is connected to Gully L120, whose head cut forms around pipe outfall 999-157. Gully 999-159 is located north of and is parallel to the two-gully system. The field team recorded each gully as a separate feature; however, the 2008 report seemed to have grouped the system together in one waypoint.

When visited in the field, all three gullies in the region exhibited signs of overhanging banks, channel incision, and unstable V-shaped banks consisting of bare soil. Since the 2008 report, no stabilization seems to have occurred in the region. **Figure 74b** provides a view looking upstream at erosion and slumping along the banks at the head cut, where pipe outfall 999-157 discharged into Gully L120.

At the time of the site visit, the field team noted a low amount of standing water in pipe outfall 999-157, and the unstable drainage feature caused severe downstream erosion in Gully L120. Although L120 flattened before the knickpoint that formed the head cut of Gully 999-158, water draining into L120 likely also caused the destabilization of Gully 999-158. Parallel to the two-gully system, the field team did not find a conclusive cause for Gully 999-159. However, an area of groundwater seepage was noted upstream from the head cut; although no water was noted in the gully channel at the time of the field visit, the seepage may have contributed to the destabilization of the soil.

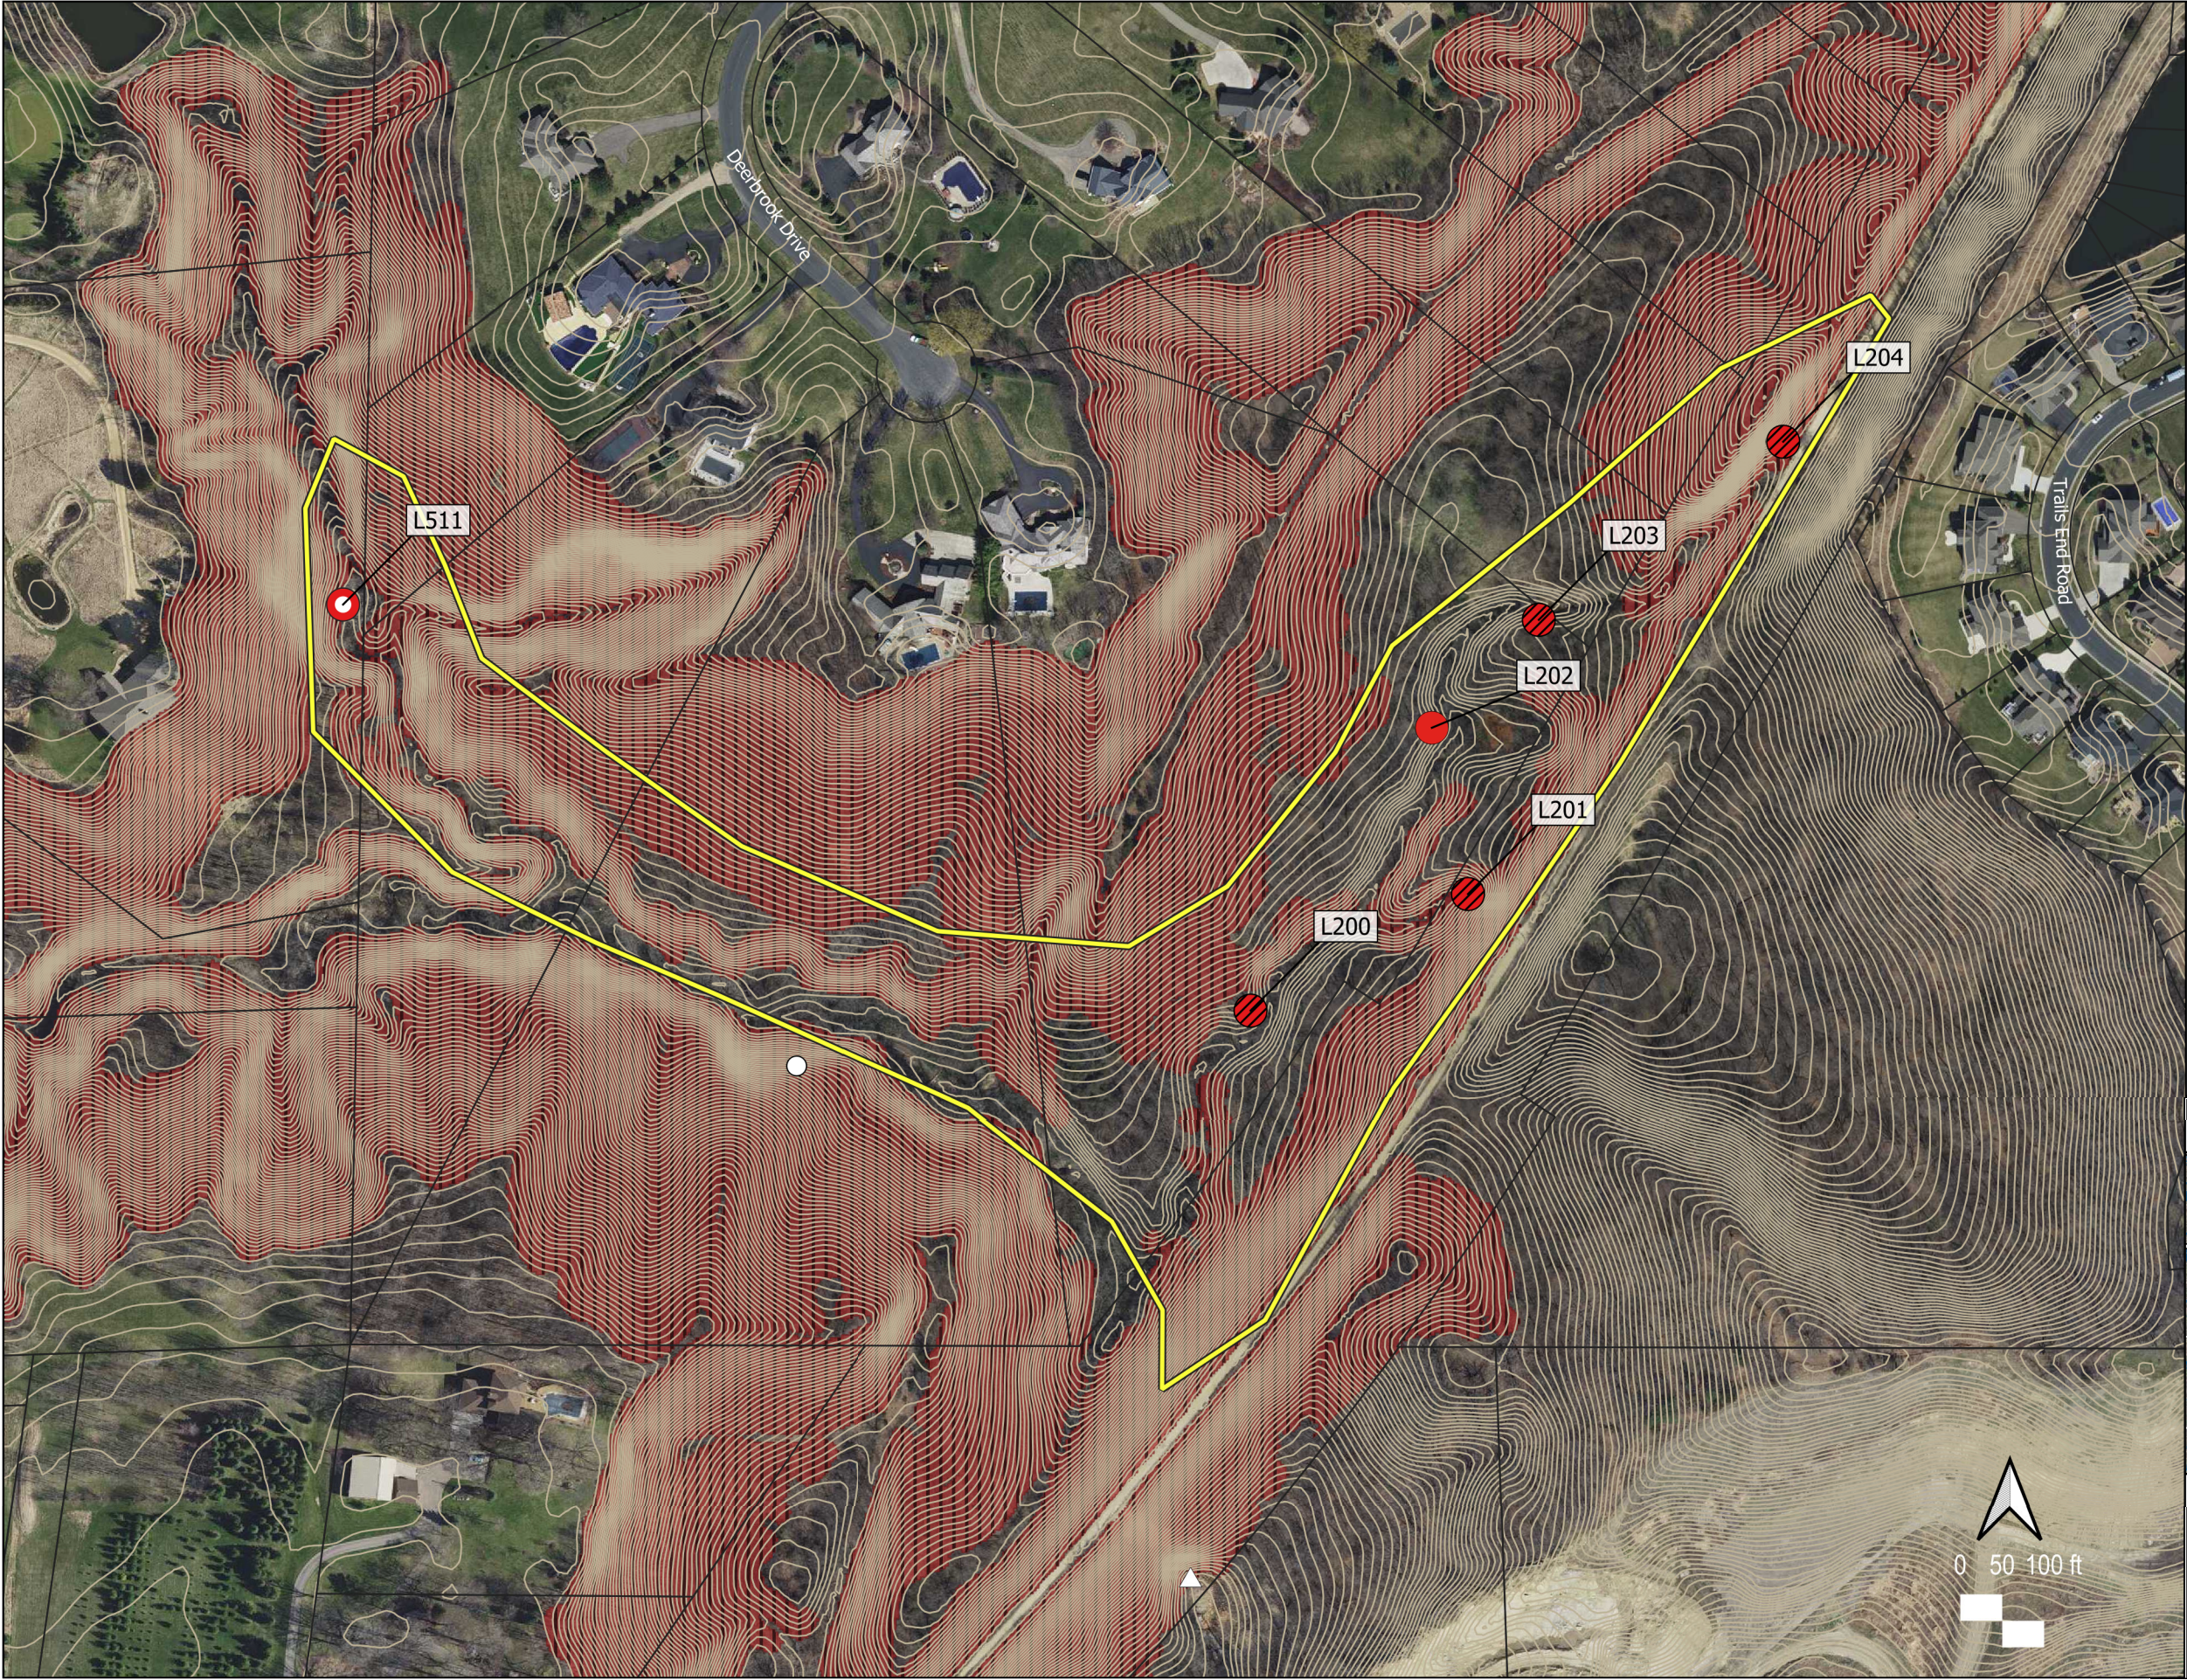
**Figure 75:
Chanhasen High-
Priority Region No. 11**

HPR 11 is located parallel to the Minnesota River Bluffs LRT Regional Trail. This cluster contains six gullies: L204, L203, L202, L201, L200, and L511 (**Figure 75**). Site L204 is the head cut of a gully that widens as more groundwater seeps contribute to the growing stream channel. Groundwater seeps first emerge at Gully L203. Gully L201 is an offshoot of this stream channel formed by an unstable drainage feature and connects to the main channel downstream from Gully L202. Gully L511 is a separate channel perpendicular to the other sites.

Sites L202, L200 and L511 shared similar characteristics because each contained a significant groundwater stream; moderate levels of water were noted at the time of the visit. The depths ranged from medium to deep, but they all had a medium bottom width and U-shaped channels consisting of bare, sandy soil. Significant sections of overhanging banks, slumping, and overall active erosion were noted at all three sites.

At the northern part of the cluster, Gully L204 began with a steep, vertical right bank showing exposed soil at the head cut. The initial cause of erosion at Site L204 was unknown. This gully continued into Gully L203, where, although obstructed by vegetation, the 2020 field team found significant areas of slumping, bare soil, and incision. They described this site as a deep trapezoid-shaped gully. A small groundwater seep first emerged at Site L203, then merging with a large section of ferrous groundwater seeps at Site L202 that seemed to destabilize the rest of the channel.

Site L201 was destabilized by a severely hanging pipe outfall. A large pile of concrete riprap did not look to be successfully stabilizing the head cut, which consisted of overhanging banks receding from the pipe outfall. This site shared characteristics such as its deep depth and bare, sandy banks with the other gullies within this cluster. Possible groundwater seeps were noted near the toe of L201 and, along with steep slopes, may be exacerbating erosion from the pipe outfall.

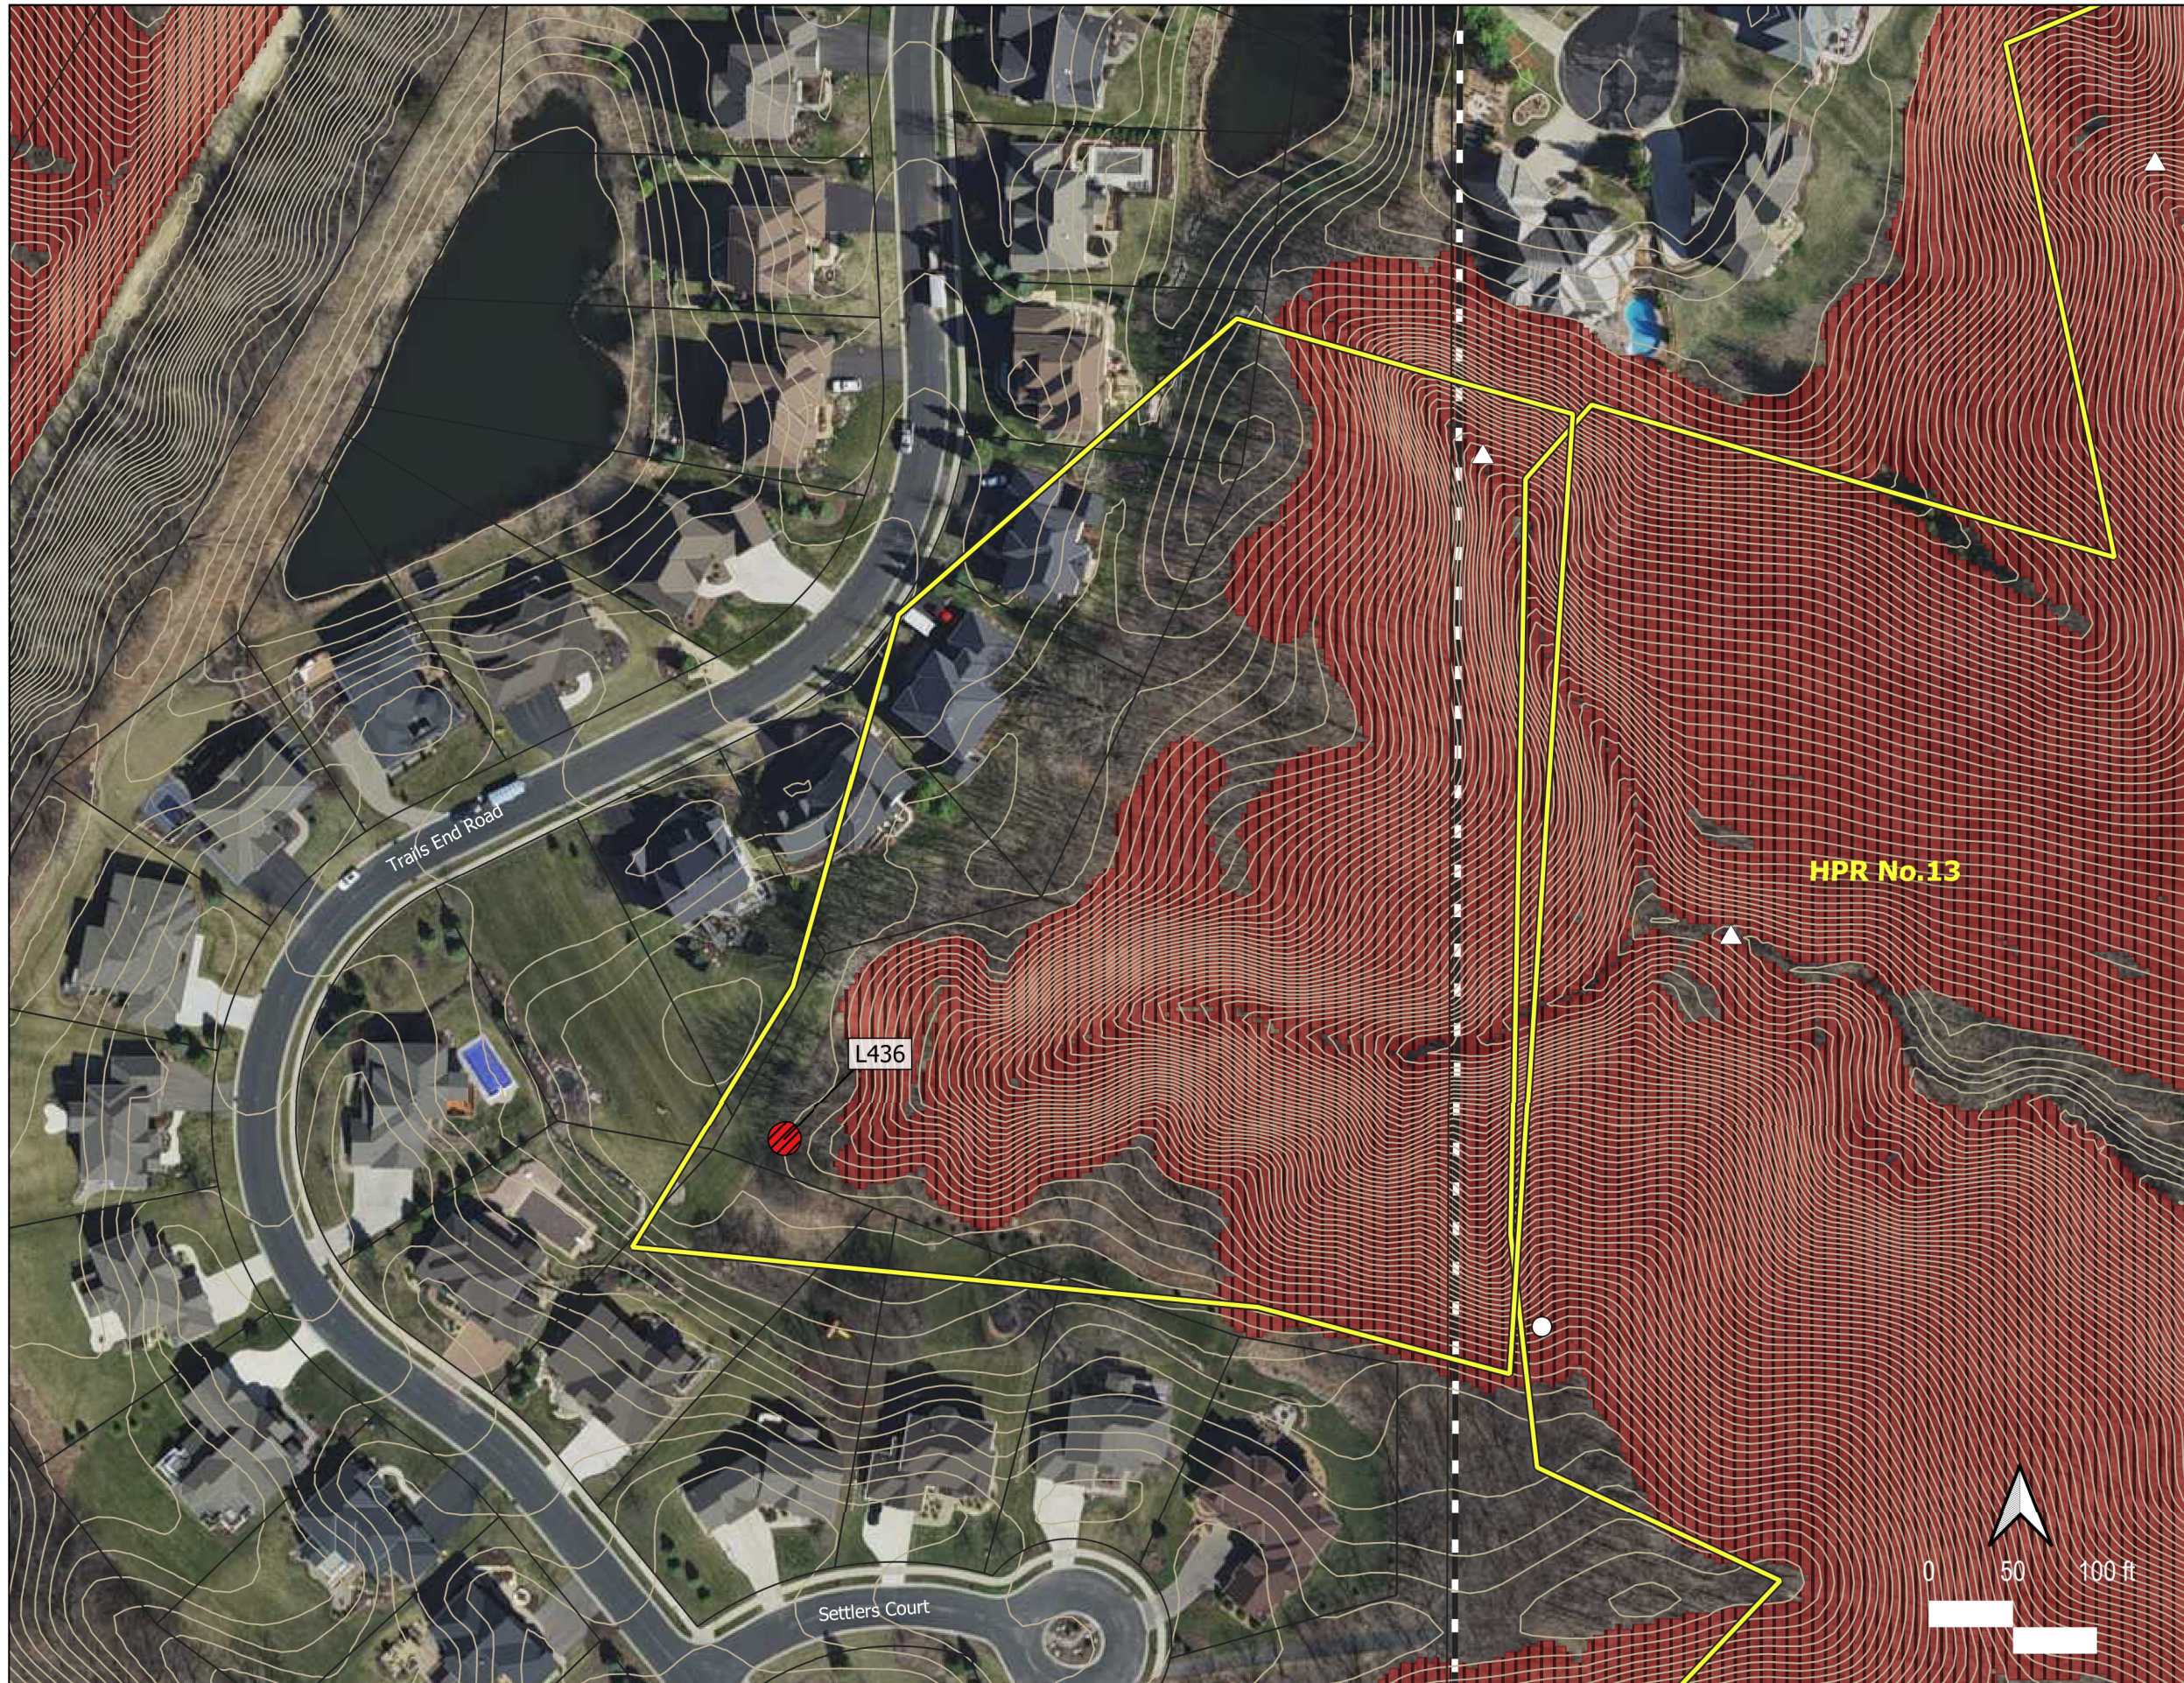
**Figure 78:
Chanhasen High-
Priority Region No. 12**

HPR 12 includes gullies L436 and L435 (**Figure 78**). Both gullies lie within the Richard T. Anderson Conservation Area. The gullies are directly connected to HPR 13 in Eden Prairie, and this area provides a potential collaboration opportunity between Eden Prairie and Chanhassen for restoration projects.

Slope and channel incision were apparent causes for both gullies. A dense canopy was a possible cause for L435, while groundwater contributed to erosion in L436. Problem indicators in both gullies included degradation, loss of bank vegetation, incision, slumping, overhanging banks, and leaning trees. The field team noted that large sections of soil appeared to have recently slumped off along the banks of L436. The previous report noted the proximity of Site L435 to a new development, and a nearby house was visible from the head cut. Gully L435 backed right onto residential property, and at the time of the visit, a tree in the channel seemed to have been recently uprooted. Without intervention, severe erosion is likely to continue along both branches.

In 2008, the field team noted “severe” and “extreme” erosion at each of the gully sites. Based on the previous comments and photos, the 2008 sites received a high erosion potential rating during the desktop analysis. The 2020 site analysis remained consistent and both sites again received a high erosion potential rating. **Figure 79** and **Figure 80** provide side-by-side comparisons of erosion progression within each gully.
