10.0 JACKSON TOWNSHIP

10.4 Jackson Township Gully Progression

10.5 Jackson Township High-Priority Sites

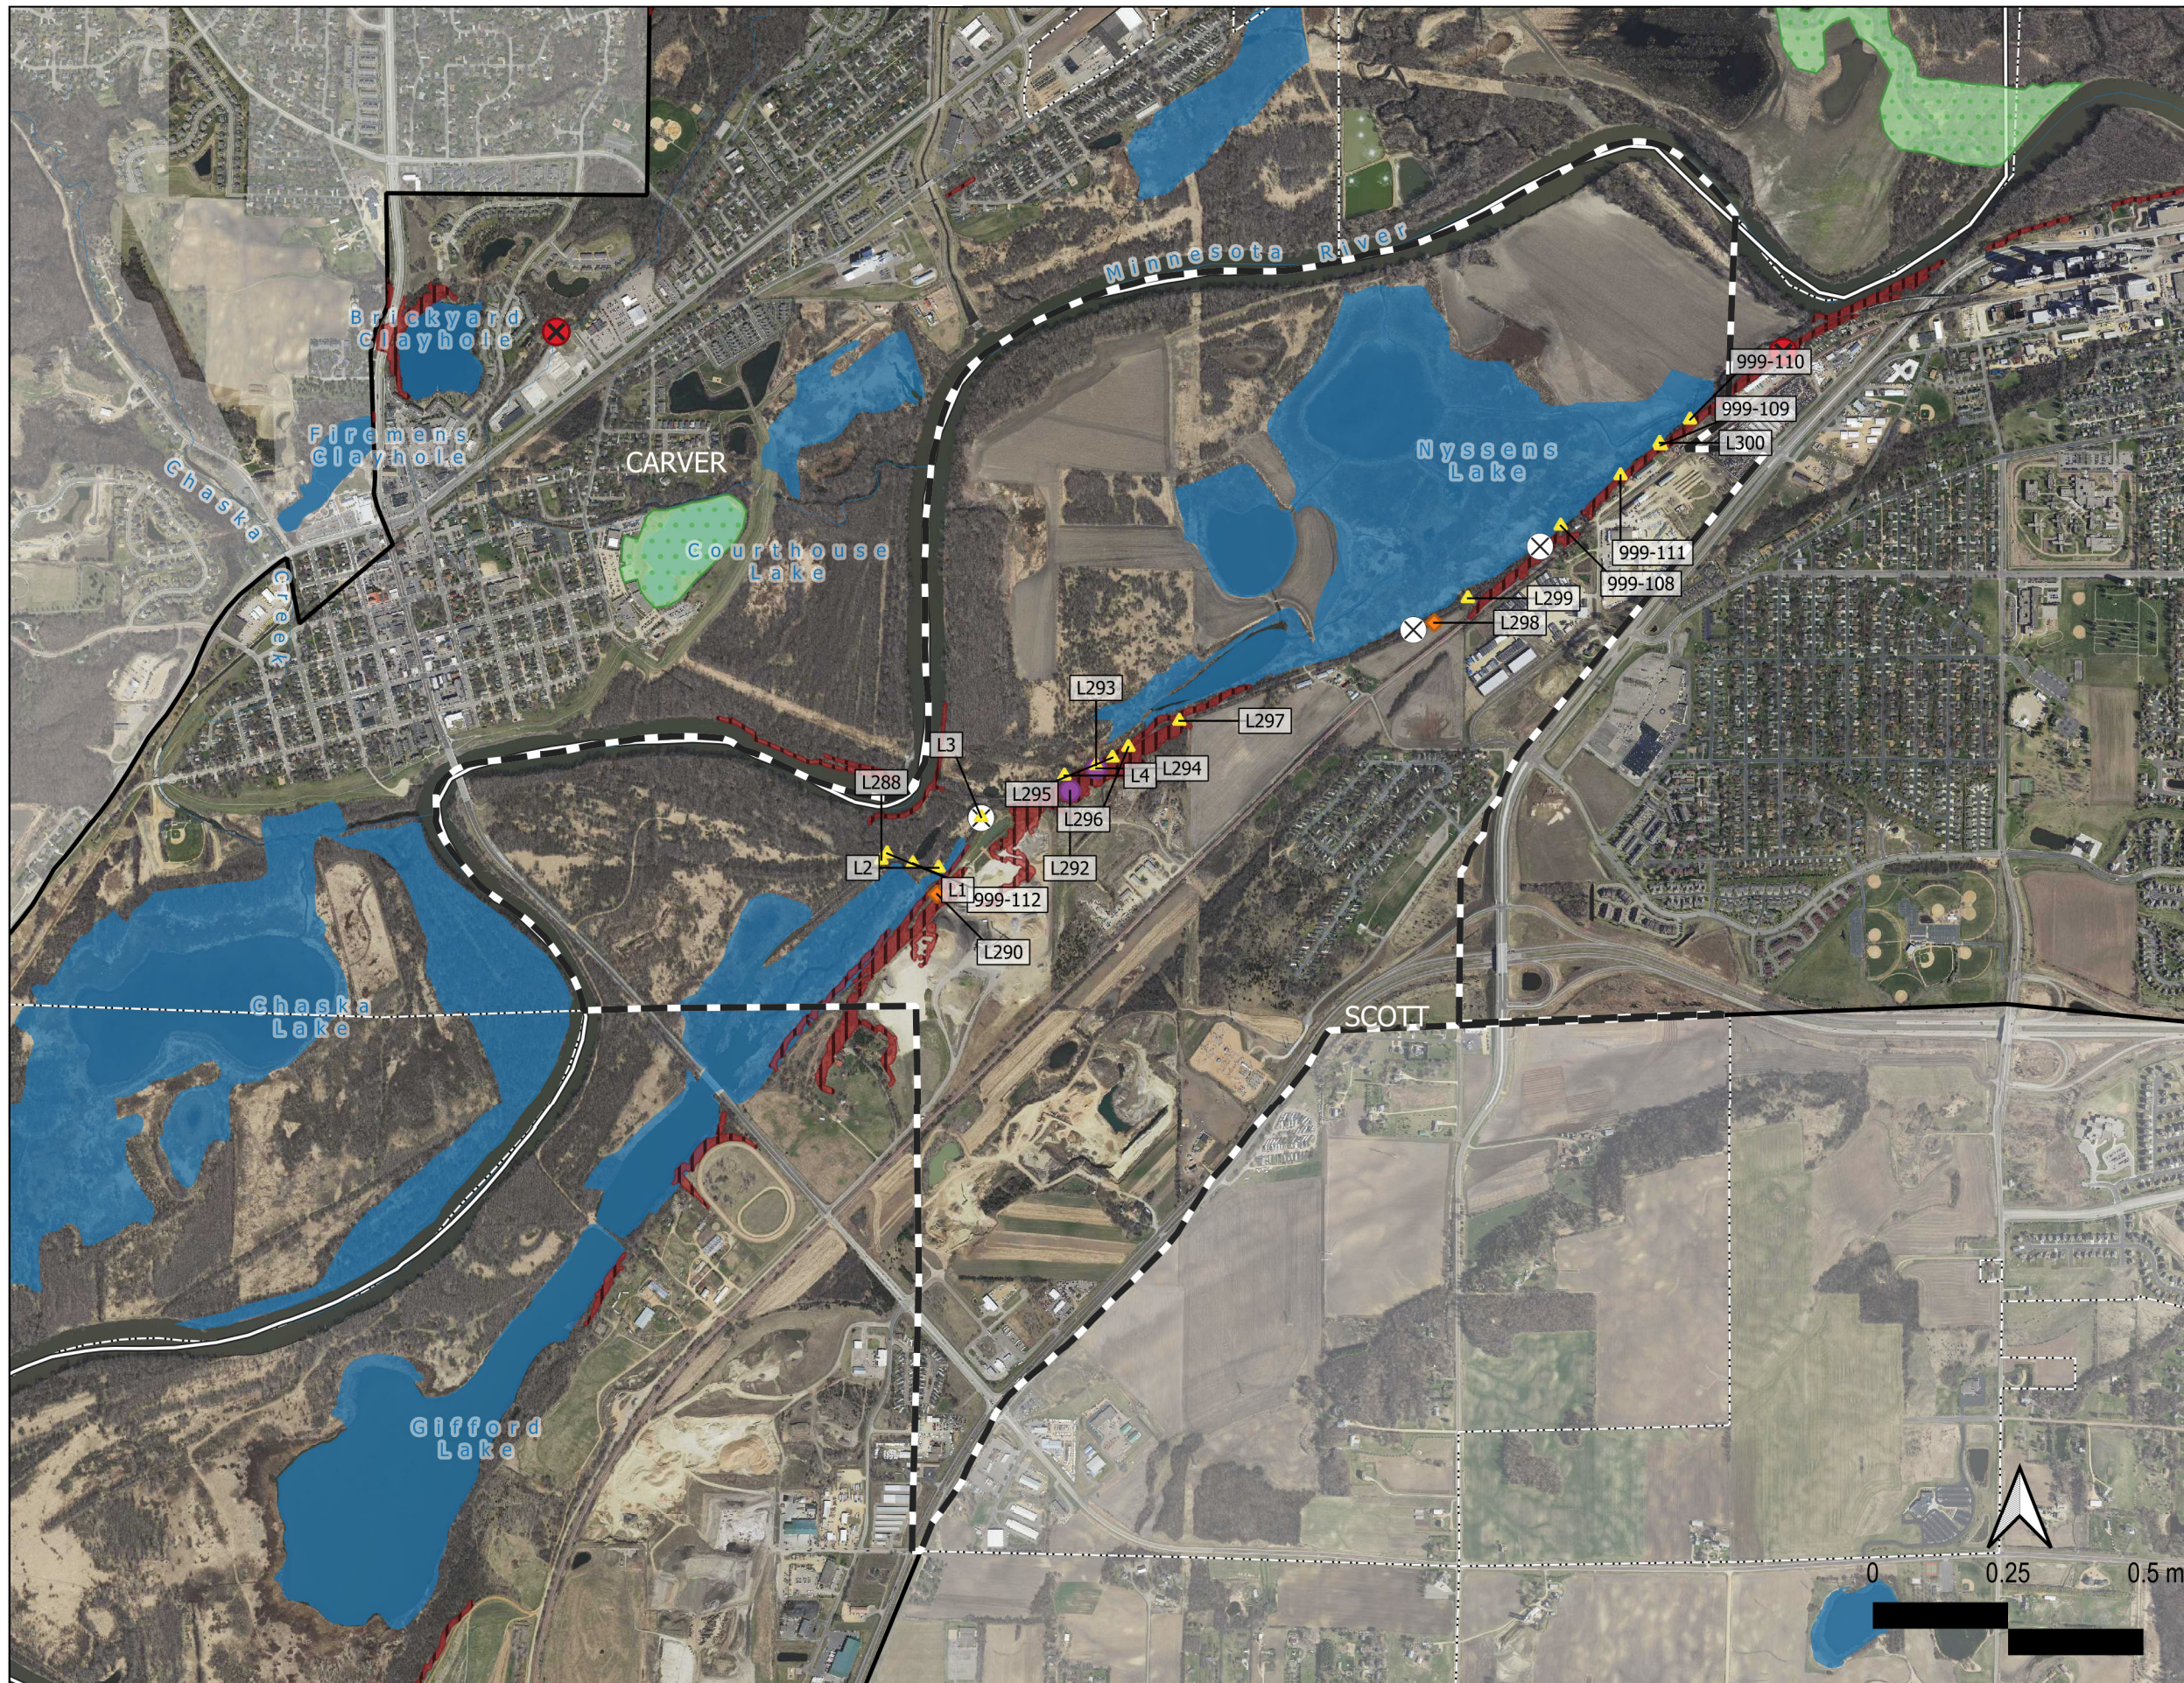
**Figure 107:
Jackson Twp. 2020
Survey Locations**

Jackson Township did not contain any groundwater-fed streams or seeps, confirmed through review of the MnDNR Minnesota Spring Inventory. Four gullies were investigated within the LMRWD boundary of Jackson Township, all located within the Steep Slopes Overlay District. All gullies and pipe outfalls in Jackson Township were centered around the walking trail near the Minnesota River floodplain. The gullies found were variable in their characteristics. Of the four gullies observed, three had unknown apparent causes, but slope was the primary suspect. Slumping and undercut/overhanging banks were commonly seen in all gullies, with channel incision, loss of bank vegetation, and pistol-butted trees noted less consistently. In general, coarse-grained clastic sediments such as sand or gravel were the predominant gully materials in the region. Additionally, gully morphology, geometry, and length were variable, but half of all sites were deep (greater than 15 feet deep), and most sites possessed a steep channel gradient.
