13.0 CITY OF MENDOTA HEIGHTS

13.3 Findings

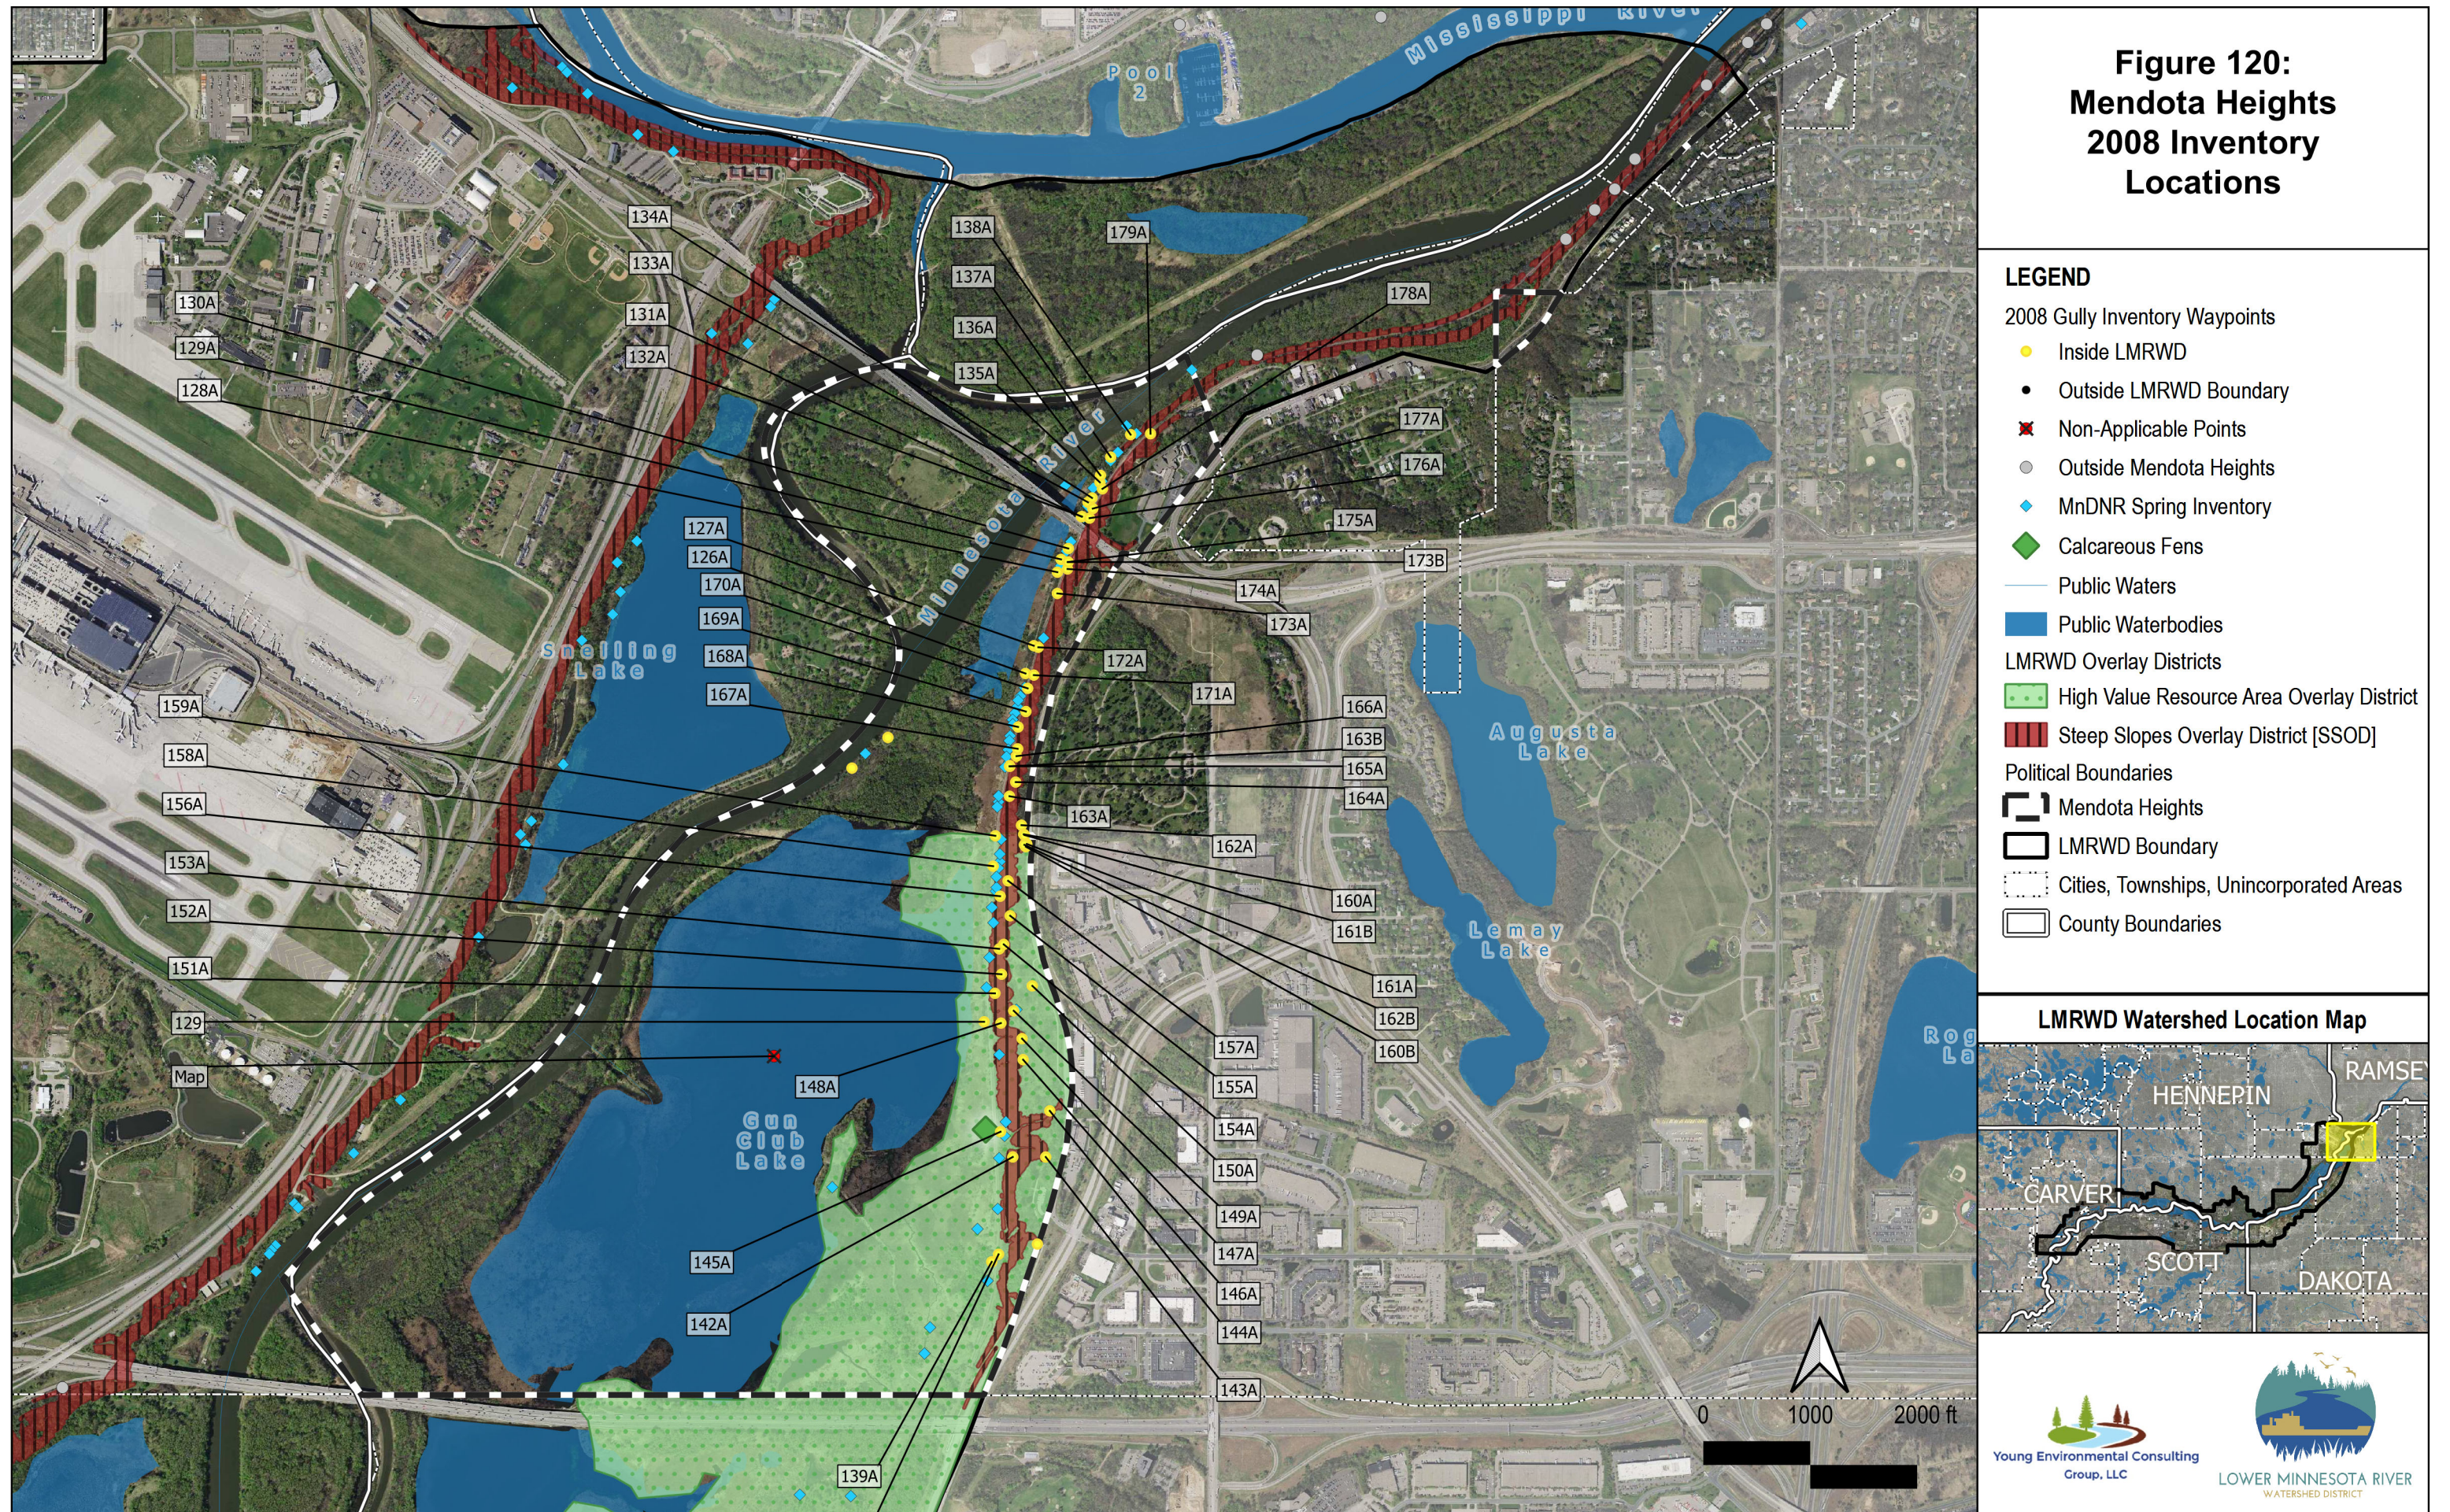
**Figure 120:
Mendota Heights
2008 Inventory
Locations**

The 2008 Inventory identified 63 sites within the City of Mendota Heights. Through the desktop analysis, one point was removed because it was an erroneous point that did not have any gully information associated with it (**Figure 120**). Using the 2008 locations as the basis for the 2020 project, the field team evaluated 61 locations in the field, including 28 gully sites, 24 pipe outfall sites, and nine combination locations (**Figure 121**).

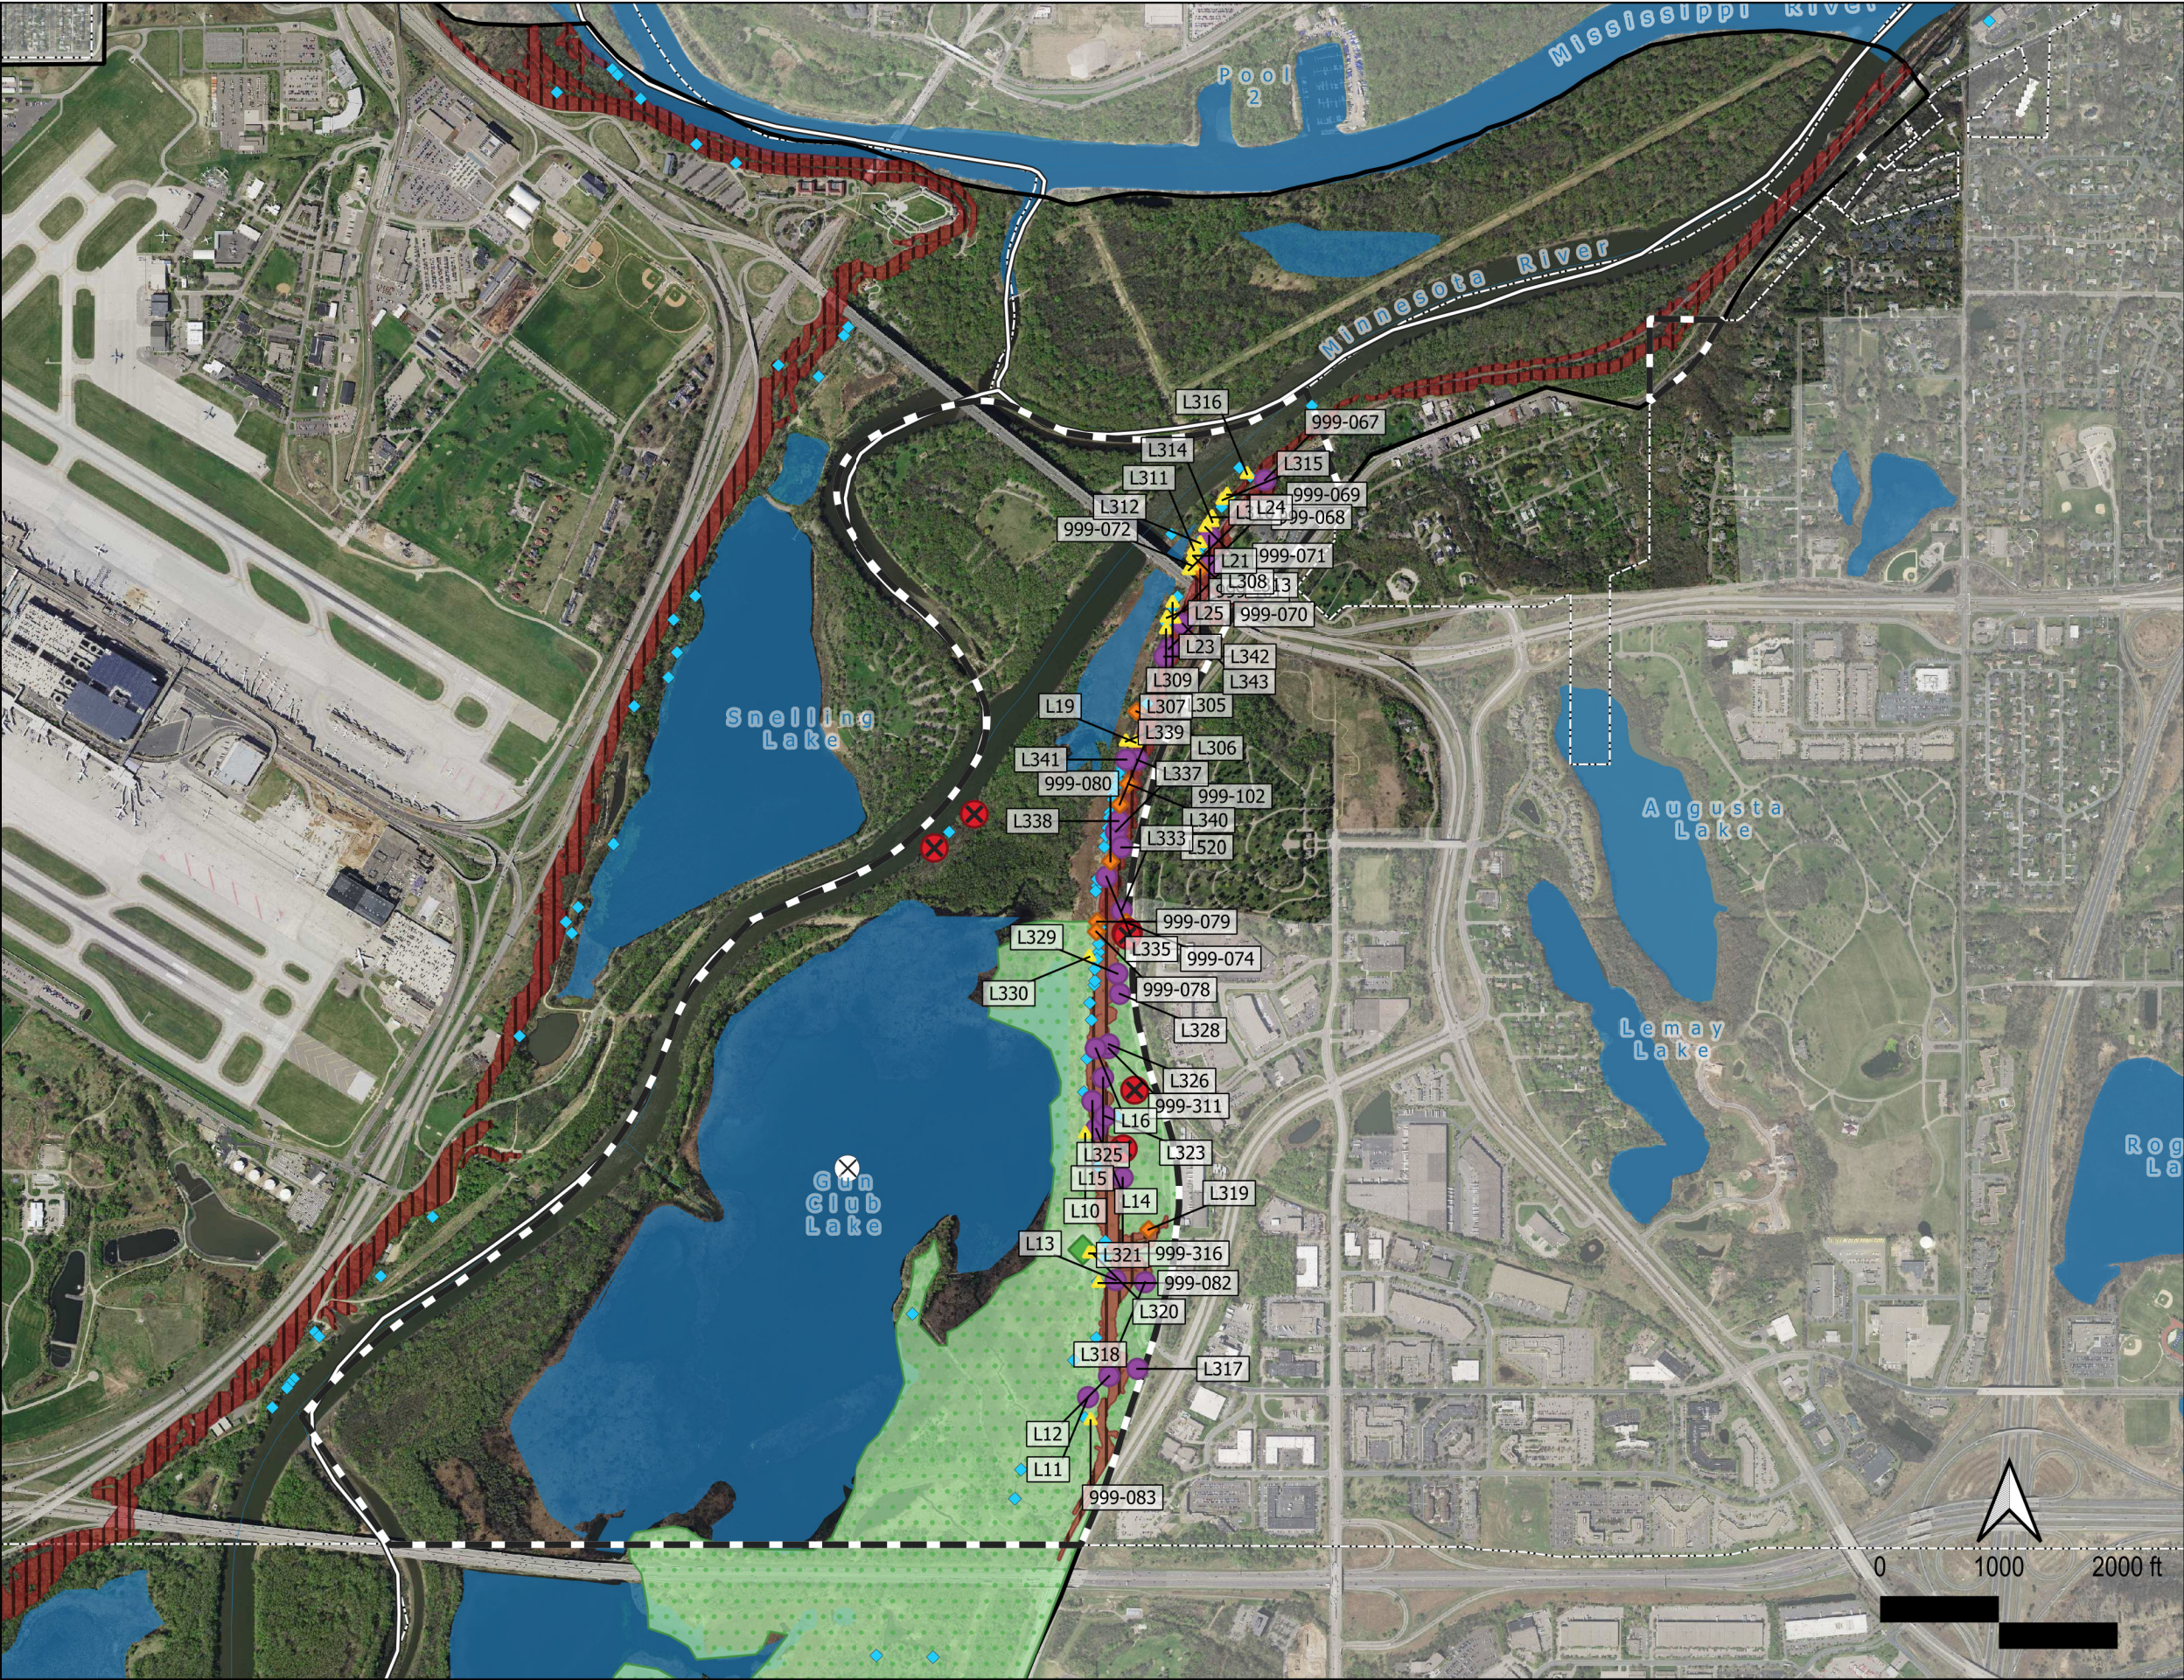
**Figure 121:
Mendota Heights
2020 Survey
Locations**

Generally, this area within the LMRWD presented difficult access conditions due to steep slopes and areas that were heavily vegetated with buckthorn, which rendered several sites inaccessible, making it impossible to evaluate them during the 2020 Inventory Study. The team accessed the sites in the city by walking down game trails, along Big Rivers Regional Trail, or along the Union Pacific freight railroad tracks. Other sites were located along major roads, but few sites were on or near private property. No interactions with property owners occurred.

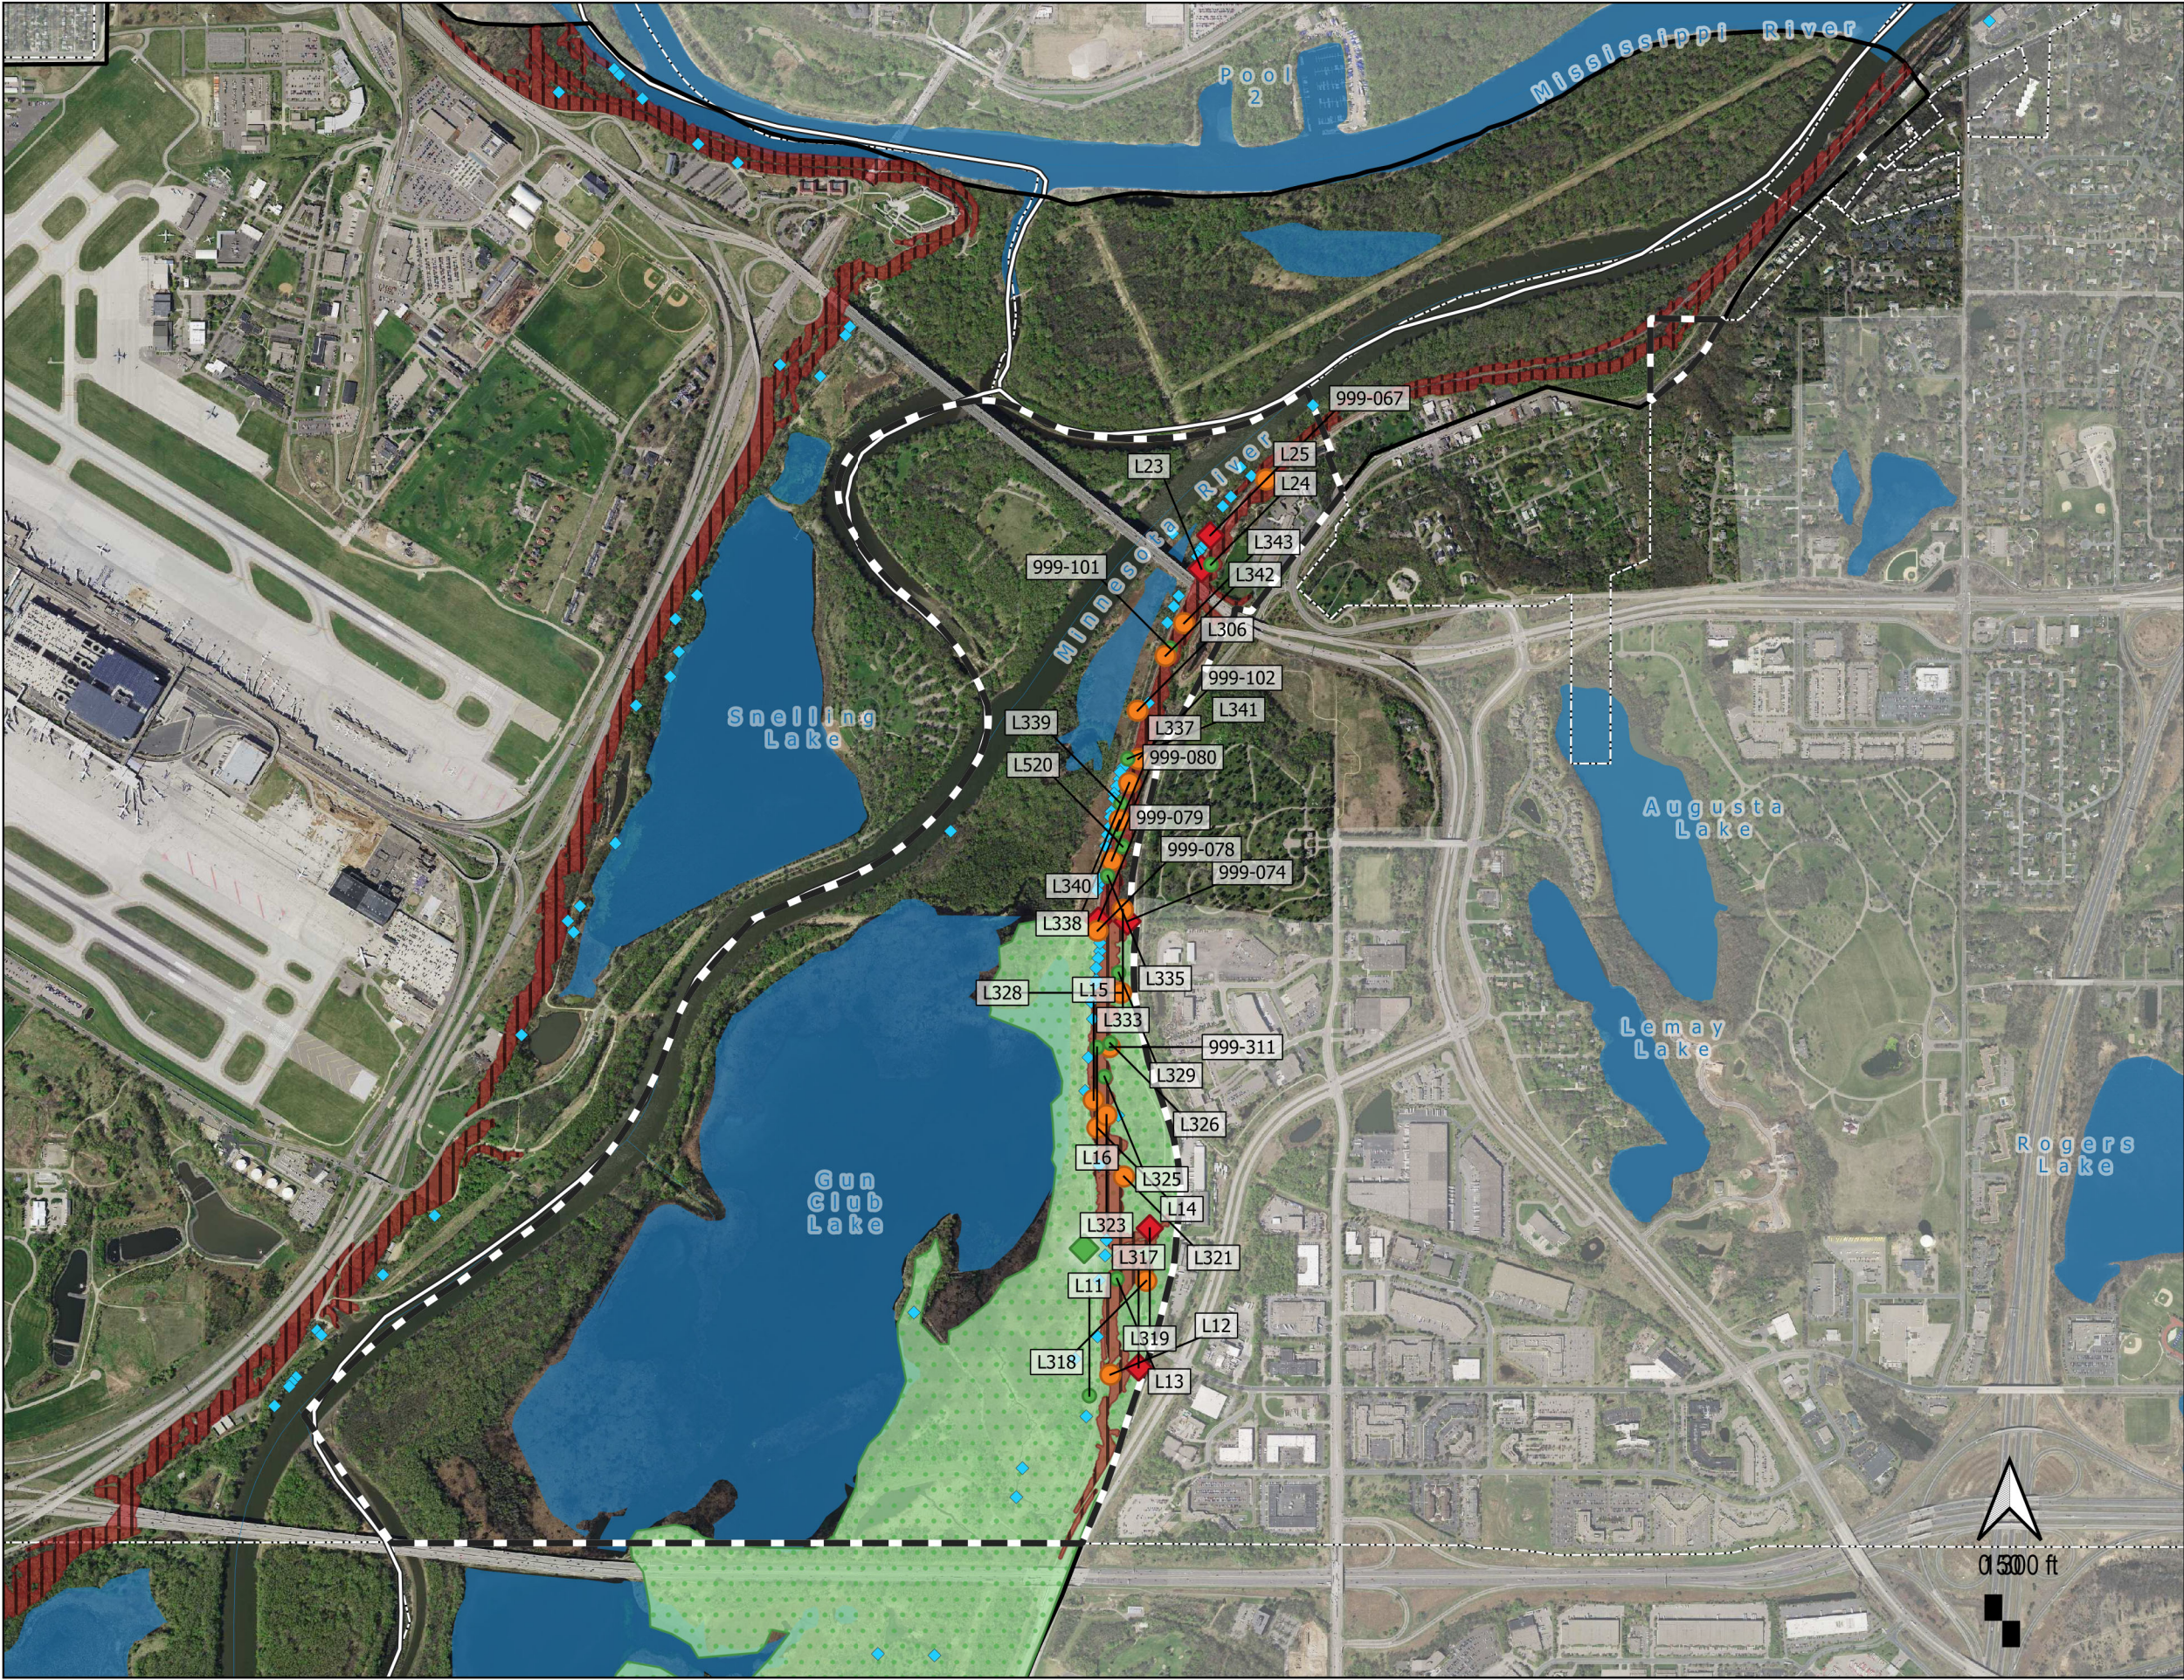
**Figure 123:
Mendota Heights
2020 Gully Conditions**

Mendota Heights contained very few groundwater-fed streams or seeps, despite evidence of groundwater upwelling in the region with the proximity of Black Dog Lake Fen and the numerous springs shown on the MnDNR Spring Inventory. Additionally, most of the gullies in Mendota Heights lay along the Steep Slopes Overlay District and shared similar characteristics (**Figure 123**). Generally, the gully head cut consisted of St. Peter sandstone eroding back and Platteville limestone toppling over the top of the contact. In many instances, upon assessing some of the 2008 gully locations, the field team determined the location would not be considered an actual gully, due to the lack of a distinct, down-cutting flow path formed by water. In those gullies, the wide, bowl-shaped head cut consisted of eroding bedrock, but few problem indicators. Generally, the team did not find that type of feature possessing high erosion potential.

The gullies in Mendota Heights generally contained debris, such as broken glass and litter, along the gully bottom.

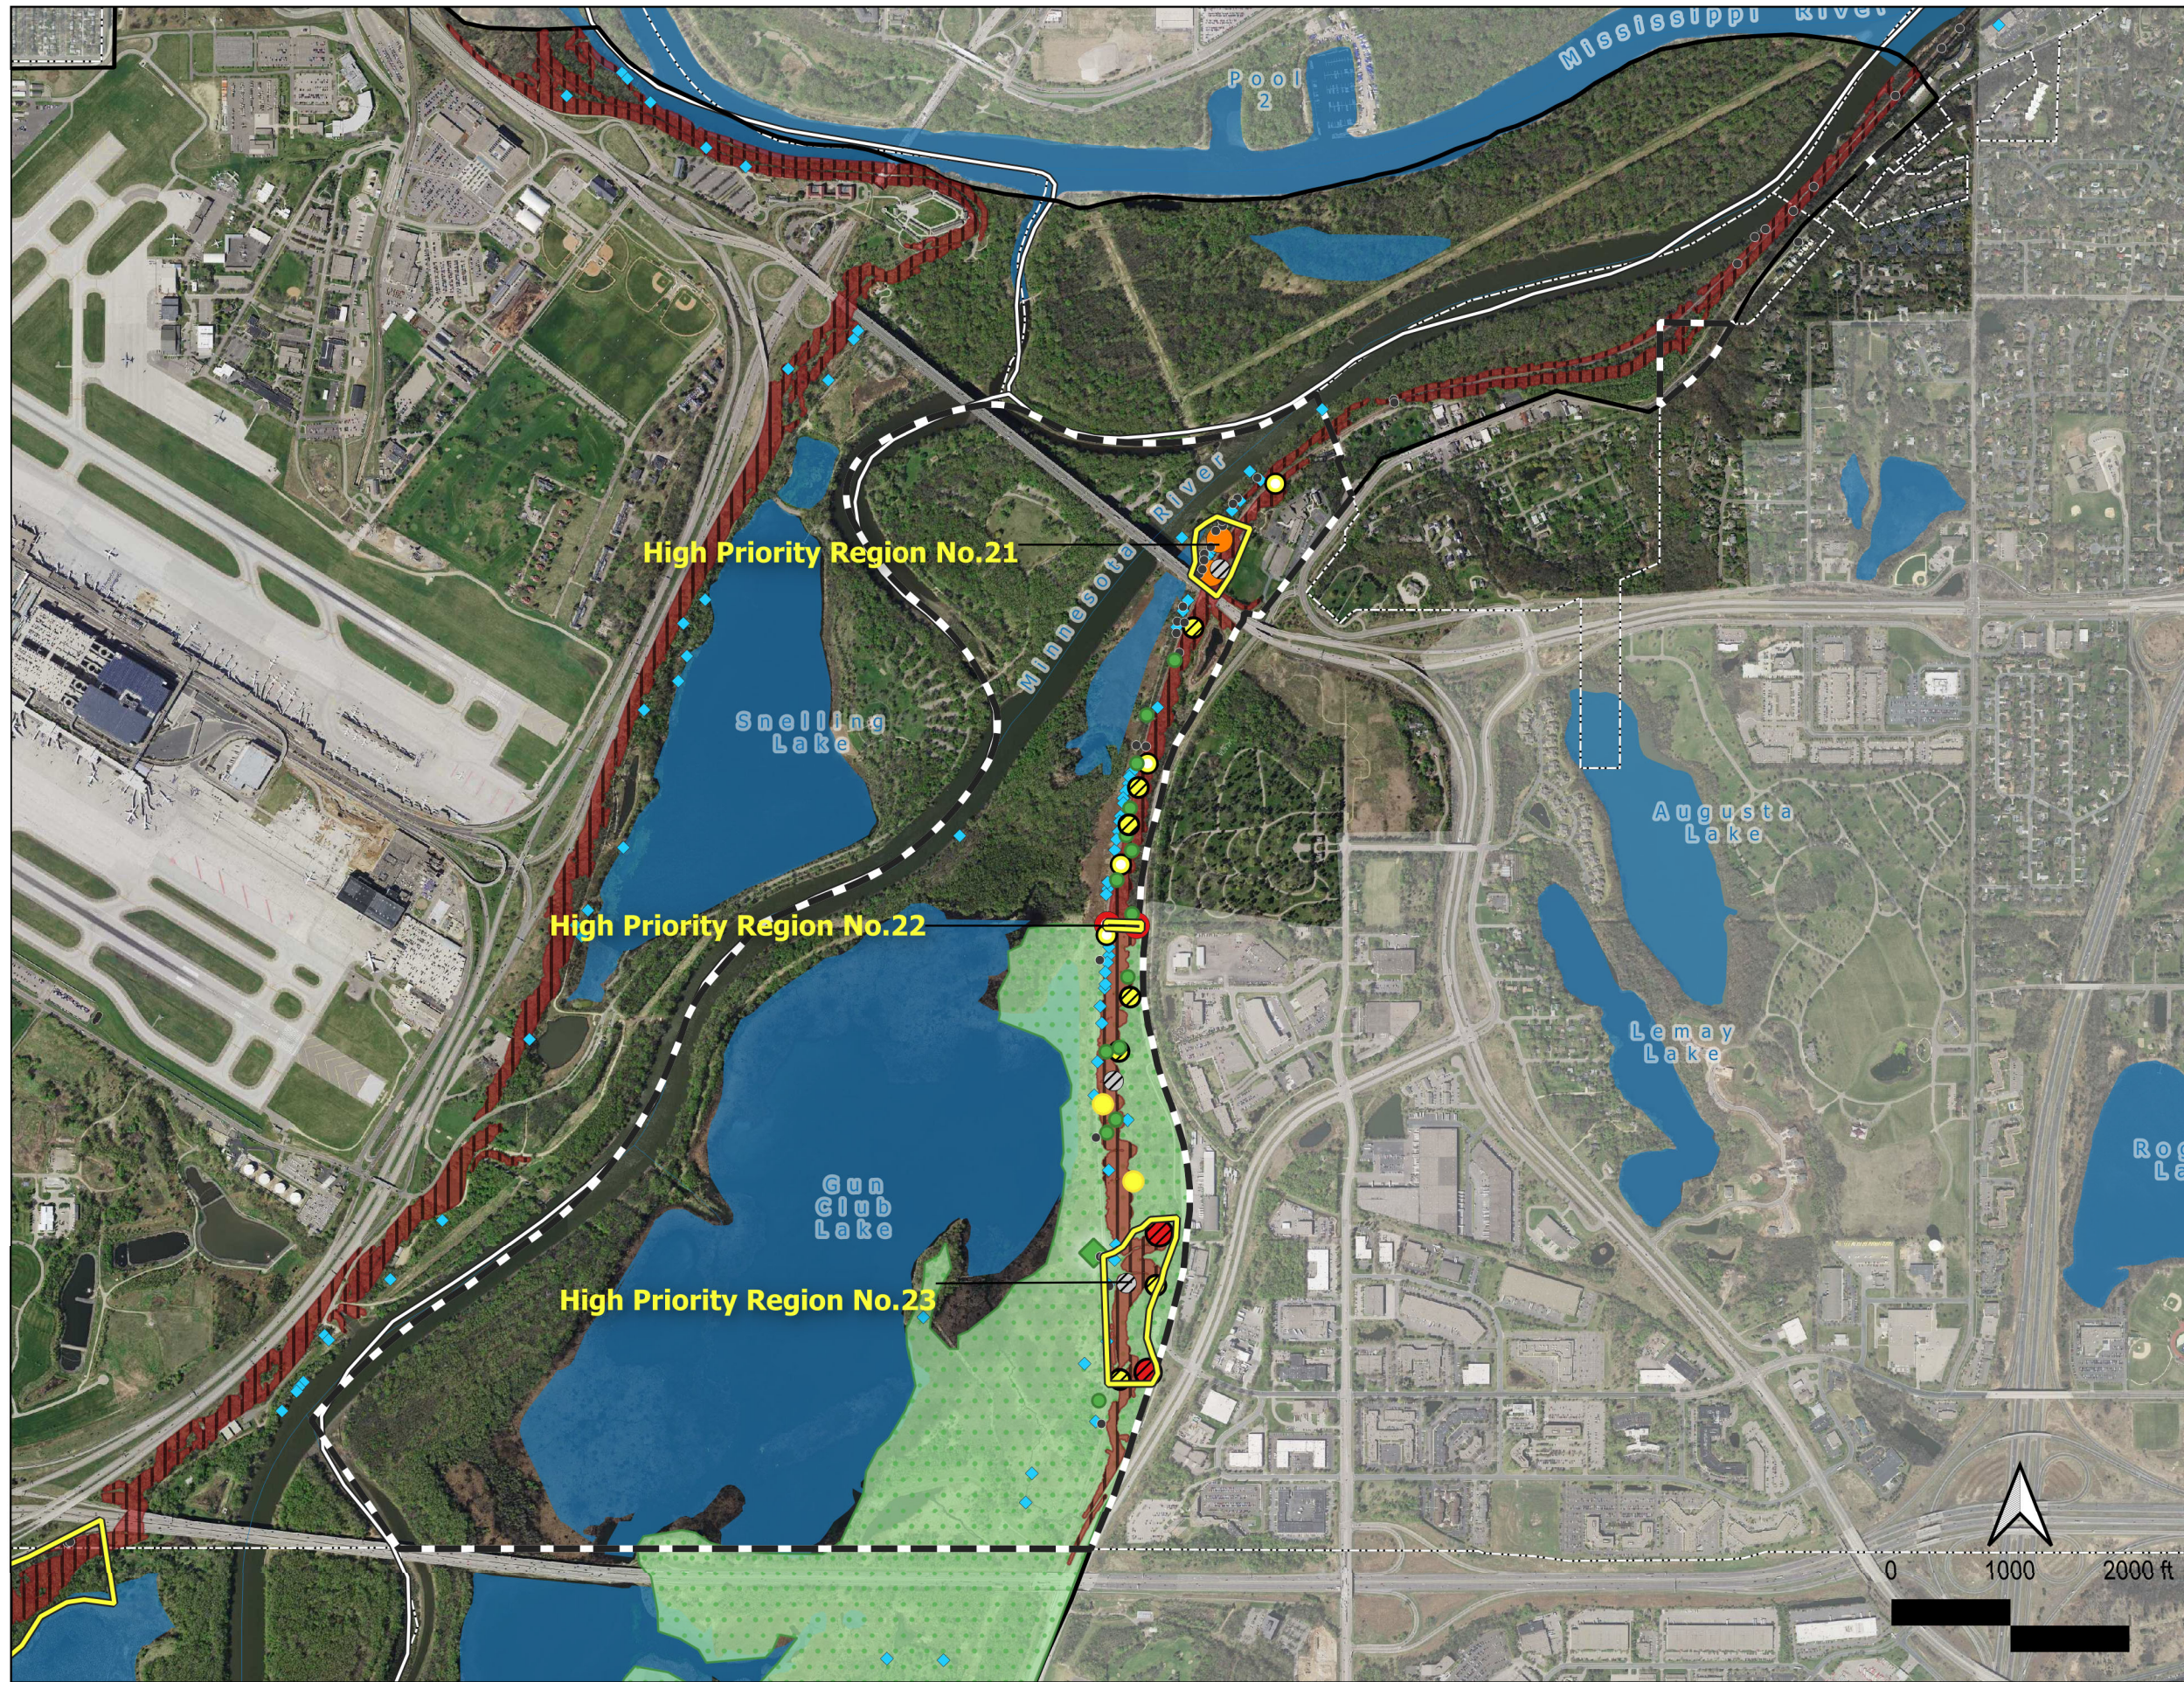
Figure 124:
Mendota Heights Erosion
Progression and HPRs

The city of Mendota Heights has three HPRs; HPR 21, 22, and 23, shown in [Figure 124](#). All three priority regions include portions of the LMRWD Steep Slopes Overlay District.

- **HPR 21:** These sites were grouped due to their geographic proximity to each other, similar characteristics, and similar erosion progression.
- **HPR 22:** This grouping reflects one large gully channel that has been evaluated with two waypoints, with one at the top of the bluff and one at the bottom.
- **HPR 23:** These sites were grouped because of their geographic proximity to each other, shared access locations, and ultimate discharge location of Gun Club Lake Fen.
