To: Leslie Stovring City of Eden Prairie

Date: 24 January 2017

Subject: 2016 Minnesota River Erosion Monitoring

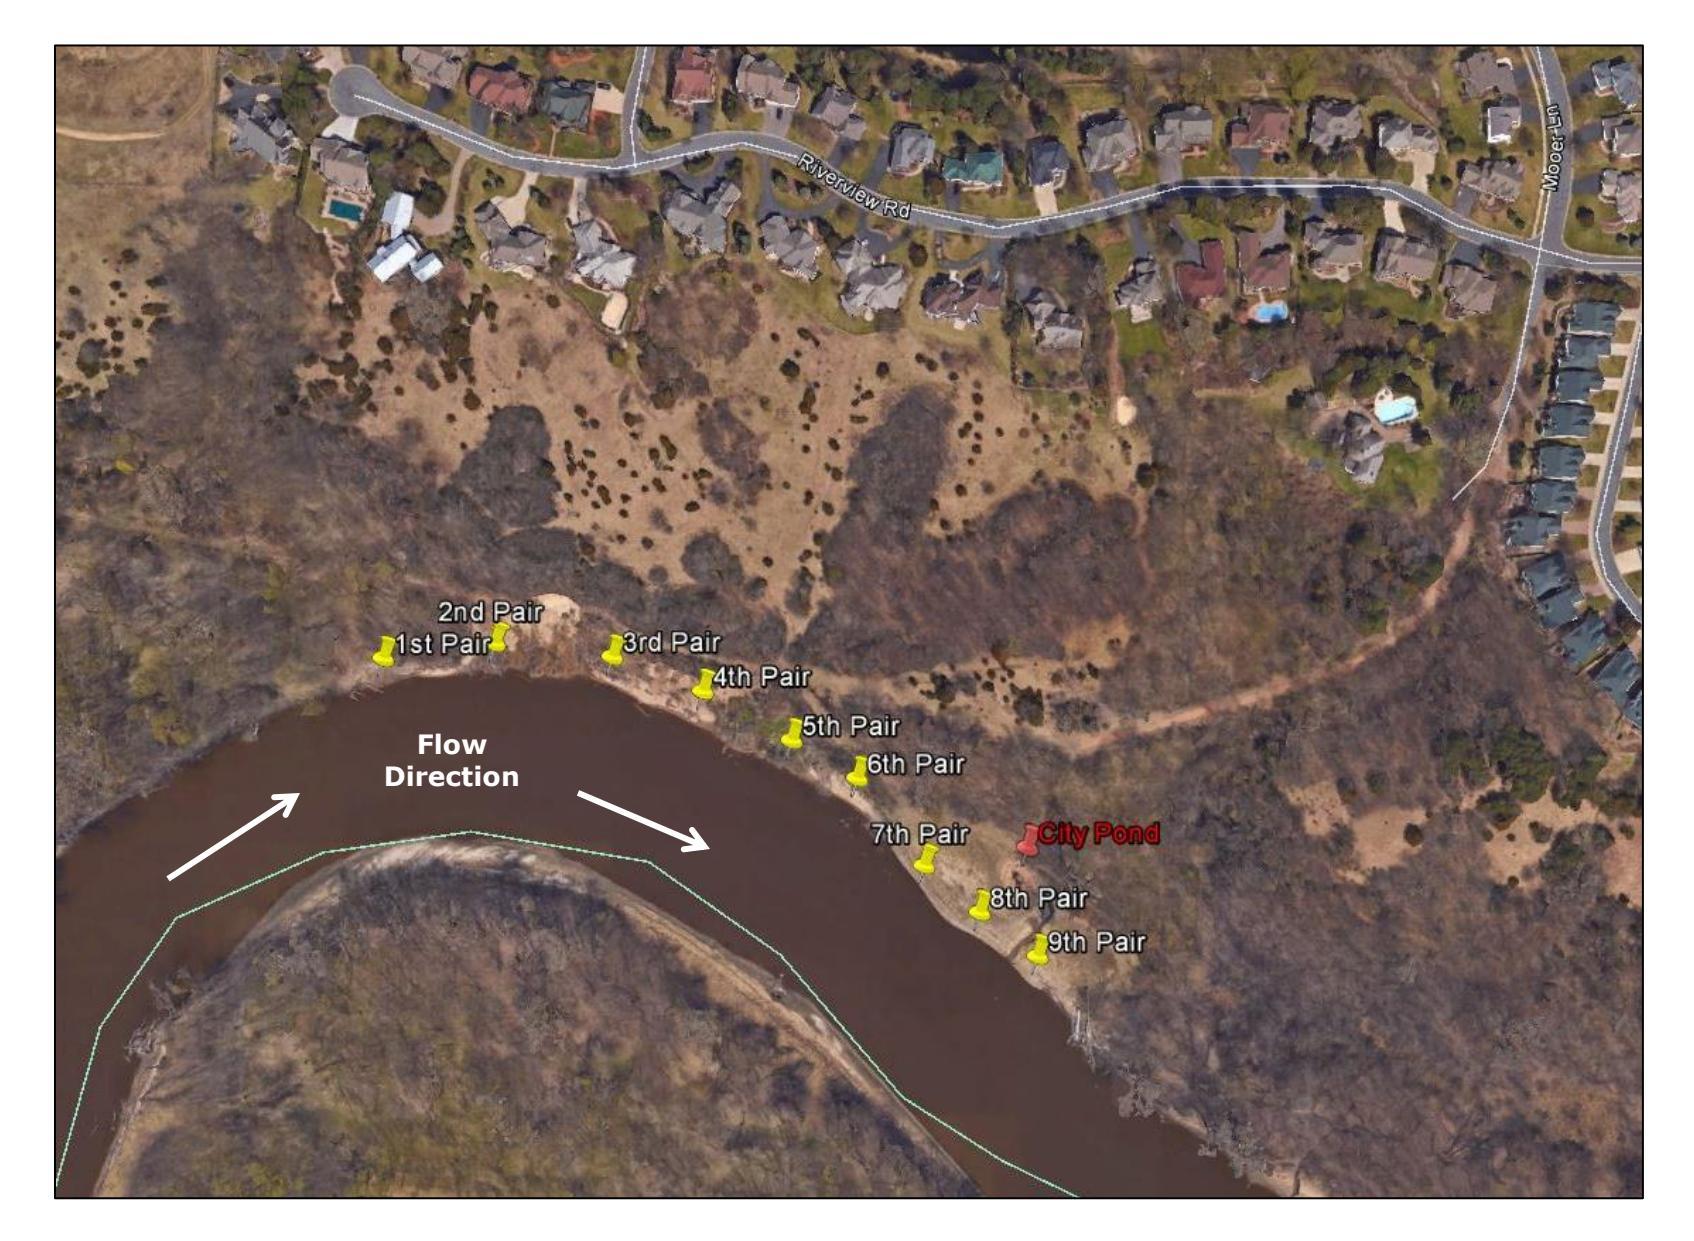
Figure 2: Bank Pin Locations

Wenck Associates, Inc. (Wenck) installed a series of bank pins to monitor bank erosion along the Minnesota River near Riverview Road (Figure 1). Two bank pins were installed at nine locations along the outside bend (Figure 2). At each location, the lower pin was set approximately 2-3 feet above the water surface and the upper pin was installed approximately 2-6 feet directly above the lower pin depending on bank conditions at each location. Each pin is made of #4 rebar cut to length (4 feet) and ground to a conical point on one end. The purpose of the bank pins is to set a fixed point to measure the rate at which the river banks are eroding. This information is used to determine if bank reenforcement is needed to prevent future failures and protect the City stormwater pond at this site.

Locations #7, #8, and #9 showed moderate bank erosion in 2016. These locations are located along a previous bank stabilization project that is intended to protect a City stormwater pond (see Figure 2). It should be pointed out that the end caps were missing at Locations #7 and #9 during the November site visit, suggesting a significant amount of force was exerted on the banks at these locations, likely high channel velocities and/or floating debris.
