Technical Memorandum

Re: Area 3 Site Visit Meeting Summary

Re: Eden Prairie Area 3 and the Minnesota River—Meeting summary and recommendations

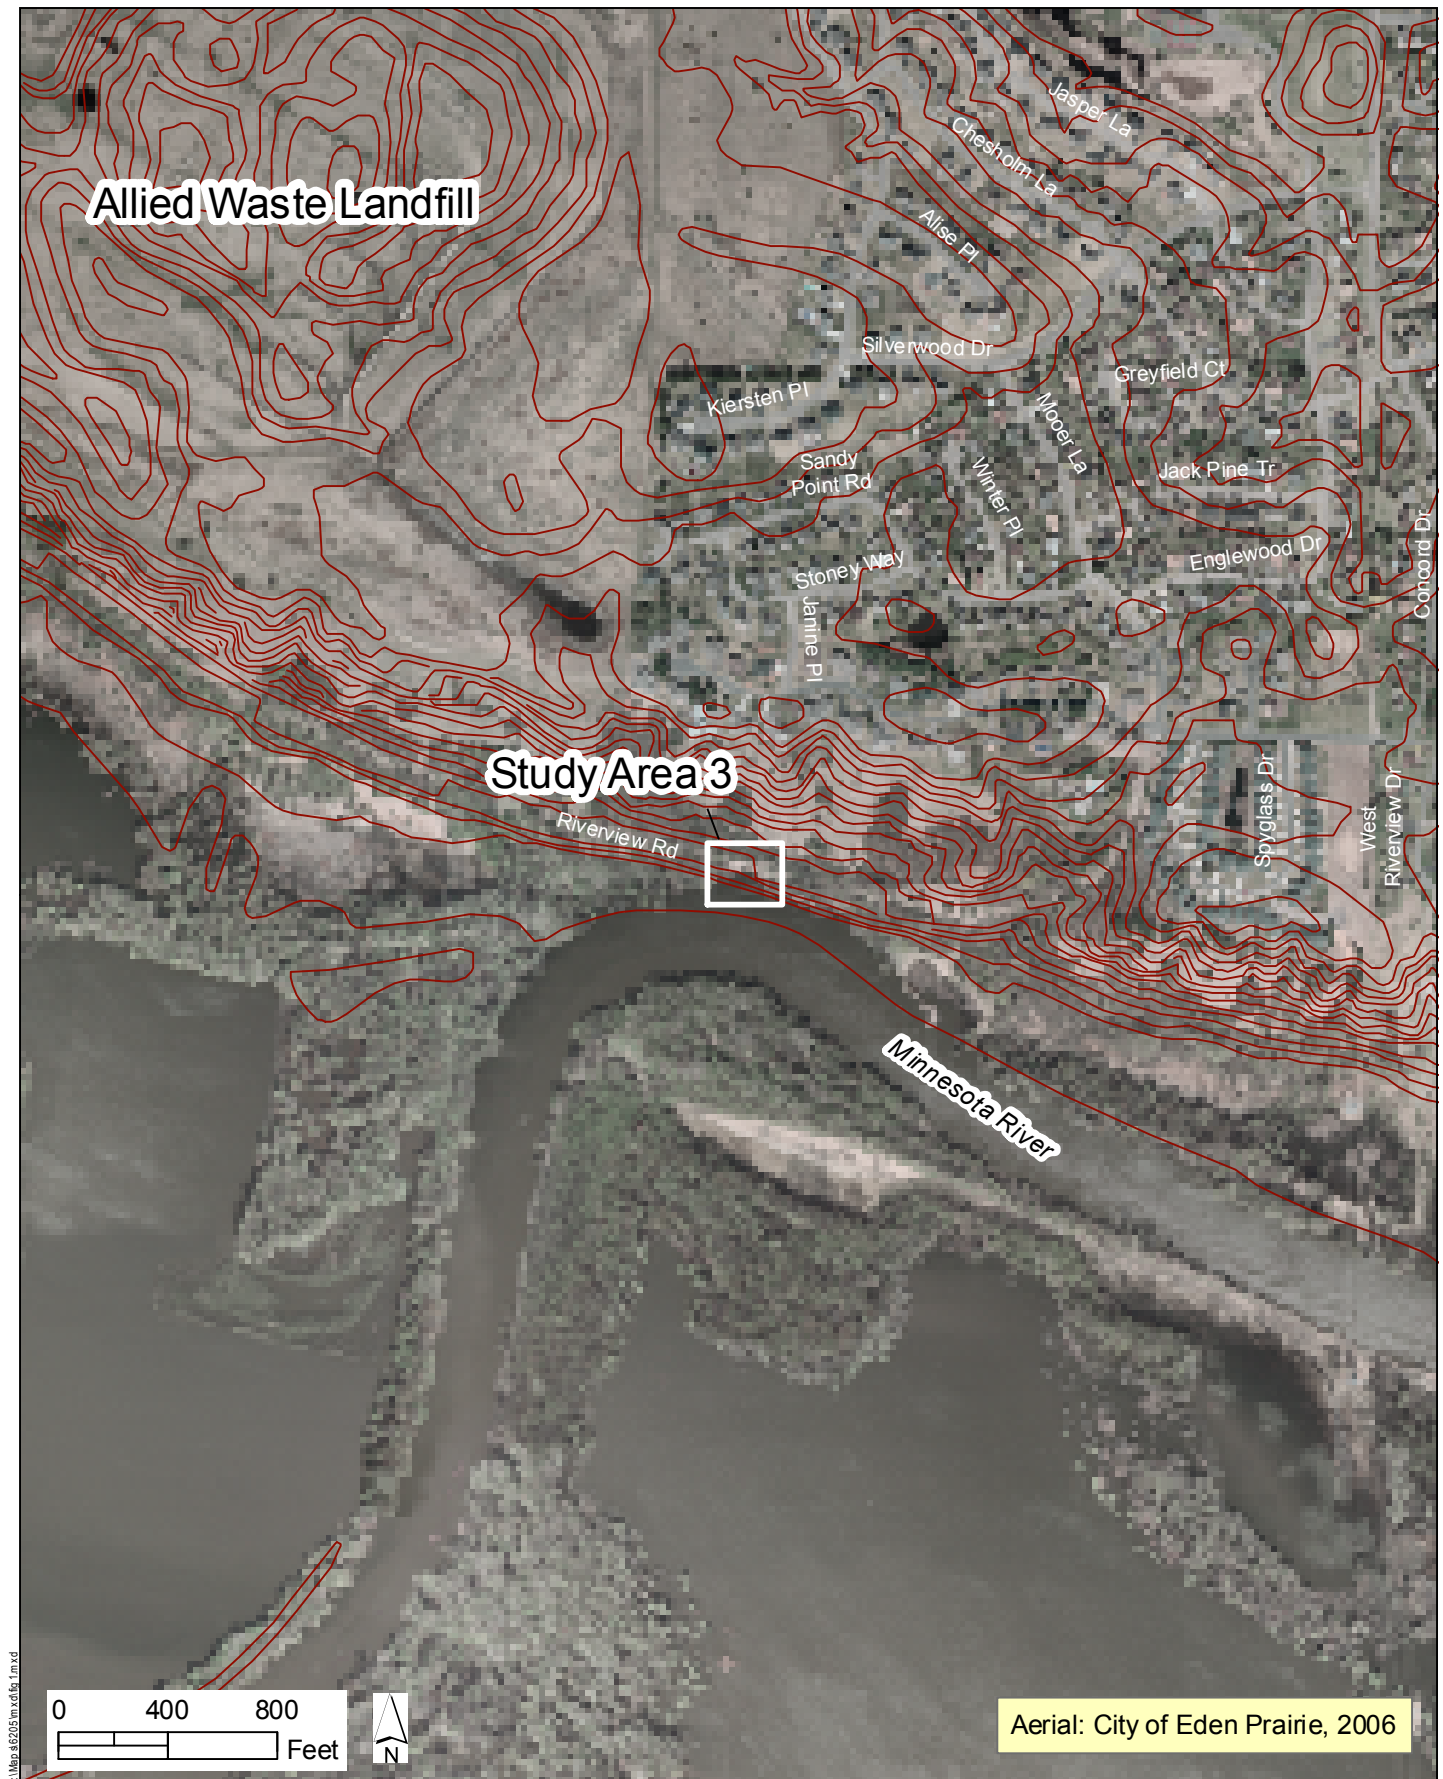
Existing Conditions

In 2010, the team of Wenck Associates, Inc. and Stanley Consultants, Inc. were retained to expand on the information produced by SRF. The Wenck team focused on the slope interface with the river (see enclosed existing conditions map). Additional data were collected, and the team completed hydrology, hydraulics slope stability and geotechnical analyses. The Wenck team’s conclusions were similar to SRF’s. They highlight that the meander is a natural process that has been accelerated by changes in hydrology and climate variability and increased erosion due to stormwater runoff concentrated on the surface and seepage flows (Wenck, 2010). The Wenck team concluded that if left as is, without stabilization, erosion will continue as the meander moves downstream. That said, they did note that the slope stability analyses showed the bluff had an acceptable safety factor for the residences and properties.

Recommendation: Based on the analysis completed and data collected, three alternatives for bank stabilization were identified: 1) riprap blanket with a PCE of \$1.9 million, 2) bendway weirs with a PCE of \$3.3 million, and 3) rock vanes with a PCE of \$1.1 million. Alternative 3 was selected because of cost.
