## LMRWD Stability Study

B14-03590 (formerly SP-09-04727)  
LMRWD Stability Analysis  
Eden Prairie, Minnesota

## Technical Memorandum

**To:** Della Nyondi Schall Young – Young Environmental Consulting Group, LLC  
**From:** Garrett Bayrd, Jacob Sharpe – Barr Engineering Co.  
**Subject:** Monitoring Event – Fall 2020  
**Date:** November 2<sup>nd</sup>, 2020  
**Project:** LMRWD Eden Prairie Slope Monitoring

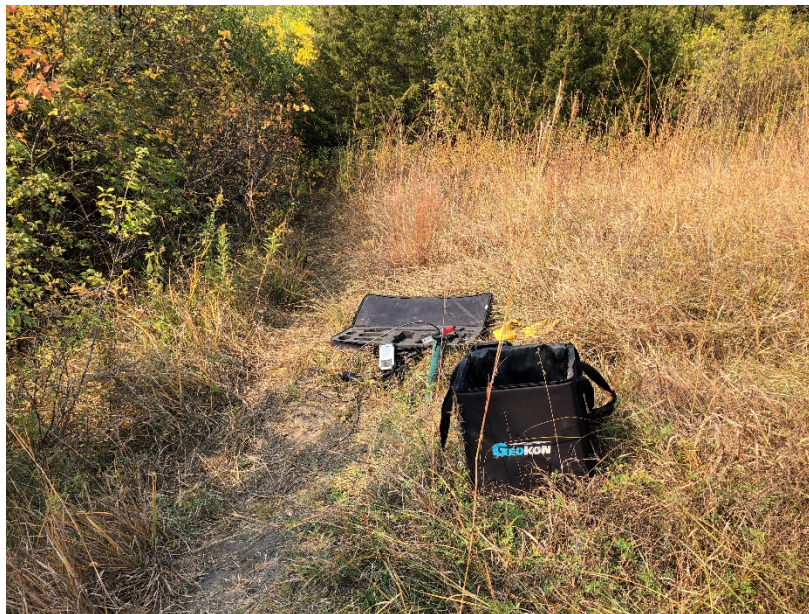
**Photo 1: Inclinometer SBINC-4**

Barr staff took initial readings in both inclinometers at the site, SBINC-3 and SBINC-4. Barr understands from discussions with the client that these inclinometers have previously been read by Braun. During the initial readings, multiple readings in each inclinometer are performed to verify that accurate readings are gathered. Plots of the initial readings are attached to this memo as Attachment 1. Because both readings were taken on the same day, the plots are not expected to show any ground displacement. The plots will be updated during the next set of readings in spring of 2021.
