# Technical Memorandum

**Date:** October 16, 2020

**Re:** Area 3 Slope Stability Project Update

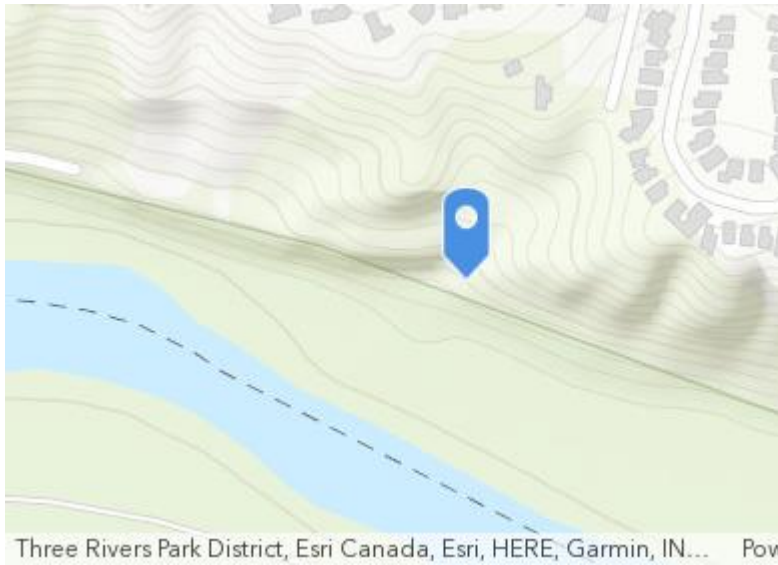
| BANK CONDITION: | Some Vegetation |
| BOTTOM CONDITION: | Bare Soil |
| APPARENT CAUSES: | Seep/groundwater, Slope |

Looking u/s from gully bottom near headcut at slumping along the right bank and a backpack for scale. Headcut visible with groundwater seep above in the background

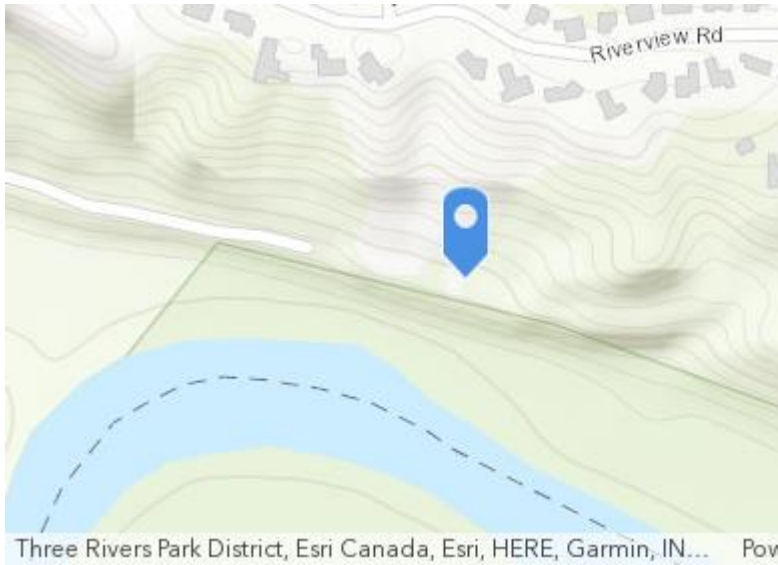
| BANK CONDITION: | Bare Soil |
| BOTTOM CONDITION: | Bare Soil |
| APPARENT CAUSES: | Seep/groundwater, Unstable drainage feature entering system ,<br>None/Unknown |
| <b>ADDITIONAL NOTES:</b><br>Not really a gully, more of a very large slump along the left bank of the MN River 2007 report noted a spring and a pipe outfall. Spring was located near the river. Pipe outfall located near the left bank of the slump, but unable to assess due to steep slope. All of these features are included in a gully sheet because of the severe erosion and inability to assess pipe.<br><br>Invasive Species? None<br>Type: None | |

Pipe found along the left bank, but unable to assess due to steep slopes

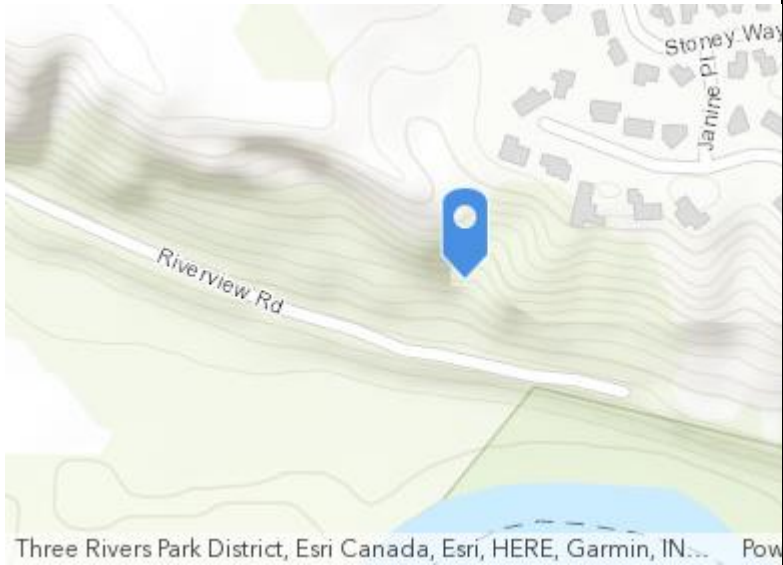
| BANK CONDITION: | Some Vegetation |
| BOTTOM CONDITION: | Bare Soil |
| APPARENT CAUSES: | Seep/groundwater, Slope, Channel Incision |

Downstream view from right bank of headcut looking at large slump along left bank.

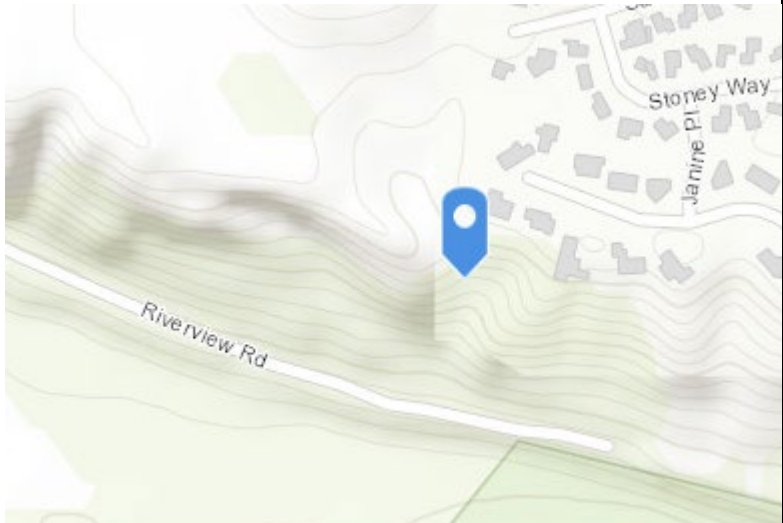
| BANK CONDITION: | Bare Soil |
| BOTTOM CONDITION: | Some Vegetation |
| APPARENT CAUSES: | Slope, None/Unknown |
| <b>ADDITIONAL NOTES:</b><br>Rated as high erosion potential because of steep bank slopes, narrow bottom width, and an actively eroding headcut with overhanging banks. There is little vegetation holding the soil in place along the banks. However, there were no deep slumps or sections of overhang noted along the banks themselves, so this gully is on the moderate end of high erosion potential.<br><br>Invasive Species? High<br>Type: Common Buckthorn<br>Debris? Tire and some fallen tree | |

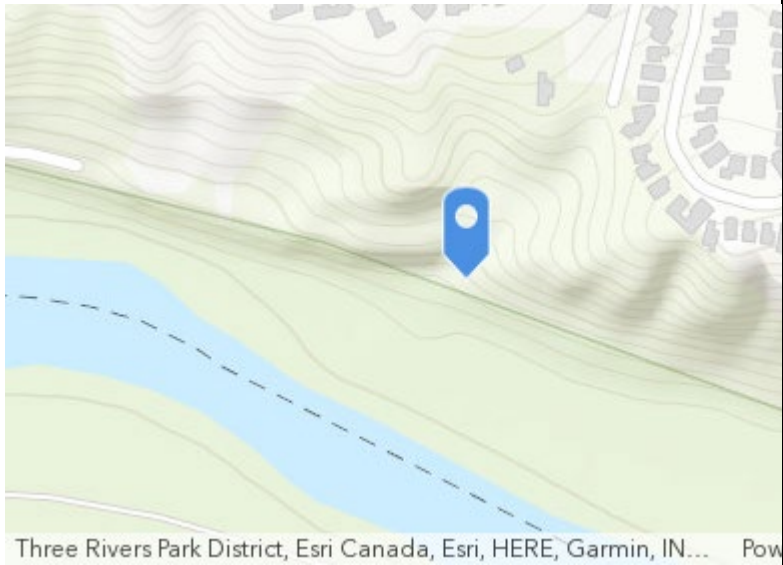
| <b>SITE SUMMARY:</b><br>Sunny<br>Rain in previous 24 hours: No<br><br>Heavily Forested<br><br>Medium: 50'-100' gully.<br><br>The problem indicators were:<br>Degradation, Loss of Bank<br>Vegetation, Vertical and/or bare<br>banks (incision), Flattened and/or<br>slumping banks (widening),<br>undercut or overhanging banks<br>(lateral scouring), pistol-butted<br>or leaning trees | |
| BANK CONDITION: | Bare Soil |
| BOTTOM CONDITION: | Bare Soil |
| APPARENT CAUSES: | Seep/groundwater, Slope, Channel Incision |

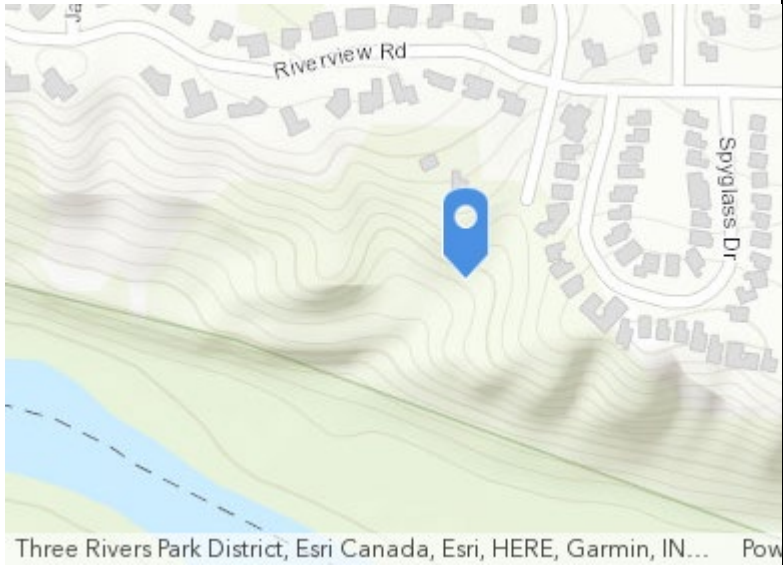
| BANK CONDITION: | Heavy Vegetation |
| BOTTOM CONDITION: | Armored |
| APPARENT CAUSES: | None/Unknown |

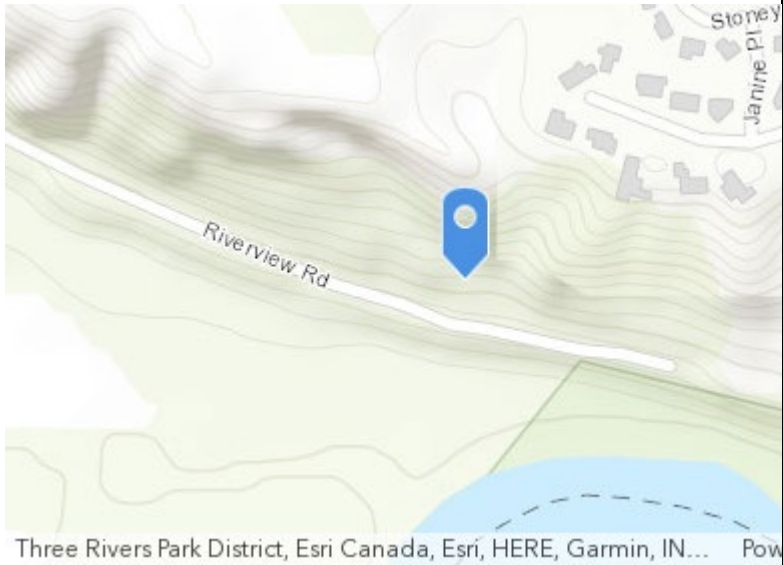
| BANK CONDITION: | Bare Soil |
| BOTTOM CONDITION: | Bare Soil |
| APPARENT CAUSES: | Channel Incision, Dense Canopy |

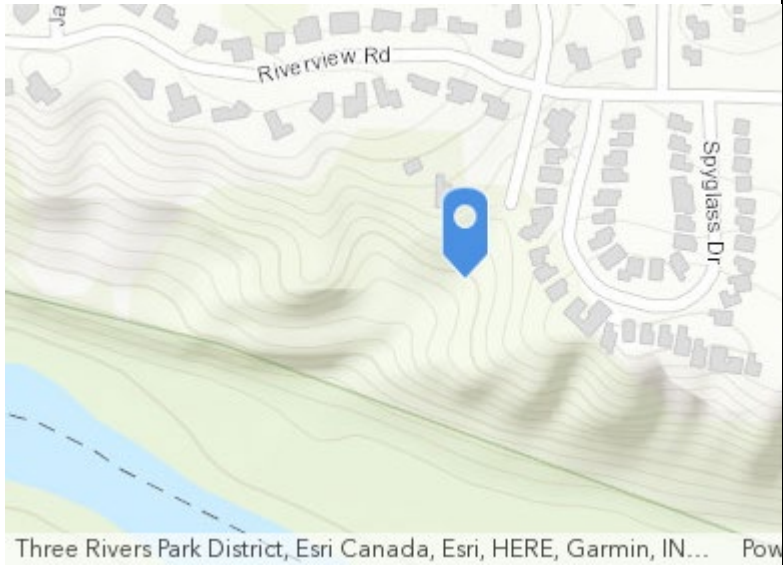
| BANK CONDITION: | Heavy Vegetation |
| BOTTOM CONDITION: | Heavy Vegetation |
| APPARENT CAUSES: | Slope, Channel Incision, Game Trails |
