Technical Memorandum

Re: University of Minnesota Partnership for the Gully Assessment and
Condition Project

ATTACHMENT 2 - ESPM CLASS GULLY DATA SHEETS

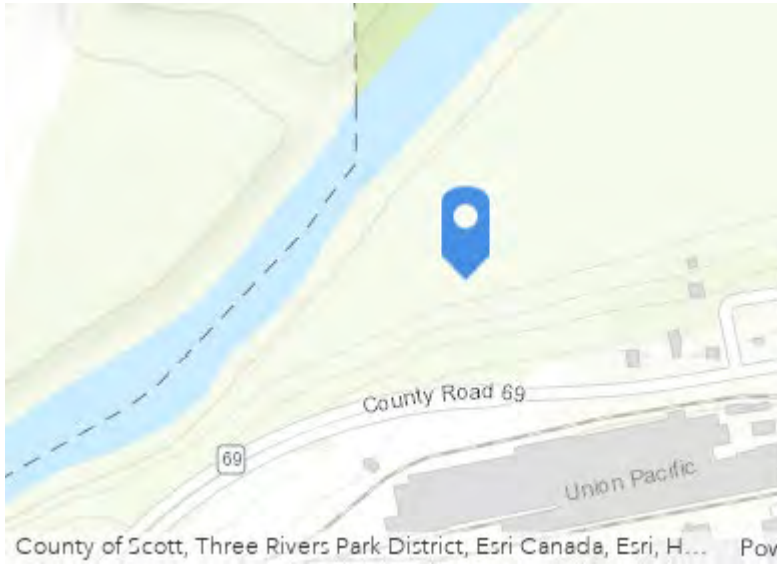
GULLY ID: ESPM Site 3

PREVIOUS WAYPOINT ID: 3	
SURVEY DATE: April 18, 2021 1:33 PM	
LOCATION: Shakopee	
TYPE OF SITE: Gully	
SITE SUMMARY: Partly Cloudy Rain in previous 24 hours: No Off bike trail Long: >100' gully. The problem indicators were: pistol-butted or leaning trees	
<p>Gully Head UTM Estimation: 30',</p> <p>Observation Point correction, if applicable:</p> <p>Connections to other points, if applicable:</p>	
GULLY INFORMATION	
EROSION POTENTIAL:	Low
GULLY DEPTH:	Medium: 3'-15'
BOTTOM WIDTH:	Wide: >5'
TOP WIDTH:	Wide: >10'
BANK CONDITION:	Some Vegetation
BOTTOM CONDITION:	Some Vegetation
CHANNEL SLOPE:	Flat
GULLY SHAPE:	Trapezoid
GULLY MATERIAL:	Fine-grained cohesive
WATER LEVELS	None, N/A
SEEP	No
APPARENT CAUSES:	Slope, Unstable drainage feature entering system
ADDITIONAL NOTES:	
Invasive Species? Unkown Type: Unkown	
Debris? Some debris and trash	
Existing Stabilization? Riprap/large stones Success: Yes

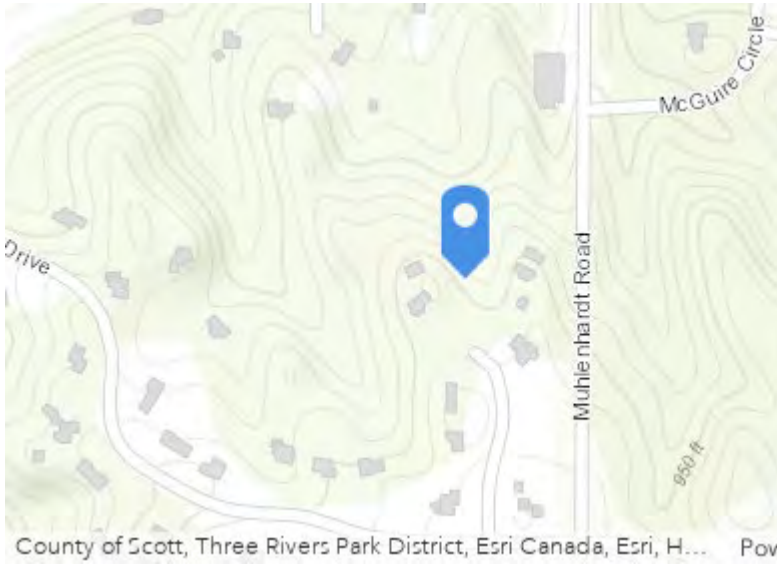
GULLY ID: ESPM Site 6

PREVIOUS WAYPOINT ID: Site 6	
SURVEY DATE: April 22, 2021 12:04 PM	
LOCATION:	
TYPE OF SITE: Gully	
SITE SUMMARY: Sunny Rain in previous 24 hours: Yes: Low Intensity, No Along a Road Long: >100' gully. The problem indicators were: Degradation, Aggradation, Flattened and/or slumping banks (widening), undercut or overhanging banks (lateral scouring), pistol-butted or leaning trees	Gully Head UTM Estimation: 30 ft, Observation Point correction, if applicable: 15T4674994956382 Connections to other points, if applicable:
GULLY INFORMATION	
EROSION POTENTIAL:	High
GULLY DEPTH:	Shallow: <3'
BOTTOM WIDTH:	Narrow/V Ditch, Medium: 1'-5'
TOP WIDTH:	Medium: 5'-10', Narrow: 1'-5'
BANK CONDITION:	Some Vegetation
BOTTOM CONDITION:	Some Vegetation
CHANNEL SLOPE:	Steep
GULLY SHAPE:	U-shaped
GULLY MATERIAL:	Gravel/cobble/ boulders , Sand, Fine-grained cohesive
WATER LEVELS	None, N/A
SEEP	No
APPARENT CAUSES:	Slope, Unstable drainage feature entering system

ADDITIONAL NOTES: Near site 6 Invasive Species? None Type: Burdock, None Debris? Little trash Existing Stabilization? Rip rap or burlap under rocks at top of gully Success: No

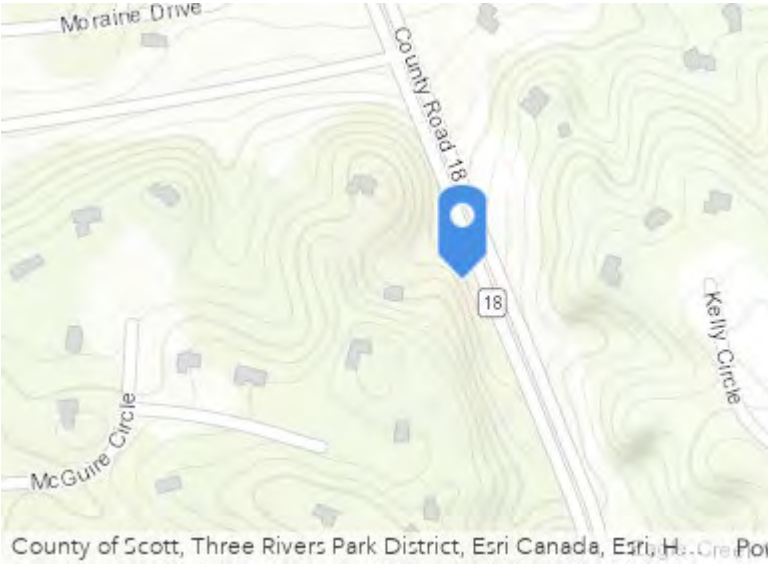
GULLY ID: ESPM Site 7

<p style="text-align: center;">Gully Head UTM Estimation: 5 ft,</p> <p style="text-align: center;">Observation Point correction, if applicable:</p> <p style="text-align: center;">Connections to other points, if applicable:</p>
PREVIOUS WAYPOINT ID: Site 7	
SURVEY DATE: April 22, 2021 12:51 PM	
LOCATION: Shakopee	
TYPE OF SITE: Gully	
SITE SUMMARY: Sunny Rain in previous 24 hours: No Off of Walking Trail Long: >100' gully. The problem indicators were: Degradation, Loss of Bank Vegetation, Flattened and/or slumping banks (widening), pistol-butted or leaning trees	
GULLY INFORMATION	
EROSION POTENTIAL:	Moderate
GULLY DEPTH:	Shallow: <3'
BOTTOM WIDTH:	Medium: 1'-5'
TOP WIDTH:	Medium: 5'-10'
BANK CONDITION:	Some Vegetation
BOTTOM CONDITION:	Some Vegetation
CHANNEL SLOPE:	Steep
GULLY SHAPE:	U-shaped
GULLY MATERIAL:	Fine-grained cohesive
WATER LEVELS	None, N/A
SEEP	No
APPARENT CAUSES:	Slope

ADDITIONAL NOTES: Slight slope drains into storm sewer at end of gully Invasive Species? Type: Debris? Lots of trash Existing Stabilization? None Success: N/A

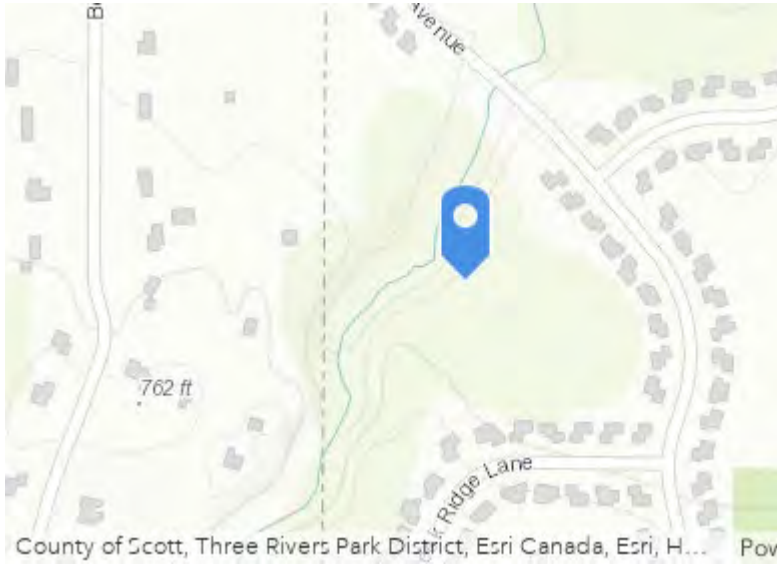
GULLY ID: ESPM Site 9

PREVIOUS WAYPOINT ID: Site 9	
SURVEY DATE: April 22, 2021 1:58 PM	
LOCATION: Savage	
TYPE OF SITE: Gully	
SITE SUMMARY: Sunny Rain in previous 24 hours: No Heavily Forested Medium: 50'-100' gully. The problem indicators were: Degradation, Aggradation, Loss of Bank Vegetation, Vertical and/or bare banks (incision), pistol-butted or leaning trees	
GULLY INFORMATION	
EROSION POTENTIAL:	Moderate
GULLY DEPTH:	Shallow: <3'
BOTTOM WIDTH:	Wide: >5'
TOP WIDTH:	Medium: 5'-10'
BANK CONDITION:	Some Vegetation
BOTTOM CONDITION:	Some Vegetation
CHANNEL SLOPE:	Flat
GULLY SHAPE:	Trapezoid
GULLY MATERIAL:	Fine-grained cohesive
WATER LEVELS	Moderate, Slow
SEEP	Yes
APPARENT CAUSES:	Seep/groundwater, Slope
ADDITIONAL NOTES:	
Invasive Species? None Type: None	
Debris? No trash some debris	
Existing Stabilization? None Success: No, N/A

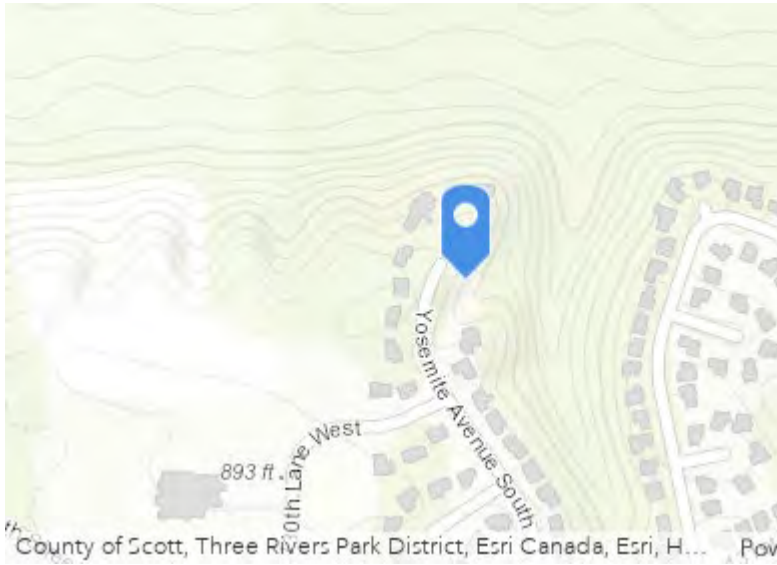
GULLY ID: ESPM Site 13

PREVIOUS WAYPOINT ID: Site 13	
SURVEY DATE: April 22, 2021 2:44 PM	
LOCATION: Savage	
TYPE OF SITE: Gully	
SITE SUMMARY: Sunny Rain in previous 24 hours: No Along a Road Long: >100' gully. The problem indicators were: Degradation, Flattened and/or slumping banks (widening), pistol-butted or leaning trees	
GULLY INFORMATION	
EROSION POTENTIAL:	High
GULLY DEPTH:	Deep: >15'
BOTTOM WIDTH:	Wide: >5'
TOP WIDTH:	Wide: >10', Medium: 5'-10', Narrow: 1'-5'
BANK CONDITION:	Some Vegetation
BOTTOM CONDITION:	Some Vegetation
CHANNEL SLOPE:	Steep
GULLY SHAPE:	V-shaped
GULLY MATERIAL:	Fine-grained cohesive
WATER LEVELS	None, N/A
SEEP	No
APPARENT CAUSES:	Slope, Unstable drainage feature entering system
ADDITIONAL NOTES:	
Invasive Species? Type:	
Debris? Some trash and debris	
Existing Stabilization? None	
Success: N/A

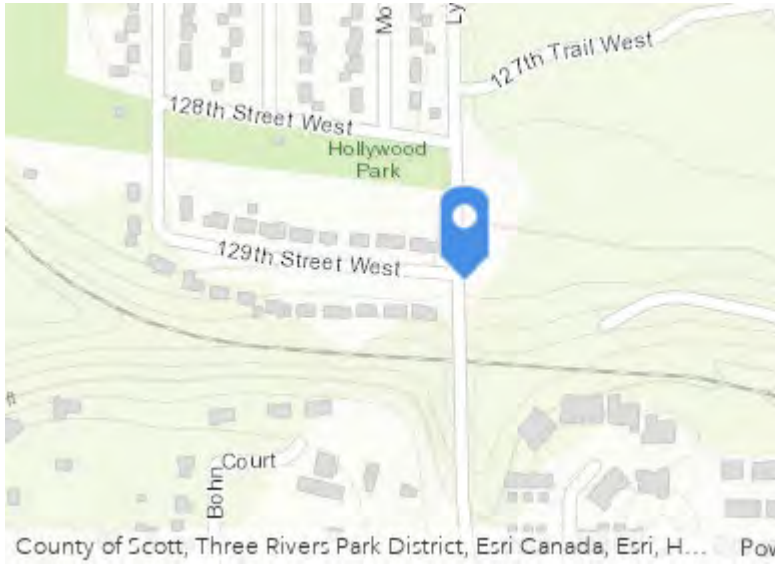
GULLY ID: ESPM Site 16

<p style="text-align: center;">Gully Head UTM Estimation: 2',</p> <p style="text-align: center;">Observation Point correction, if applicable:</p> <p style="text-align: center;">Connections to other points, if applicable:</p>
PREVIOUS WAYPOINT ID: Site 16	
SURVEY DATE: April 22, 2021 3:10 PM	
LOCATION: Savage	
TYPE OF SITE: Gully	
SITE SUMMARY: Partly Cloudy Rain in previous 24 hours: Yes: Low Intensity Off of Walking Trail Medium: 50'-100' gully. The problem indicators were: Loss of Bank Vegetation, Vertical and/or bare banks (incision), pistol-butted or leaning trees	
GULLY INFORMATION	
EROSION POTENTIAL:	Moderate
GULLY DEPTH:	Shallow: <3'
BOTTOM WIDTH:	Medium: 1'-5'
TOP WIDTH:	Narrow: 1'-5'
BANK CONDITION:	Bare Soil, Some Vegetation
BOTTOM CONDITION:	Some Vegetation
CHANNEL SLOPE:	Flat
GULLY SHAPE:	Trapezoid
GULLY MATERIAL:	Gravel/cobble/ boulders
WATER LEVELS	Low, Slow
SEEP	No

APPARENT CAUSES:	Unstable drainage feature entering system , Channel Incision
ADDITIONAL NOTES: Invasive Species? Type: Debris? Some trash Existing Stabilization? Riprap Success: Yes

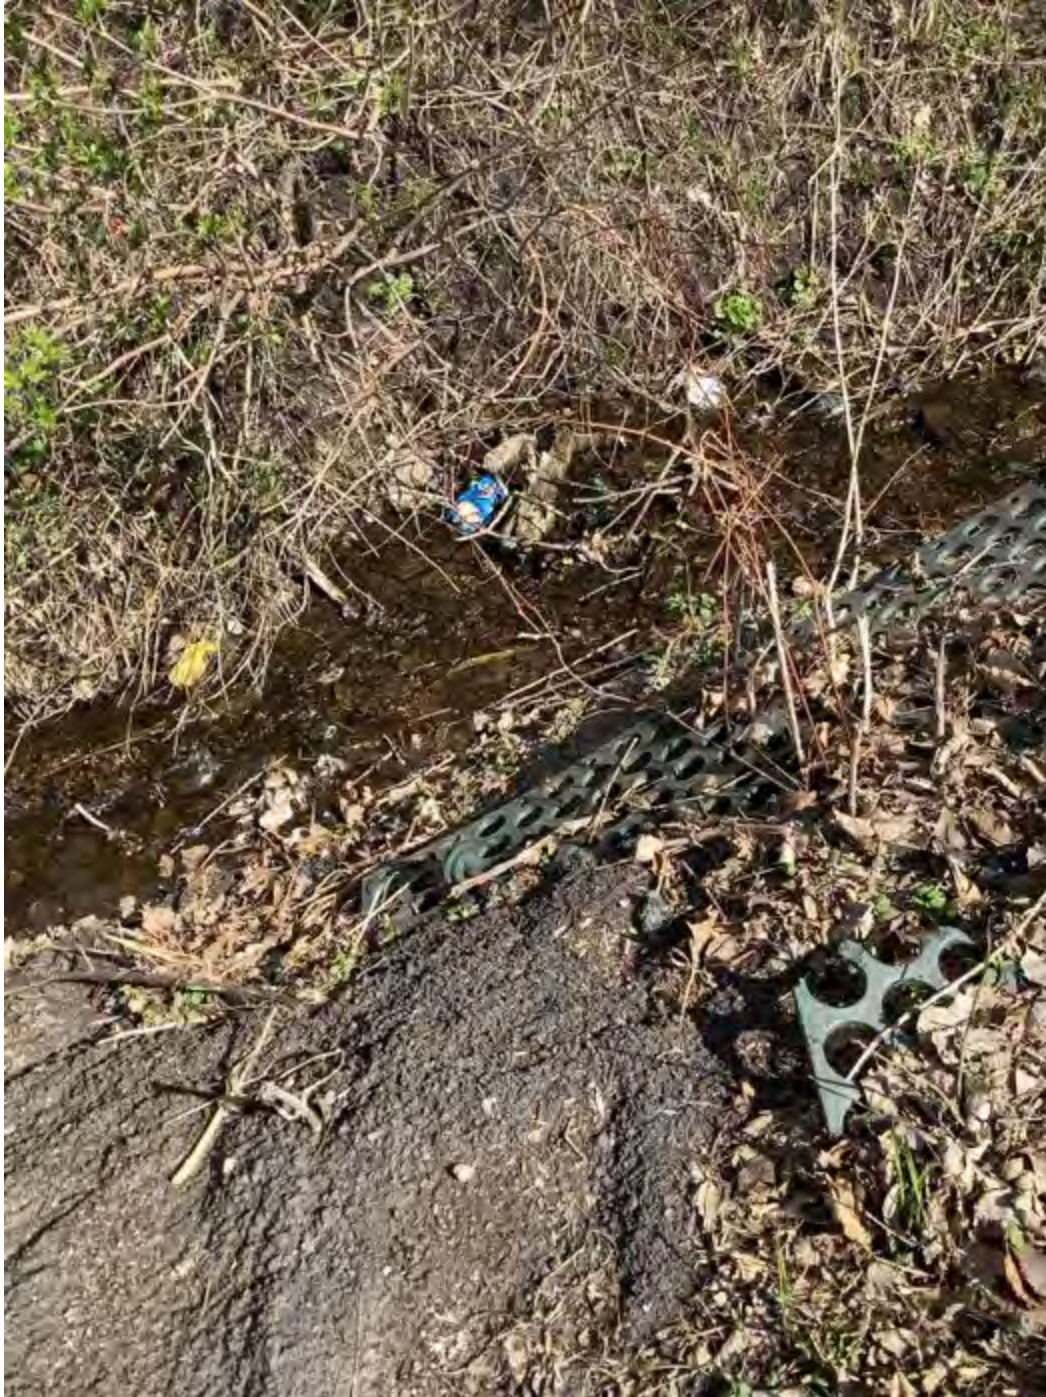
Debris and trash

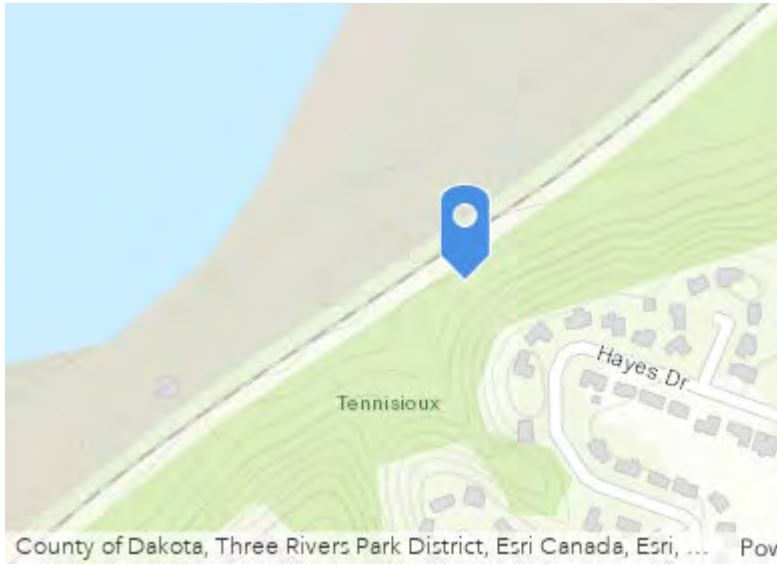
GULLY ID: ESPM Site 22

PREVIOUS WAYPOINT ID:	
SURVEY DATE: April 17, 2021 2:26 PM	
LOCATION:	
TYPE OF SITE: Gully	
SITE SUMMARY: Sunny Rain in previous 24 hours: No Heavily Forested Long: >100' gully. The problem indicators were: Loss of Bank Vegetation, undercut or overhanging banks (lateral scouring)	Gully Head UTM Estimation: 20, Observation Point correction, if applicable: Connections to other points, if applicable:
GULLY INFORMATION	
EROSION POTENTIAL:	Low
GULLY DEPTH:	Shallow: <3'
BOTTOM WIDTH:	Wide: >5'
TOP WIDTH:	Wide: >10'
BANK CONDITION:	Some Vegetation
BOTTOM CONDITION:	Armored
CHANNEL SLOPE:	Steep
GULLY SHAPE:	U-shaped
GULLY MATERIAL:	Gravel/cobble/ boulders
WATER LEVELS	Low, Slow
SEEP	No
APPARENT CAUSES:	None/Unknown
ADDITIONAL NOTES: 8ft storm drain outlet creates stream Invasive Species? Medium Type: Common Buckthorn Debris? Some Existing Stabilization? N/a Success: N/A

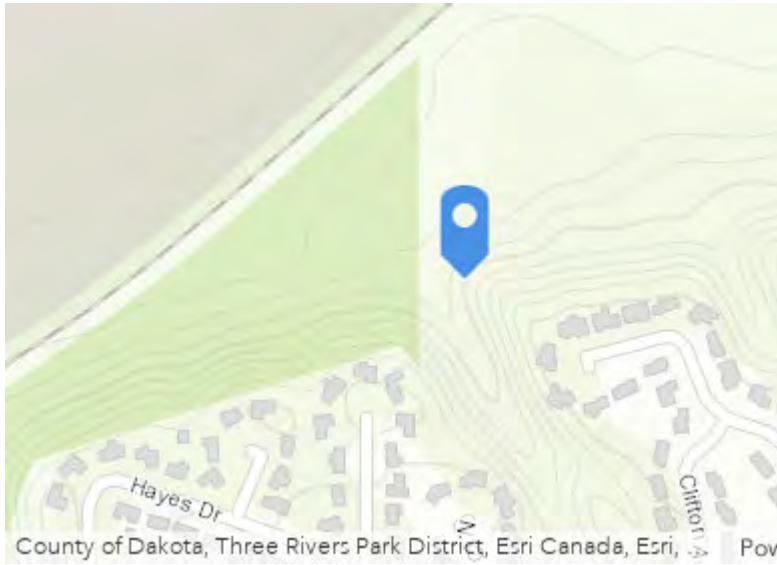
GULLY ID: ESPM Site 23

PREVIOUS WAYPOINT ID:	
SURVEY DATE: April 17, 2021 2:12 PM	
LOCATION:	
TYPE OF SITE: Gully	
SITE SUMMARY: Sunny Rain in previous 24 hours: No Off of Walking Trail Long: >100' gully. The problem indicators were: Degradation, Loss of Bank Vegetation, Vertical and/or bare banks (incision), pistol-butted or leaning trees	Gully Head UTM Estimation: 100ft, Observation Point correction, if applicable: Connections to other points, if applicable:
GULLY INFORMATION	
EROSION POTENTIAL:	High
GULLY DEPTH:	Shallow: <3'
BOTTOM WIDTH:	Wide: >5'
TOP WIDTH:	Wide: >10'
BANK CONDITION:	Bare Soil
BOTTOM CONDITION:	Some Vegetation
CHANNEL SLOPE:	Flat
GULLY SHAPE:	U-shaped
GULLY MATERIAL:	Gravel/cobble/ boulders
WATER LEVELS	Low, Slow
SEEP	Yes
APPARENT CAUSES:	Slope, Scour from debris jam or other channel obstruction, Channel Incision, Dense Canopy
ADDITIONAL NOTES: In wildlife refuge and disappears after entering hidden pipe, couldn't find outlet Invasive Species? Medium Type: Common Buckthorn Debris? No Existing Stabilization? Boulders on slopes (pictured) Success: Yes

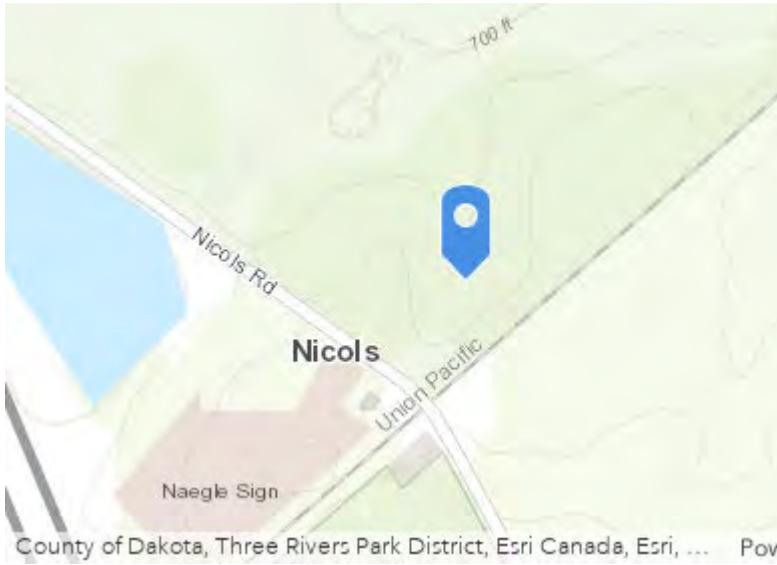
GULLY ID: ESPM Site 26

PREVIOUS WAYPOINT ID:	
SURVEY DATE: April 17, 2021 12:47 PM	
LOCATION:	
TYPE OF SITE: Gully	
SITE SUMMARY: Sunny Rain in previous 24 hours: No Along a Road Long: >100' gully. The problem indicators were: None	<p>Gully Head UTM Estimation: 100ftish,</p> <p>Observation Point correction, if applicable:</p> <p>Connections to other points, if applicable: No</p>
GULLY INFORMATION	
EROSION POTENTIAL:	Low
GULLY DEPTH:	Shallow: <3'
BOTTOM WIDTH:	Medium: 1'-5'
TOP WIDTH:	Narrow: 1'-5'
BANK CONDITION:	Heavy Vegetation
BOTTOM CONDITION:	Bare Soil, Heavy Vegetation
CHANNEL SLOPE:	Flat
GULLY SHAPE:	U-shaped
GULLY MATERIAL:	Sand
WATER LEVELS	Low, Slow
SEEP	No
APPARENT CAUSES:	None/Unknown
ADDITIONAL NOTES:	
Invasive Species? None Type: None	
Debris? No	
Existing Stabilization? NONE Success: N/A

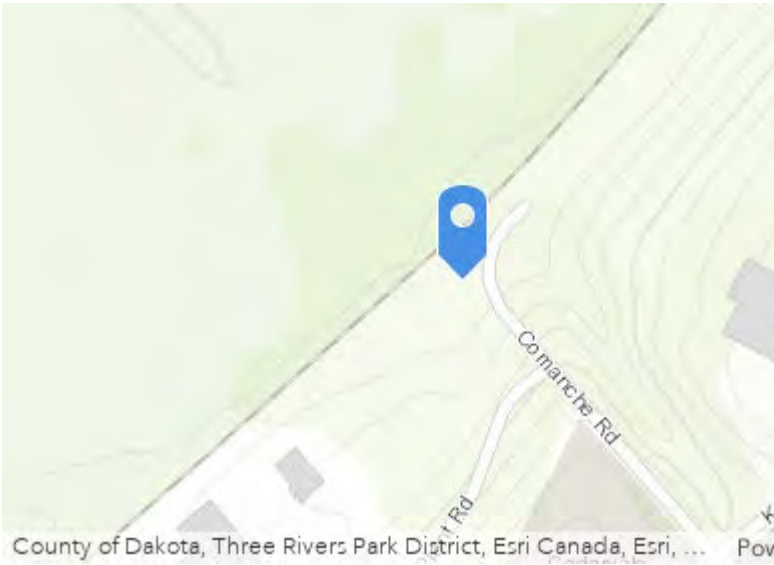
GULLY ID: ESPM Site 28

PREVIOUS WAYPOINT ID:	
SURVEY DATE: April 17, 2021 12:18 PM	
LOCATION:	
TYPE OF SITE: Gully	
SITE SUMMARY: Sunny Rain in previous 24 hours: No Along a Road Long: >100' gully. The problem indicators were: None	<p>Gully Head UTM Estimation: 100ft,</p> <p>Observation Point correction, if applicable:</p> <p>Connections to other points, if applicable: We had two locations which are the same gully</p>
GULLY INFORMATION	
EROSION POTENTIAL:	Low
GULLY DEPTH:	Shallow: <3'
BOTTOM WIDTH:	Medium: 1'-5'
TOP WIDTH:	Wide: >10'
BANK CONDITION:	Heavy Vegetation
BOTTOM CONDITION:	Armored
CHANNEL SLOPE:	Flat
GULLY SHAPE:	U-shaped
GULLY MATERIAL:	Gravel/cobble/ boulders
WATER LEVELS	None, N/A
SEEP	No
APPARENT CAUSES:	None/Unknown
ADDITIONAL NOTES:	
<p>Part of the stormwater drainage system, looks like it receives heavy flow during storm events but it's in great shape. Gully empties into wetland where it joins wastewater treatment outflow.</p> <p>Invasive Species? Low</p> <p>Type: Common Buckthorn</p> <p>Debris? Not much trash, some</p> <p>Existing Stabilization? Rip rap with energy dissipation Boulder piles (pictured) also one erosion control log</p> <p>Success: Yes</p>

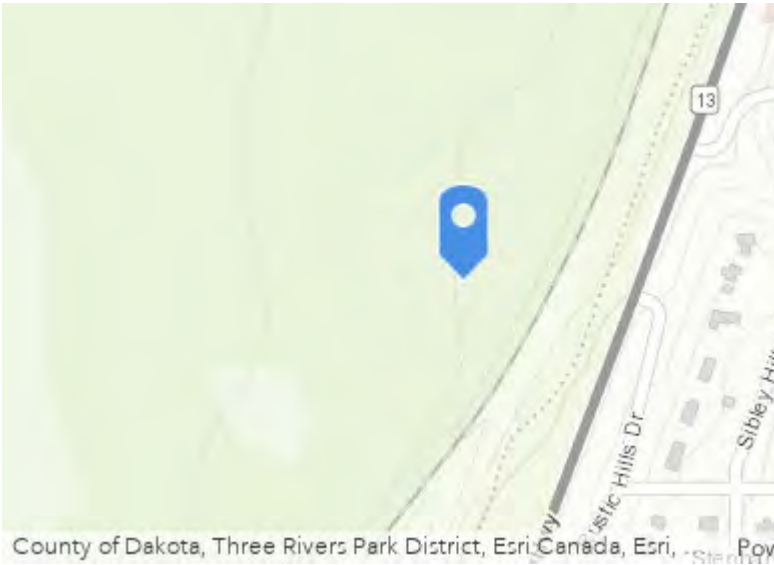
GULLY ID: ESPM Site 29

PREVIOUS WAYPOINT ID:	
SURVEY DATE: April 17, 2021 11:06 AM	
LOCATION:	
TYPE OF SITE: Gully	
SITE SUMMARY: Sunny Rain in previous 24 hours: No Off of Walking Trail Short: <50' gully. The problem indicators were: None	
GULLY INFORMATION	
EROSION POTENTIAL:	Low
GULLY DEPTH:	Shallow: <3'
BOTTOM WIDTH:	N/A - Not Visible
TOP WIDTH:	Narrow: 1'-5'
BANK CONDITION:	Heavy Vegetation
BOTTOM CONDITION:	Heavy Vegetation
CHANNEL SLOPE:	Flat
GULLY SHAPE:	
GULLY MATERIAL:	Sand
WATER LEVELS	None, N/A
SEEP	No
APPARENT CAUSES:	None/Unknown
ADDITIONAL NOTES: No gully present Invasive Species? Low Type: Common Buckthorn Debris? None Existing Stabilization? Heavy vegetation, no gully presents Success: N/A, Unknown
