Gully ID: 07:19-11:55	MAP

Date & Time: July 19, 2021 11:55 AM	
Location: Savage	
Weather: Sunny Storm/Rainfall Event in the Past 24 Hours? No	
GULLY INFORMATION	
Calculated Erosion Potential:	High
Approximate Depth:	5-Deep (>15')
Approximate Bottom Width:	5-Narrow/V-Ditch
Approximate Gully Length:	5-Long (>100')
Condition of Gully Bottom:	5-Bare Soil
Condition of Gully Banks:	3-Some Vegetation
Gully Bank Angles:	5-Acute (<45 degrees or undercut)
Gully Shape:	5-V-Shaped
Gully Material:	Silt/Clay

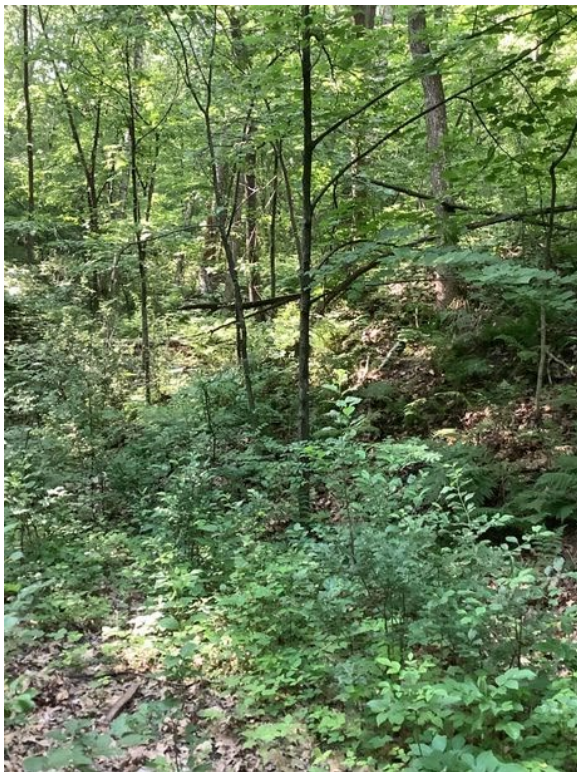
Photo1

Seep:	No	
Stormwater Inputs:	0-Not present	
Fallen Trees:	Yes	
Degradation:	3-Moderate	
Aggradation:	1-Low	
Slumping:	1-Low	
Additional Notes:	Classification? Moderate (x - x) Notes/Comments: Long gully with vegetation on banks and bottom. A few fallen trees throughout, but not much slumping.

Upstream view of left bank.

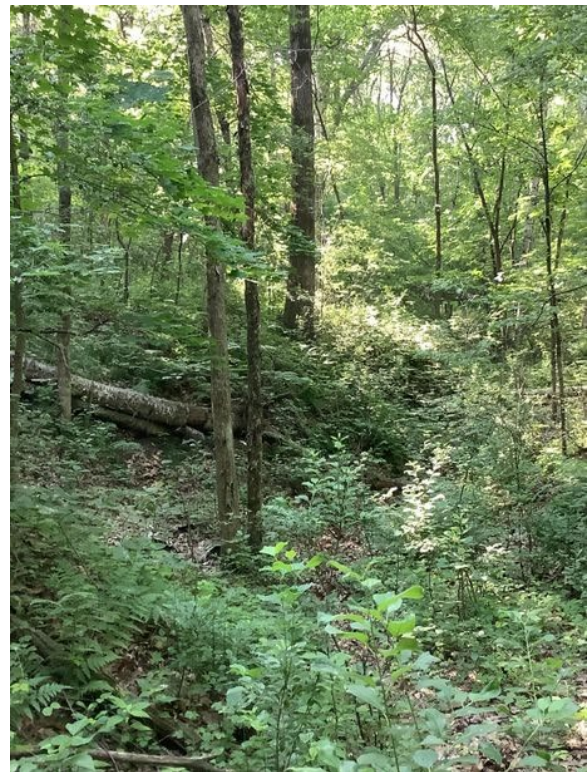
Photo2

Upstream view of right bank .
