2021 GULLY INVENTORY AND CONDITION ASSESSMENT, VOLUME 2

July 15, 2022

Lower Minnesota River Watershed District
112 E. 5th Street, #102
Chaska, MN 55318

Young Environmental Consulting Group, LLC
6040 Earle Brown Drive, Suite 306
Brooklyn Center, MN 55430

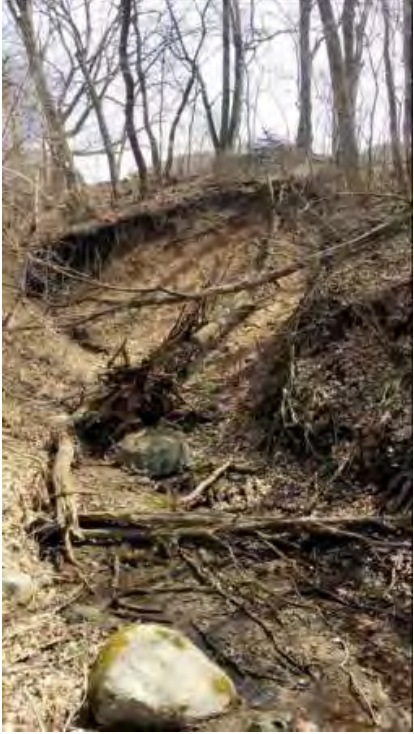
Name and Location	Concerns, Management Category, and Recommendations	
<p>Site 3 (Gully 07:21-11:37)</p> <p>10550 McCool Court</p>	<p>Concerns: Private irrigation and groundwater springs were destabilizing the slope on a private residential property. Spring flows were also observed to be contributing to erosion.</p> <p>Management Category: Management required</p> <p>Recommendations: Stabilize the gully with fill and riprap; encourage the landowner to extend downspouts and drainpipes to the toe of slopes, and provide energy dissipation at these outlets to prevent further erosion (i.e., private irrigation management). Increase vegetation and add boulders around the spring to slow flows. In severe cases the report recommended installing dry wells or a vegetated swale to collect water and increase permeability in the soil.</p>

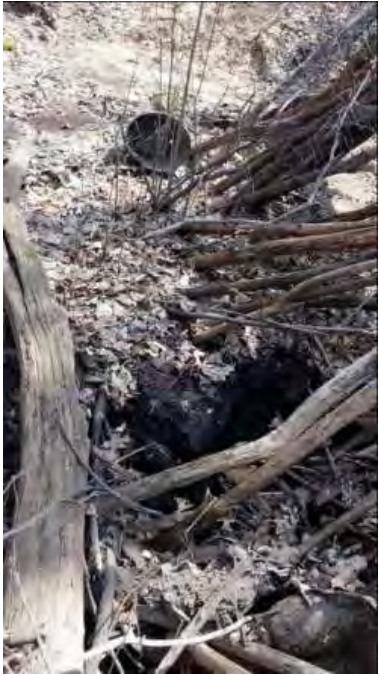
<p>Site 4 (Gully 08:11-10:27)</p> <p>10640 McCool Court</p>	<p>Concerns: Private irrigation was destabilizing the slope on a residential property.</p> <p>Management Category: Management required</p> <p>Recommendations: Stabilize the gully with fill, turf reinforcement mat, and vegetation in addition to private irrigation management.</p>

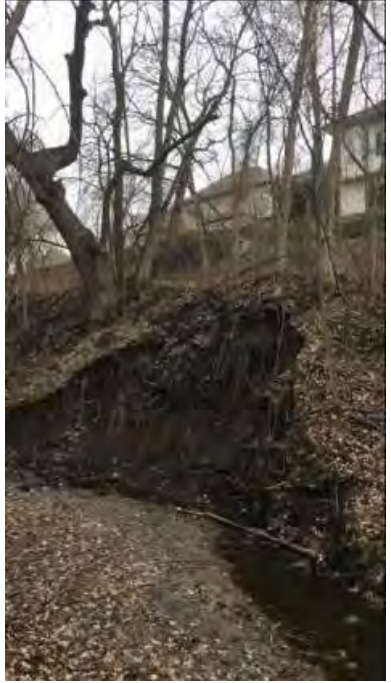
Name and Location	Concerns, Management Category, and Recommendations	
<p>Site 7 (Gully 06:08-11:05)</p> <p>10700 Cambridge Court</p>	<p>Concerns: Failing and eroded slope on private residential property caused by inadequate storm drainage was threatening the municipal storm sewer and private property.</p> <p>Management Category: Management required</p> <p>Recommendations: Stabilize the gully with fill, geotextile fabric, and riprap; correct private irrigation management and work to divert gully flows from the eroded bank.</p>

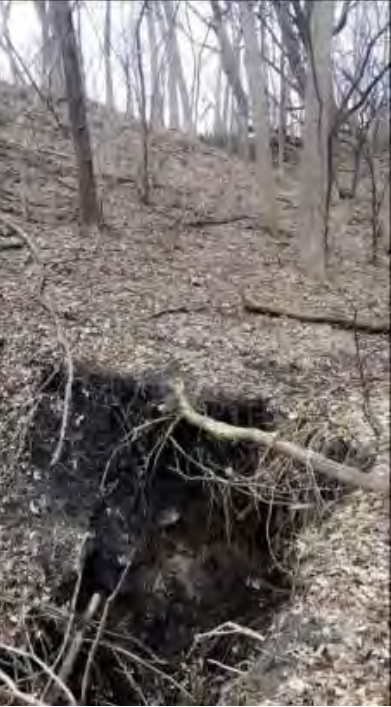
<p>Site 8 (Gully 06:08-11:03)</p> <p>10700 Cambridge Court</p>	<p>Concerns: Failing and eroded slope on private residential property caused by inadequate storm drainage was threatening municipal storm sewer and private property.</p> <p>Management Category: Management required</p> <p>Recommendations: Stabilize the gully with fill, geotextile fabric, and riprap; encourage landowner to extend downspouts and drainpipes to toes of slopes and provide energy dissipation at outlets; divert gully flows from the eroded bank.</p>

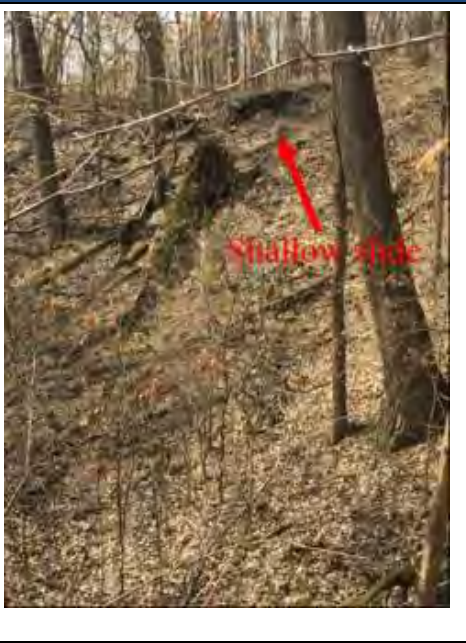
Name and Location	Concerns, Management Category, and Recommendations	
<p>Burnsville Sites 23 (Unable to be accessed) CenterPoint Energy Facility</p>	<p>Concerns: Landslide on CenterPoint Energy property</p> <p>Management Category: Management required</p> <p>Recommendations: Vegetation establishment and private irrigation management</p>

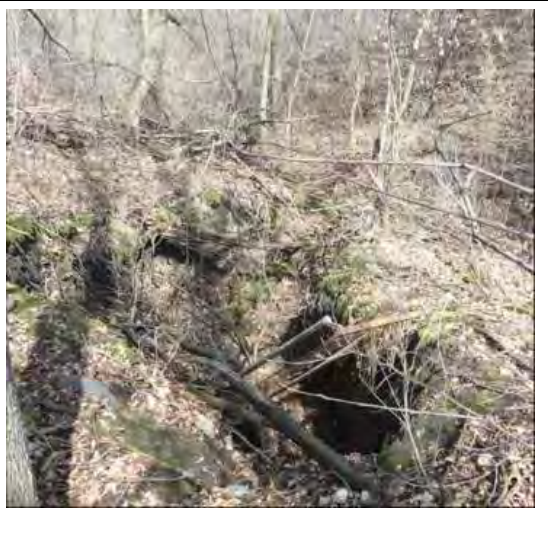
<p>Burnsville Site 27 (Unable to access) CenterPoint Energy Facility</p>	<p>Concerns: Gully on CenterPoint Energy property</p> <p>Management Category: Management required</p> <p>Recommendations: Vegetation establishment and private irrigation management.</p>

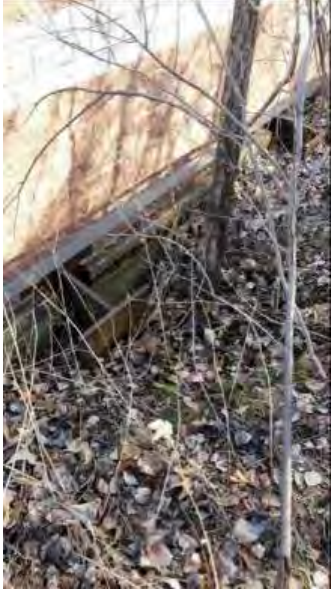
Name and Location	Concerns, Management Category, and Recommendations	
<p>Site 32 (Gully 06:29-01:23)</p> <p>401 Cliff Road</p>	<p>Concerns: Retaining wall stress because of poor drainage and ground subsidence could impact infrastructure.</p> <p>Management Category: Management required</p> <p>Recommendations: Encourage landowner to install drainage behind retaining wall; monitor for additional erosion after 2.8 inches or more of rainfall within 24 hours.</p>

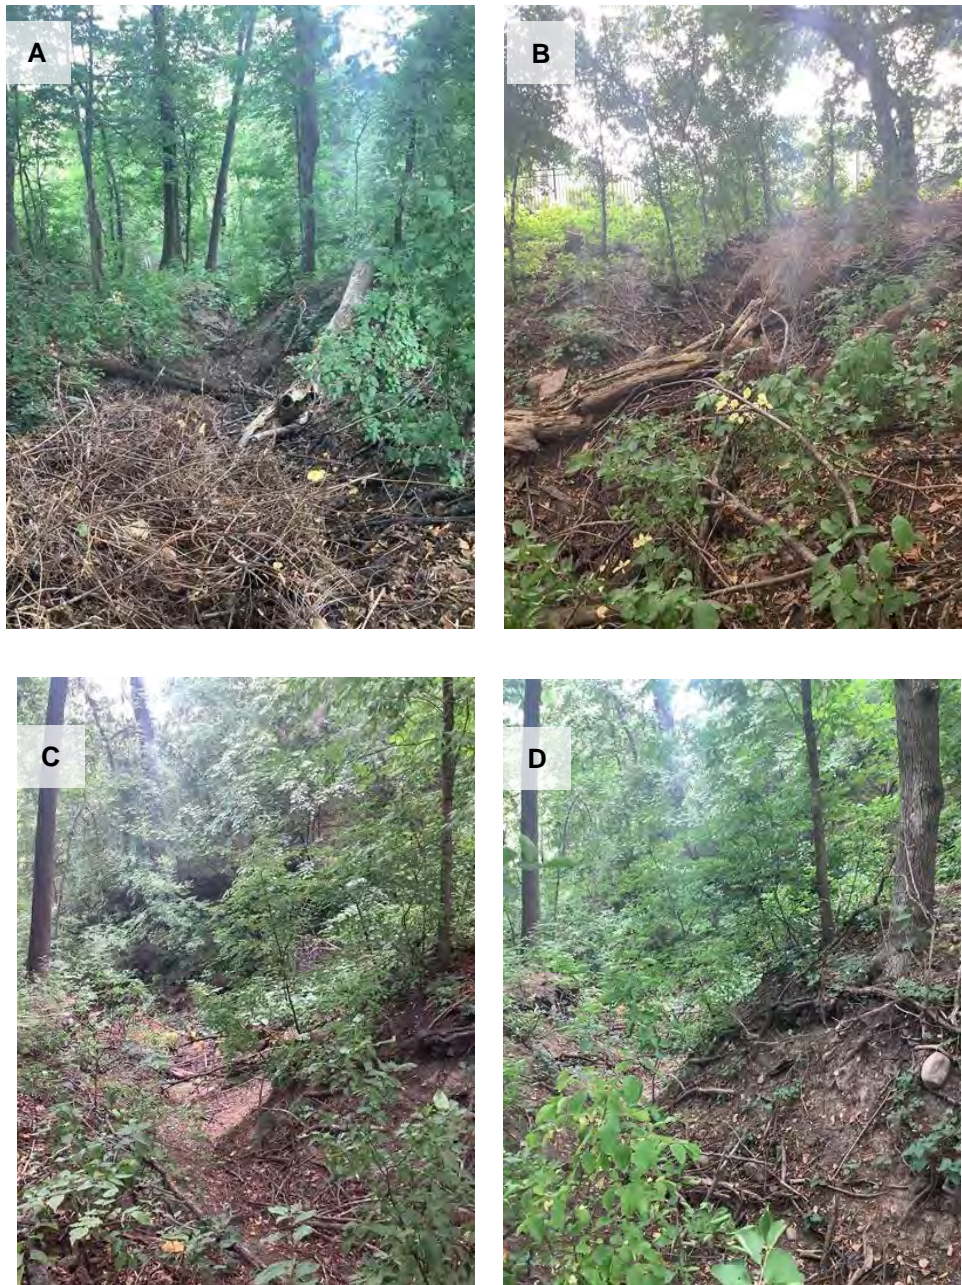
Figure 13: Photos of Gully 07:21–11:44 A) Downstream view from top of gully, B) Upstream view of headcut, C) Downstream view of confluence with Gully 07:21–11:43, D) Downstream view of right bank

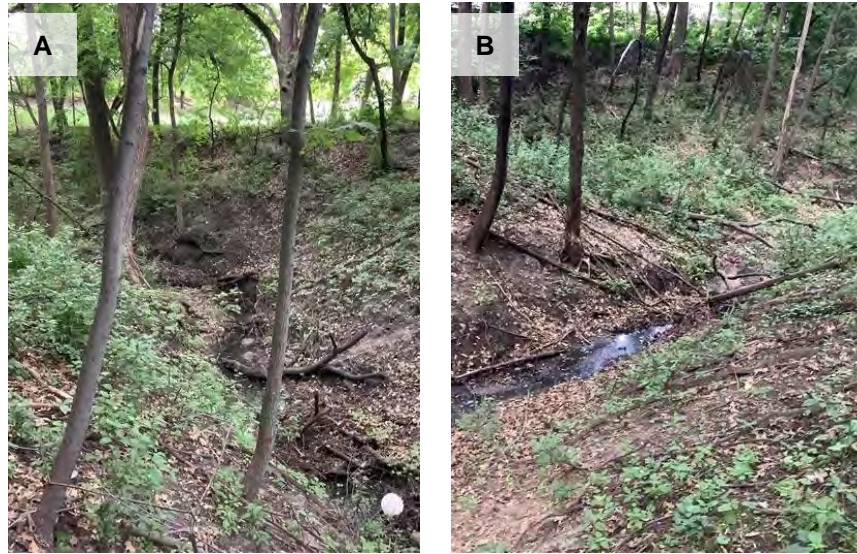
This site was located at the west end of Cedarbridge Park in Burnsville. This was a very large gully with a constant flow of water at the bottom. The bottom of the gully had no vegetation although each bank had a moderate amount (Figure 16). The bank angles were about 45°, and the gully took a general V-shape. There was severe degradation on the banks of the gully along with moderate slumping of the banks. Additionally, there were many pistol-butted trees, indicating a slowly progressing slope failure. This site scored a 37 for erosion potential, placing it in the moderate erosion category; however, when combined with the Tier 1 impact zone, this gully is classified as a high-risk site.

Figure 16: Photos of Gully 06:08-13:18 A) Upstream view of gully, B) Downstream view of gully

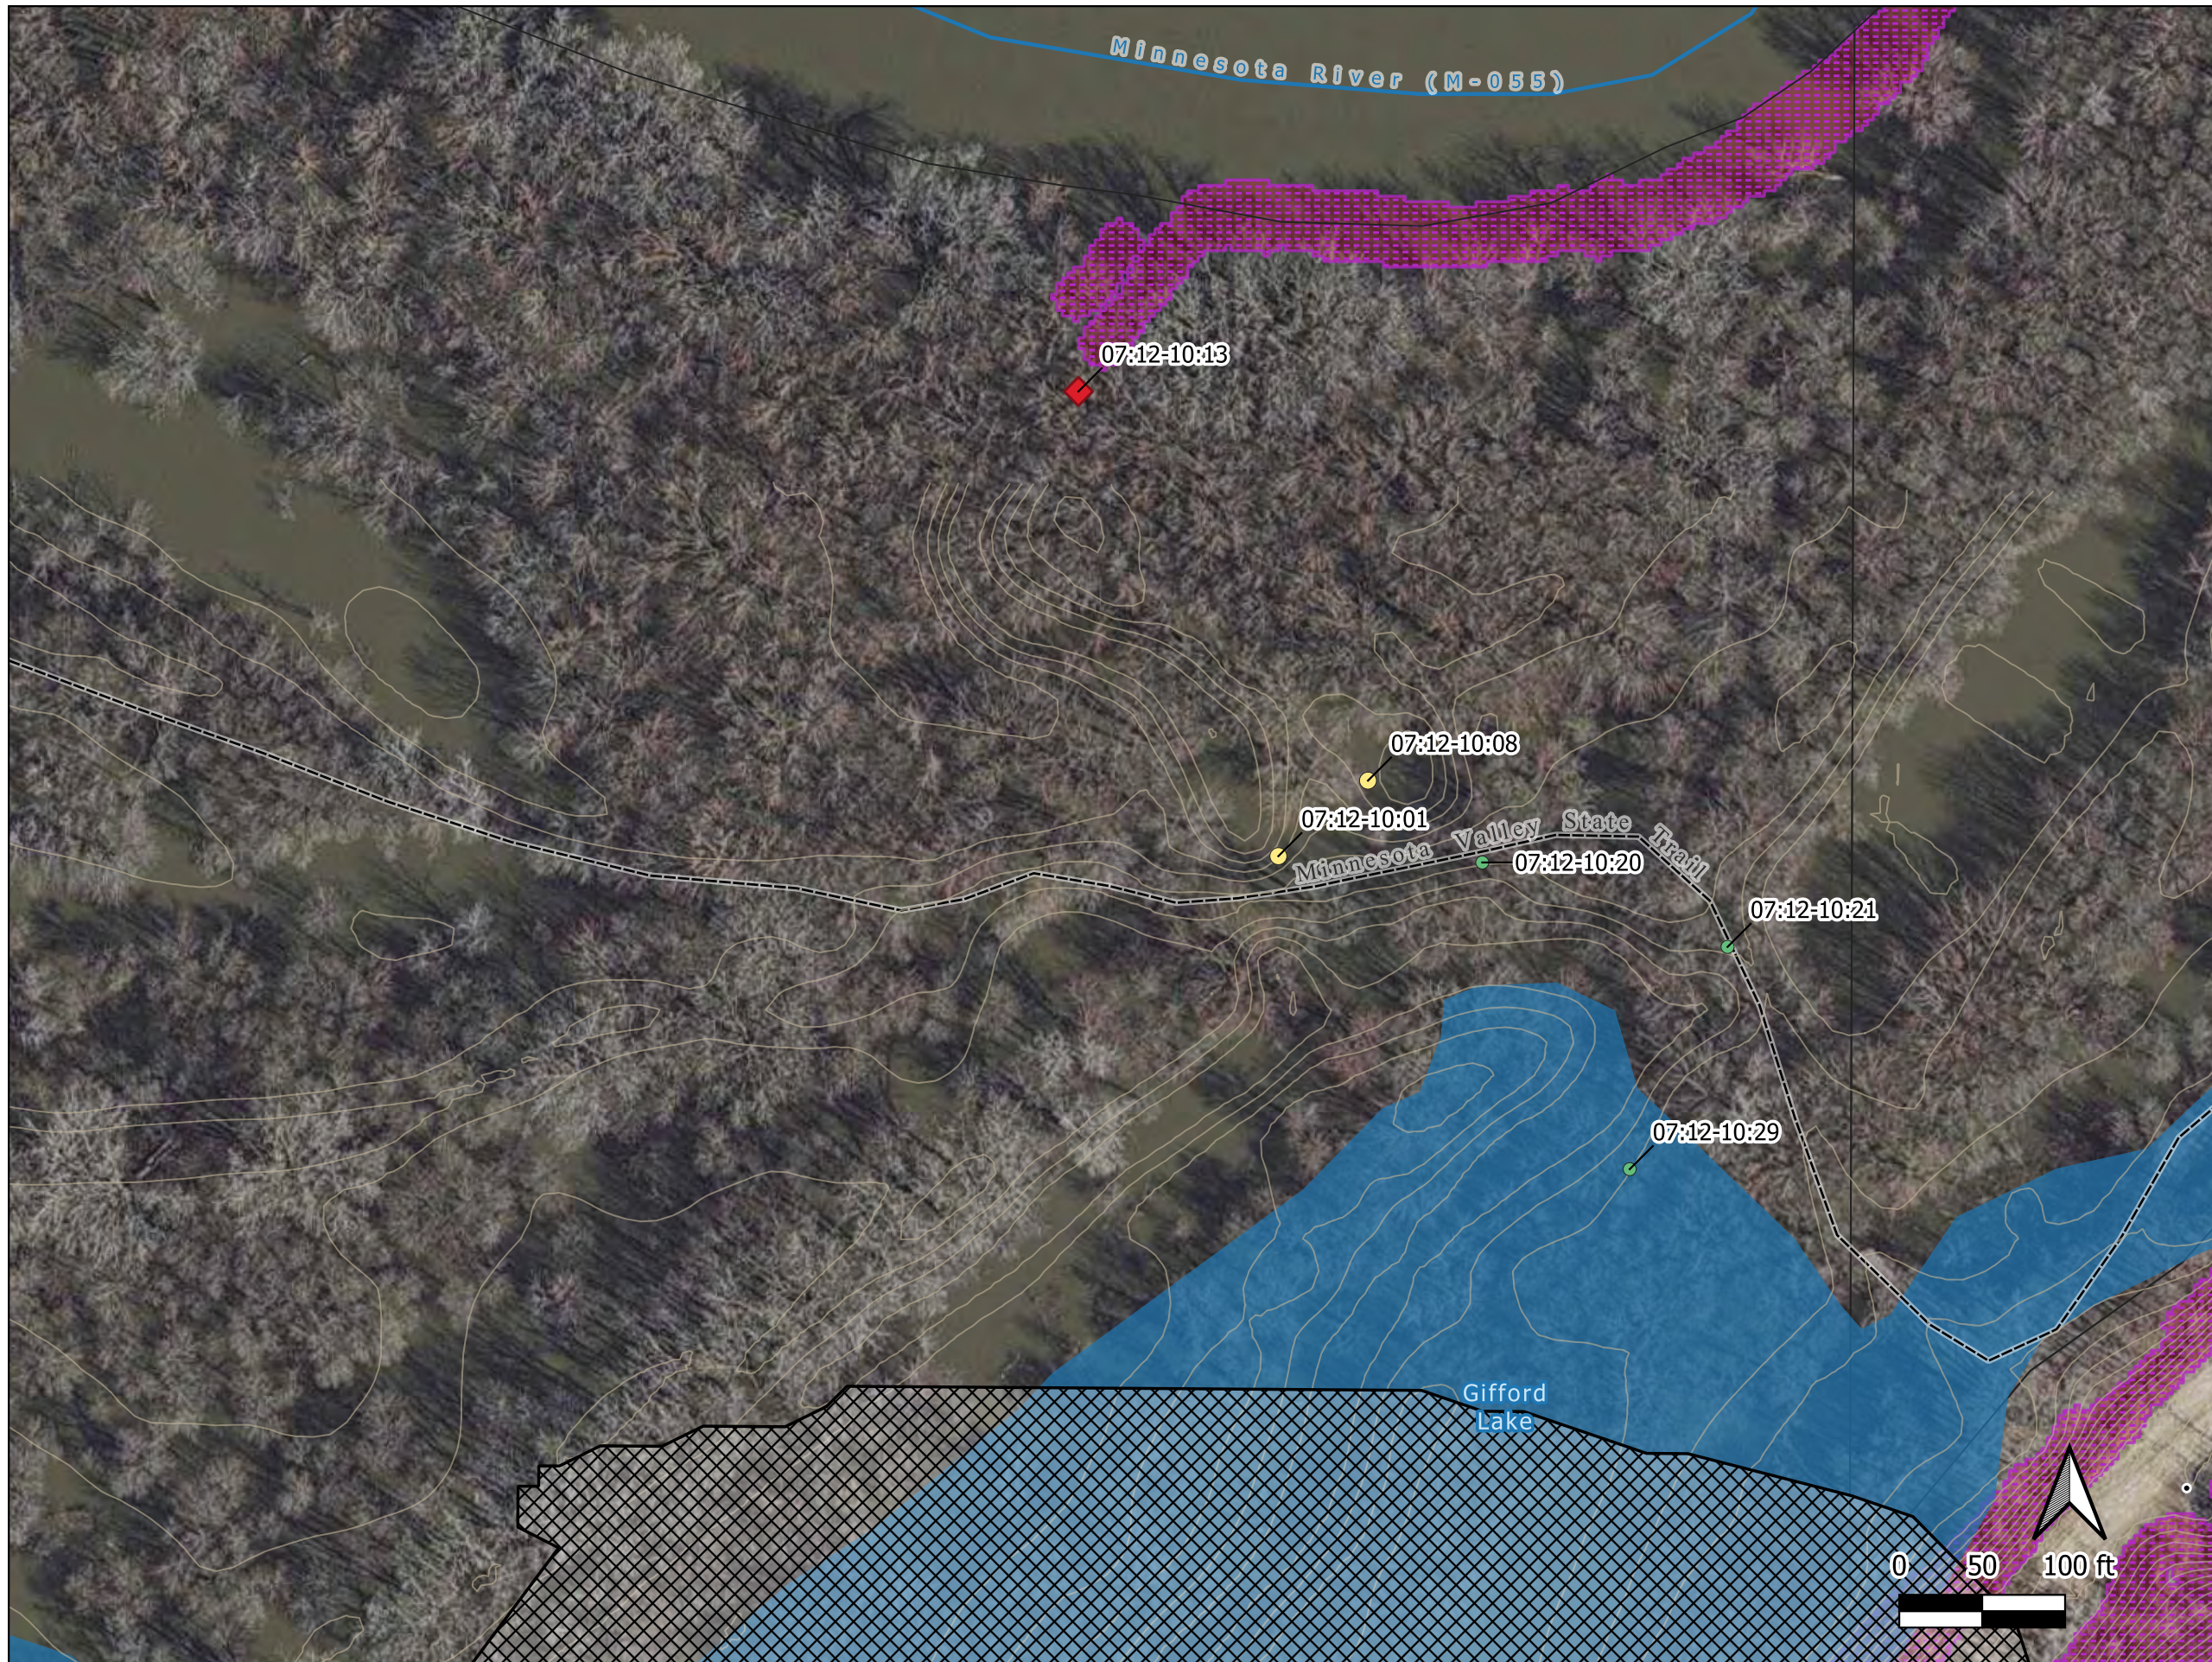
The only high-risk gully in Jackson Township found in 2021 was Gully 07:12–10:13, located downstream of Gully 07:12–10:01 (Figure 31). A moderate erosion potential and medium-risk gully, it drains directly into the Minnesota River. This gully was long and deep with a small stream of stagnant water (Figure 32). The bottom and banks both had some vegetation and were made of silt and clay. The degradation was significant, causing slumping banks and trees leaning over the channel.

Jackson Township only contained one gully that was in the very-high risk category. However, it is located near the Minnesota River and may have only been observed this year because of low river levels. Rather than recommend mitigation, future monitoring should occur during higher river levels to determine whether this site is in fact a gully and not a backwater channel to the Minnesota River. Additionally, the inaccessible areas should be surveyed in the future to determine whether gullies are present.

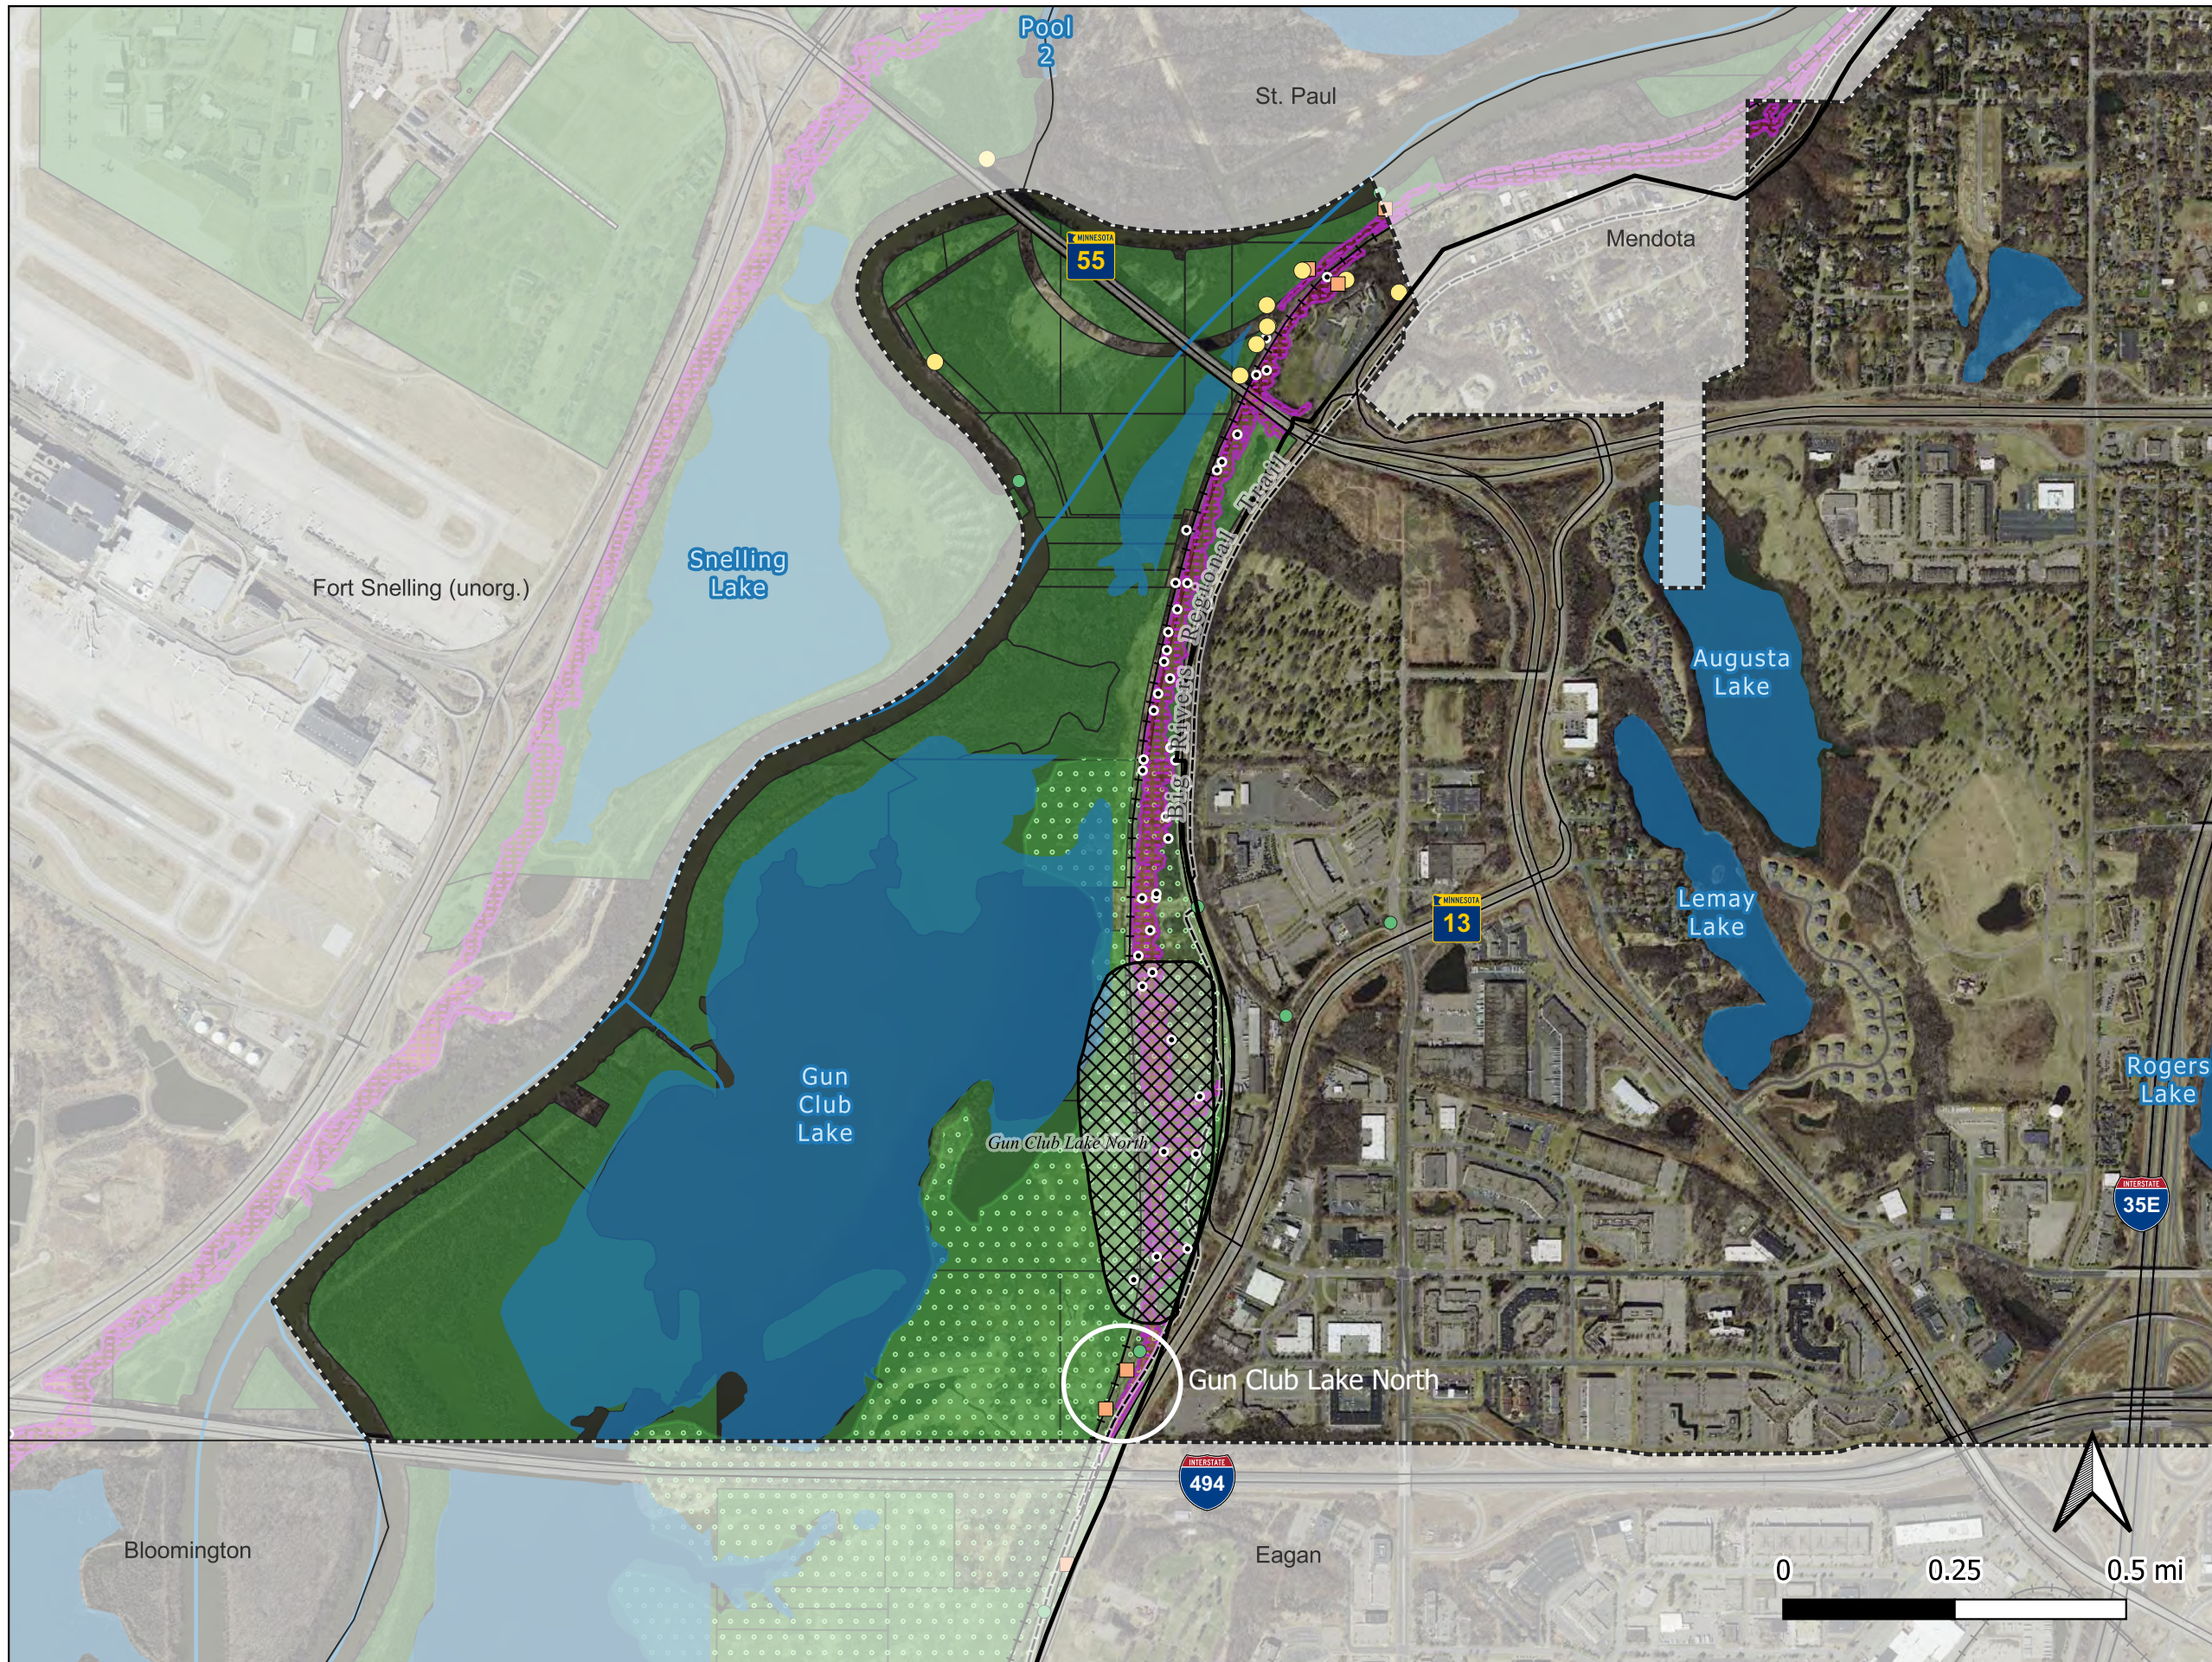
Figure 33: Mendota Heights Gullies

The 2021 work identified an additional 19 potential sites earmarked for a survey in 2021 (Figure 33). The survey in Mendota Heights focused on the areas not covered by the 2020 survey, but few additional sites were found. Of the identified potential gully locations, the field team collected data on 21 gullies in addition to several areas that could not be accessed (Figure 33). The Big Rivers Regional Trail construction impeded access to the trail and surrounding land from the Big Rivers Regional Trail parking lot to about 0.5 miles north where the trail crosses Sibley Memorial Highway. The project is expected to run through December 2021. It is recommended that this area be assessed once construction is complete to confirm that the gullies identified by desktop analysis exist, especially because of the proximity to Gun Club Lake HVRA.

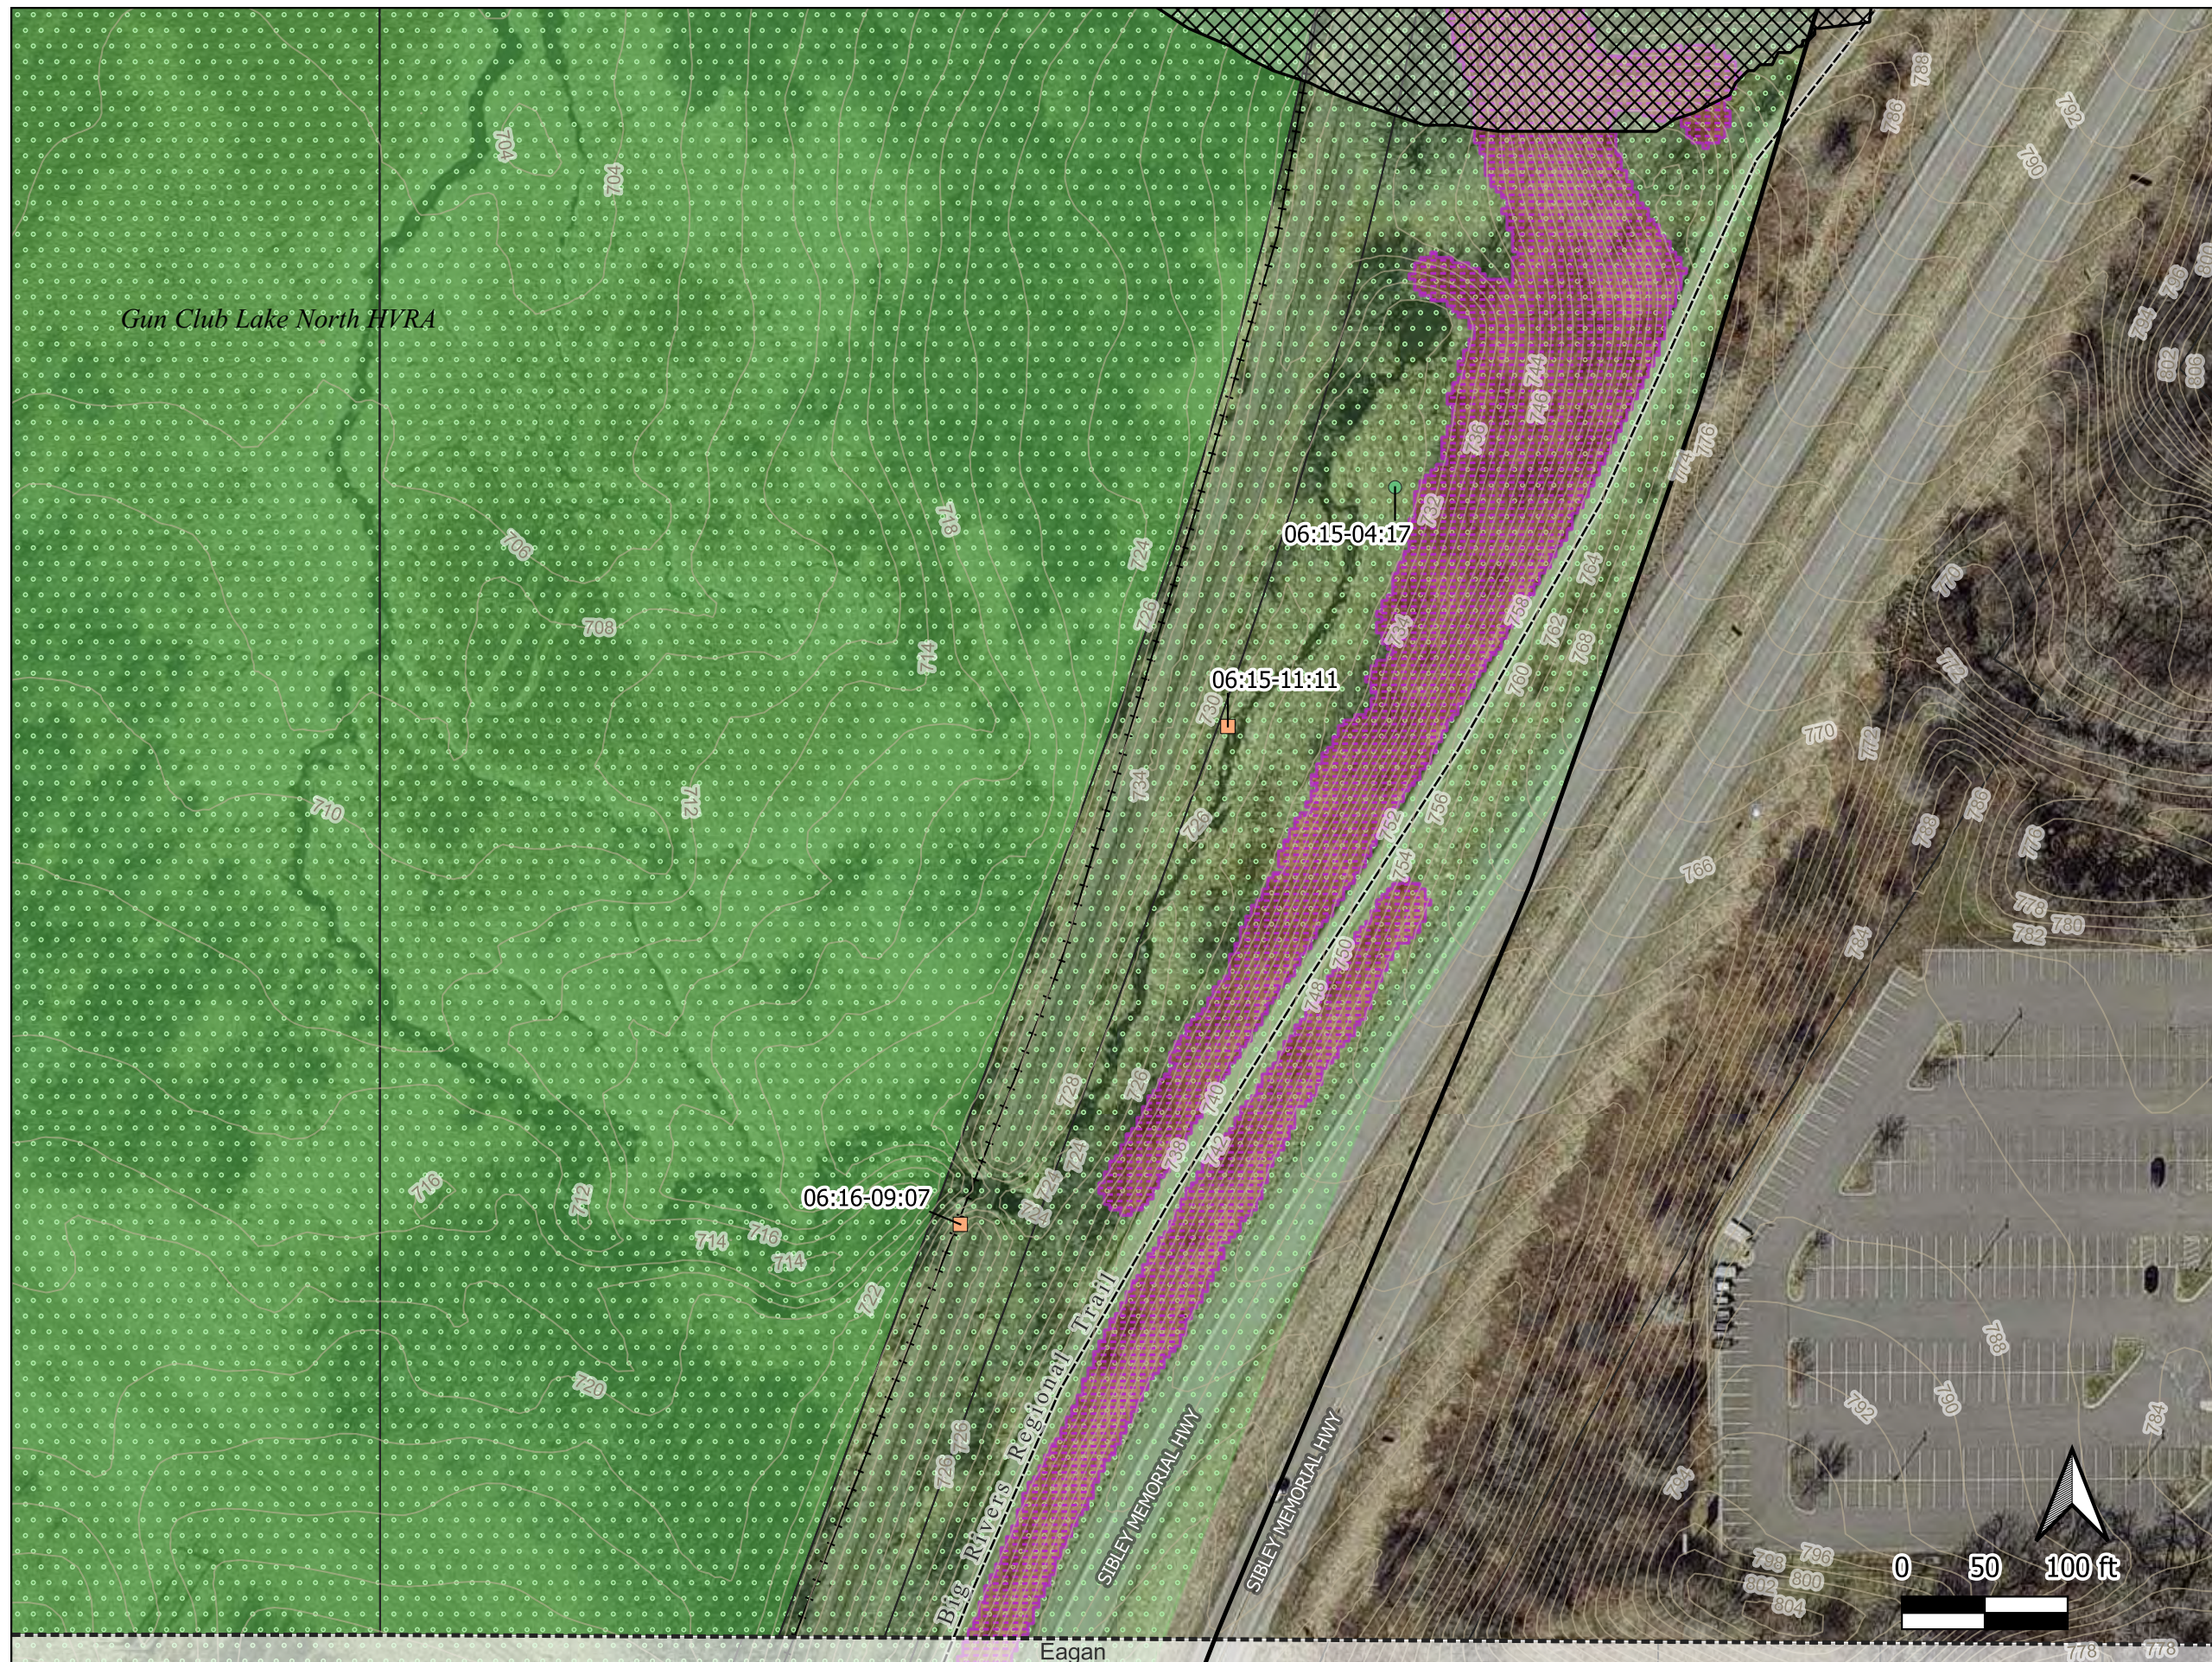
Figure 34: Gun Club Lake North Gullies

Of those locations identified as high-risk, only the sites near Gun Club Lake North warrant further attention at this time because of the potential effects on the calcareous fen (Figure 34).

This area is already under review as part of a stormwater intrusion study for the Gun Club Lake North fen complex. This area has been degraded because of the influx of warmer and more polluted stormwater runoff, which has created a scar on the fen. As part of the 2021 Gully Project, this area was surveyed to establish the current conditions in this gully.

The Gun Club Lake North gullies show evidence of extreme slumping, and the information has been incorporated into the stormwater intrusion study. It is recommended that the Big Rivers Regional Trail area be assessed once construction is complete to confirm whether the gullies identified by desktop analysis exist and to confirm the impact construction may have had on the existing Gun Club Lake North gullies and the gullies that were surveyed in 2020. It is possible that some of these sites may have been fixed during Big River Regional Trail construction; but because of the trail's proximity to Gun Club Lake and waters that connect the Minnesota River, it is crucial that this area be surveyed.

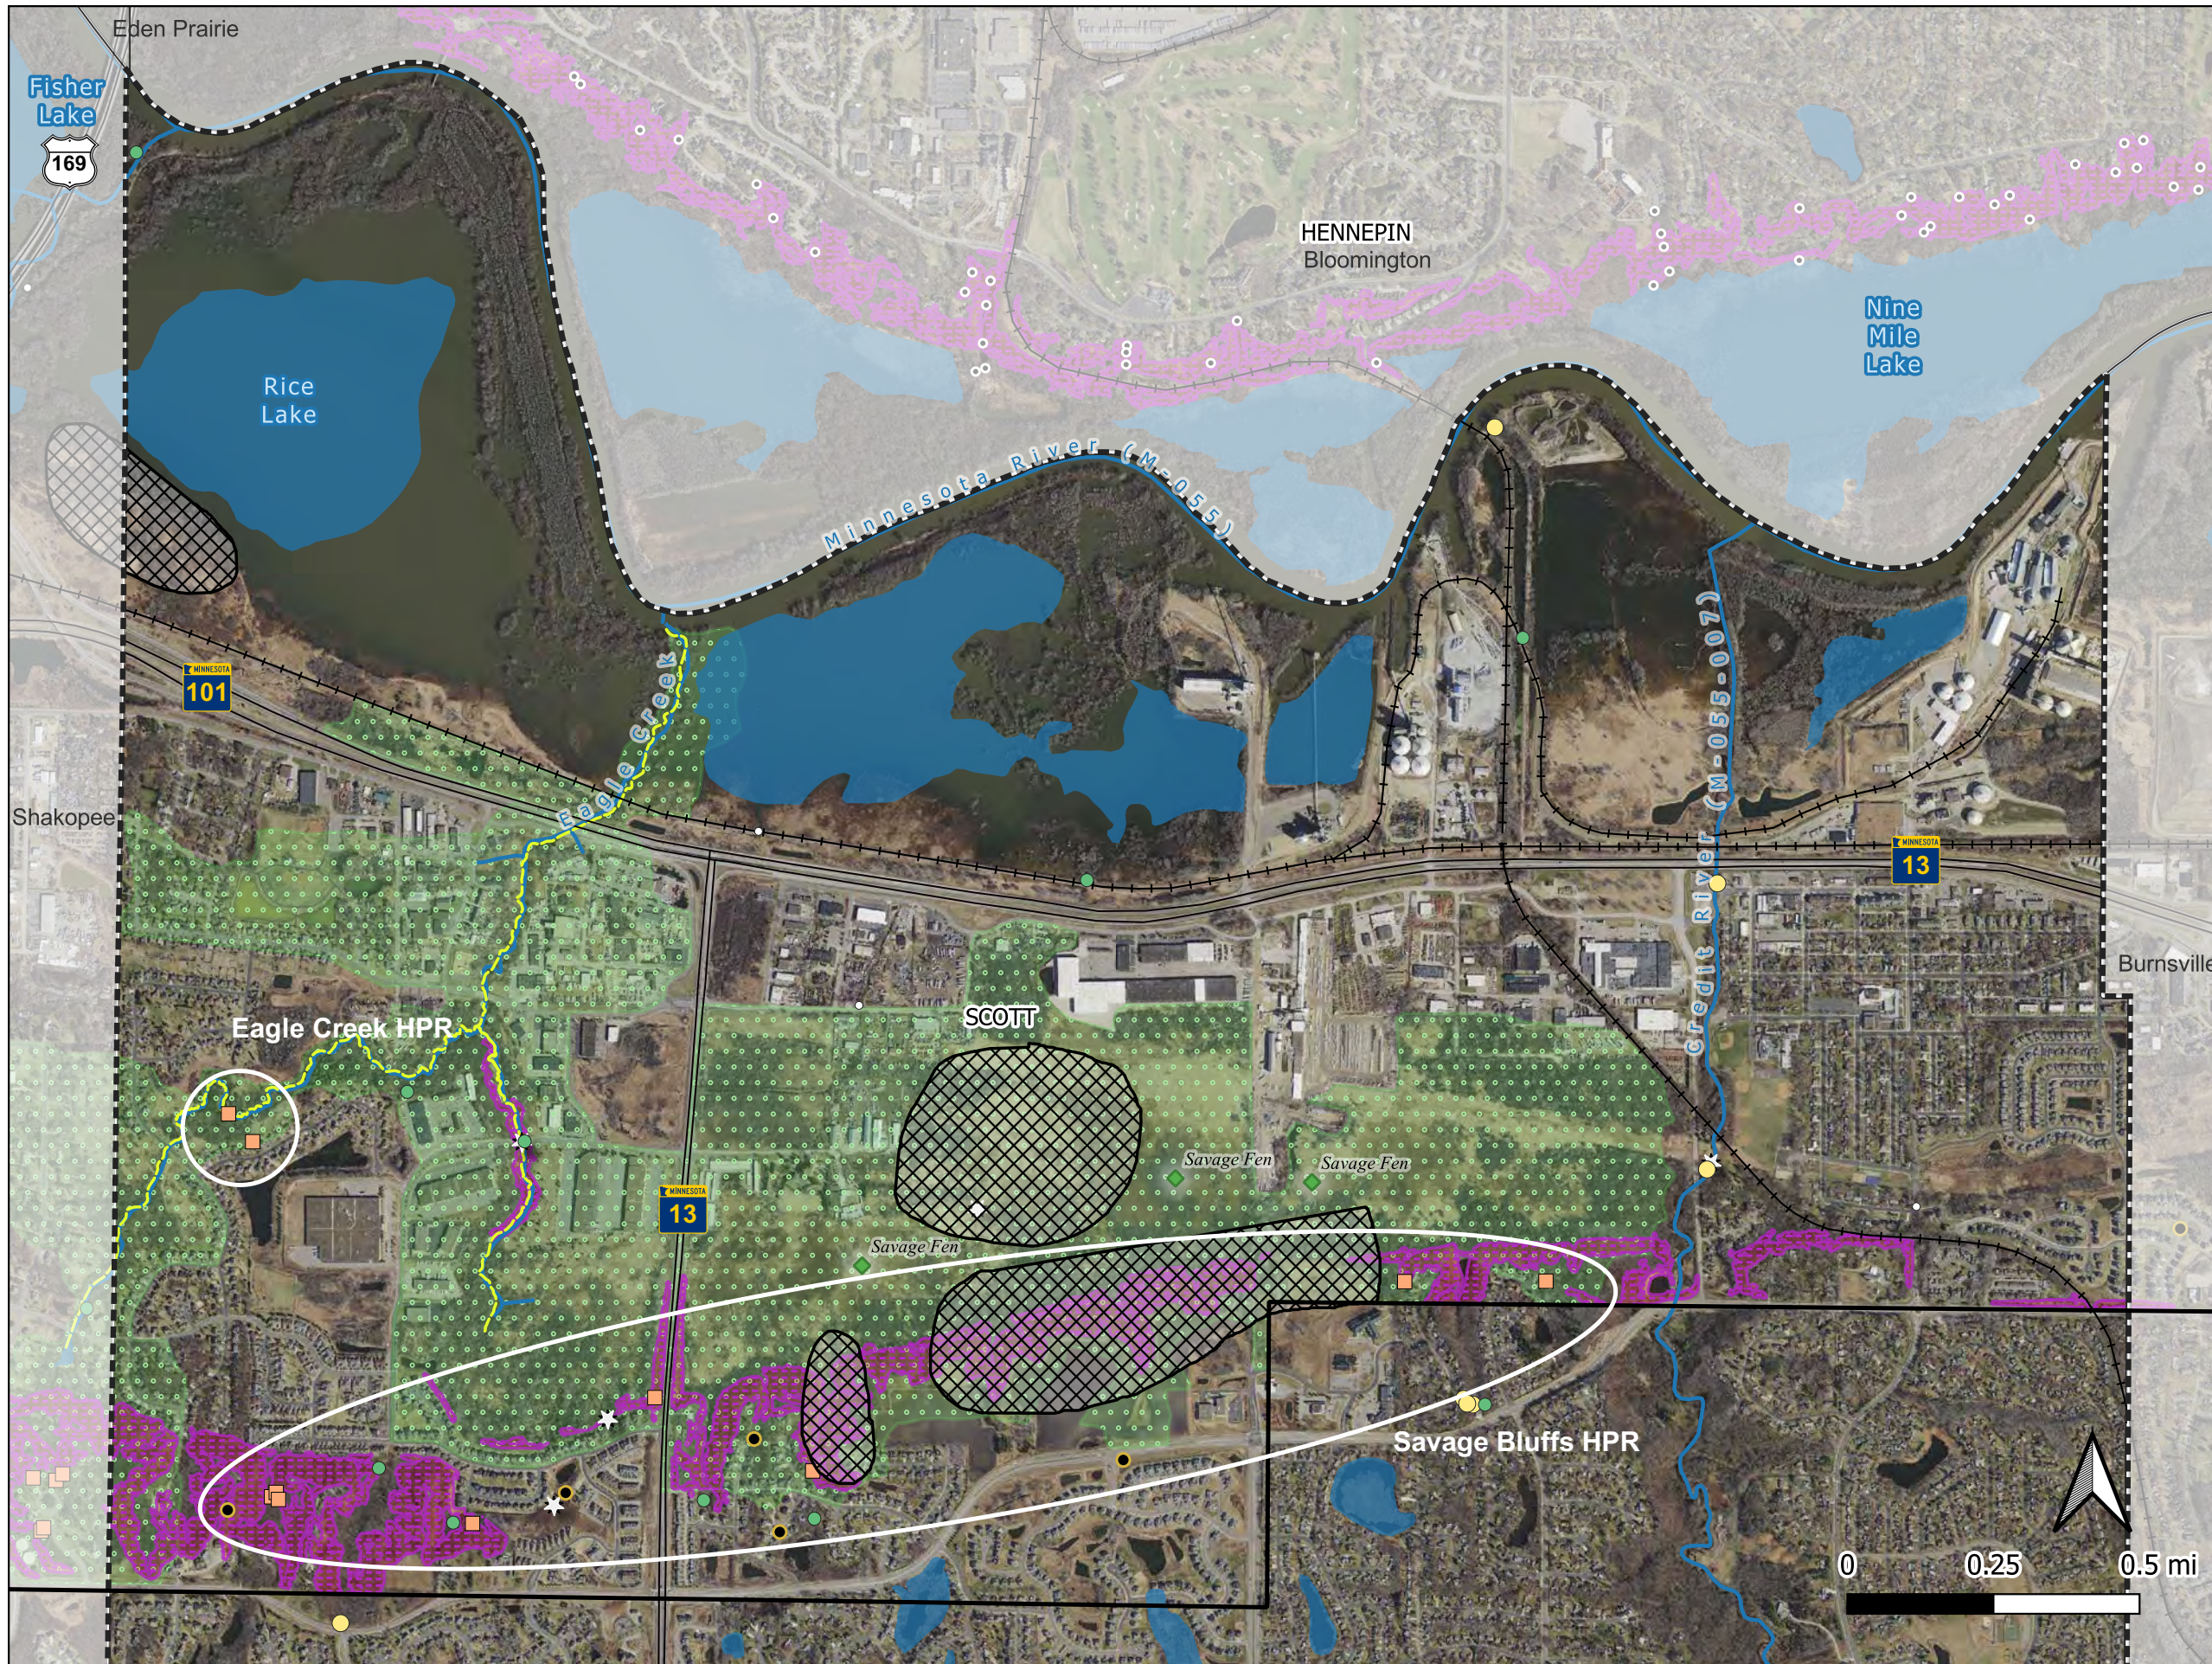
Figure 36: Savage Gullies

There were 40 potential sites identified through the desktop analysis in Savage (Figure 36). Many of these sites were located in the southern part of the LMRWD, just north of McColl Drive, where there are many bluffs and steep slopes. More sites were found along Eagle Creek and along the river.

Of the identified potential gully locations, the field team collected data on 31 gullies in addition to four areas that could not be accessed. The inaccessible locations were either fenced off, guarded by a dog, or inaccessible because of heavy vegetation. There was one large area between Highway 13 and McColl Drive that was almost entirely blocked off by fences or heavy vegetation. Based on the desktop analysis, there were at least five potential sites in this area, so discussions with the owners of the land will be valuable for surveys of this area in the future. Additionally, the field team went to five potential gully sites that were accessible, but no gullies were found.
