2021 GULLY INVENTORY AND CONDITION ASSESSMENT, VOLUME 2

July 15, 2022

Lower Minnesota River Watershed District
112 E. 5th Street, #102
Chaska, MN 55318

Young Environmental Consulting Group, LLC
6040 Earle Brown Drive, Suite 306
Brooklyn Center, MN 55430

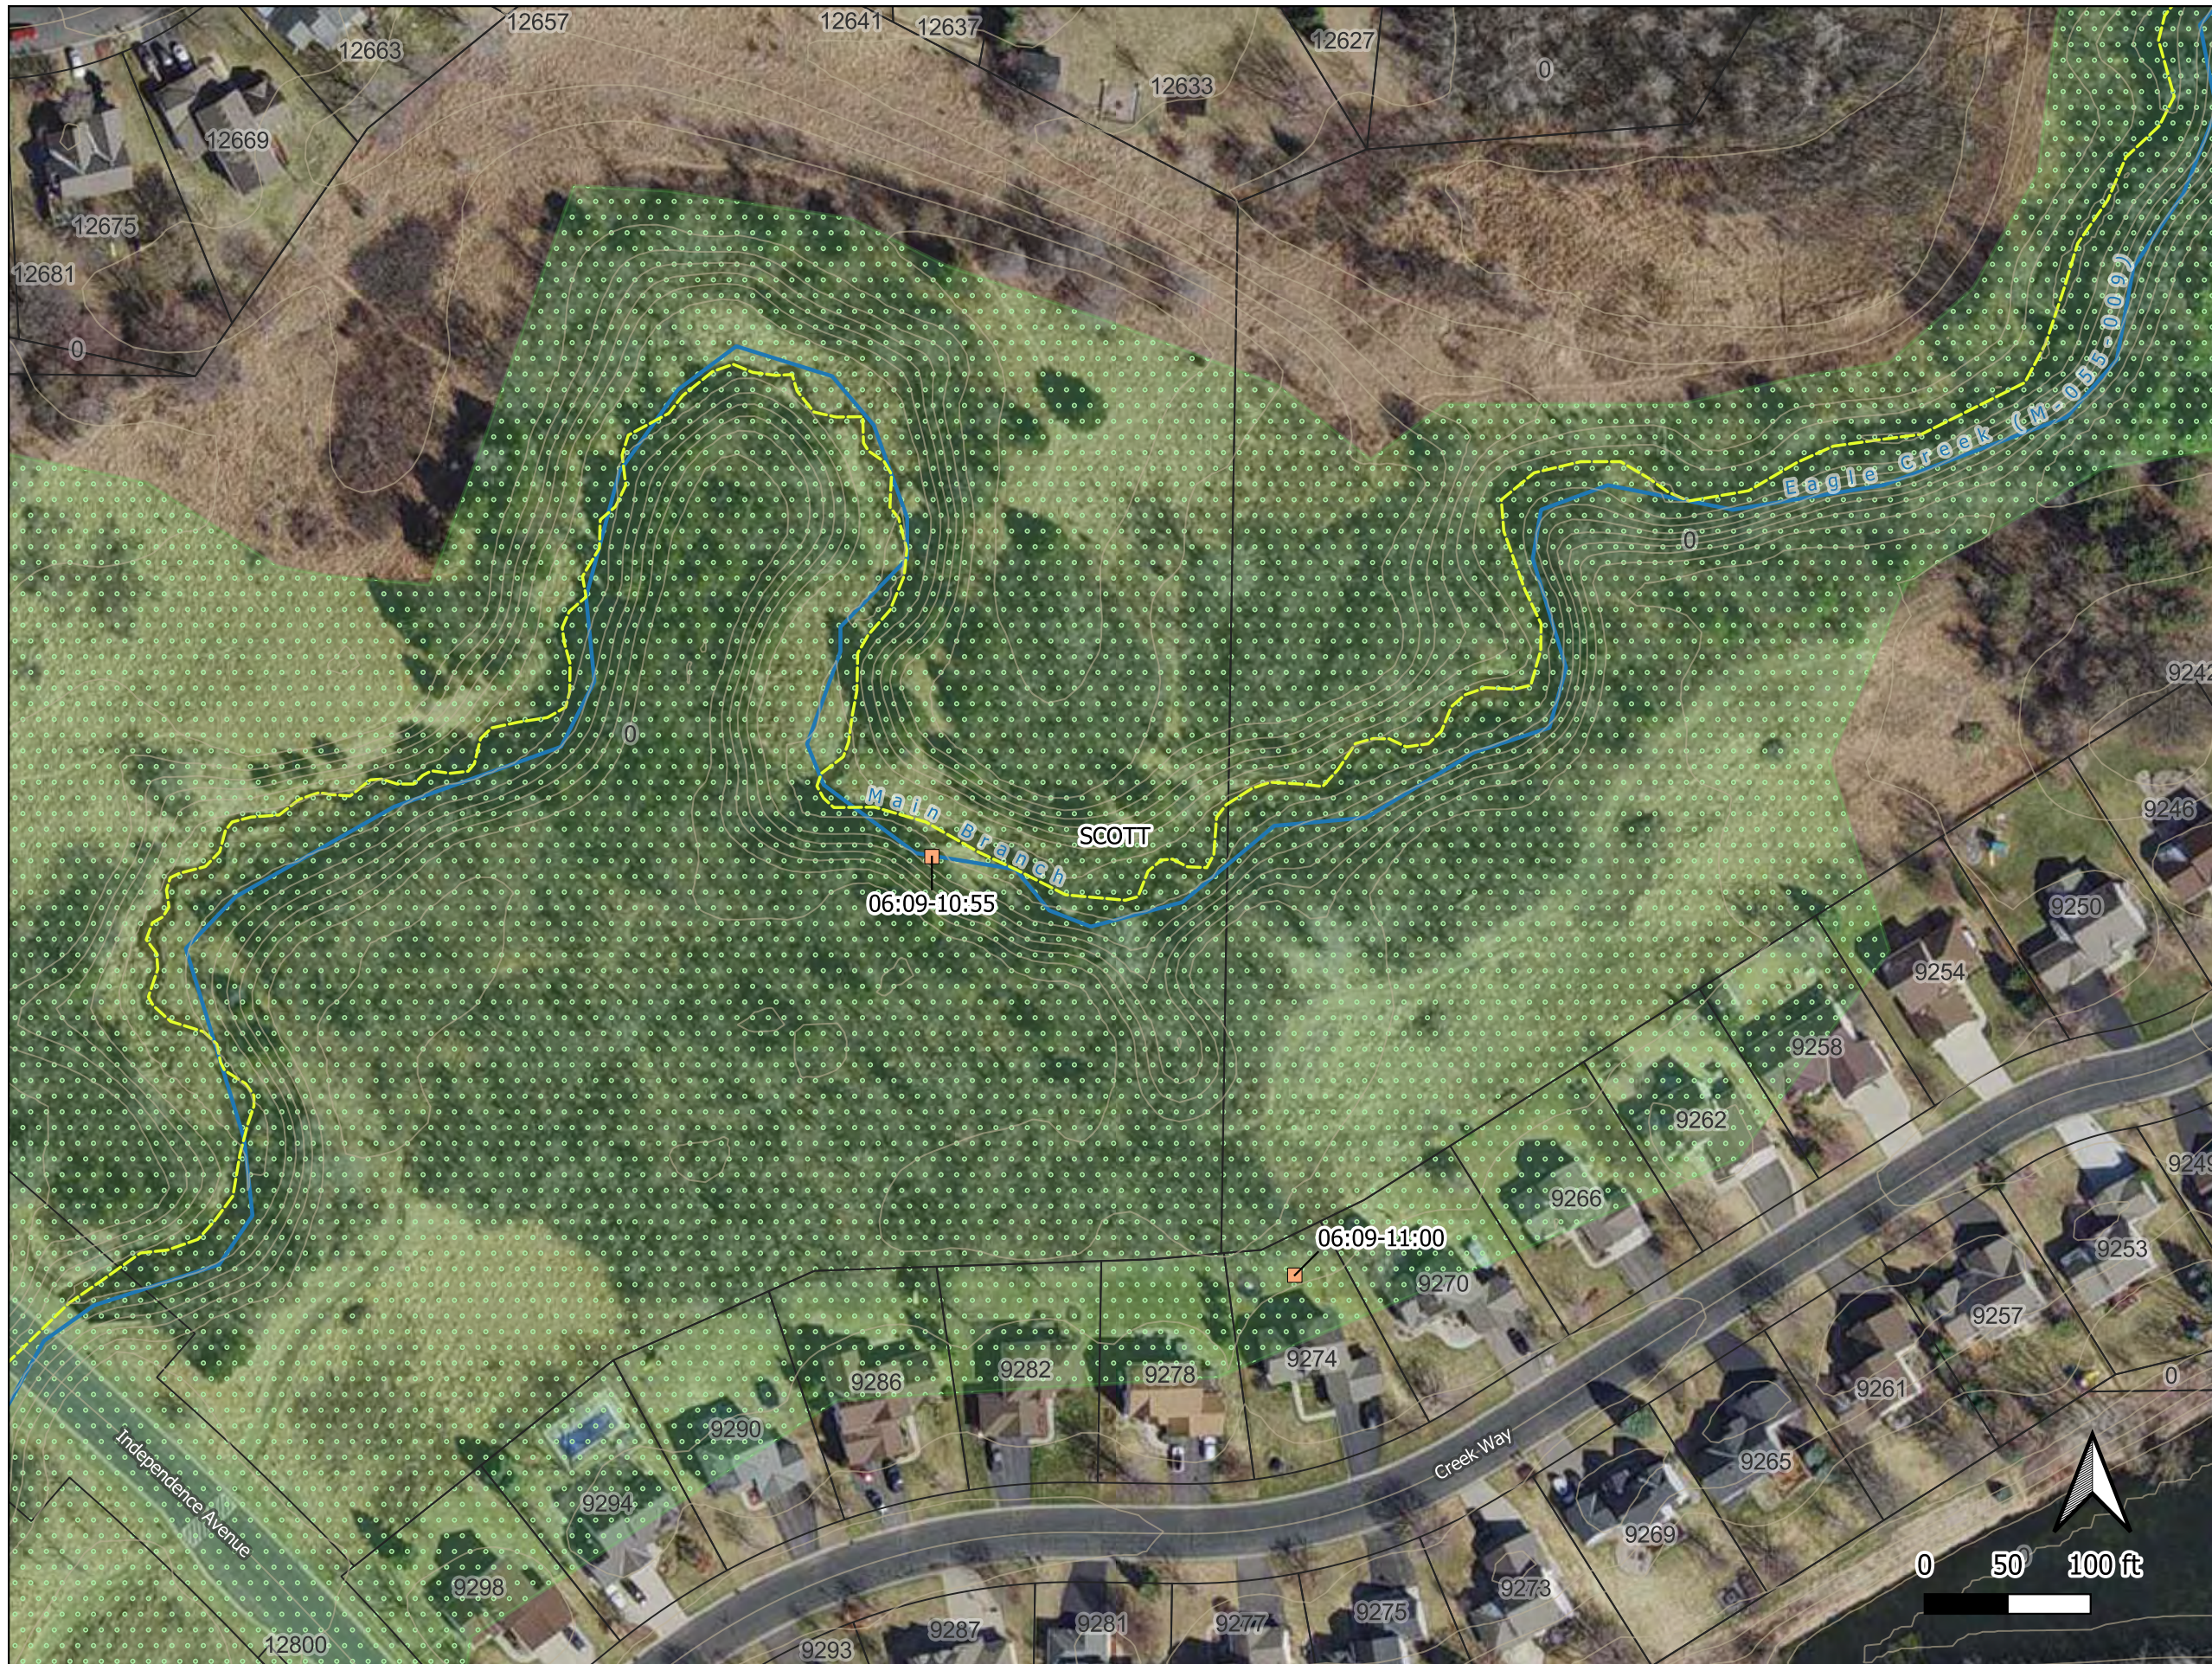
Figure 37: Eagle Creek HPR

This HPR comprises two gullies directly contributing to Eagle Creek, Gully 06:09–10:55 and Gully 06:09–11:00, both shown in Figure 37 and discussed below.

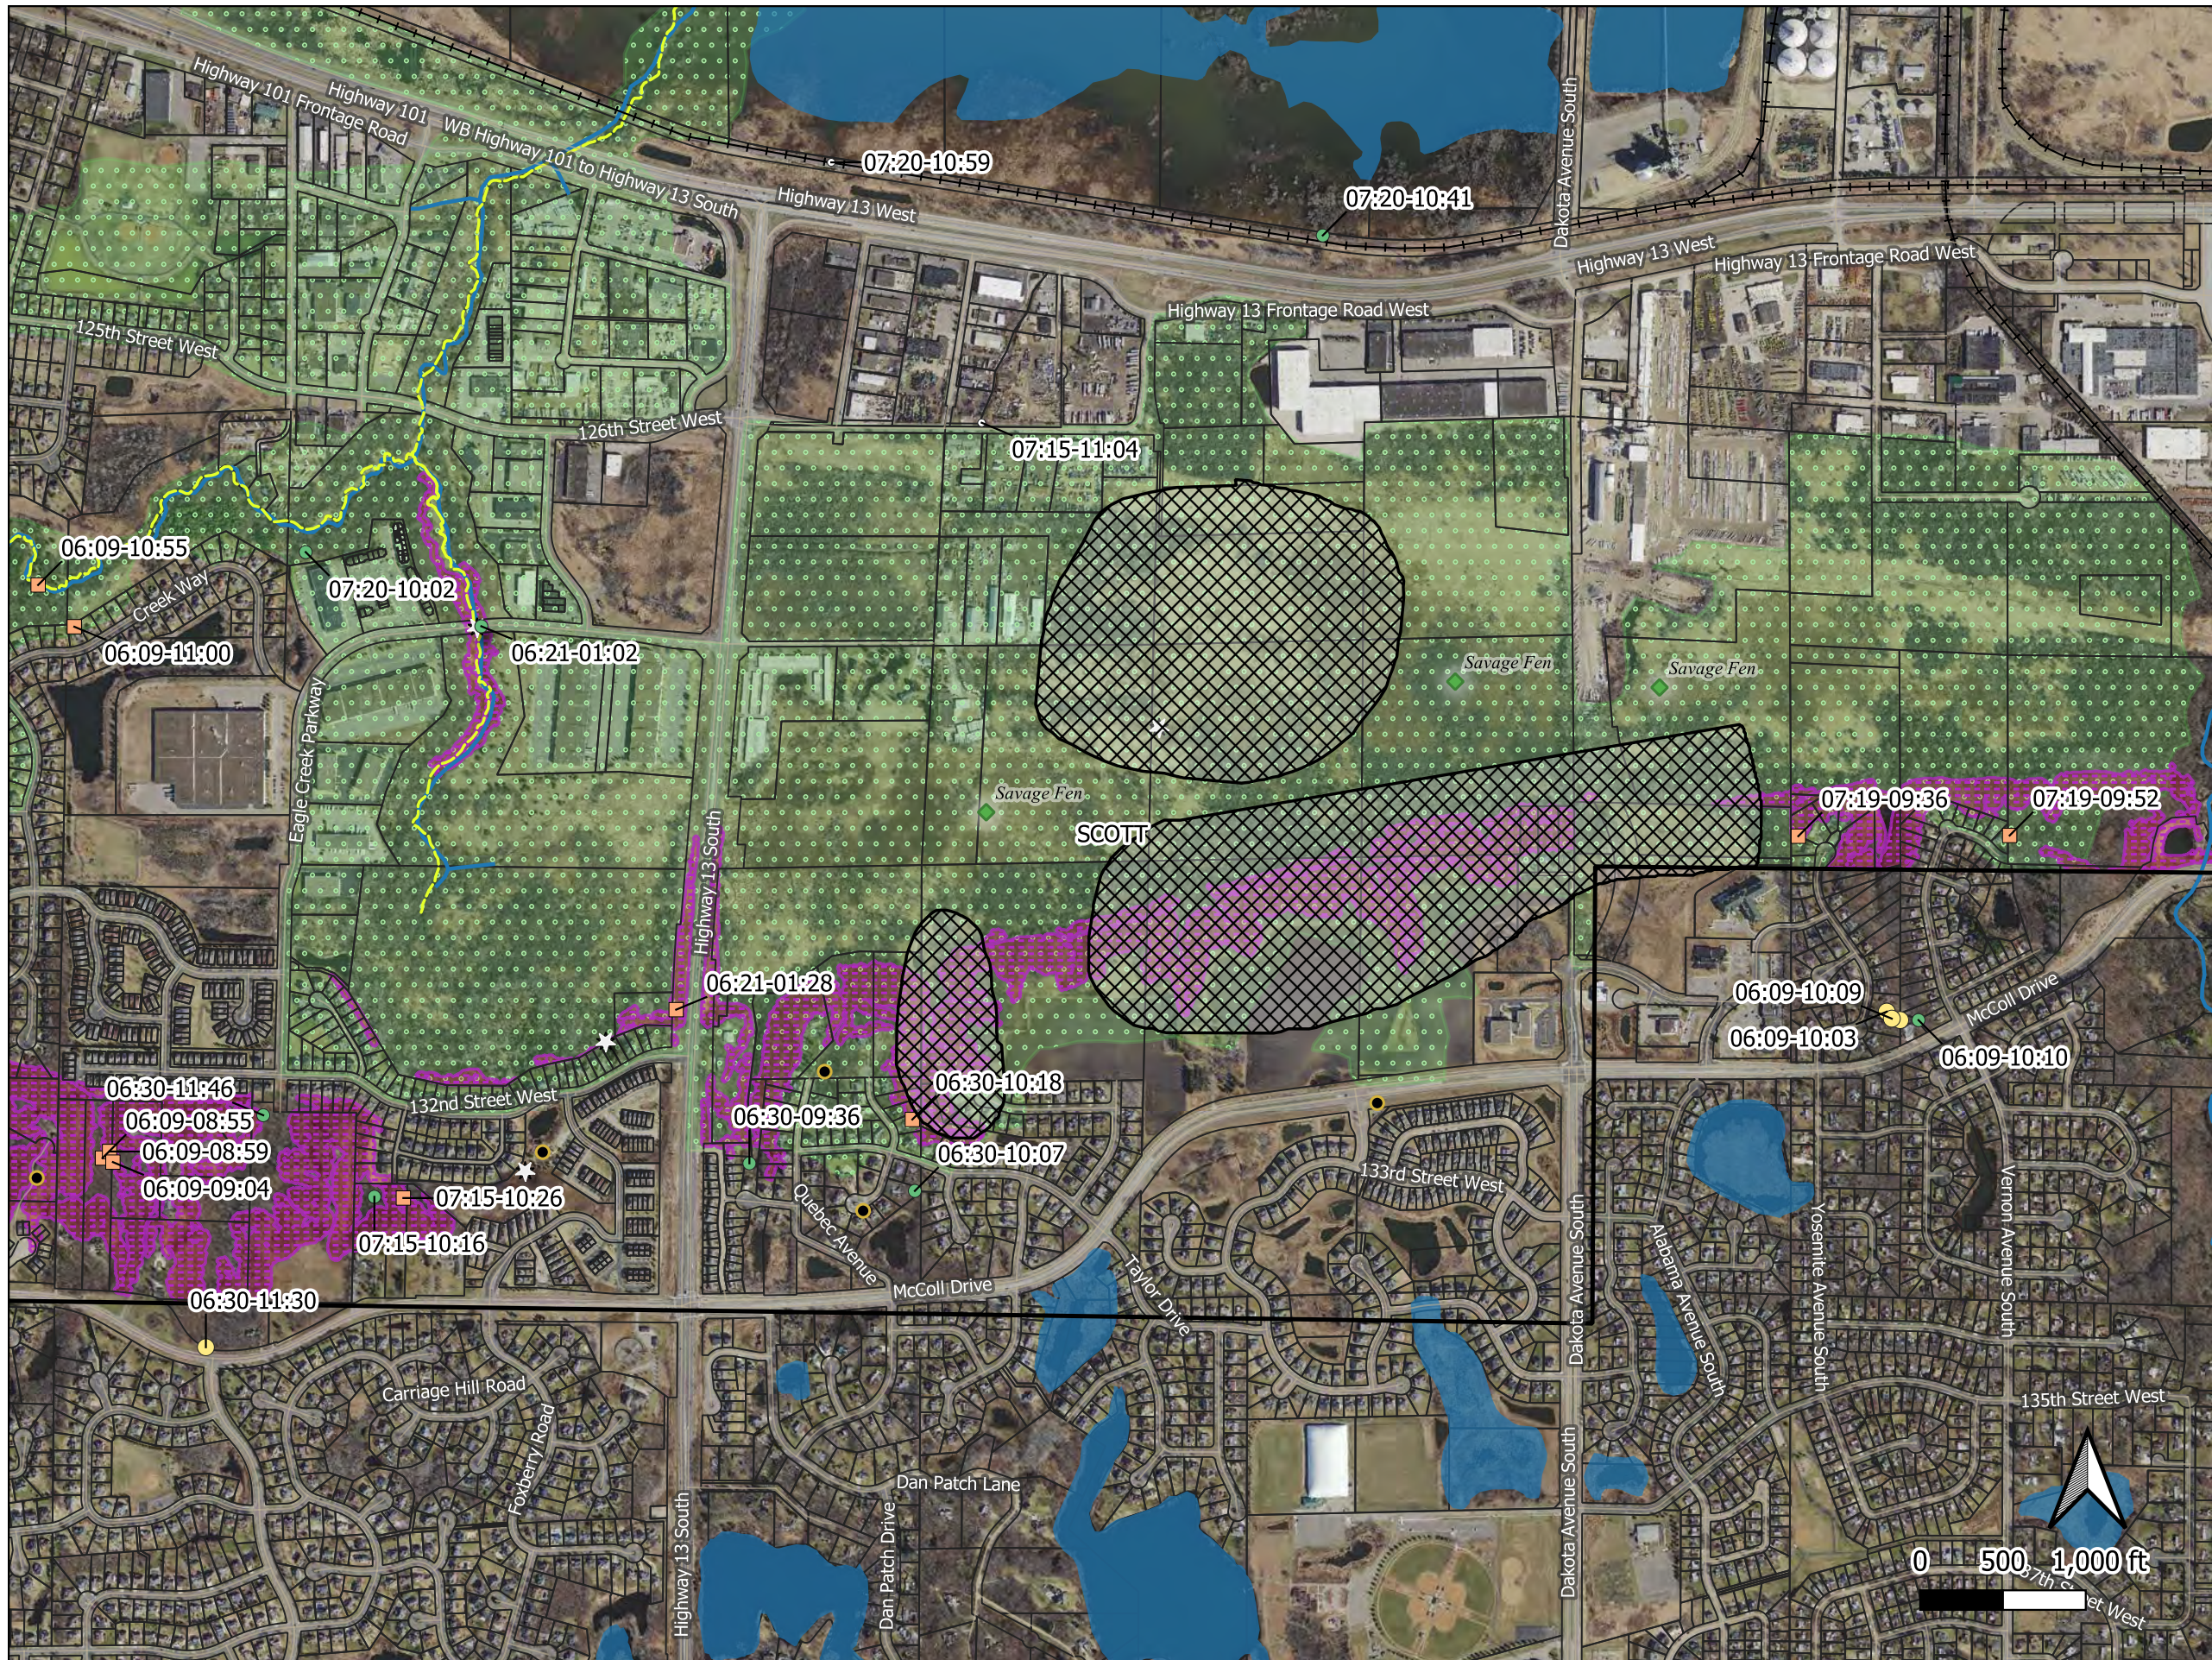
Figure 39: Savage Bluffs HPR

The Savage Bluff area includes the southern border of the LMRWD within Savage and the bluffs that drop down into the Savage Fen Natural Science Area (Figure 39). Many high-risk gullies were identified in this area; however, none were classified as VHR. An example of one of these high-risk gullies appears below and in Figure 40.

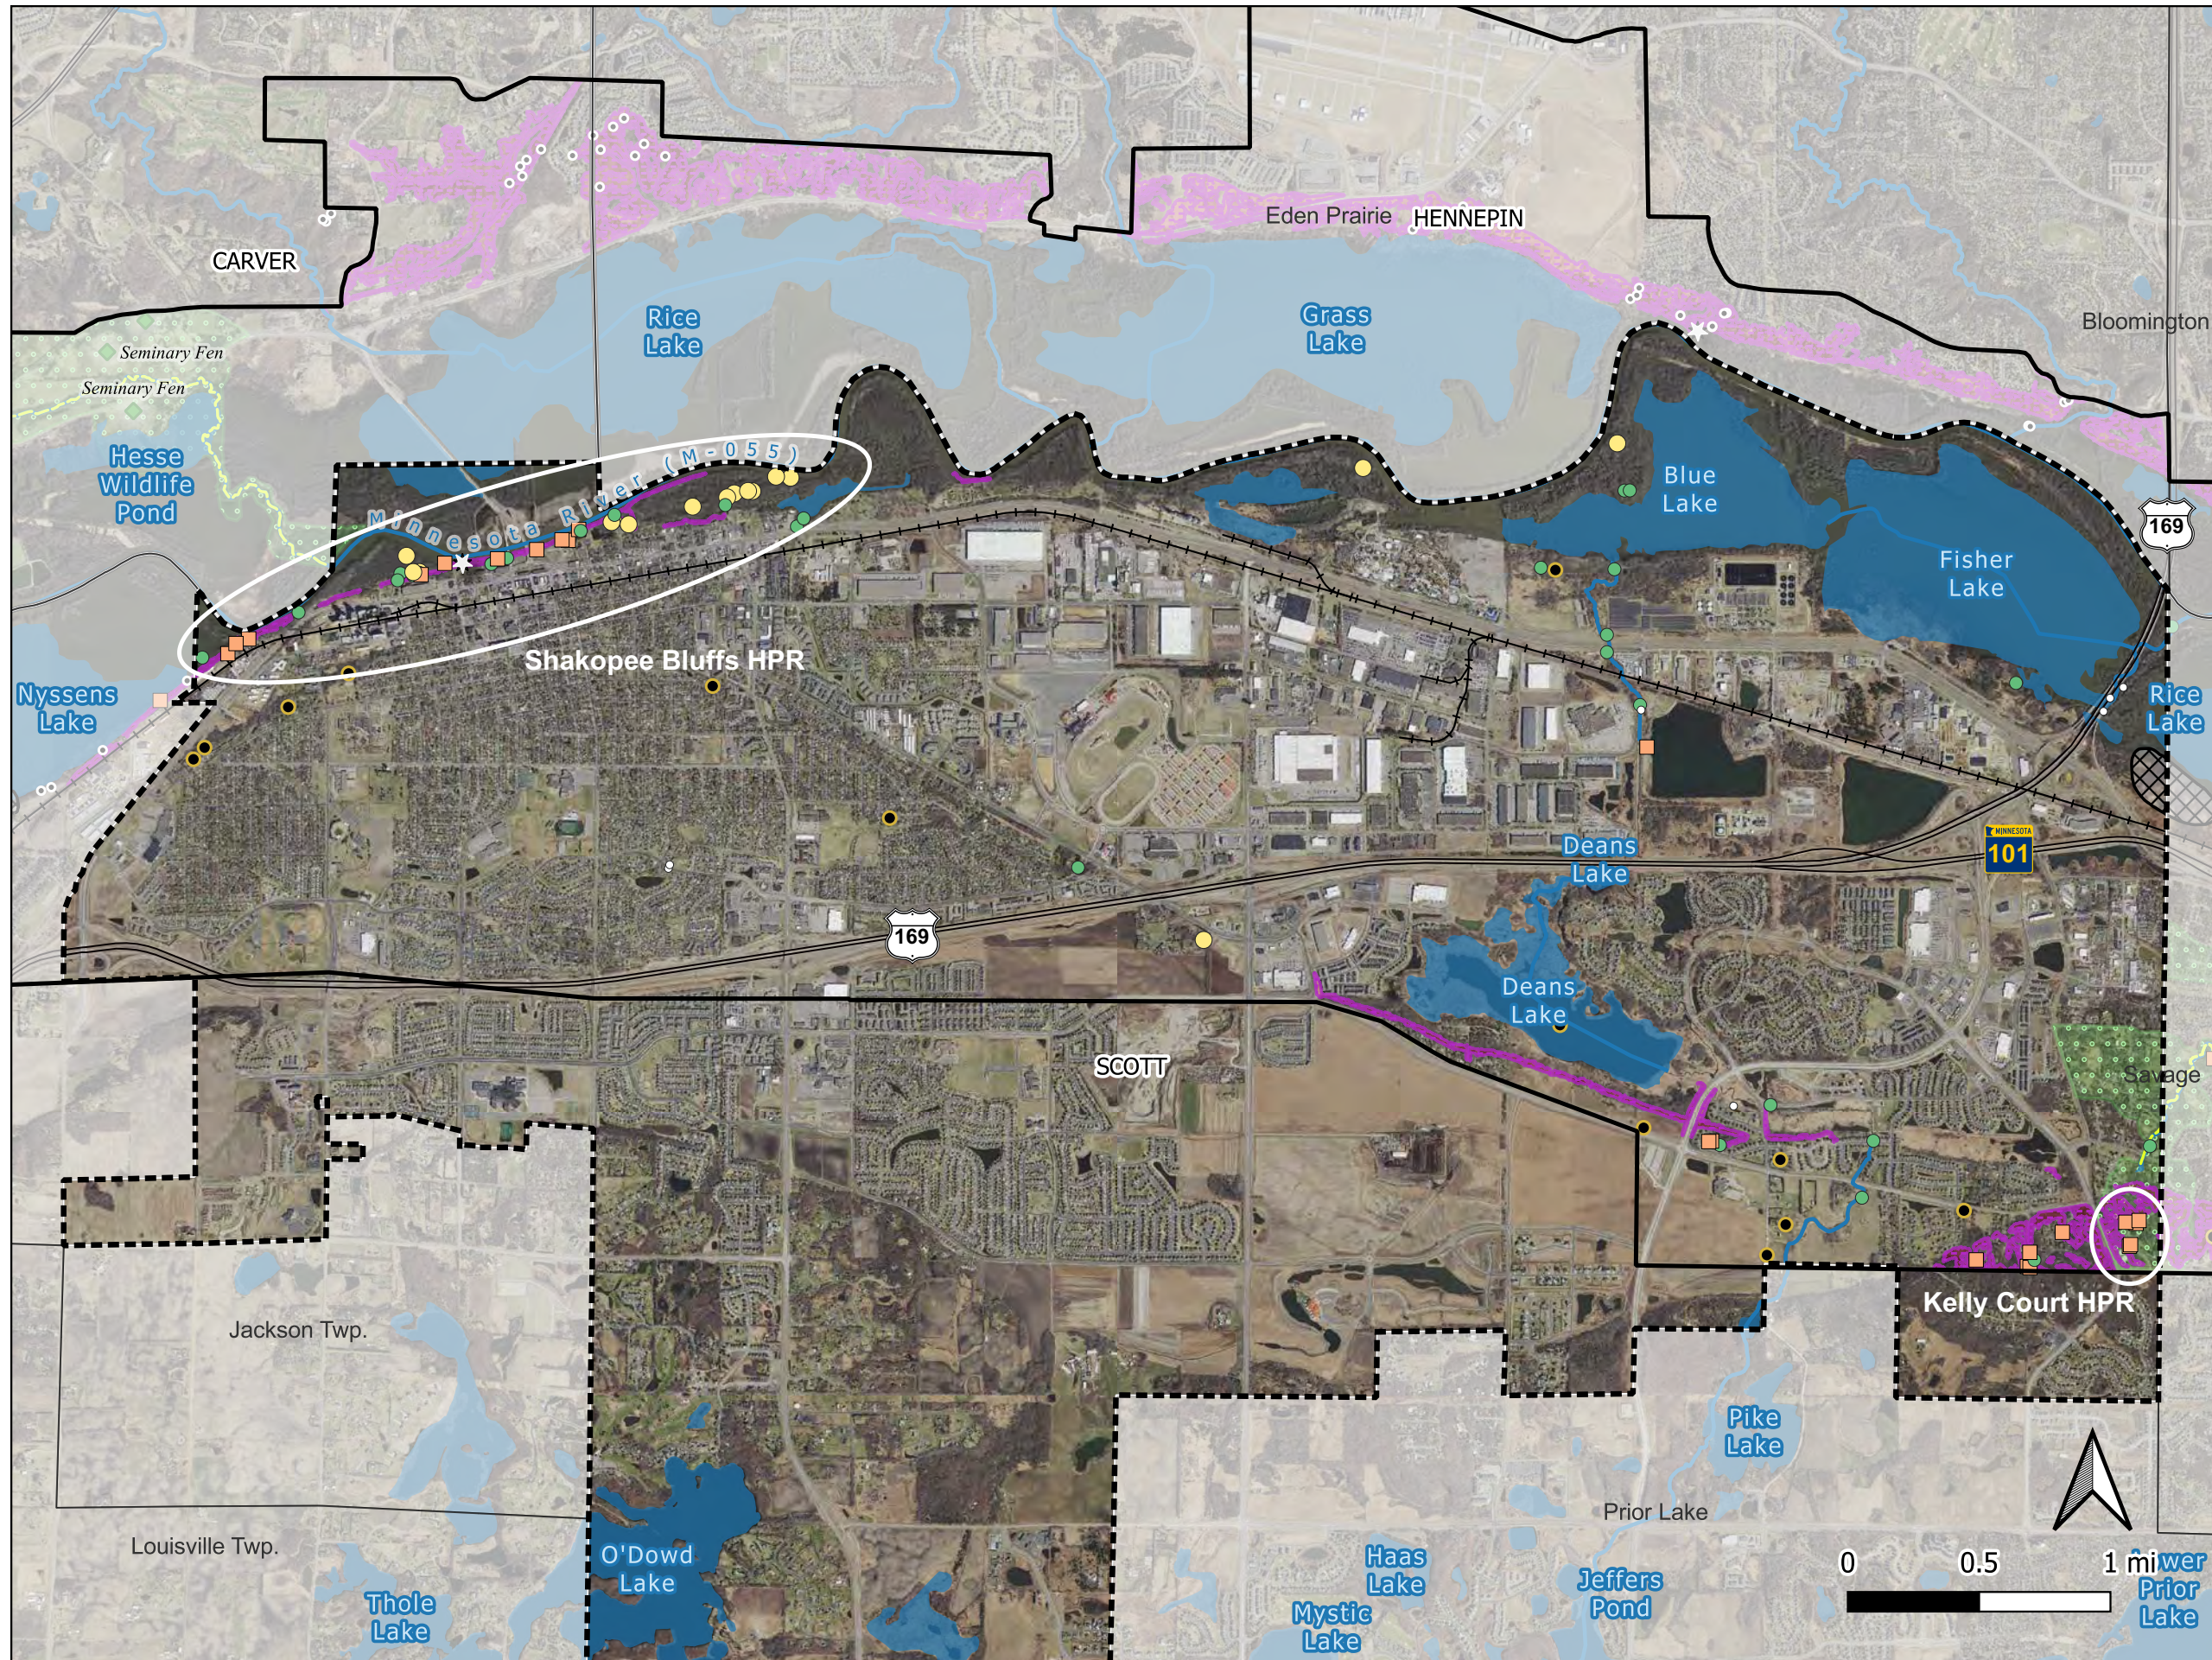
Figure 41: Shakopee Gullies

Shakopee had the most potential gully sites, with the desktop analysis identifying 89 potential gully locations. Of the identified potential locations, the field team collected data on 75 gullies in addition to one potential gully location that was inaccessible and 13 potential gully sites did not contain a gully (Figure 41). These were primarily grassy areas, divots between properties, or land that was not gully-like at all, indicating potential changes to the landscape since the MnDNR LiDAR data were collected.

A total of 75 gully sites were found in Shakopee; of these sites, 17 had low erosion potential, 41 were moderate, and 17 locations had high erosion potential based on the field team's assessment outlined in Section 2. When the impact and risk analysis scoring methods (Appendix B) were applied to the Shakopee gullies, no gullies were identified as VHR; and 23 gully locations were identified as high risk, with the rest in medium-, low-, and very low-risk categories (Figure 41).

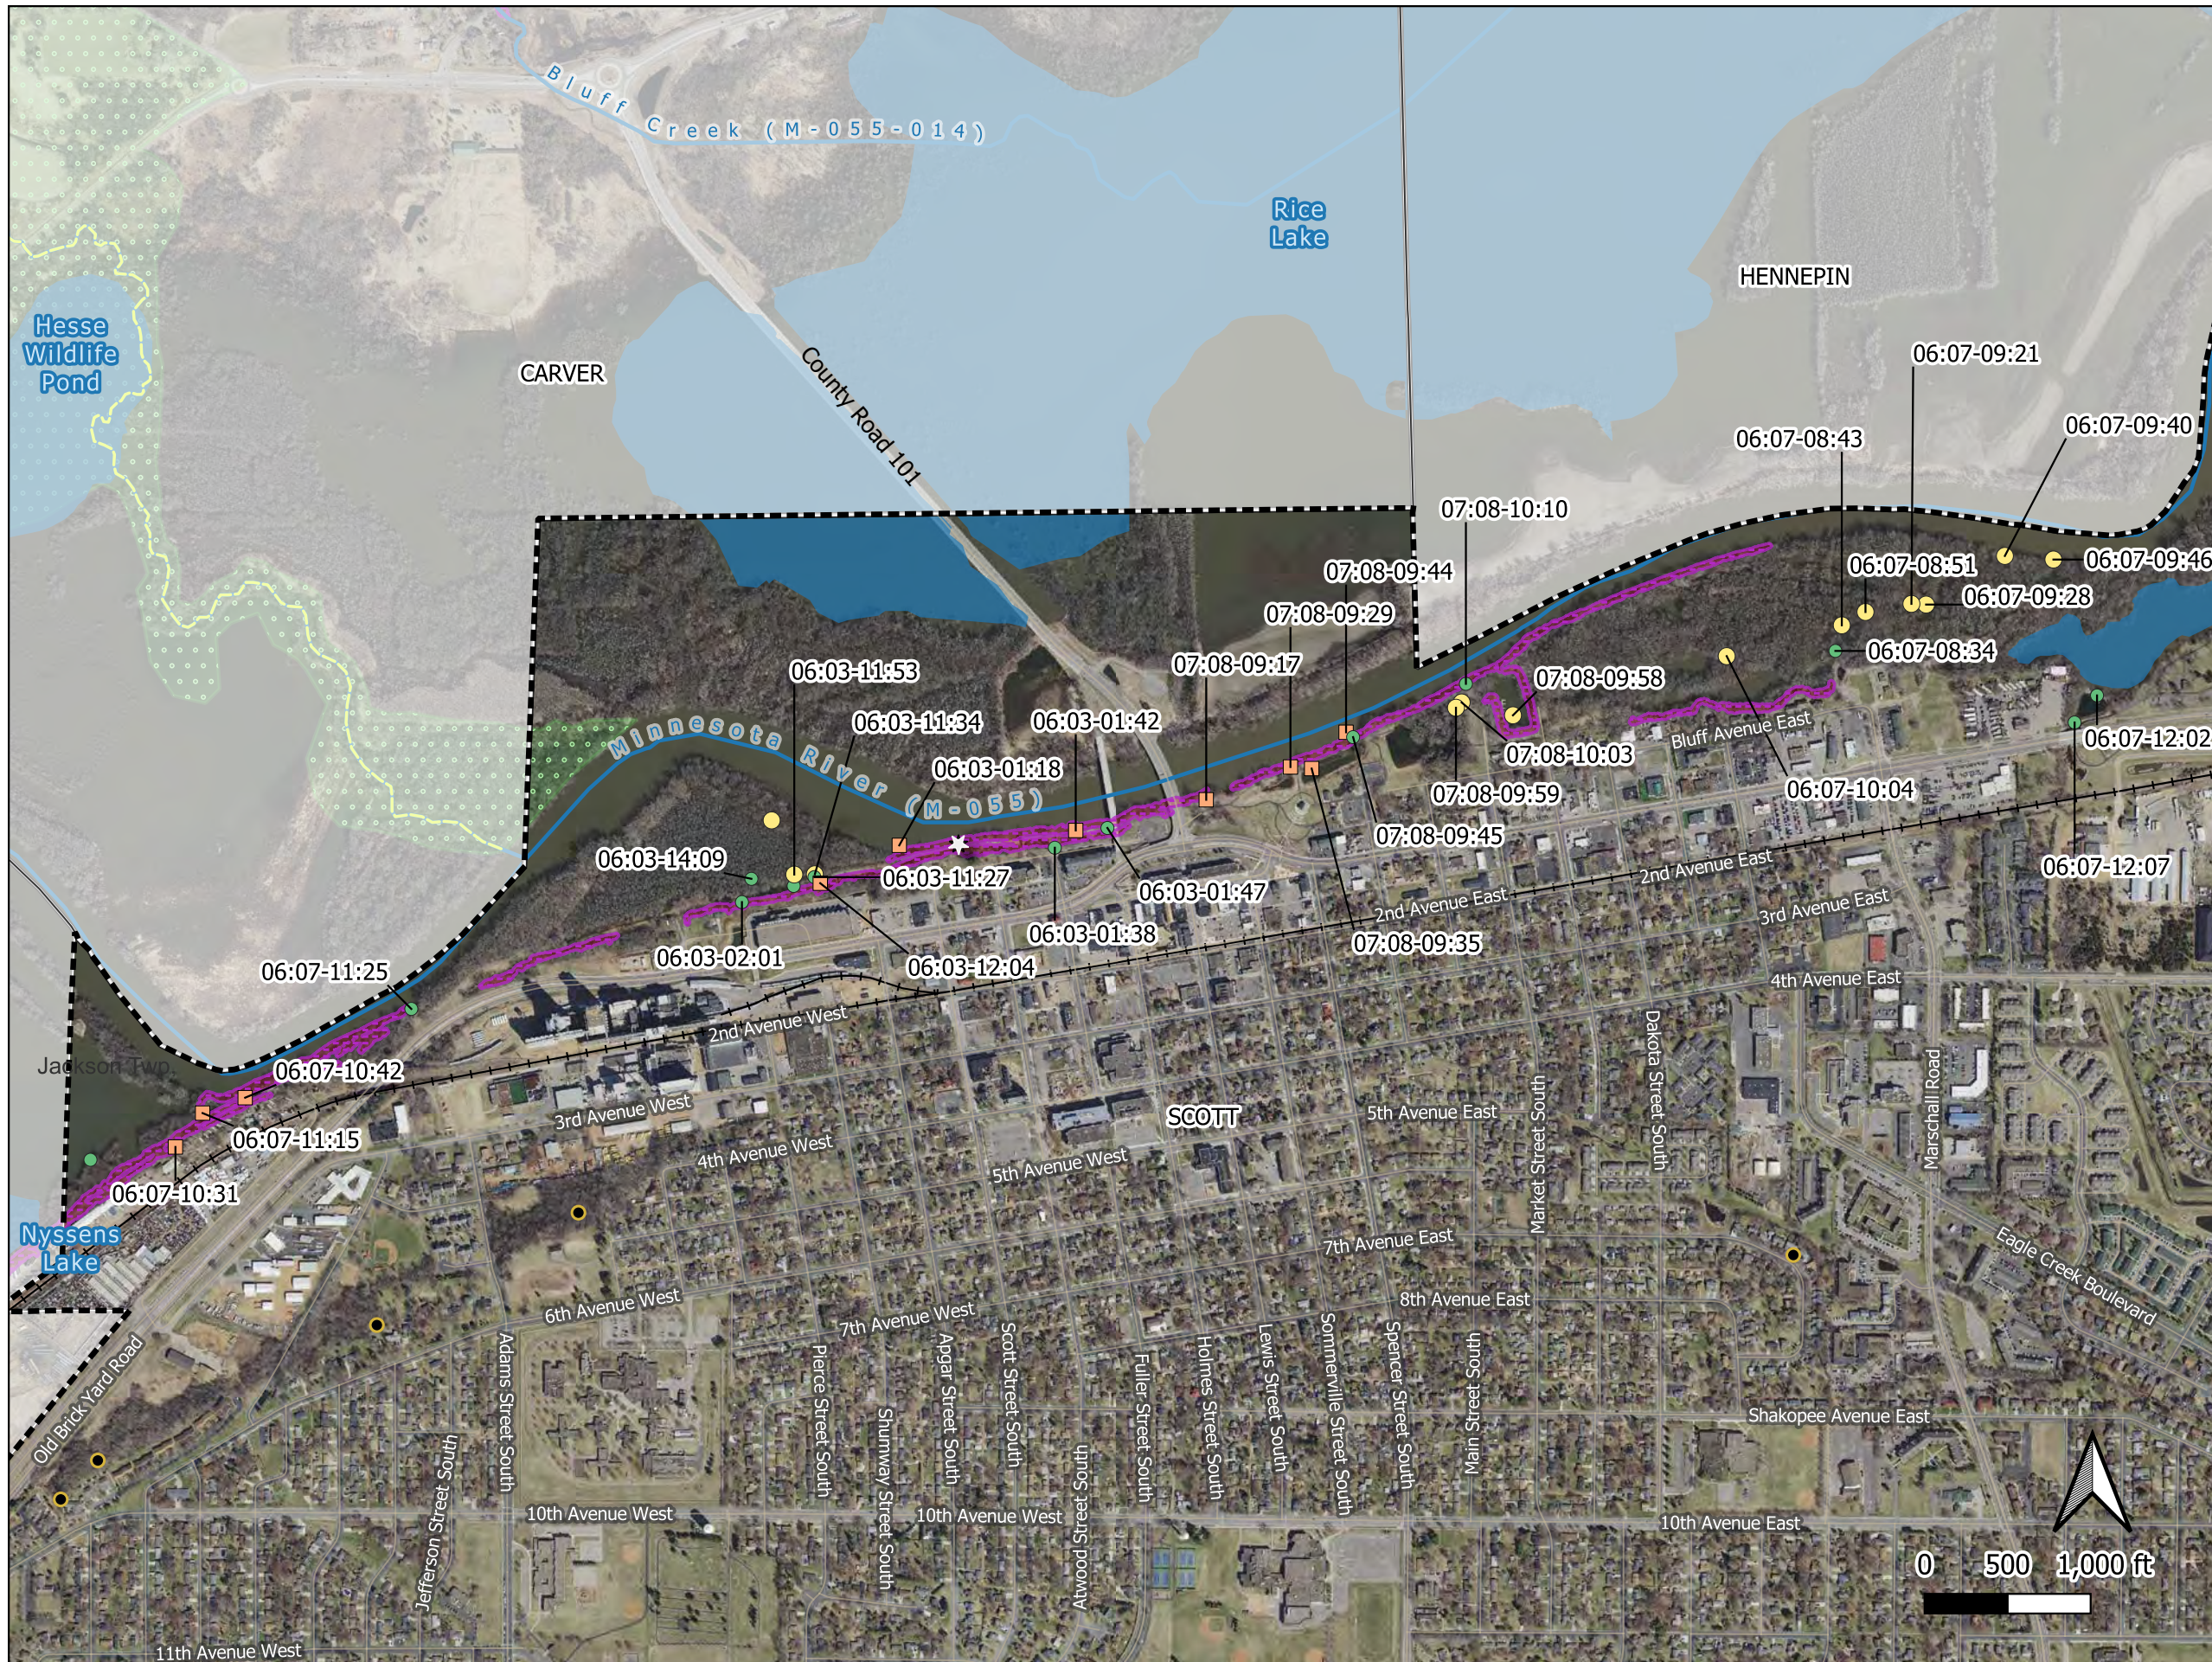
Figure 42: Shakopee Bluffs HPR

These gullies represent areas within Shakopee that are adjacent to the Minnesota River and subject to periodic flooding from it (Figure 42). At the time of observation, the Minnesota River was at historically low levels; future evaluation of the gullies near the Minnesota River should occur during higher river levels to determine whether these sites are true gullies and not backwater channels to the Minnesota River.

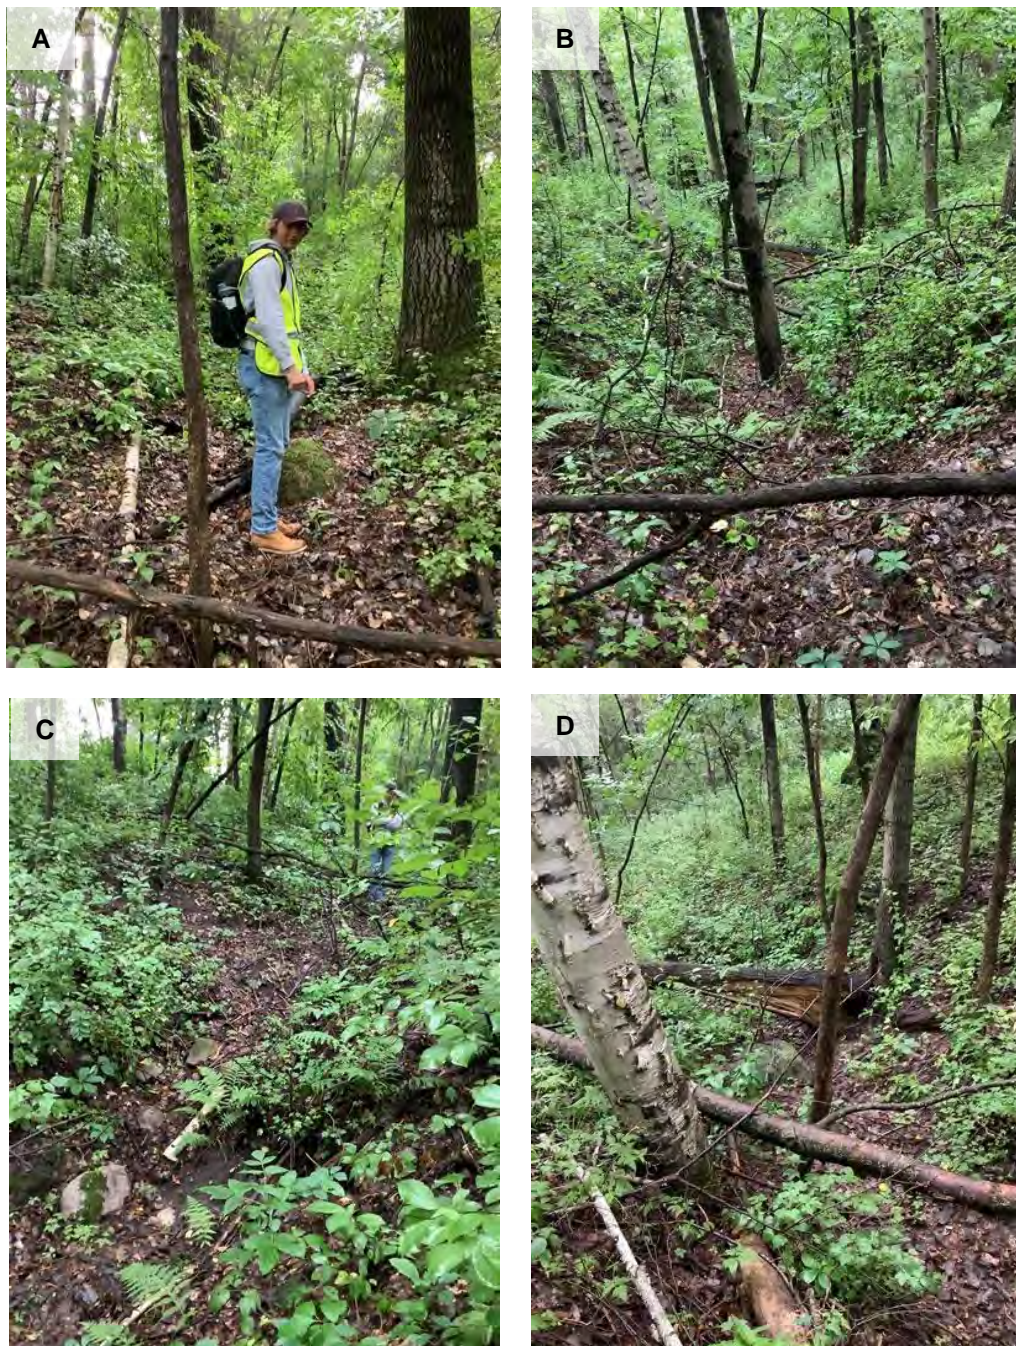
This site was located at 2108 Kelly Court in Shakopee. This gully began as a large, U-shaped gully, then transitioned to a narrower, V-shaped gully (Figure 48). The gully was long, medium depth, medium width, and made of silt. The bottom had no vegetation, but the banks were covered in moderate vegetation. The degradation was moderate, and some trees were leaning over the channel with slumping banks. This gully received a moderate erosion potential score of 34 for a risk rating of high.

Figure 48: Photos of Gully 07:07-08:50. A) Upstream view of the flatter area at the beginning of the gully, B) Downstream view of the gully where there were fallen trees and a boardwalk running across the banks, C) Upstream view of area where slope drops off and gully becomes more severe, D) Downstream view of fallen tree

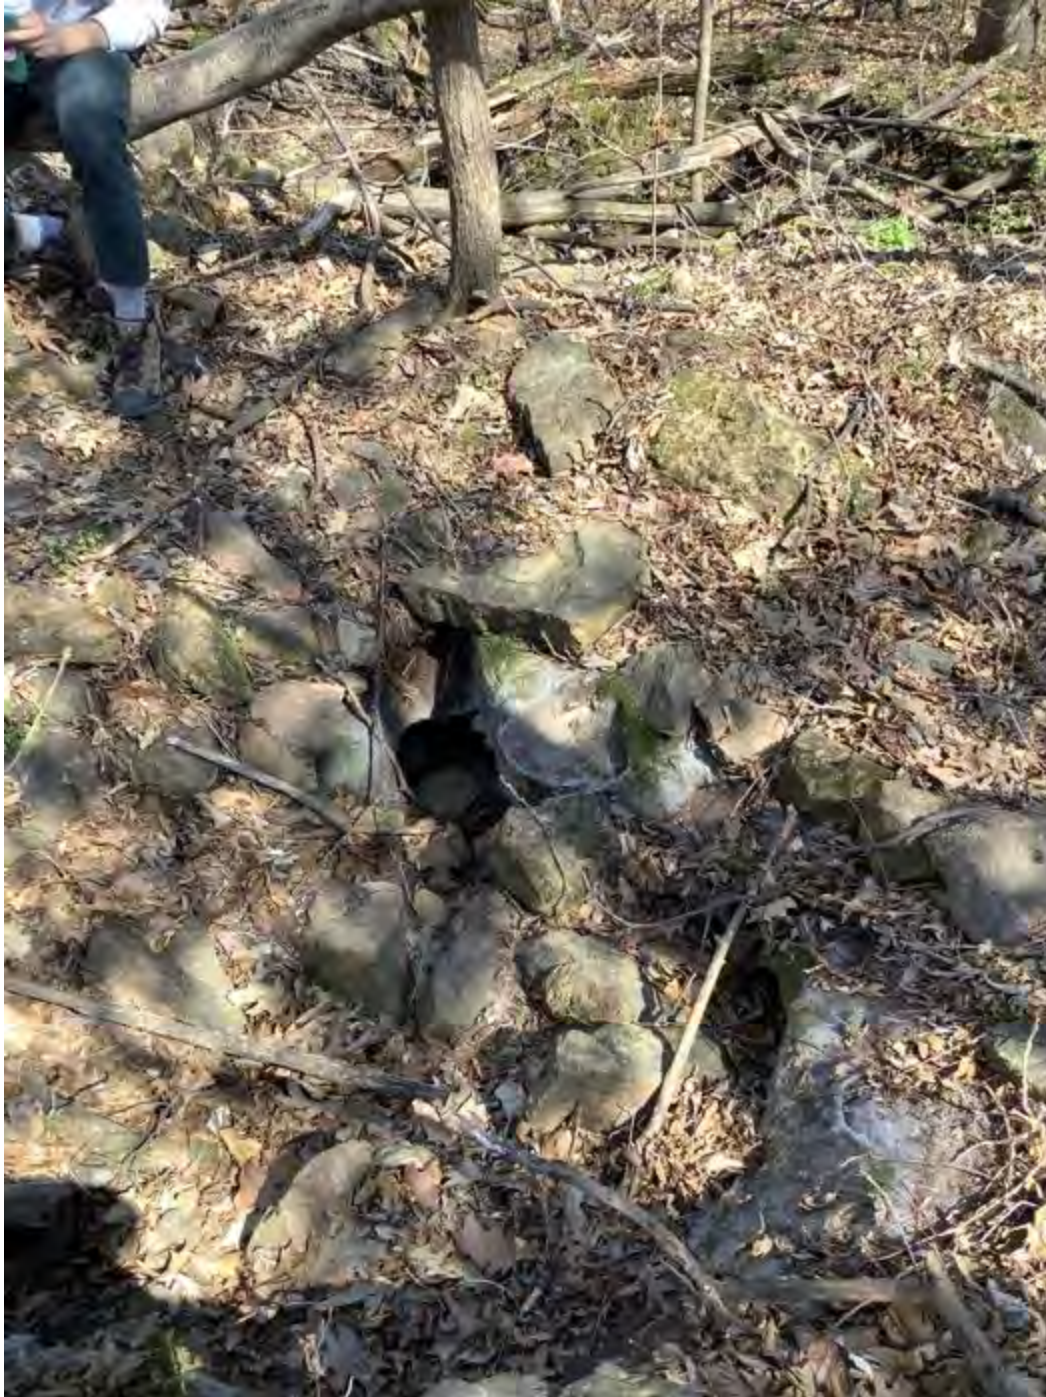
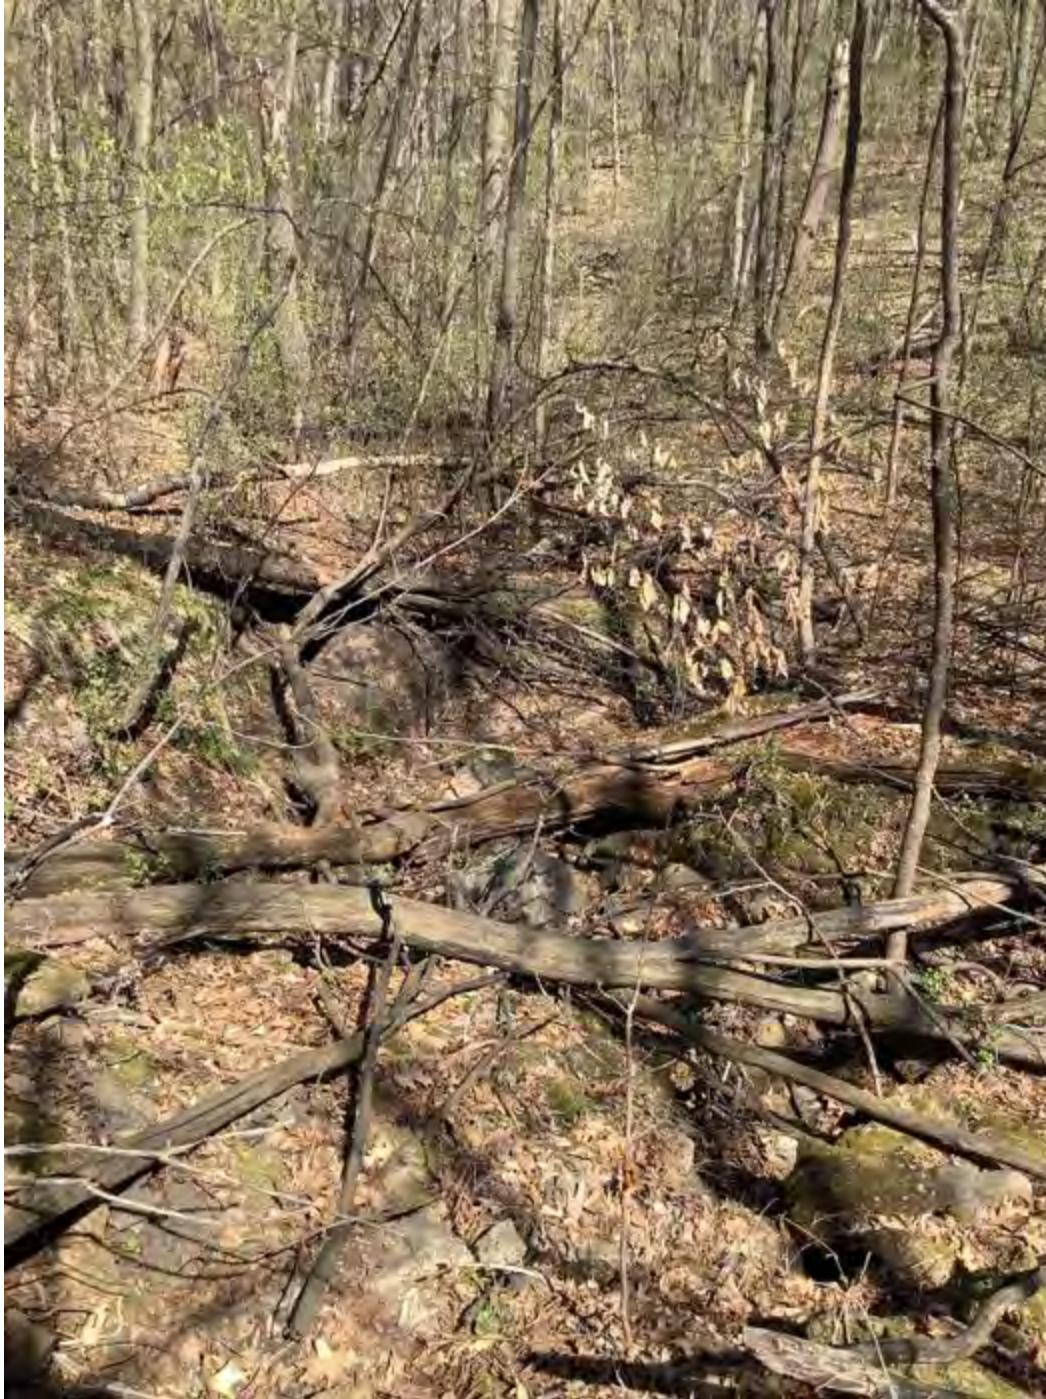
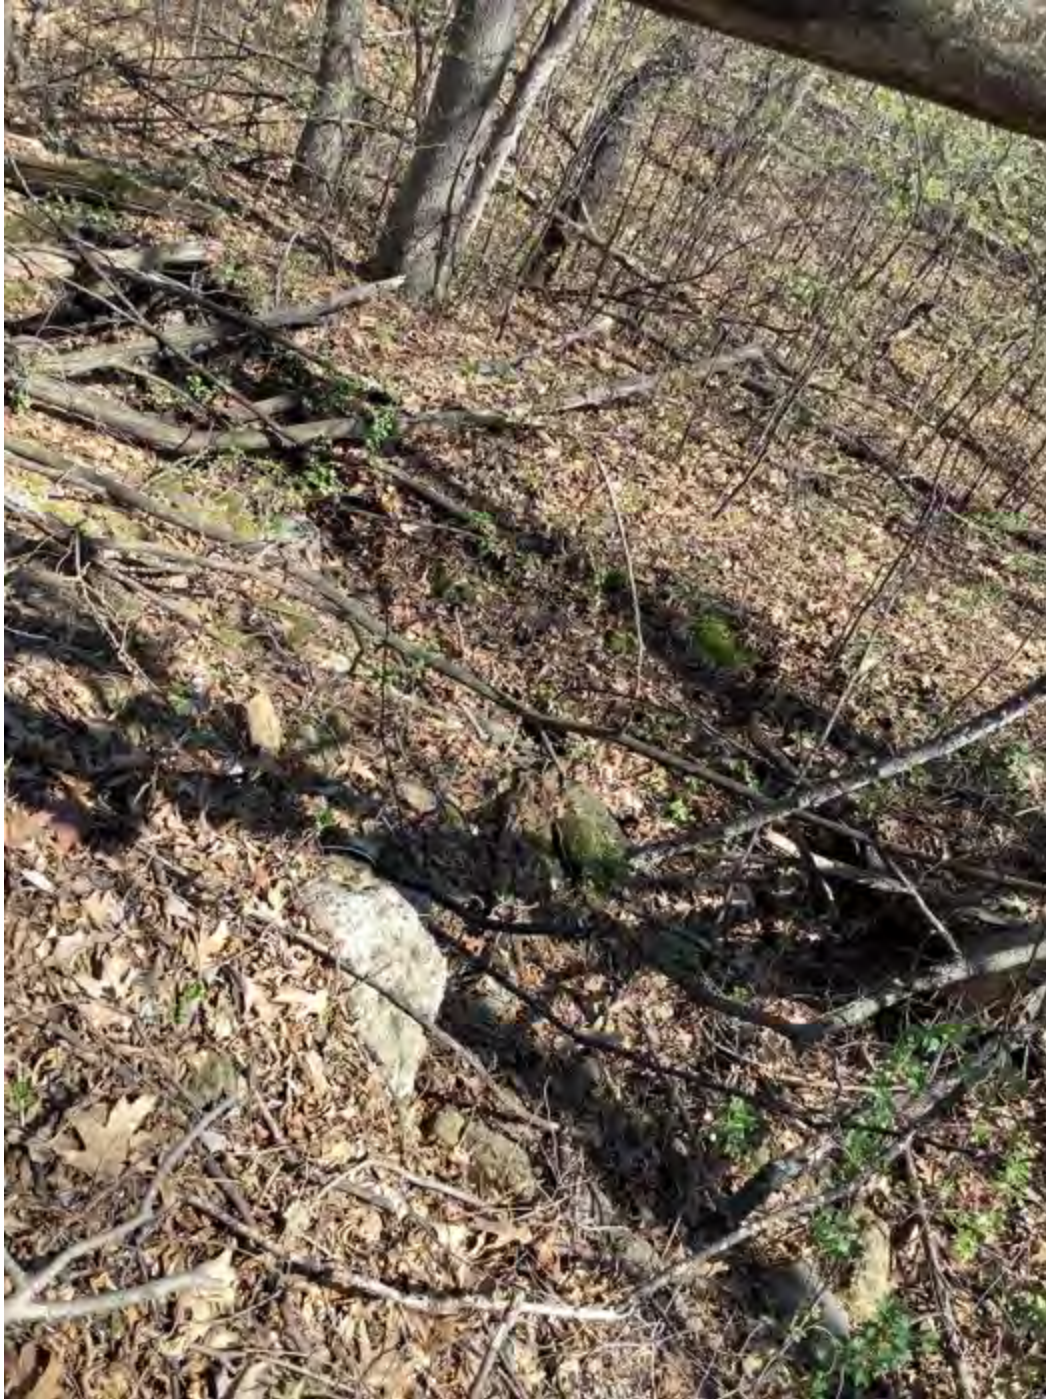
GULLY ID: ESPM Site 6

PREVIOUS WAYPOINT ID: Site 6	
SURVEY DATE: April 22, 2021 12:04 PM	
LOCATION:	
TYPE OF SITE: Gully	
SITE SUMMARY: Sunny Rain in previous 24 hours: Yes: Low Intensity, No Along a Road Long: >100' gully. The problem indicators were: Degradation, Aggradation, Flattened and/or slumping banks (widening), undercut or overhanging banks (lateral scouring), pistol-butted or leaning trees	Gully Head UTM Estimation: 30 ft, Observation Point correction, if applicable: 15T4674994956382 Connections to other points, if applicable:
GULLY INFORMATION	
EROSION POTENTIAL:	High
GULLY DEPTH:	Shallow: <3'
BOTTOM WIDTH:	Narrow/V Ditch, Medium: 1'-5'
TOP WIDTH:	Medium: 5'-10', Narrow: 1'-5'
BANK CONDITION:	Some Vegetation
BOTTOM CONDITION:	Some Vegetation
CHANNEL SLOPE:	Steep
GULLY SHAPE:	U-shaped
GULLY MATERIAL:	Gravel/cobble/ boulders , Sand, Fine-grained cohesive
WATER LEVELS	None, N/A
SEEP	No
APPARENT CAUSES:	Slope, Unstable drainage feature entering system

ADDITIONAL NOTES: Near site 6 Invasive Species? None Type: Burdock, None Debris? Little trash Existing Stabilization? Rip rap or burlap under rocks at top of gully Success: No
