2021 GULLY INVENTORY AND CONDITION ASSESSMENT, VOLUME 2

July 15, 2022

Lower Minnesota River Watershed District
112 E. 5th Street, #102
Chaska, MN 55318

Young Environmental Consulting Group, LLC
6040 Earle Brown Drive, Suite 306
Brooklyn Center, MN 55430

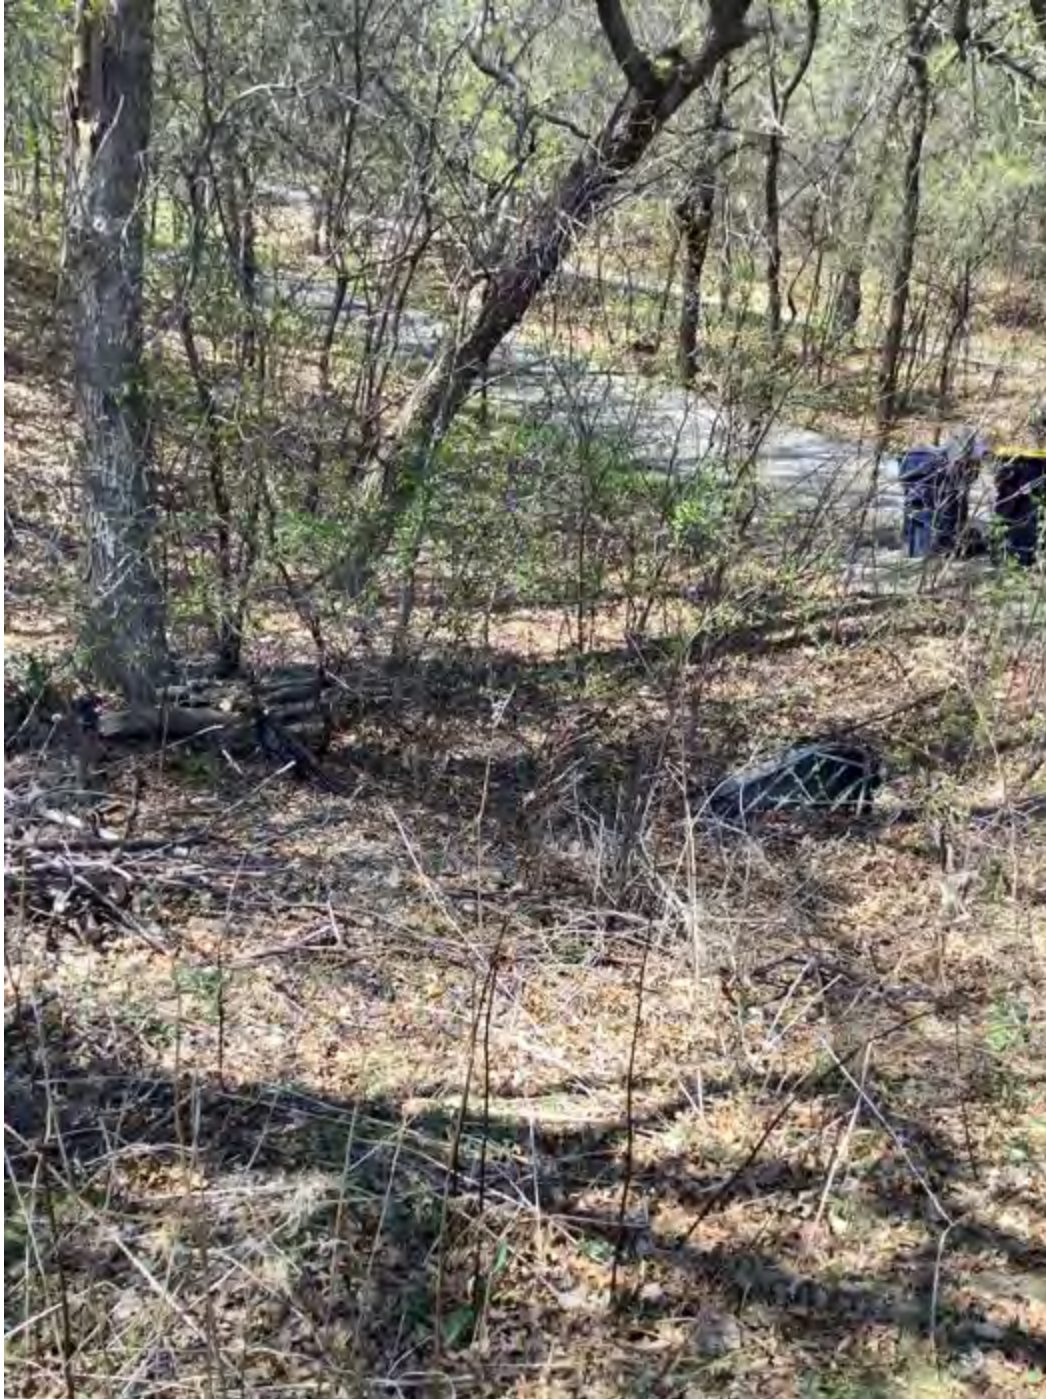
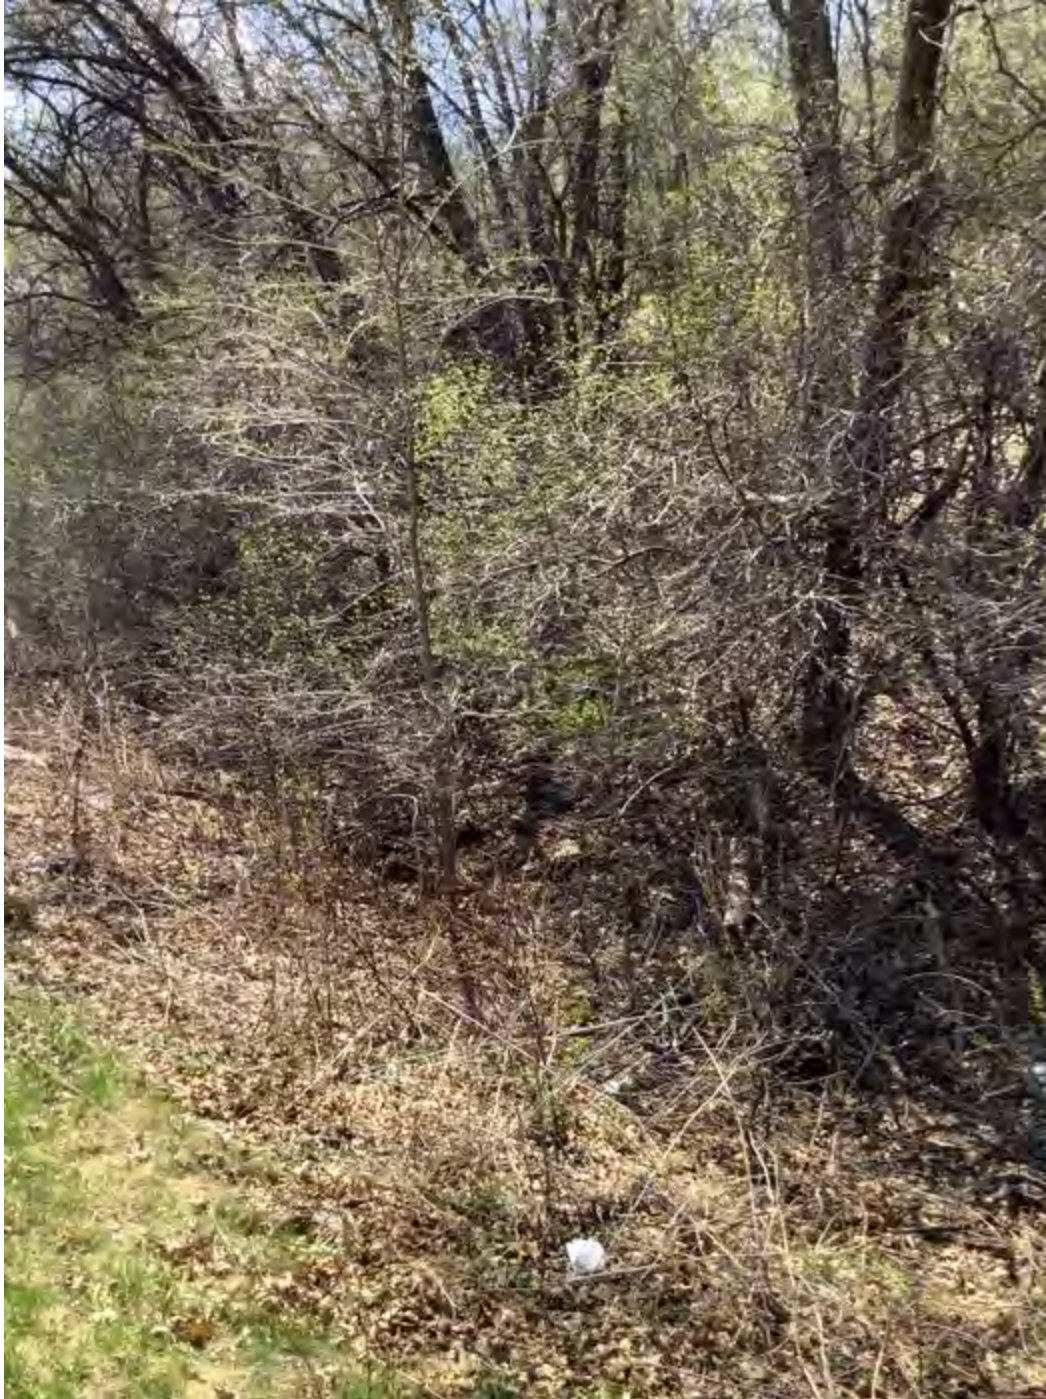
GULLY ID: ESPM Site 7

<p>County of Scott, Three Rivers Park District, Esri Canada, Esri, Inc., DeLorme, Garmin</p>
PREVIOUS WAYPOINT ID: Site 7	
SURVEY DATE: April 22, 2021 12:51 PM	
LOCATION: Shakopee	
TYPE OF SITE: Gully	
SITE SUMMARY: Sunny Rain in previous 24 hours: No Off of Walking Trail Long: >100' gully. The problem indicators were: Degradation, Loss of Bank Vegetation, Flattened and/or slumping banks (widening), pistol-butted or leaning trees	
GULLY INFORMATION	
EROSION POTENTIAL:	Moderate
GULLY DEPTH:	Shallow: <3'
BOTTOM WIDTH:	Medium: 1'-5'
TOP WIDTH:	Medium: 5'-10'
BANK CONDITION:	Some Vegetation
BOTTOM CONDITION:	Some Vegetation
CHANNEL SLOPE:	Steep
GULLY SHAPE:	U-shaped
GULLY MATERIAL:	Fine-grained cohesive
WATER LEVELS	None, N/A
SEEP	No
APPARENT CAUSES:	Slope
ADDITIONAL NOTES: Slight slope drains into storm sewer at end of gully Invasive Species? Type: Debris? Lots of trash Existing Stabilization? None Success: N/A

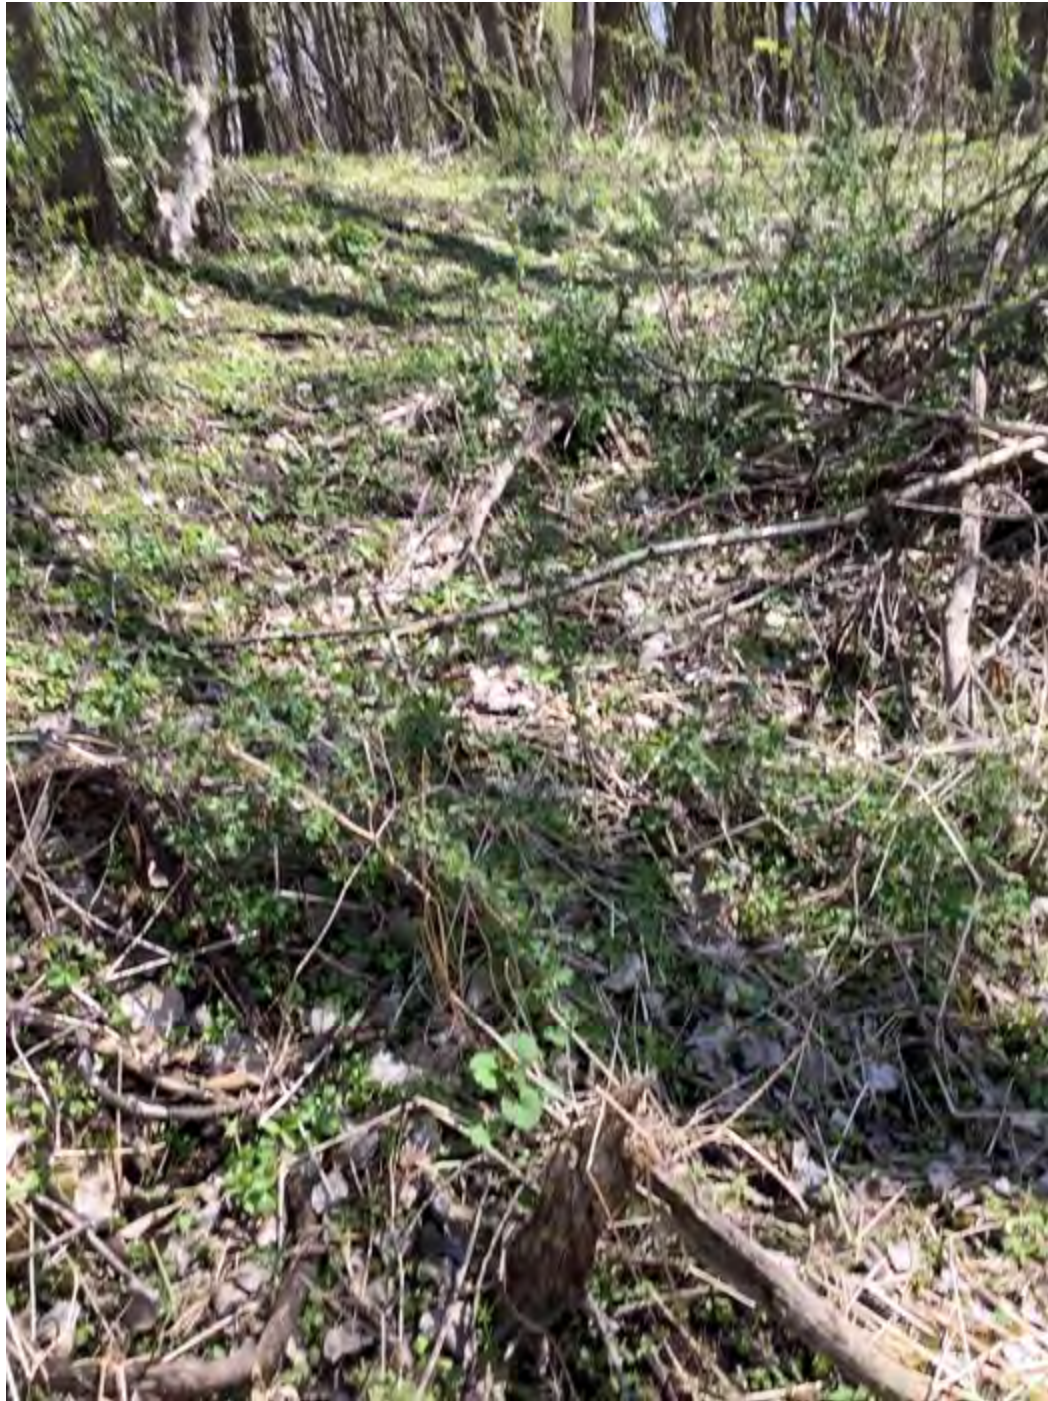
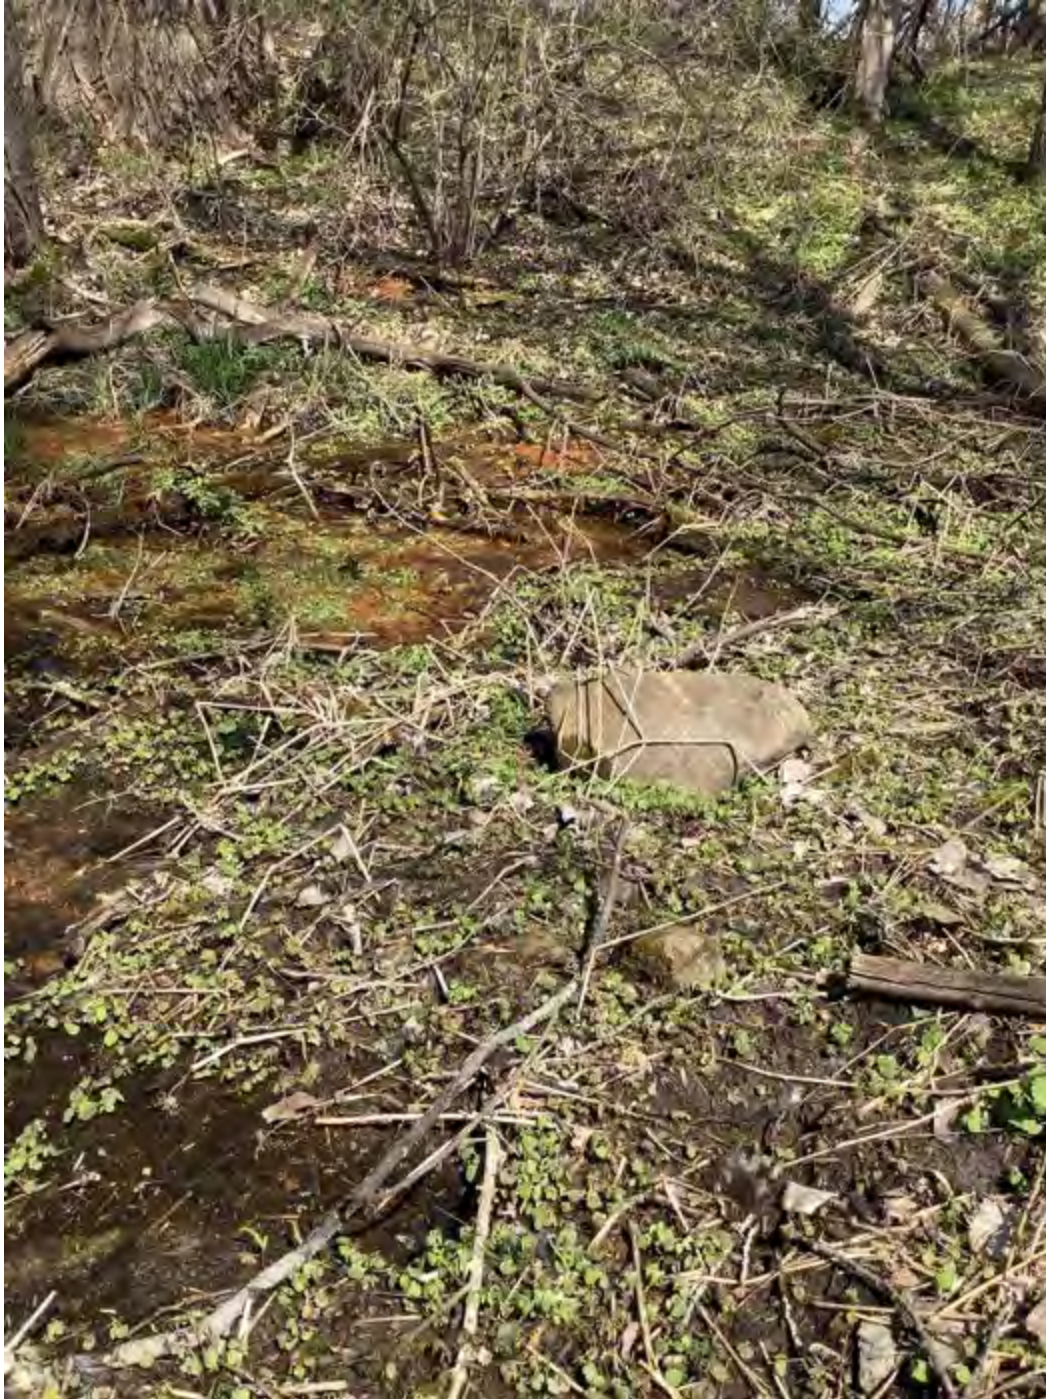
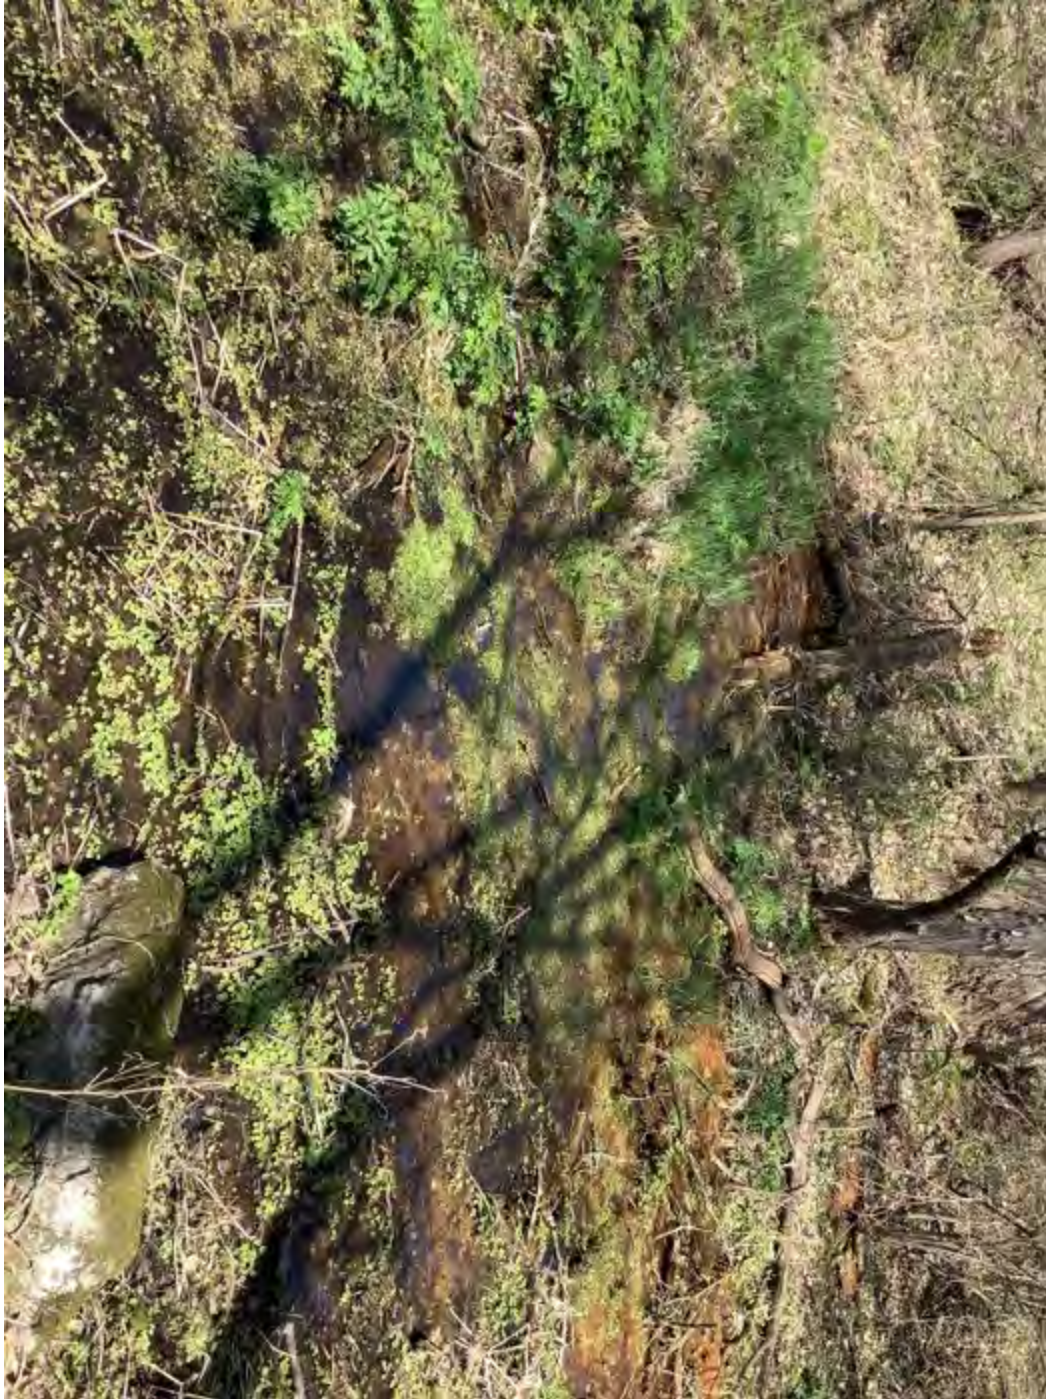
GULLY ID: ESPM Site 9

PREVIOUS WAYPOINT ID: Site 9	
SURVEY DATE: April 22, 2021 1:58 PM	
LOCATION: Savage	
TYPE OF SITE: Gully	
SITE SUMMARY: Sunny Rain in previous 24 hours: No Heavily Forested Medium: 50'-100' gully. The problem indicators were: Degradation, Aggradation, Loss of Bank Vegetation, Vertical and/or bare banks (incision), pistol-butted or leaning trees	
GULLY INFORMATION	
EROSION POTENTIAL:	Moderate
GULLY DEPTH:	Shallow: <3'
BOTTOM WIDTH:	Wide: >5'
TOP WIDTH:	Medium: 5'-10'
BANK CONDITION:	Some Vegetation
BOTTOM CONDITION:	Some Vegetation
CHANNEL SLOPE:	Flat
GULLY SHAPE:	Trapezoid
GULLY MATERIAL:	Fine-grained cohesive
WATER LEVELS	Moderate, Slow
SEEP	Yes
APPARENT CAUSES:	Seep/groundwater, Slope
ADDITIONAL NOTES:	
Invasive Species? None Type: None	
Debris? No trash some debris	
Existing Stabilization? None Success: No, N/A

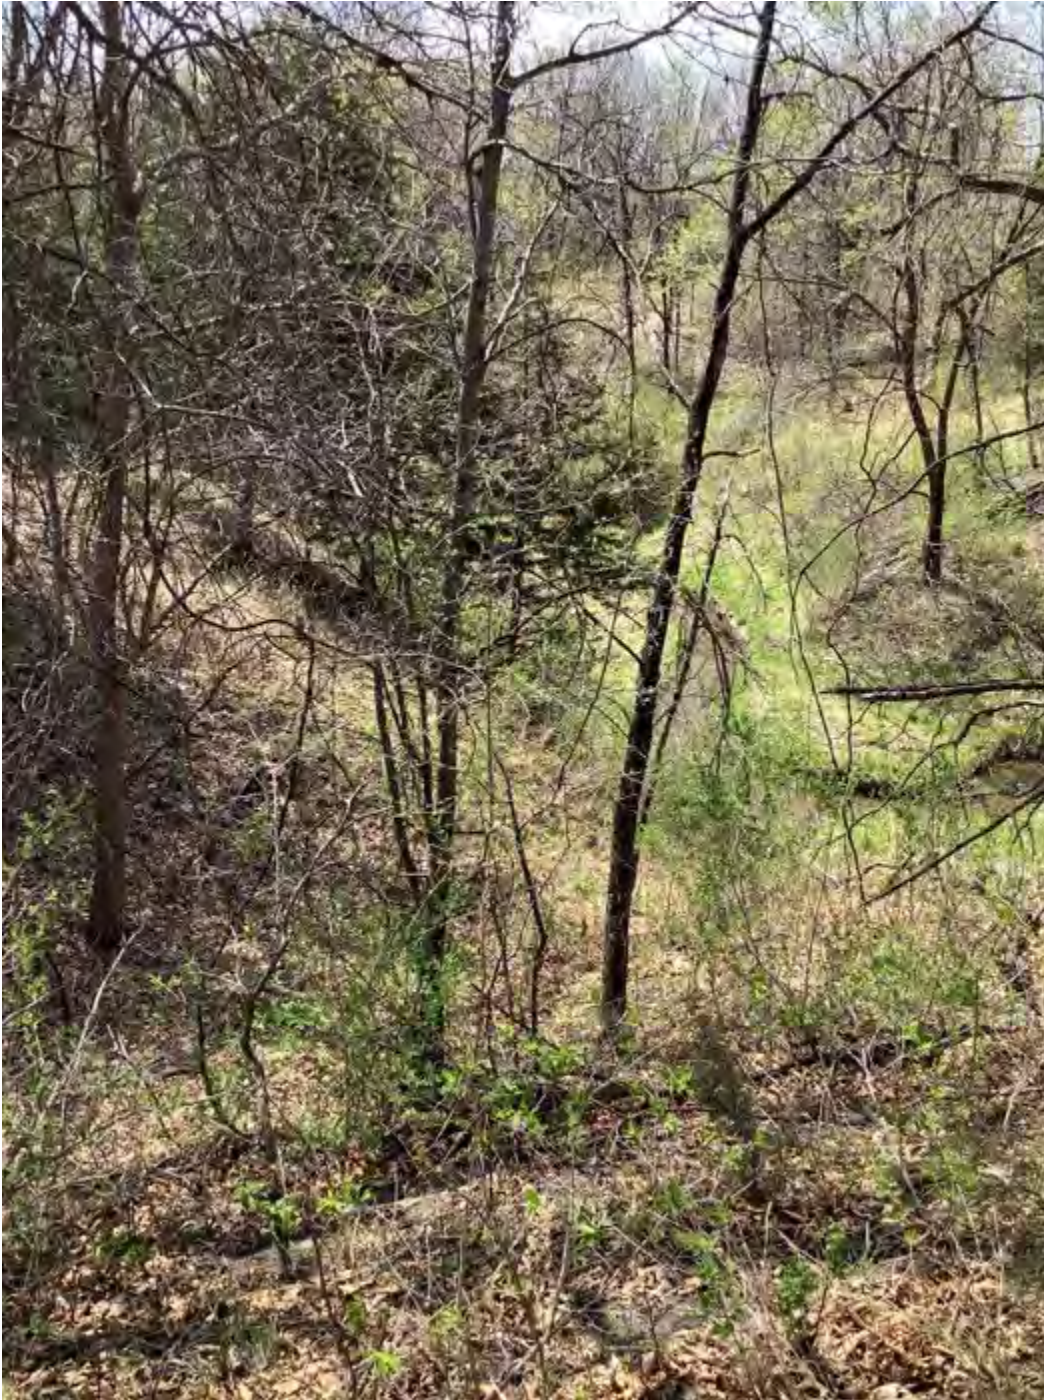
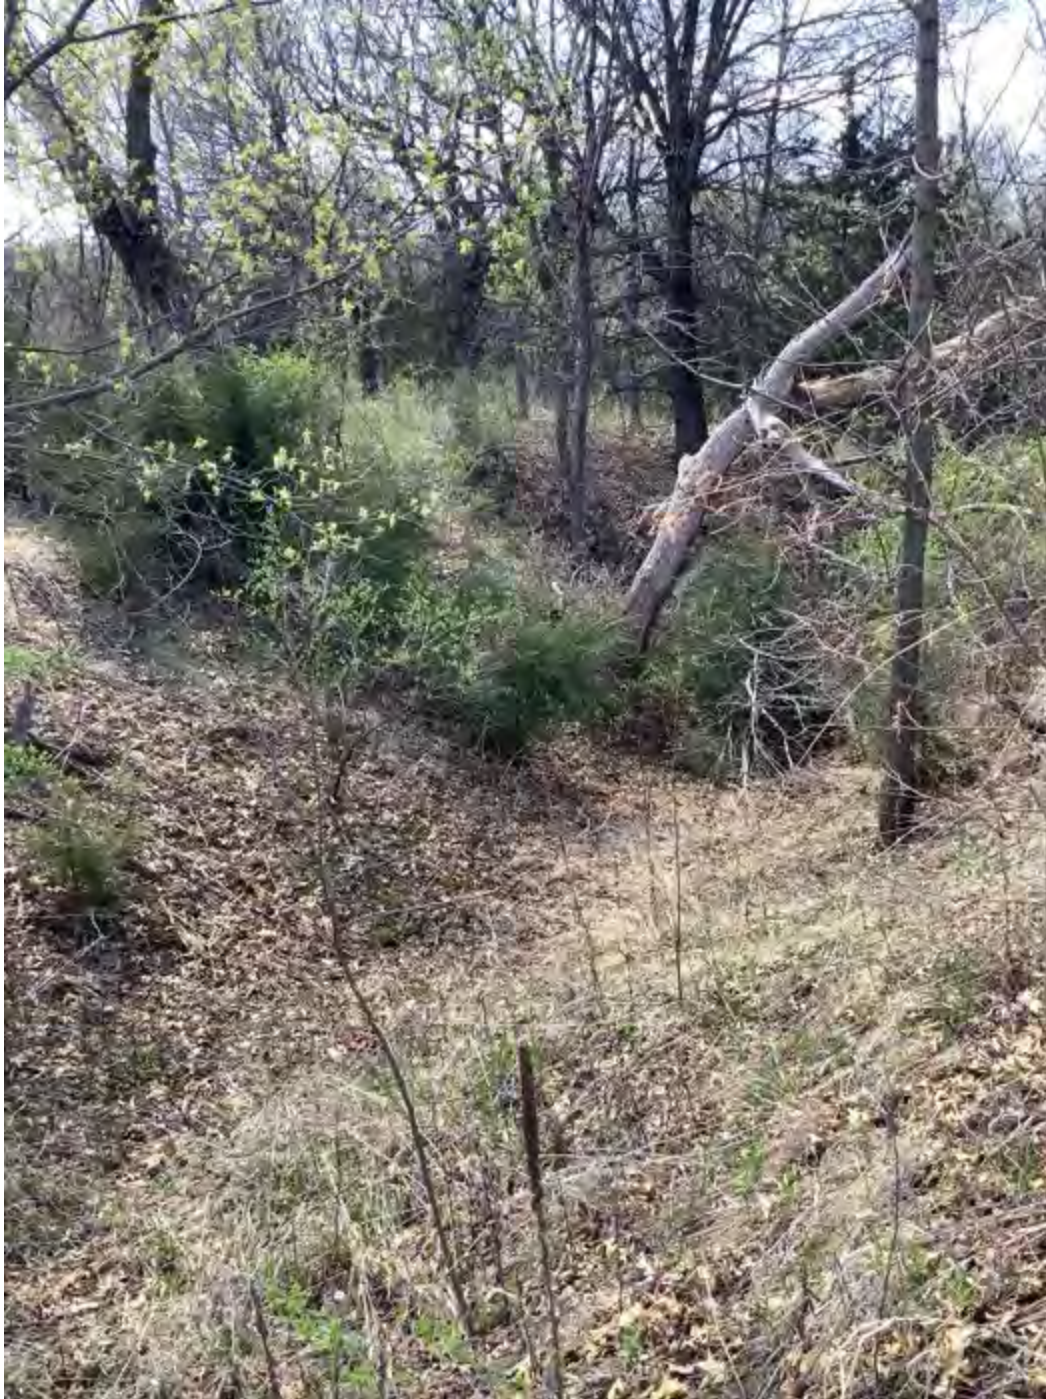
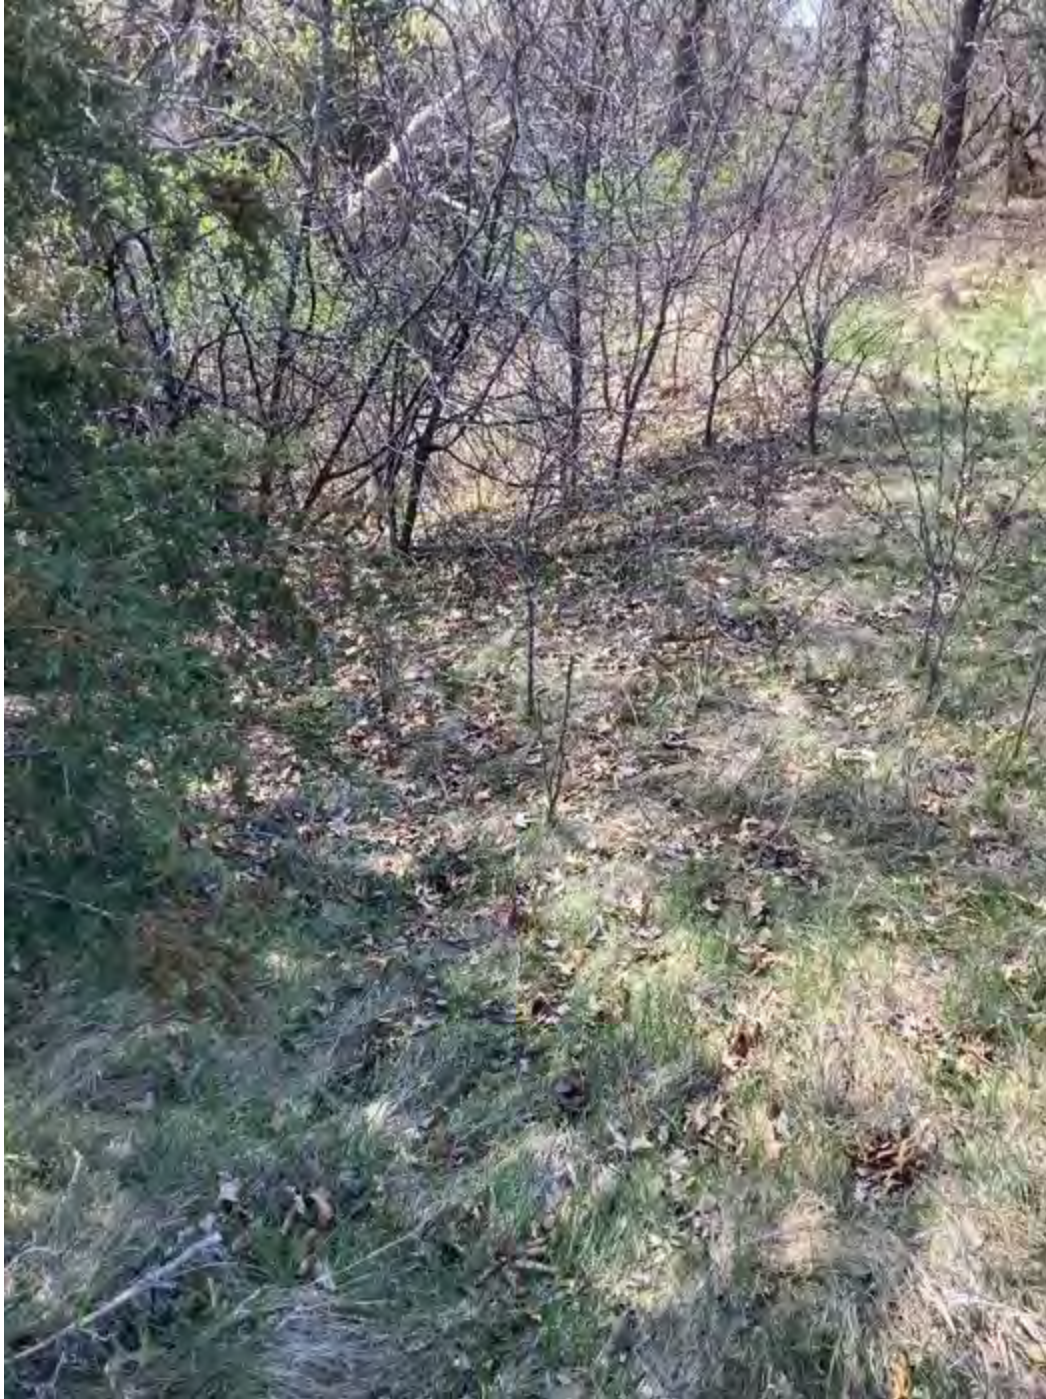
GULLY ID: ESPM Site 10	 
PREVIOUS WAYPOINT ID: Site 10	
SURVEY DATE: April 22, 2021 1:11 PM	
LOCATION:	
TYPE OF SITE: Gully	
SITE SUMMARY: Sunny Rain in previous 24 hours: No Along a Road Medium: 50'-100' gully. The problem indicators were: Aggradation, Loss of Bank Vegetation, Flattened and/or slumping banks (widening), pistol-butted or leaning trees	<p>Gully Head UTM Estimation: 15 ft,</p> <p>Observation Point correction, if applicable:</p> <p>Connections to other points, if applicable:</p>
GULLY INFORMATION	
EROSION POTENTIAL:	High
GULLY DEPTH:	Deep: >15'
BOTTOM WIDTH:	Medium: 1'-5', Wide: >5'
TOP WIDTH:	Wide: >10'
BANK CONDITION:	Some Vegetation
BOTTOM CONDITION:	Some Vegetation
CHANNEL SLOPE:	Steep
GULLY SHAPE:	V-shaped
GULLY MATERIAL:	Fine-grained cohesive
WATER LEVELS	None, N/A
SEEP	No
APPARENT CAUSES:	Slope, Unstable drainage feature entering system
ADDITIONAL NOTES:	
In state aquatic management site

Invasive Species? Type:	
Debris? Some trash	
Existing Stabilization? None	
Success: N/A

Start of gully

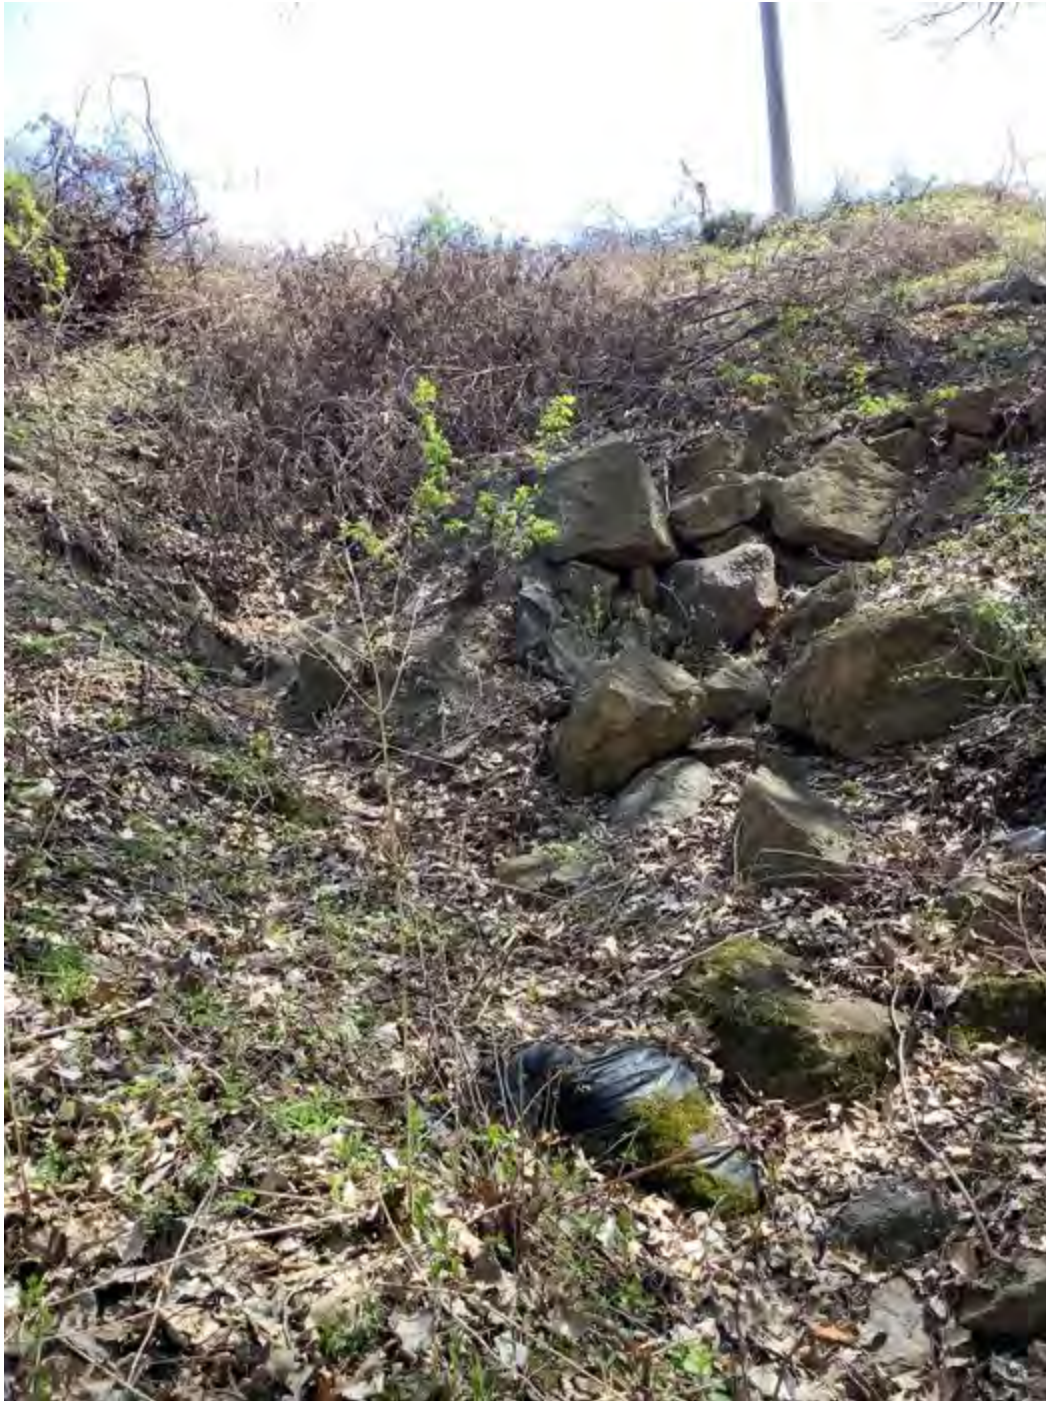
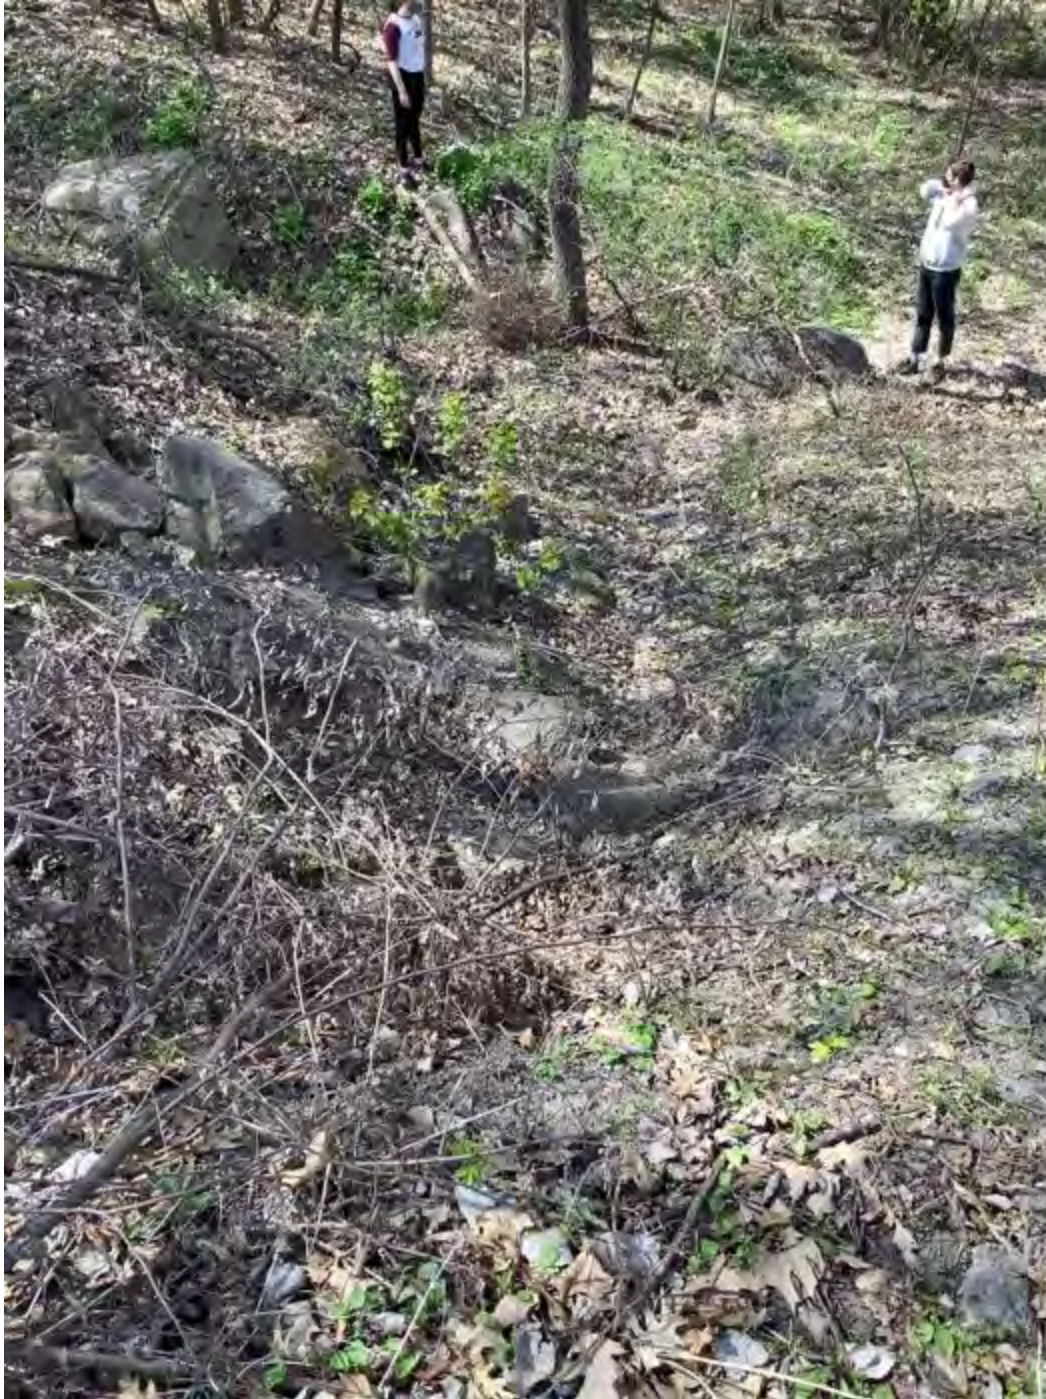
GULLY ID: ESPM Site 11	 
PREVIOUS WAYPOINT ID: Site 11	
SURVEY DATE: April 22, 2021 1:29 PM	
LOCATION: Savage	
TYPE OF SITE: Gully	
SITE SUMMARY: Sunny Rain in previous 24 hours: No Along a Road Medium: 50'-100' gully. The problem indicators were: Degradation, Aggradation, Loss of Bank Vegetation, Vertical and/or bare banks (incision), Flattened and/or slumping banks (widening)	
GULLY INFORMATION	
EROSION POTENTIAL:	High
GULLY DEPTH:	Shallow: <3'
BOTTOM WIDTH:	Medium: 1'-5'
TOP WIDTH:	Narrow: 1'-5'
BANK CONDITION:	Some Vegetation
BOTTOM CONDITION:	Bare Soil
CHANNEL SLOPE:	Steep
GULLY SHAPE:	V-shaped
GULLY MATERIAL:	Sand, Fine-grained cohesive
WATER LEVELS	None, N/A
SEEP	No
APPARENT CAUSES:	Slope, Unstable drainage feature entering system , Channel Incision
ADDITIONAL NOTES: Invasive Species? None Type: None Debris? Some debris but no trash Existing Stabilization? None Success: No, N/A

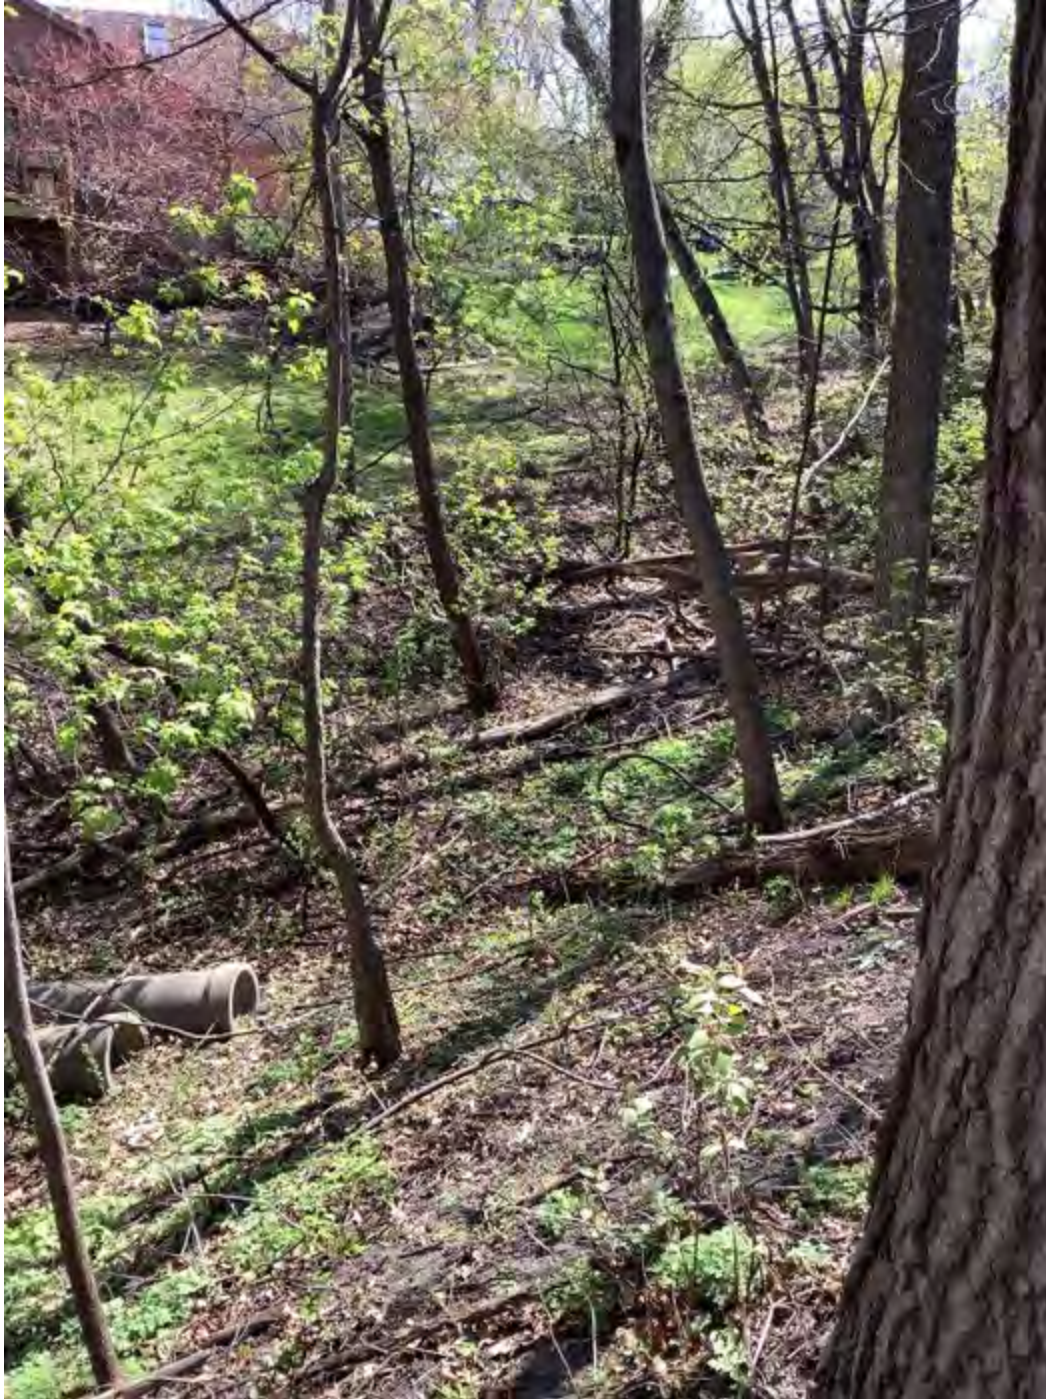
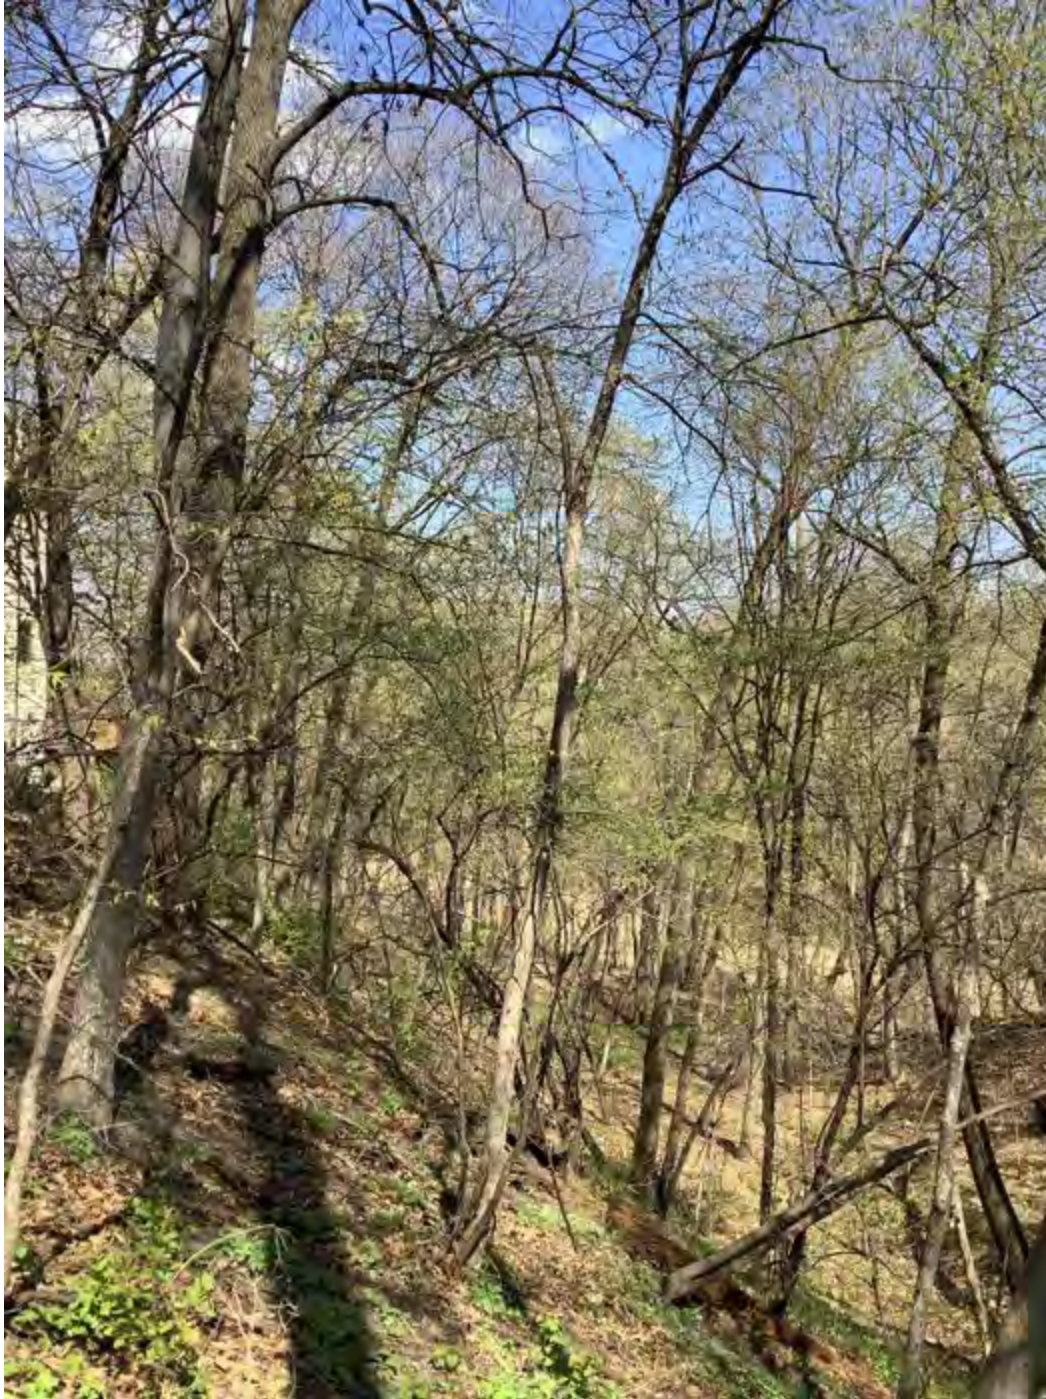
GULLY ID: ESPM Site 13

<p>Gully Head UTM Estimation: 50 ft,</p> <p>Observation Point correction, if applicable:</p> <p>Connections to other points, if applicable:</p>
PREVIOUS WAYPOINT ID: Site 13	
SURVEY DATE: April 22, 2021 2:44 PM	
LOCATION: Savage	
TYPE OF SITE: Gully	
SITE SUMMARY: Sunny Rain in previous 24 hours: No Along a Road Long: >100' gully. The problem indicators were: Degradation, Flattened and/or slumping banks (widening), pistol-butted or leaning trees	
GULLY INFORMATION	
EROSION POTENTIAL:	High
GULLY DEPTH:	Deep: >15'
BOTTOM WIDTH:	Wide: >5'
TOP WIDTH:	Wide: >10', Medium: 5'-10', Narrow: 1'-5'
BANK CONDITION:	Some Vegetation
BOTTOM CONDITION:	Some Vegetation
CHANNEL SLOPE:	Steep
GULLY SHAPE:	V-shaped
GULLY MATERIAL:	Fine-grained cohesive
WATER LEVELS	None, N/A
SEEP	No
APPARENT CAUSES:	Slope, Unstable drainage feature entering system
ADDITIONAL NOTES:	
Invasive Species? Type:	
Debris? Some trash and debris

Existing Stabilization? None	
Success: N/A

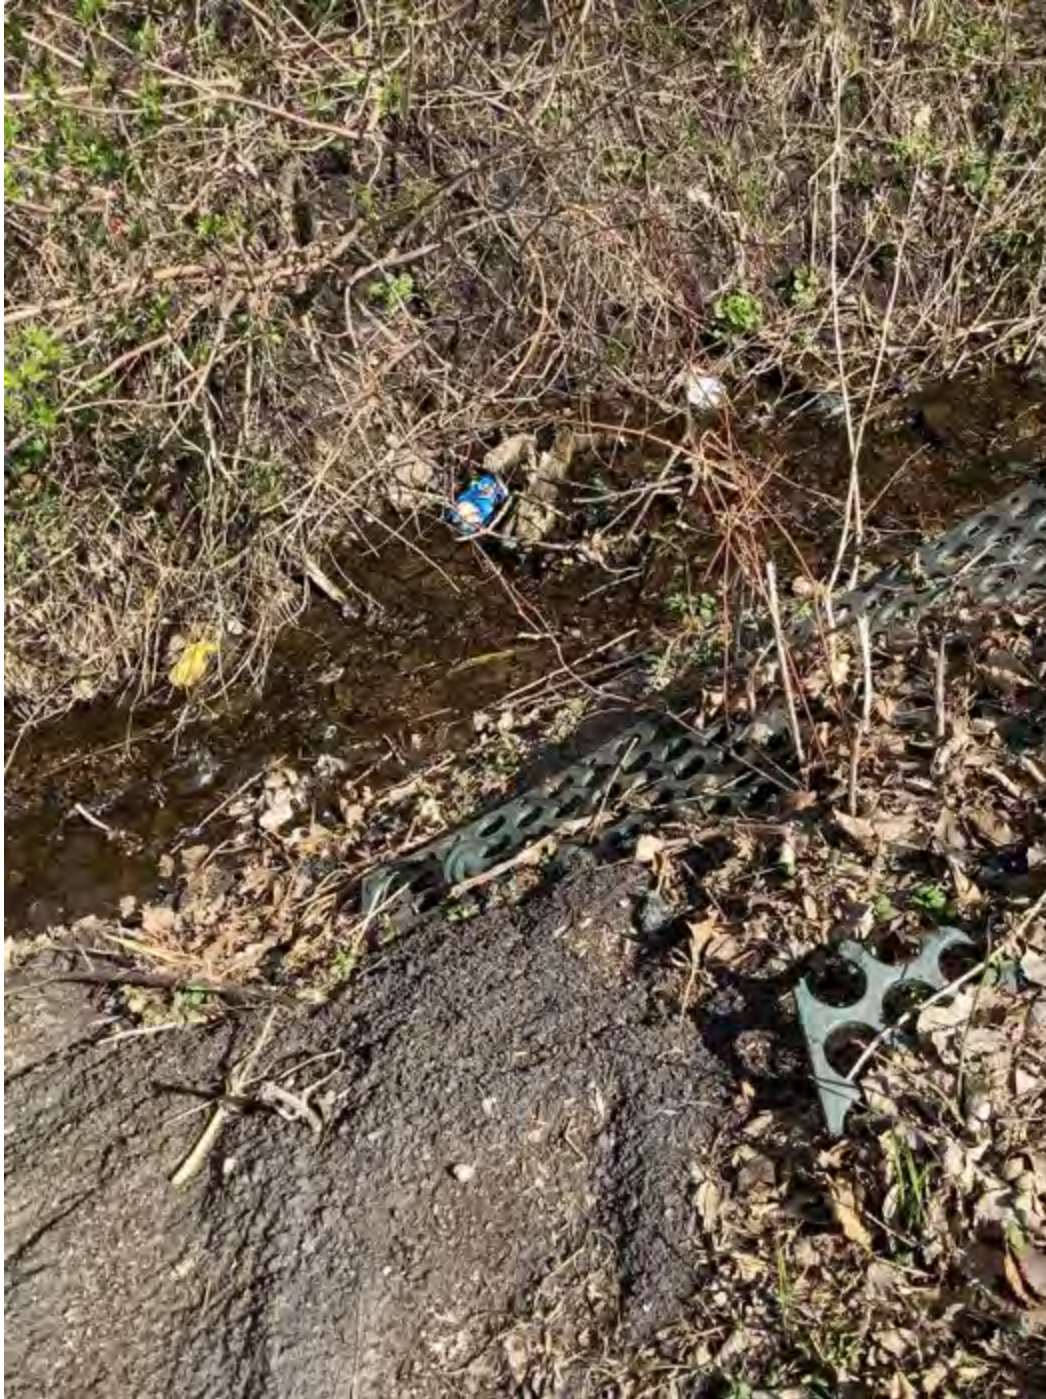
Debris and trash

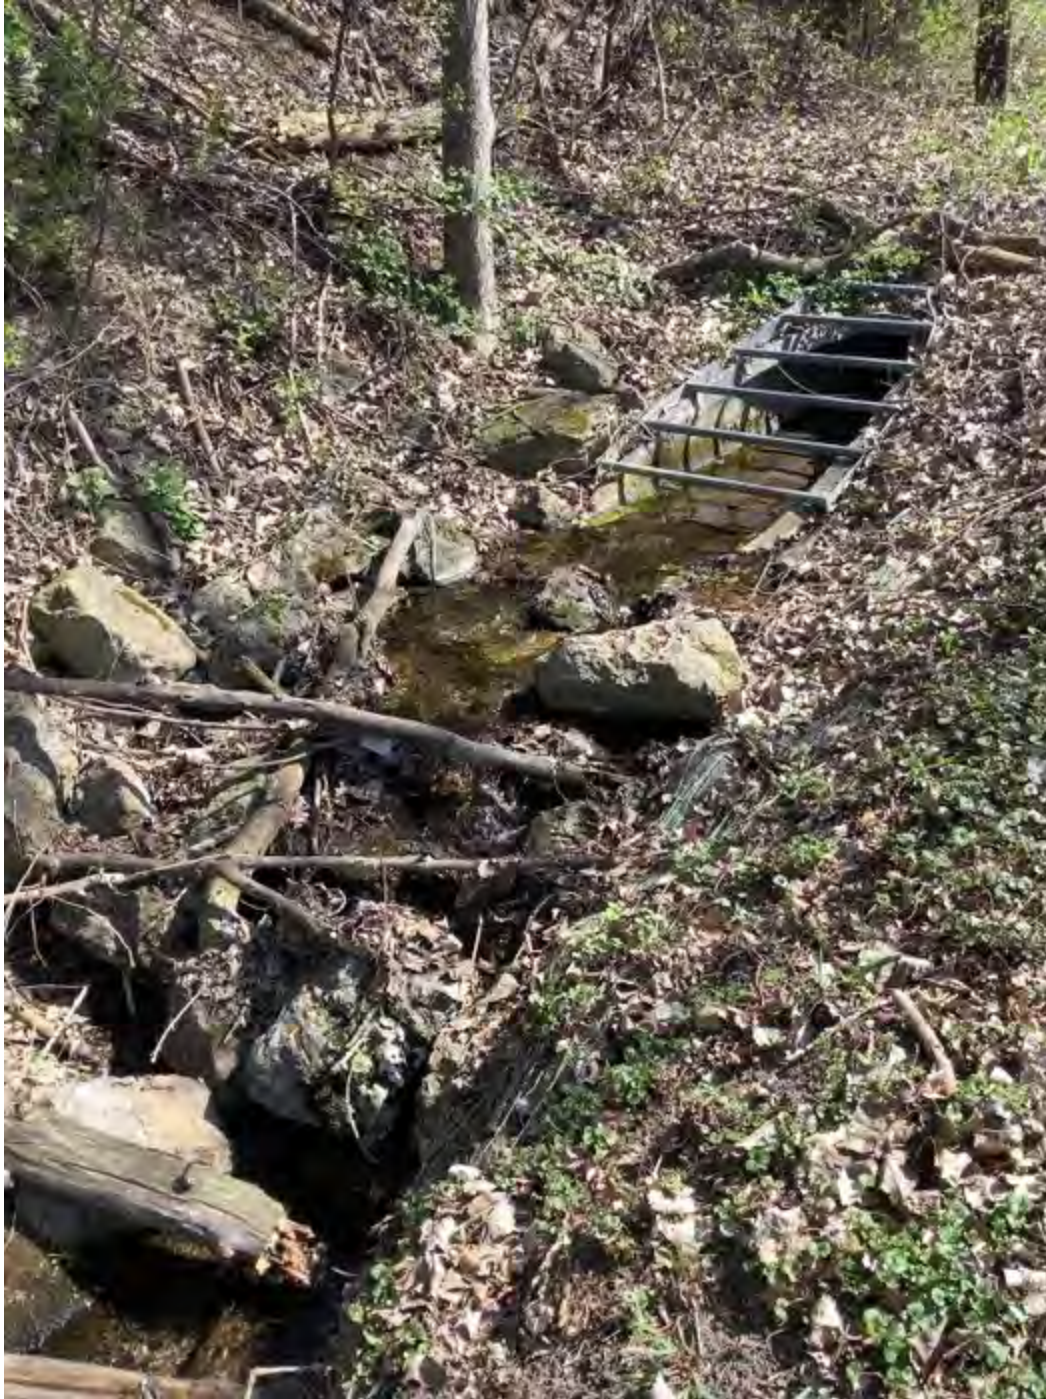
Aproned outlet
