2021 GULLY INVENTORY AND CONDITION ASSESSMENT, VOLUME 2

July 15, 2022

Lower Minnesota River Watershed District
112 E. 5th Street, #102
Chaska, MN 55318

Young Environmental Consulting Group, LLC
6040 Earle Brown Drive, Suite 306
Brooklyn Center, MN 55430

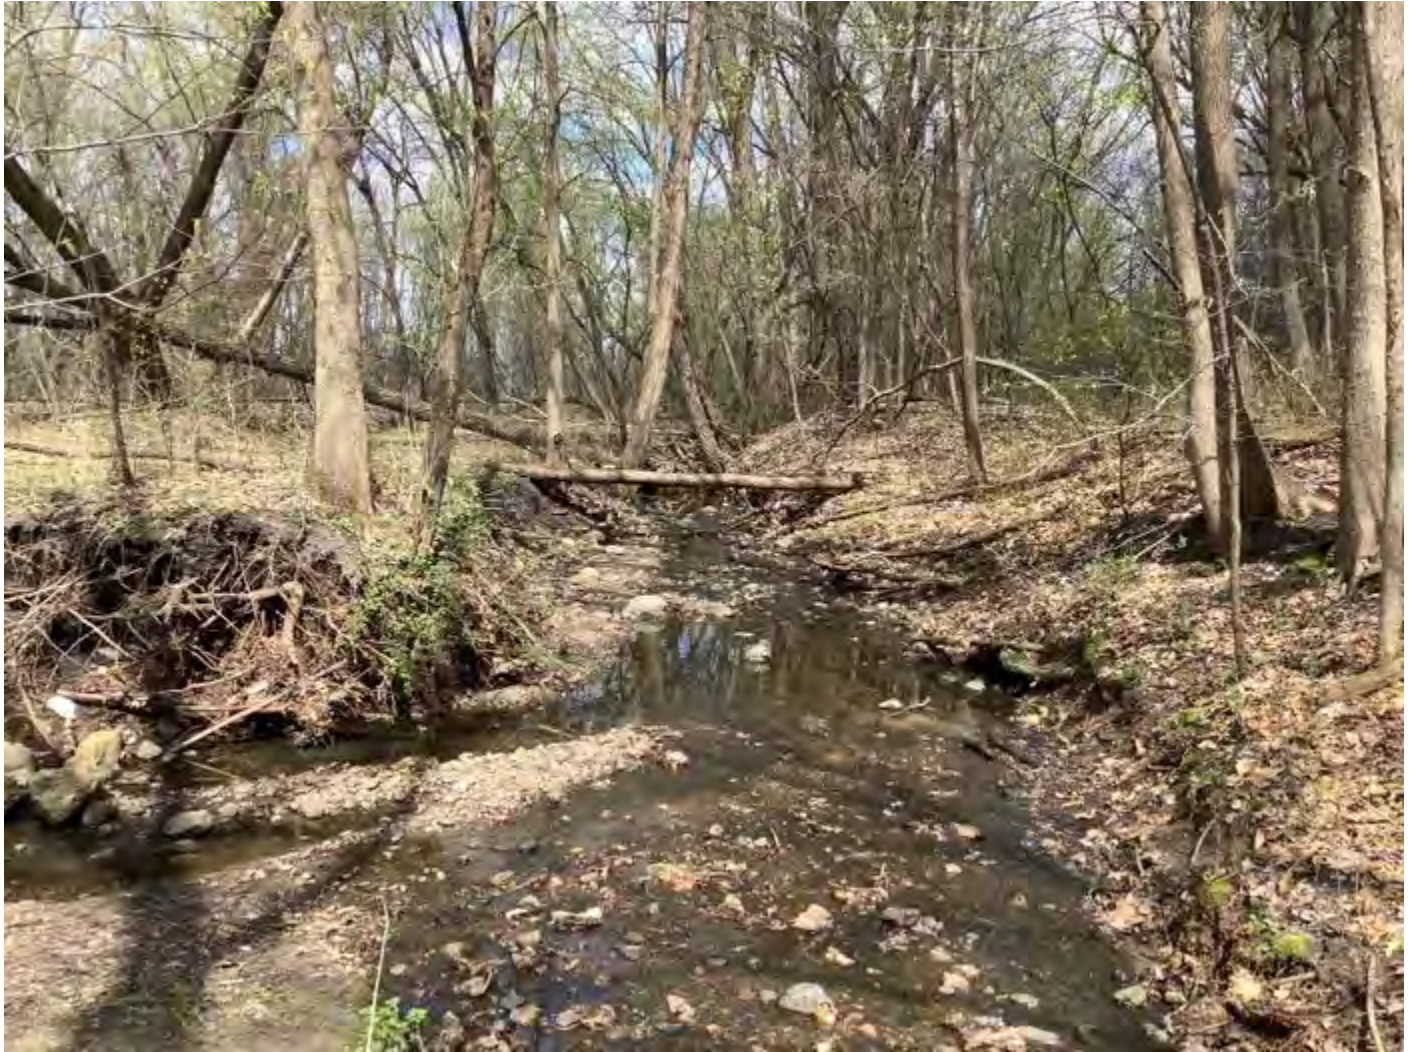
PREVIOUS WAYPOINT ID:	
SURVEY DATE: April 17, 2021 2:26 PM	
LOCATION:	
TYPE OF SITE: Gully	
SITE SUMMARY: Sunny Rain in previous 24 hours: No Heavily Forested Long: >100' gully. The problem indicators were: Loss of Bank Vegetation, undercut or overhanging banks (lateral scouring)	Gully Head UTM Estimation: 20, Observation Point correction, if applicable: Connections to other points, if applicable:
GULLY INFORMATION	
EROSION POTENTIAL:	Low
GULLY DEPTH:	Shallow: <3'
BOTTOM WIDTH:	Wide: >5'
TOP WIDTH:	Wide: >10'
BANK CONDITION:	Some Vegetation
BOTTOM CONDITION:	Armored
CHANNEL SLOPE:	Steep
GULLY SHAPE:	U-shaped
GULLY MATERIAL:	Gravel/cobble/ boulders
WATER LEVELS	Low, Slow
SEEP	No
APPARENT CAUSES:	None/Unknown
ADDITIONAL NOTES: 8ft storm drain outlet creates stream Invasive Species? Medium Type: Common Buckthorn Debris? Some Existing Stabilization? N/a Success: N/A

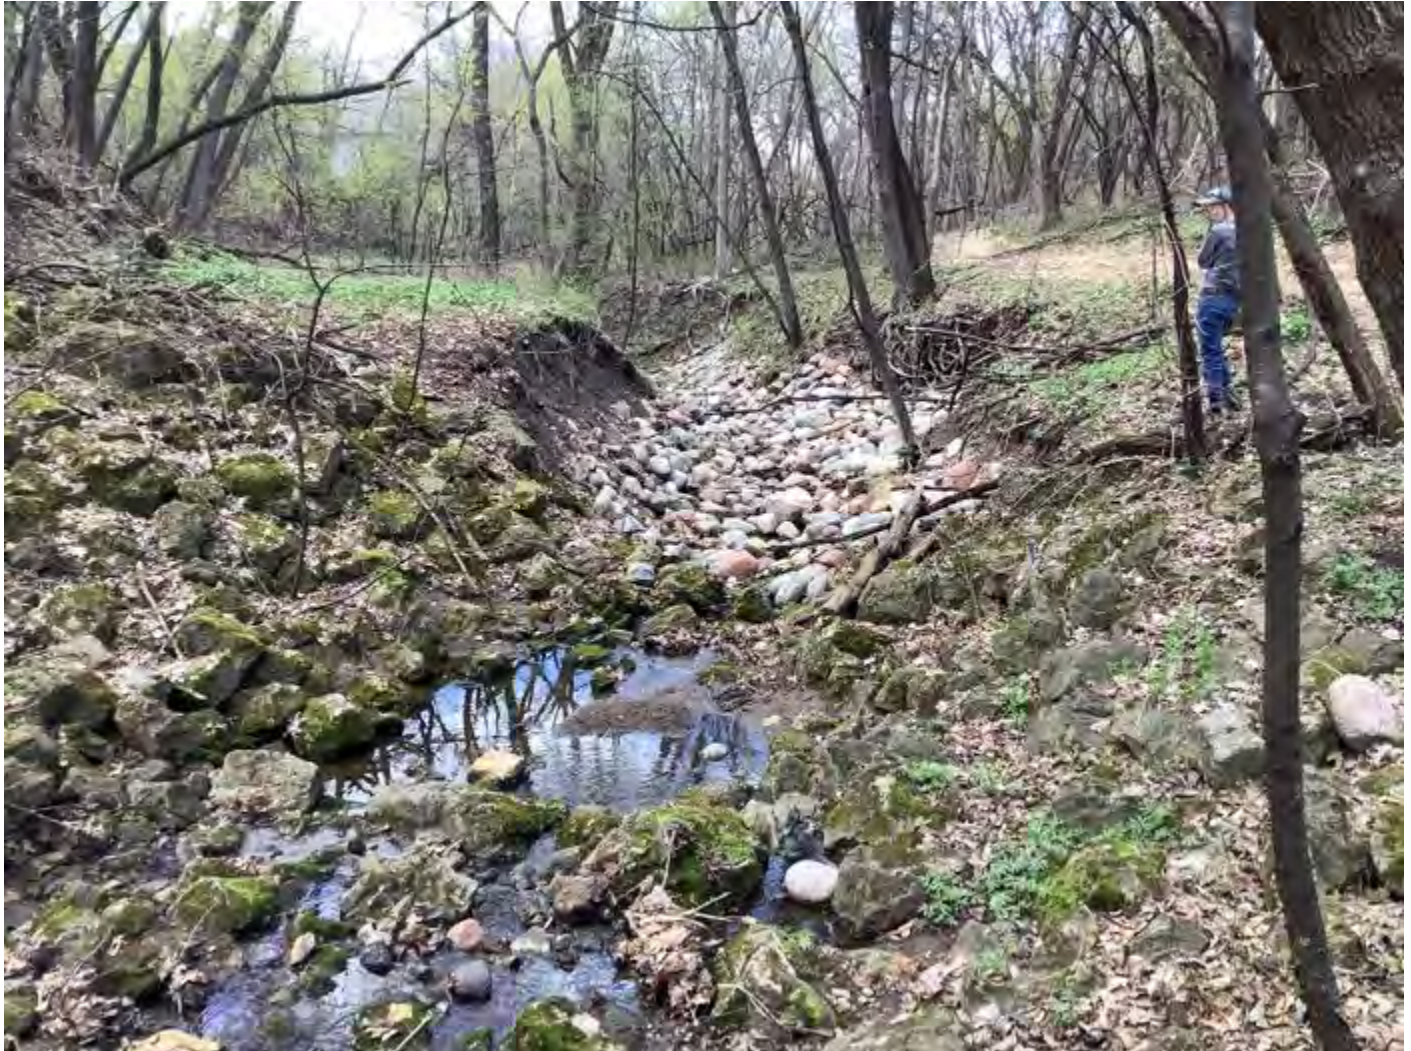
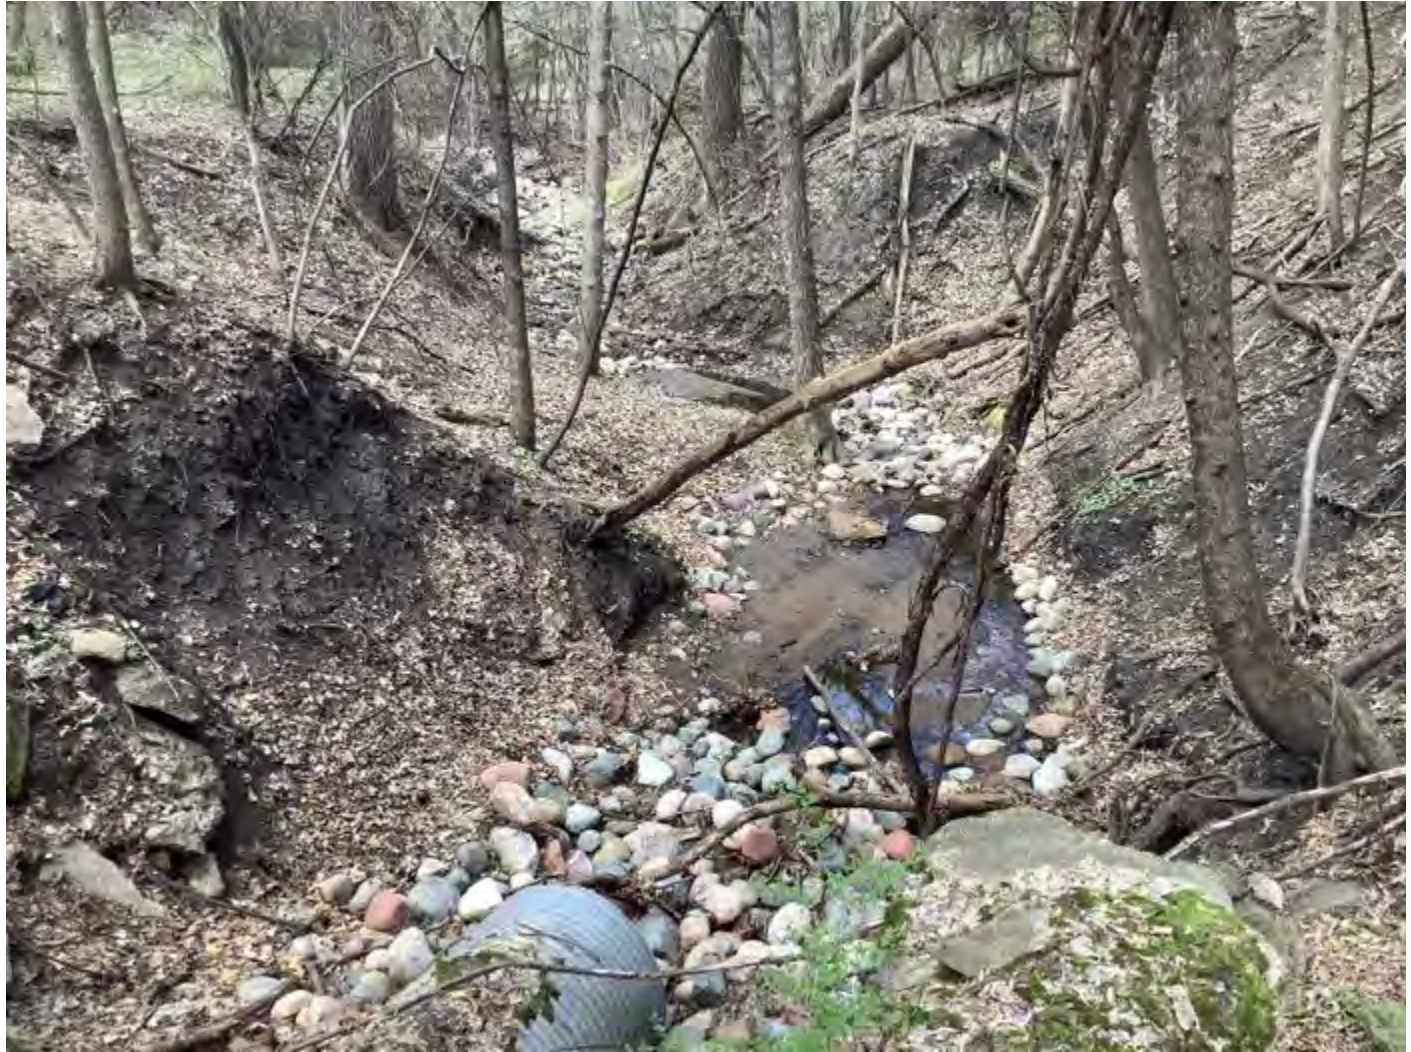
GULLY ID: ESPM Site 23

PREVIOUS WAYPOINT ID:	
SURVEY DATE: April 17, 2021 2:12 PM	
LOCATION:	
TYPE OF SITE: Gully	
SITE SUMMARY: Sunny Rain in previous 24 hours: No Off of Walking Trail Long: >100' gully. The problem indicators were: Degradation, Loss of Bank Vegetation, Vertical and/or bare banks (incision), pistol-butted or leaning trees	Gully Head UTM Estimation: 100ft, Observation Point correction, if applicable: Connections to other points, if applicable:
GULLY INFORMATION	
EROSION POTENTIAL:	High
GULLY DEPTH:	Shallow: <3'
BOTTOM WIDTH:	Wide: >5'
TOP WIDTH:	Wide: >10'
BANK CONDITION:	Bare Soil
BOTTOM CONDITION:	Some Vegetation
CHANNEL SLOPE:	Flat
GULLY SHAPE:	U-shaped
GULLY MATERIAL:	Gravel/cobble/ boulders
WATER LEVELS	Low, Slow
SEEP	Yes
APPARENT CAUSES:	Slope, Scour from debris jam or other channel obstruction, Channel Incision, Dense Canopy
ADDITIONAL NOTES: In wildlife refuge and disappears after entering hidden pipe, couldn't find outlet Invasive Species? Medium Type: Common Buckthorn Debris? No Existing Stabilization? Boulders on slopes (pictured) Success: Yes

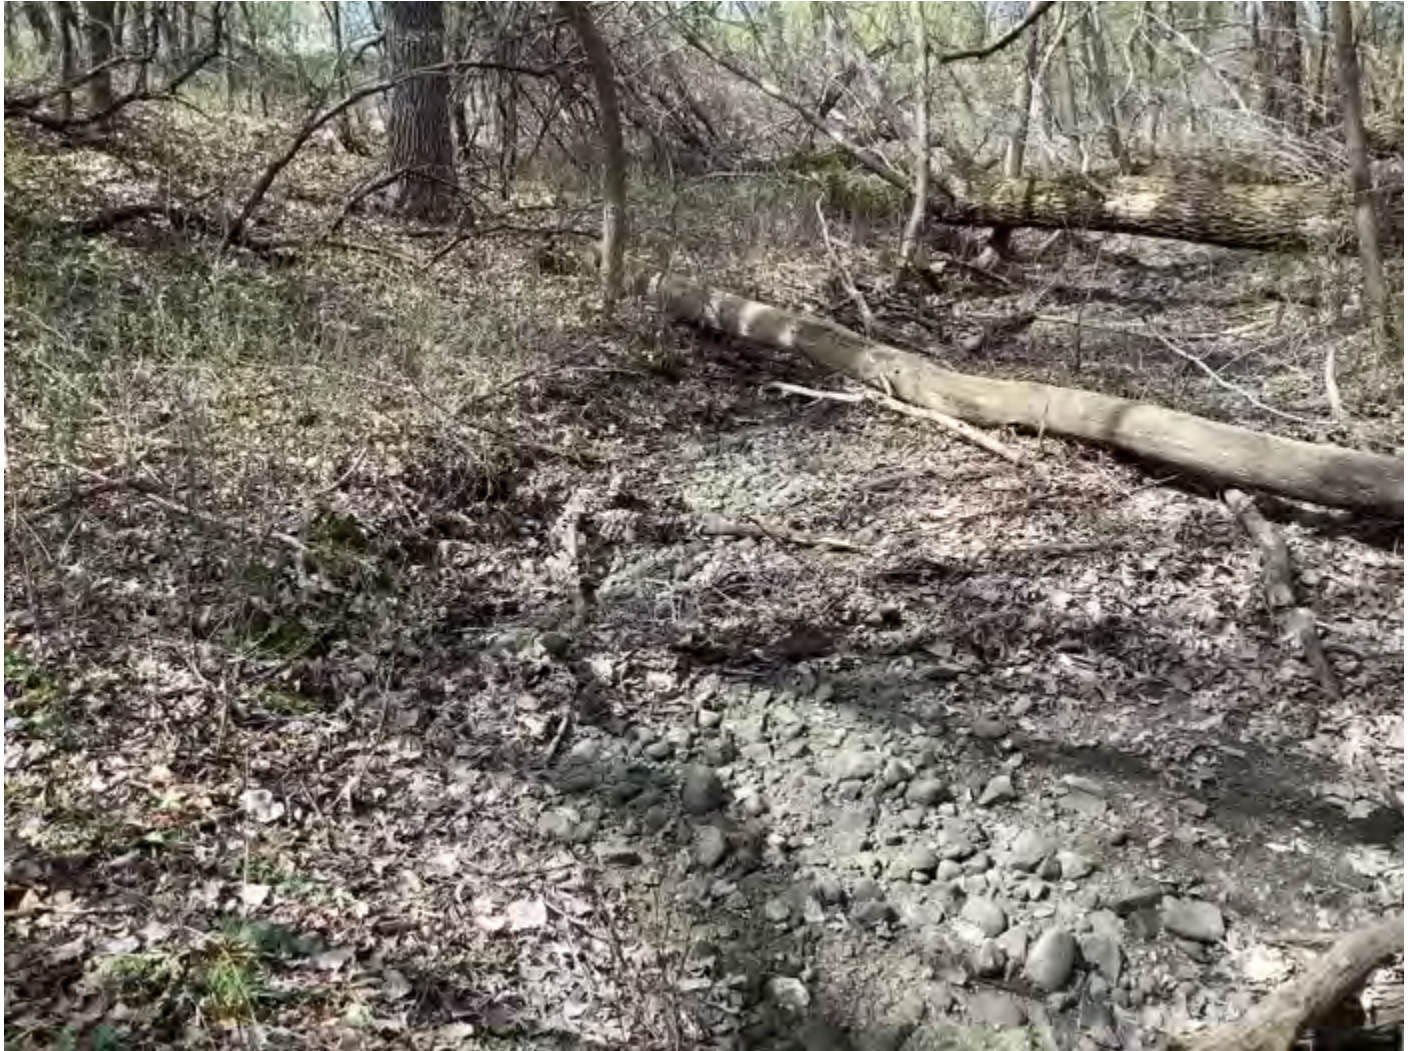
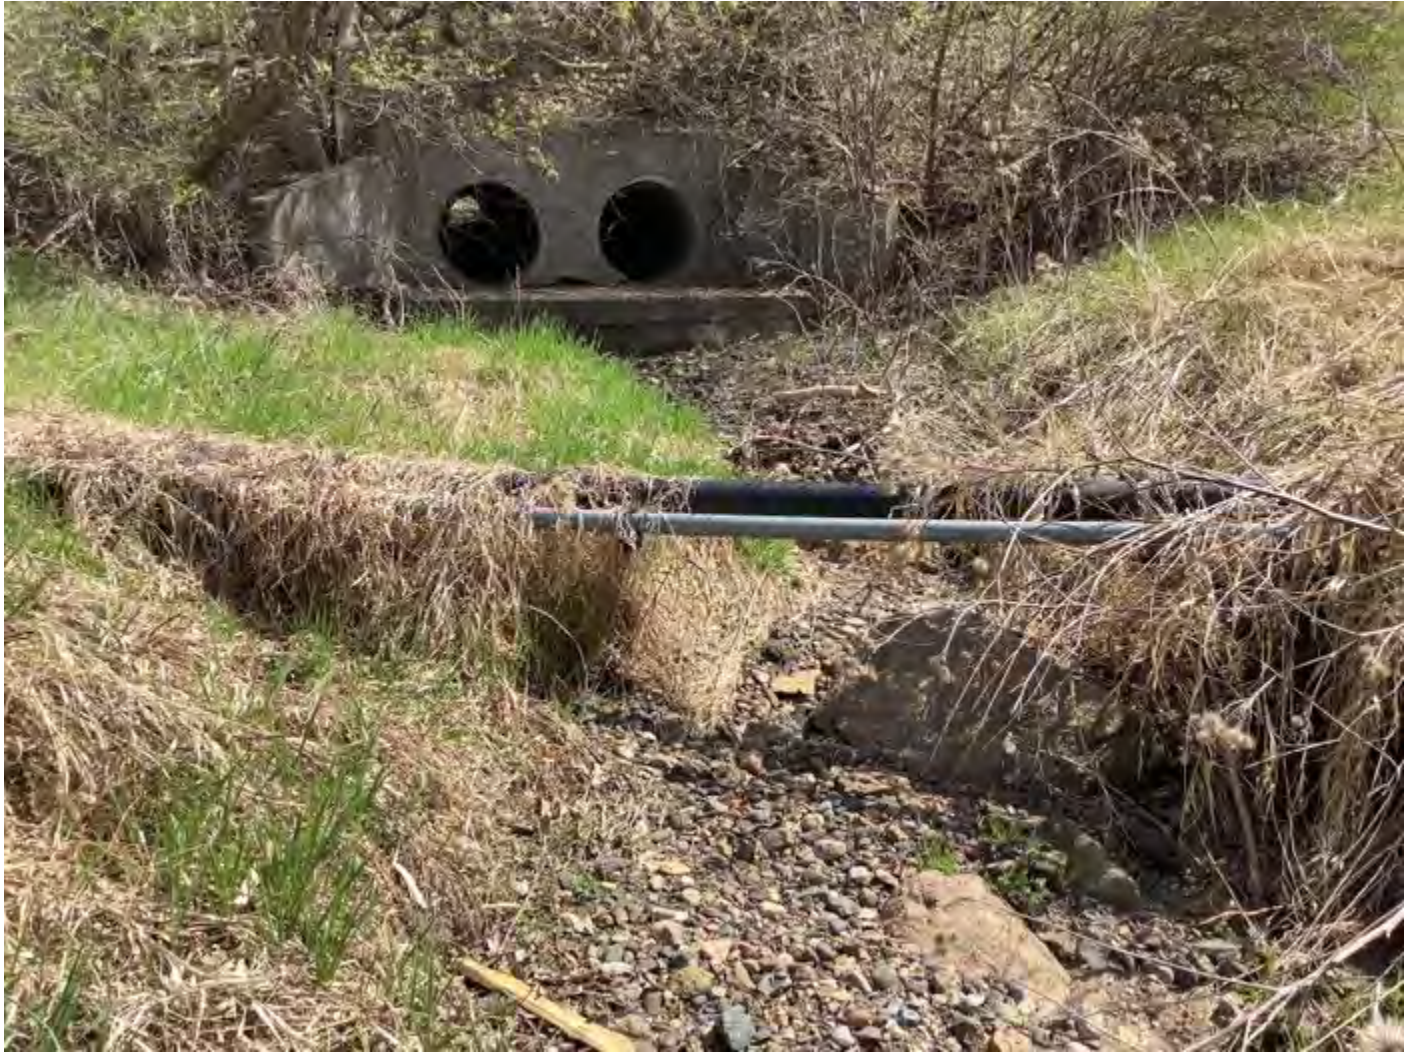
GULLY ID: ESPM Site 28

PREVIOUS WAYPOINT ID:	
SURVEY DATE: April 17, 2021 12:18 PM	
LOCATION:	
TYPE OF SITE: Gully	
SITE SUMMARY: Sunny Rain in previous 24 hours: No Along a Road Long: >100' gully. The problem indicators were: None	
<p>Gully Head UTM Estimation: 100ft,</p> <p>Observation Point correction, if applicable:</p> <p>Connections to other points, if applicable: We had two locations which are the same gully</p>	
GULLY INFORMATION	
EROSION POTENTIAL:	Low
GULLY DEPTH:	Shallow: <3'
BOTTOM WIDTH:	Medium: 1'-5'
TOP WIDTH:	Wide: >10'
BANK CONDITION:	Heavy Vegetation
BOTTOM CONDITION:	Armored
CHANNEL SLOPE:	Flat
GULLY SHAPE:	U-shaped
GULLY MATERIAL:	Gravel/cobble/ boulders
WATER LEVELS	None, N/A
SEEP	No
APPARENT CAUSES:	None/Unknown
ADDITIONAL NOTES:	
<p>Part of the stormwater drainage system, looks like it receives heavy flow during storm events but it's in great shape. Gully empties into wetland where it joins wastewater treatment outflow.</p> <p>Invasive Species? Low</p> <p>Type: Common Buckthorn</p> <p>Debris? Not much trash, some</p> <p>Existing Stabilization? Rip rap with energy dissipation Boulder piles (pictured) also one erosion control log</p> <p>Success: Yes</p>

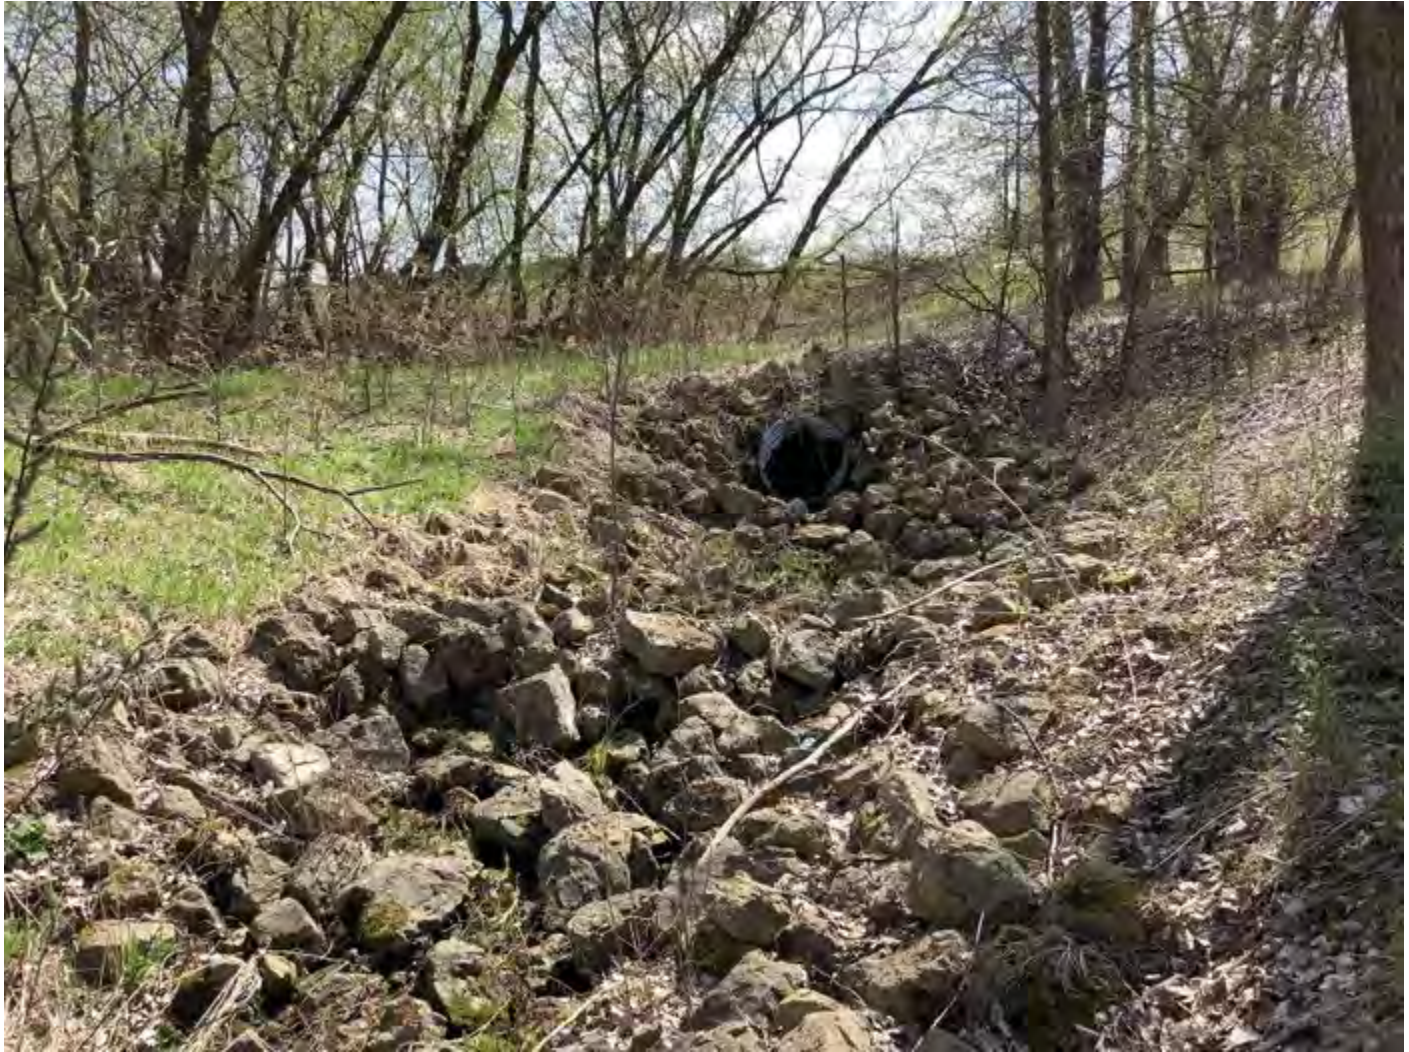
About 1/3 to top of gully

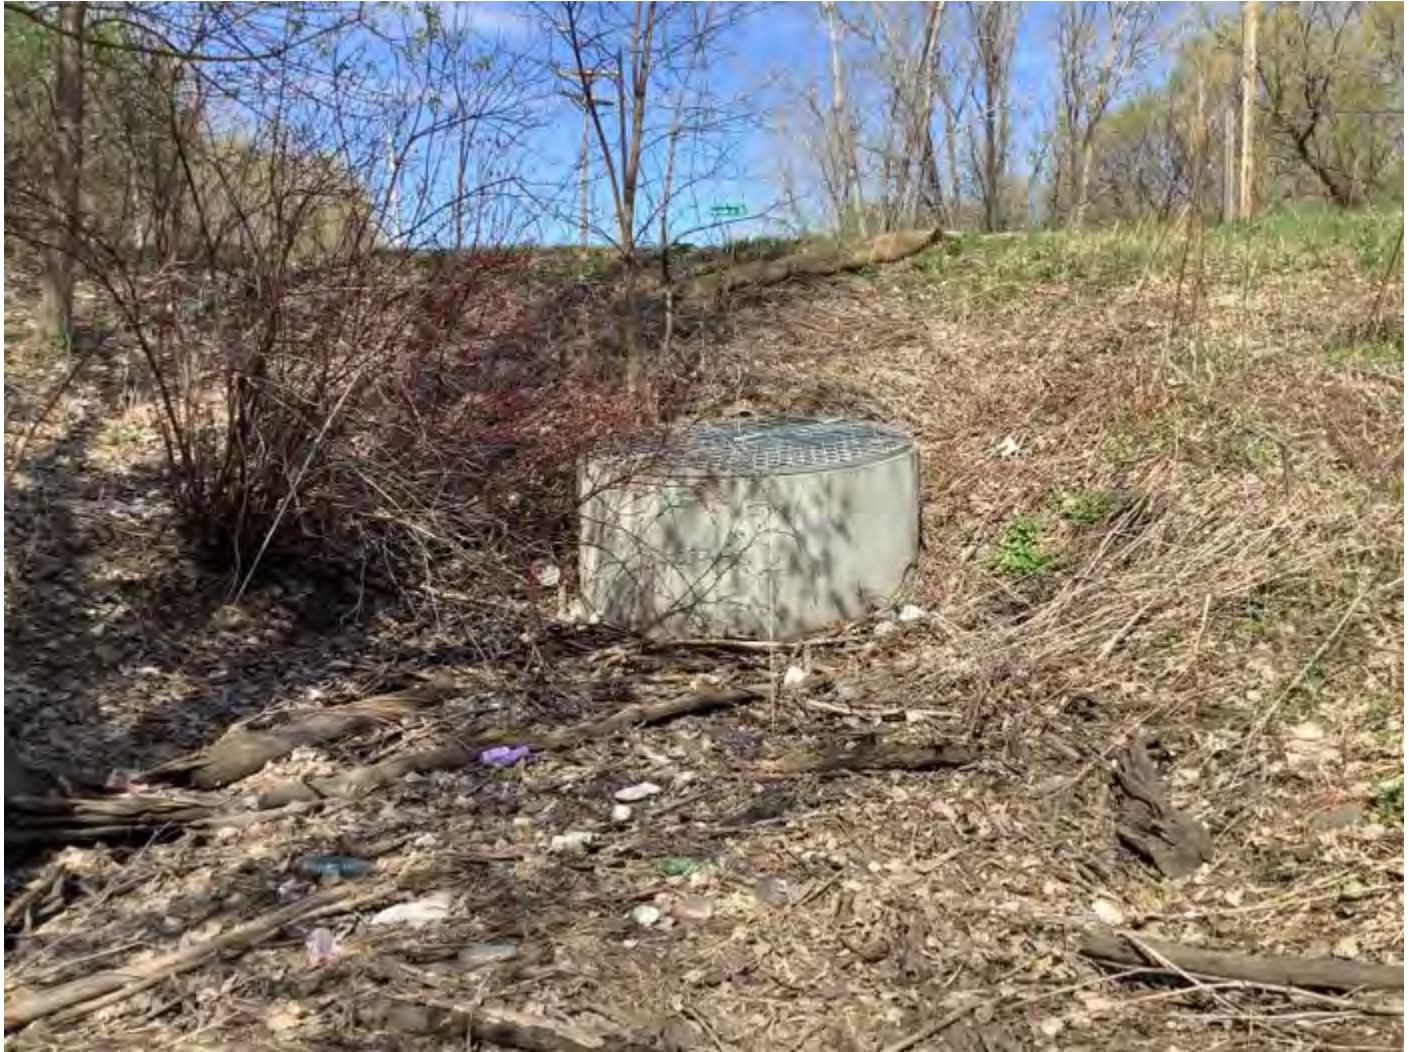
Other side of the last pictures outlet

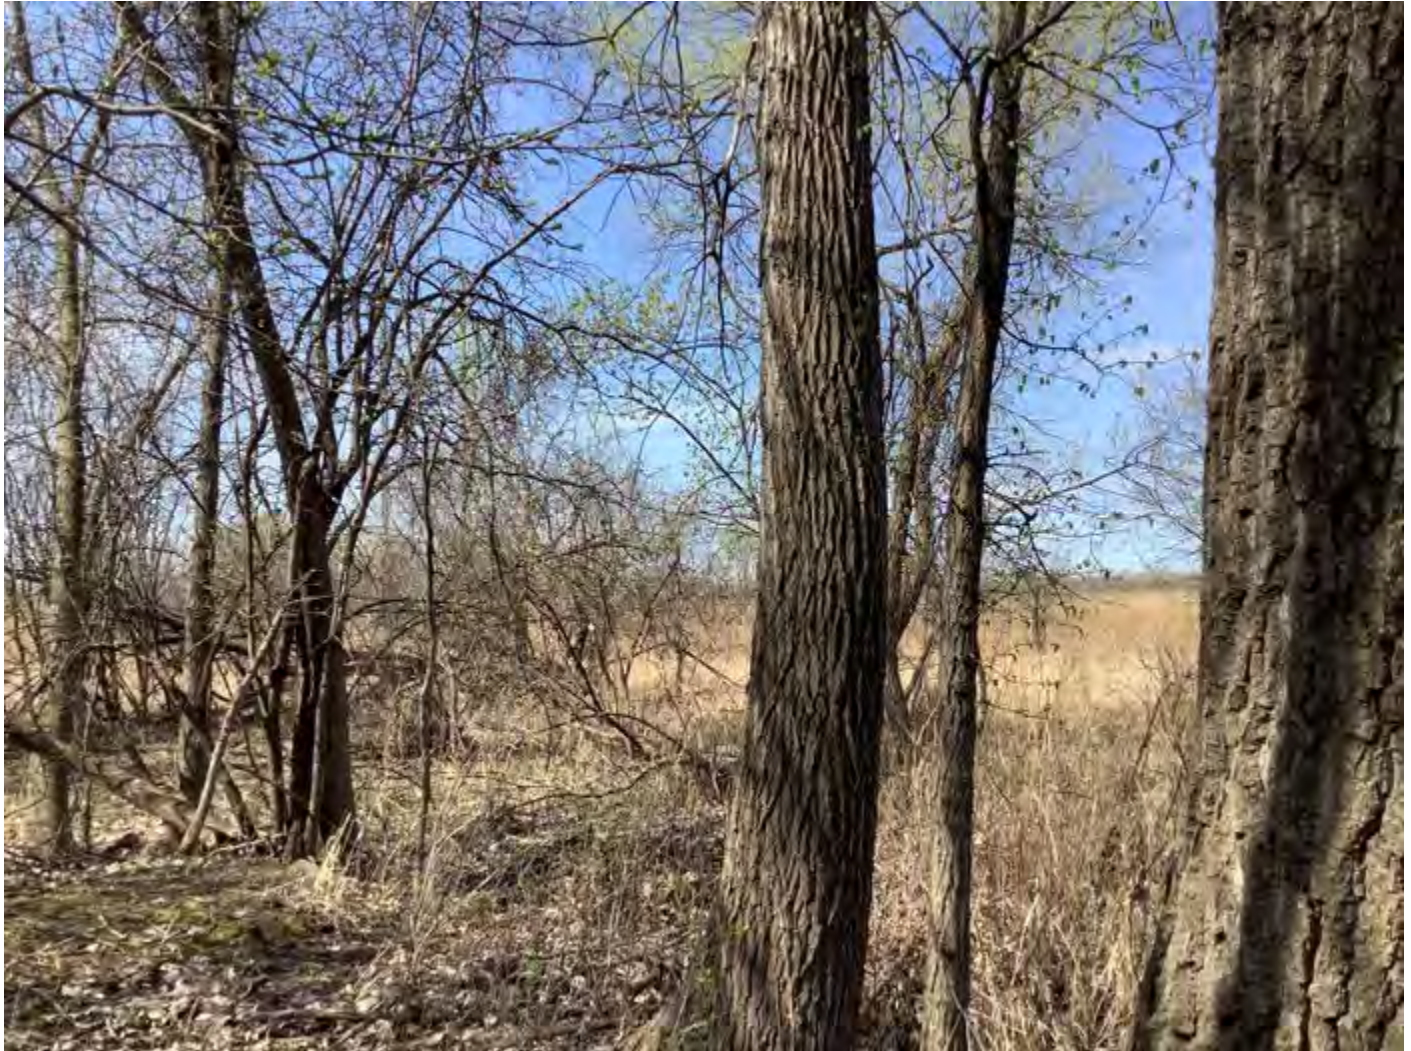
GULLY ID: ESPM Site 29

<p style="text-align: center;">Gully Head UTM Estimation: N/a, Observation Point correction, if applicable: Connections to other points, if applicable:</p>
PREVIOUS WAYPOINT ID:	
SURVEY DATE: April 17, 2021 11:06 AM	
LOCATION:	
TYPE OF SITE: Gully	
SITE SUMMARY: Sunny Rain in previous 24 hours: No Off of Walking Trail Short: <50' gully. The problem indicators were: None	
GULLY INFORMATION	
EROSION POTENTIAL:	Low
GULLY DEPTH:	Shallow: <3'
BOTTOM WIDTH:	N/A - Not Visible
TOP WIDTH:	Narrow: 1'-5'
BANK CONDITION:	Heavy Vegetation
BOTTOM CONDITION:	Heavy Vegetation
CHANNEL SLOPE:	Flat
GULLY SHAPE:	
GULLY MATERIAL:	Sand
WATER LEVELS	None, N/A
SEEP	No
APPARENT CAUSES:	None/Unknown
ADDITIONAL NOTES: No gully present Invasive Species? Low Type: Common Buckthorn Debris? None Existing Stabilization? Heavy vegetation, no gully presents Success: N/A, Unknown
