Technical Memorandum

Re: 2025 Gully Inventory – Post-Field Assessment Summary

2023 Gully Inventory and Condition Assessment Project

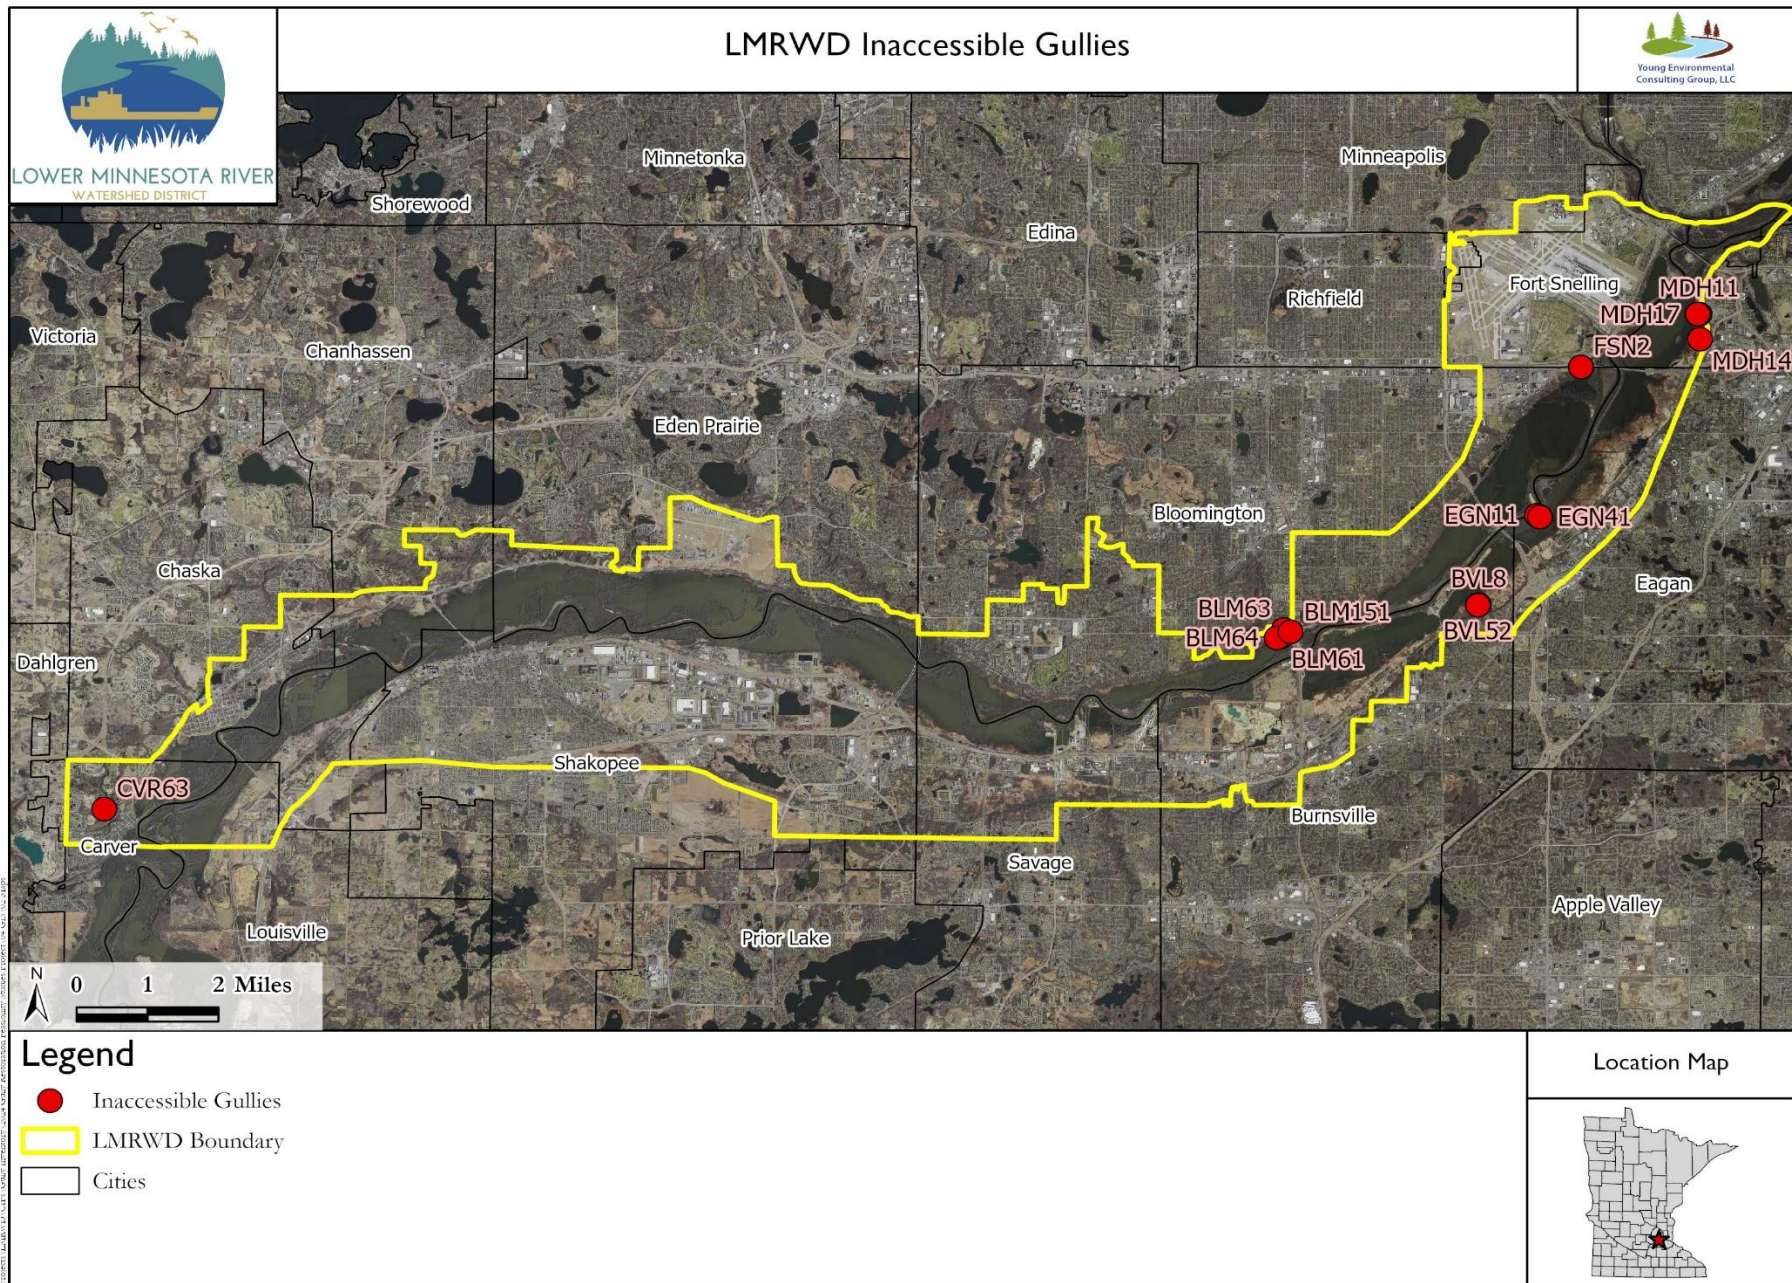
Figure 1. Previously Inaccessible Gullies Surveyed in 2025

EGN11 and 49 were the only gullies field staff were not able to access. GPS pinpoints the location of these gullies within the Minnesota River, suggesting that the coordinates are inaccurate
