SITE LOCATION: CSAH 61-Flying Cloud Drive

PURPOSE: Construction Stormwater Site Visit on Behalf of the Lower Minnesota River Watershed District (LMRWD)

DATE & TIME: 4 December 2018, 0830-1030

INSPECTOR: Sarah Duke Middleton, Water Resources Scientist
Young Environmental Consulting Group, LLC

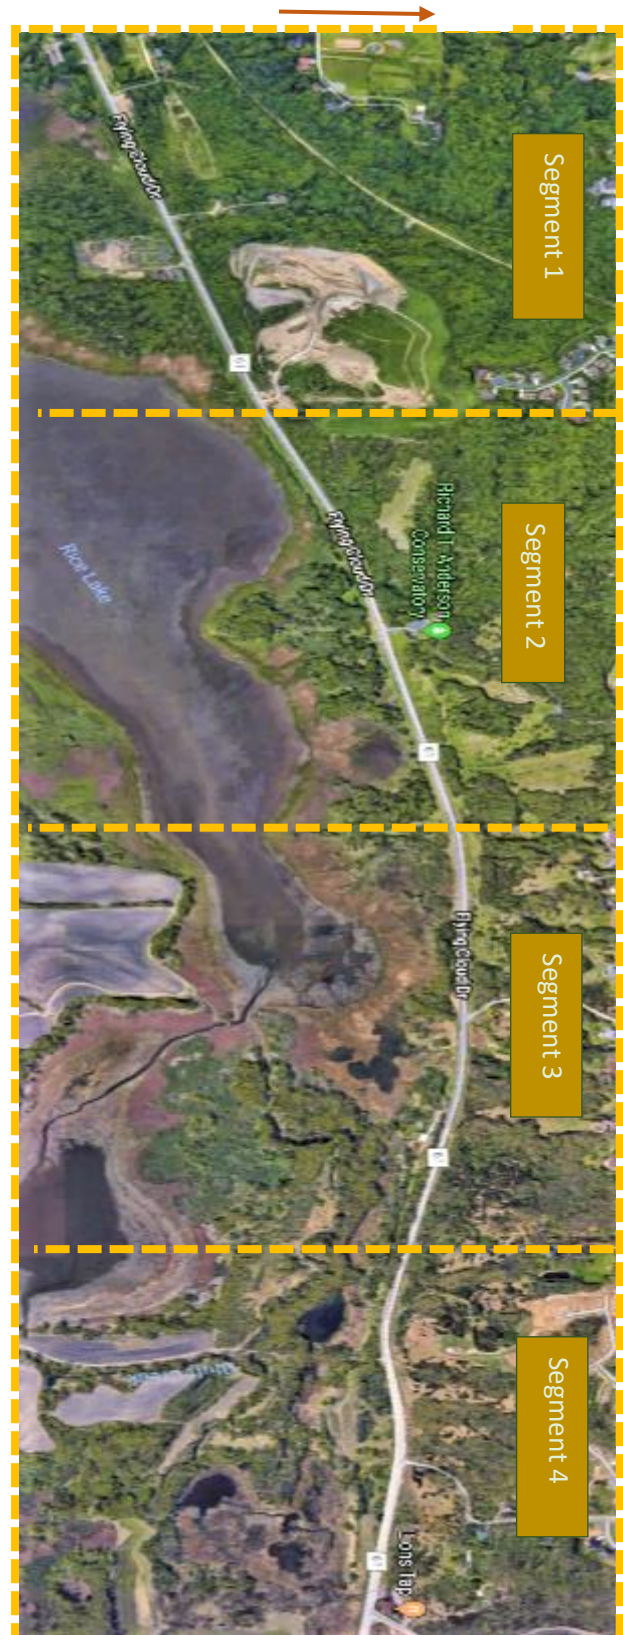
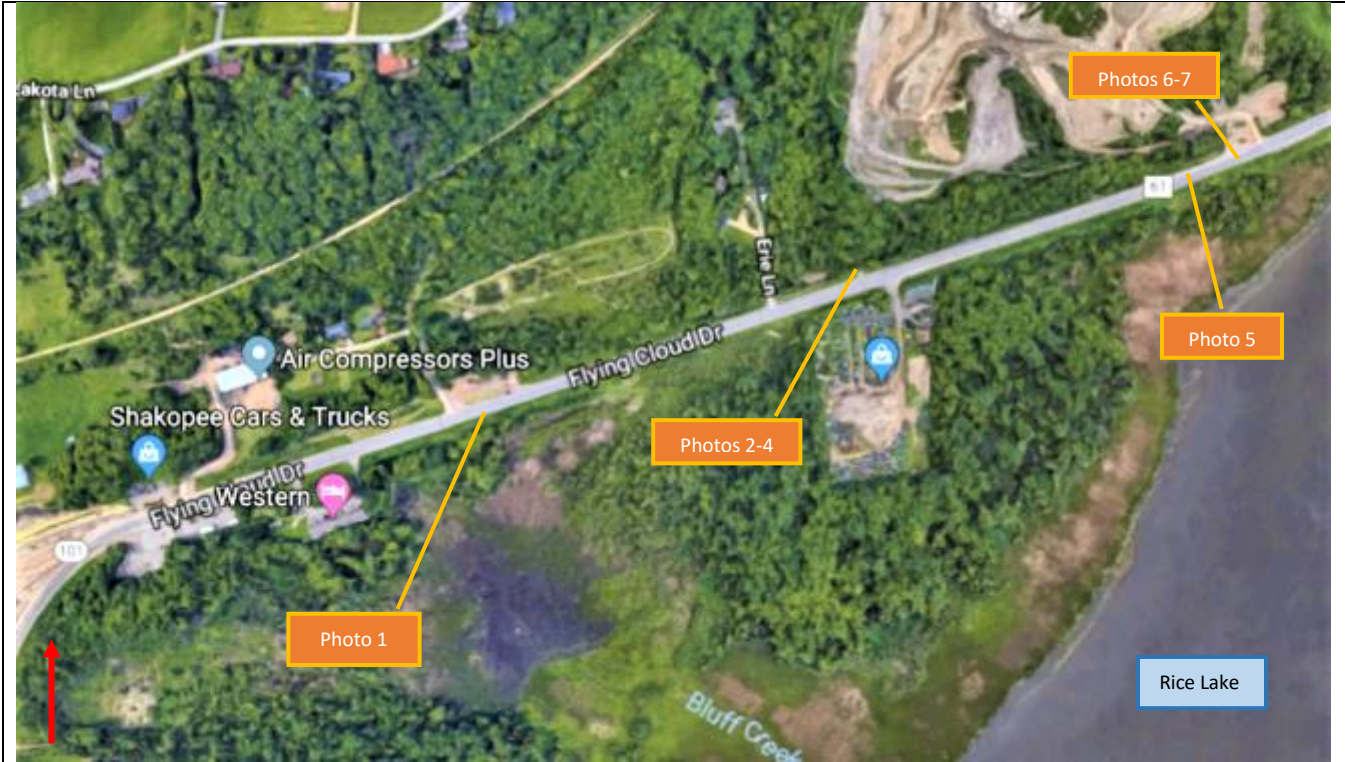
Due to the linear nature of the project, the site has been divided into four segments (see aerial photo ->). The photo log will highlight locations of site features at the segment level.
