LOWER MINNESOTA RIVER WATERSHED DISTRICT

Lower Minnesota River Watershed District Board of Managers Meeting

Monday, January 7, 2019

PURPOSE: Construction Stormwater Site Visit on Behalf of the Lower Minnesota River Watershed District (LMRWD)

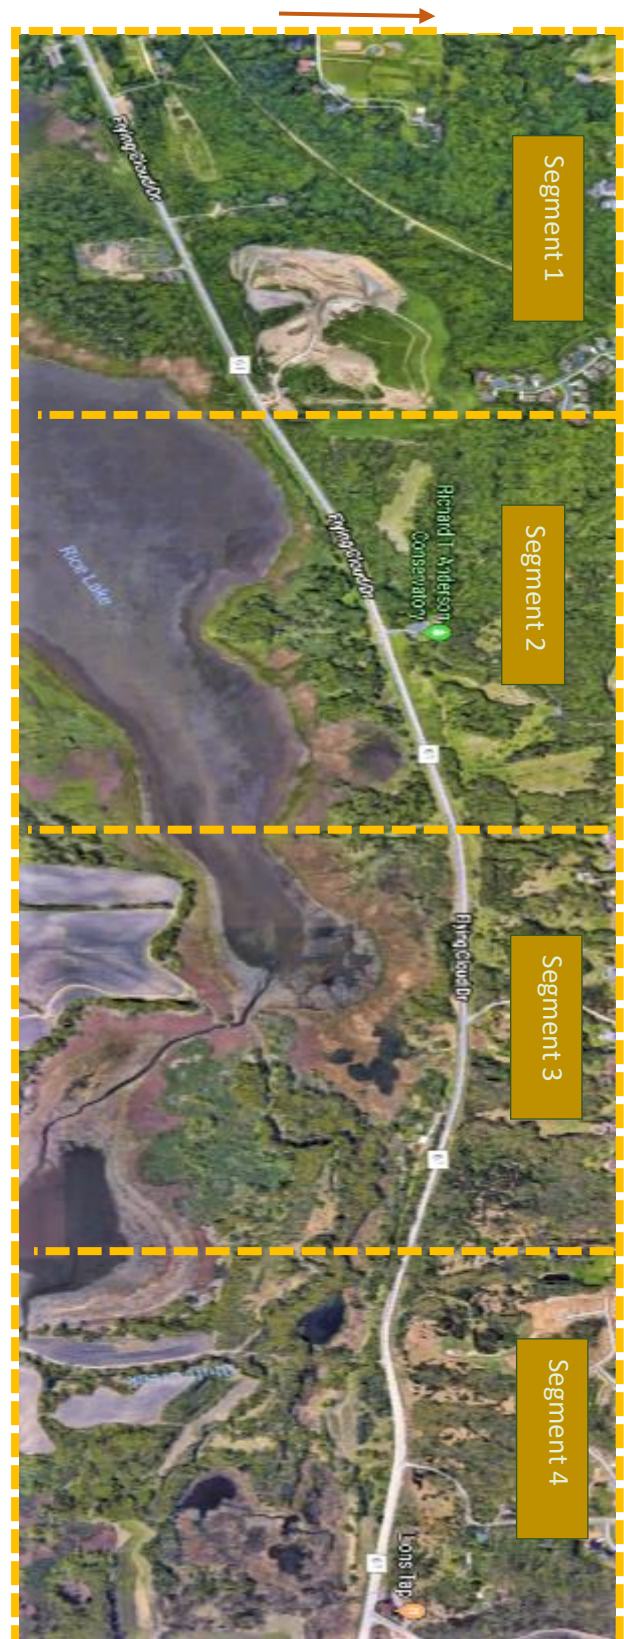
Due to the linear nature of the project, the site has been divided into four segments (see aerial photo ->). The photo log will highlight locations of site features at the segment level.
