## Memorandum

**To:** Della Schall Young, Principal, Young Environmental Consulting Group, LLC  
Linda Loomis, Administrator, Lower Minnesota River Watershed District  
**From:** Jeff Weiss, PE, Senior Water Resources Engineer  
Adam Howard, PE, Water Resources Engineer  
**Subject:** East Chaska Creek Assessment  
**Date:** January 18, 2019  
**Project:** 23101028.02

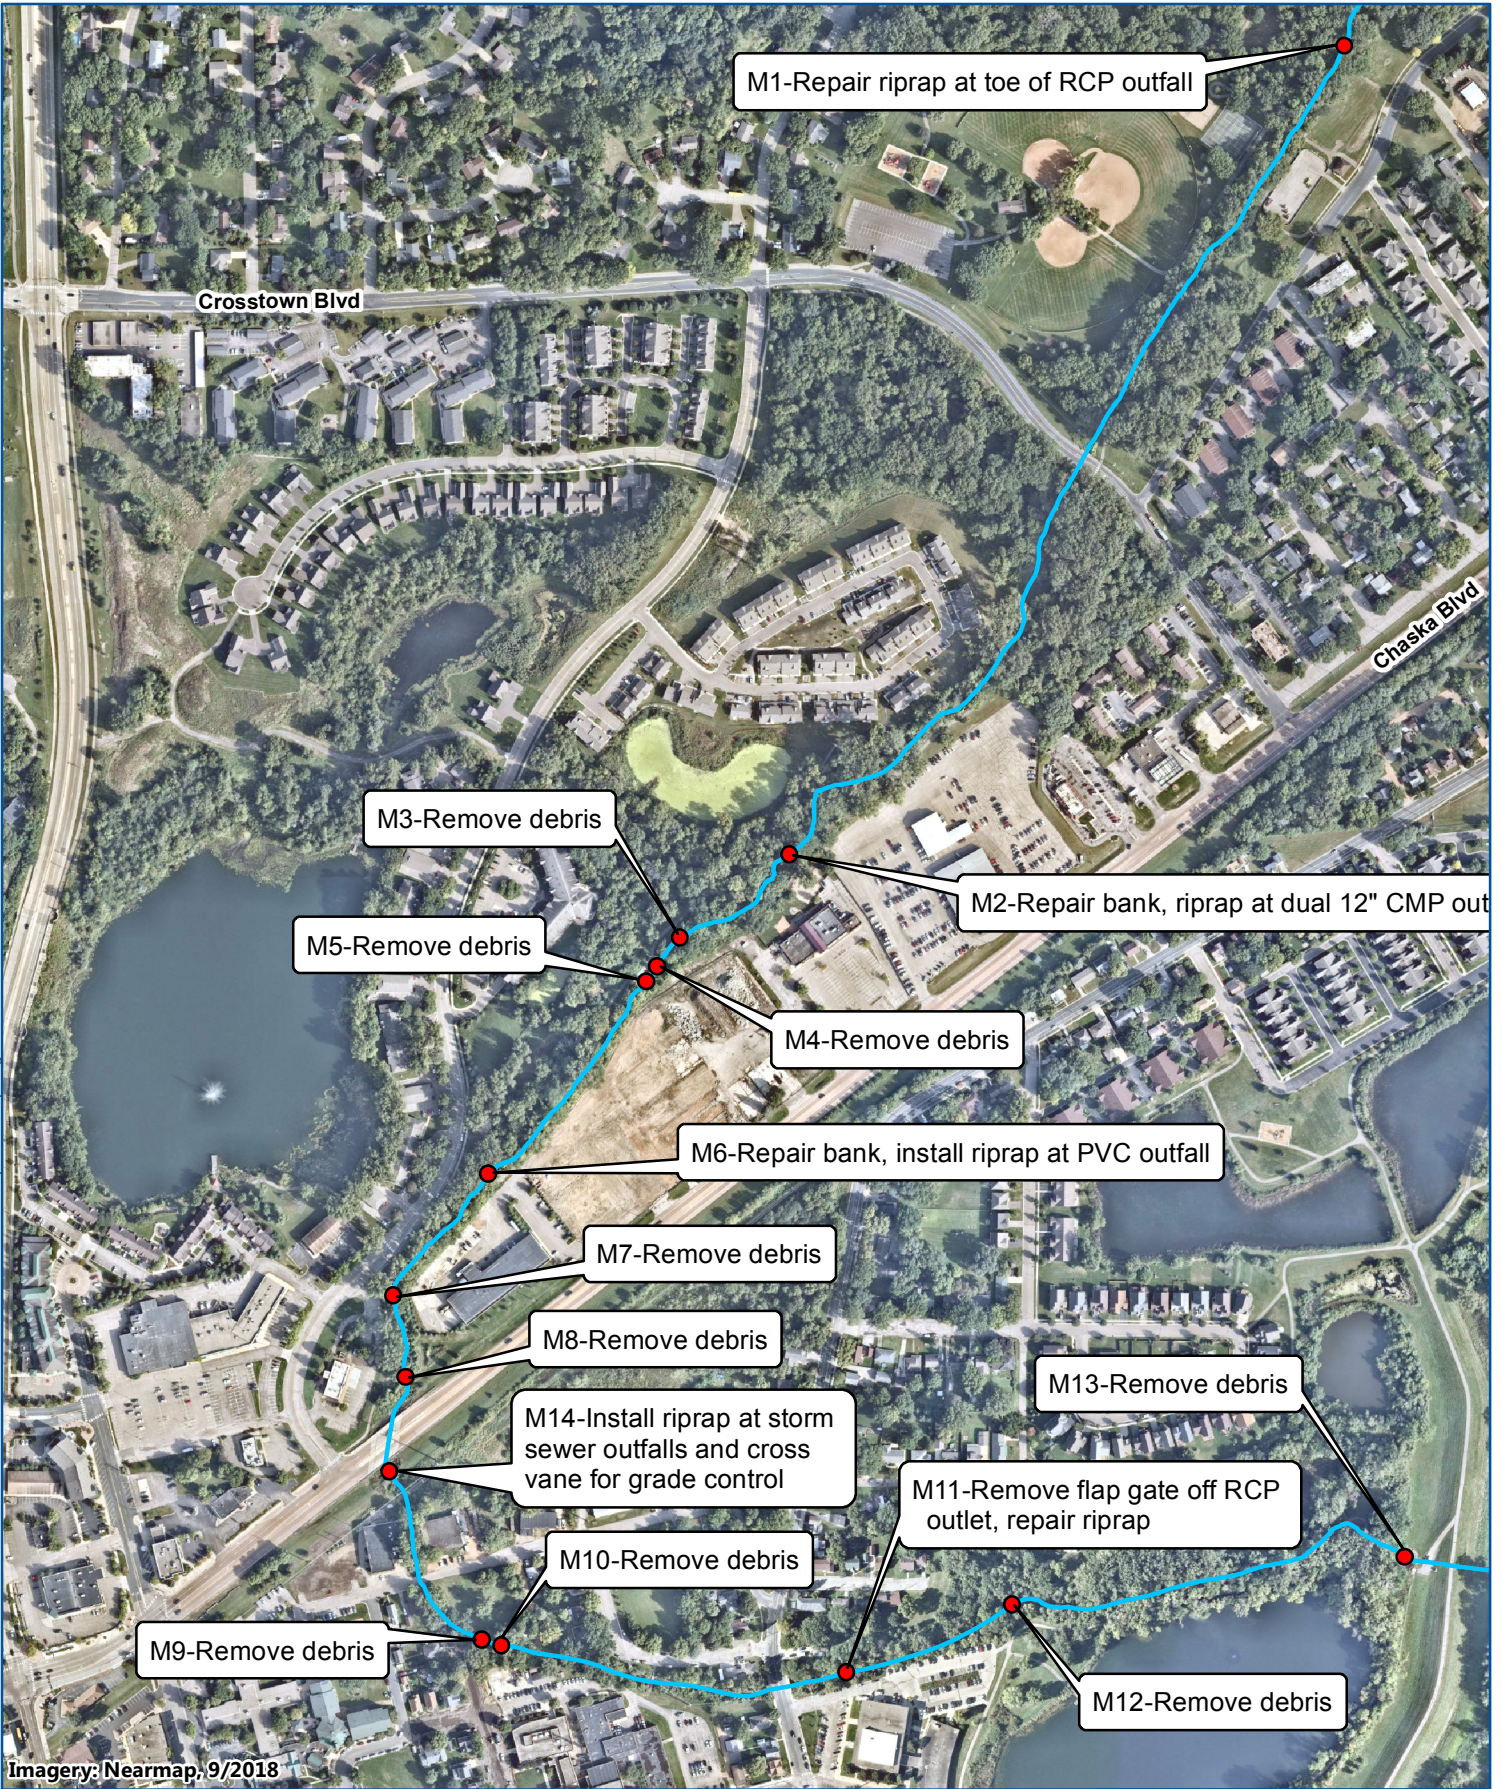
**RECOMMENDED  
MAINTENANCE  
ACTIVITIES**  
East Chaska Creek Project  
Chaska, MN  
**FIGURE 1**

Staff from Barr and Young Environmental noted if previously recommended maintenance activities had been completed. Table 1 and Figure 1 summarize the status of maintenance activities.

- 1) Add Site M16 to the recommendation maintenance items
- 2) Coordinate with the city of Chaska to save money by completing maintenance and stabilization projects at the same time.

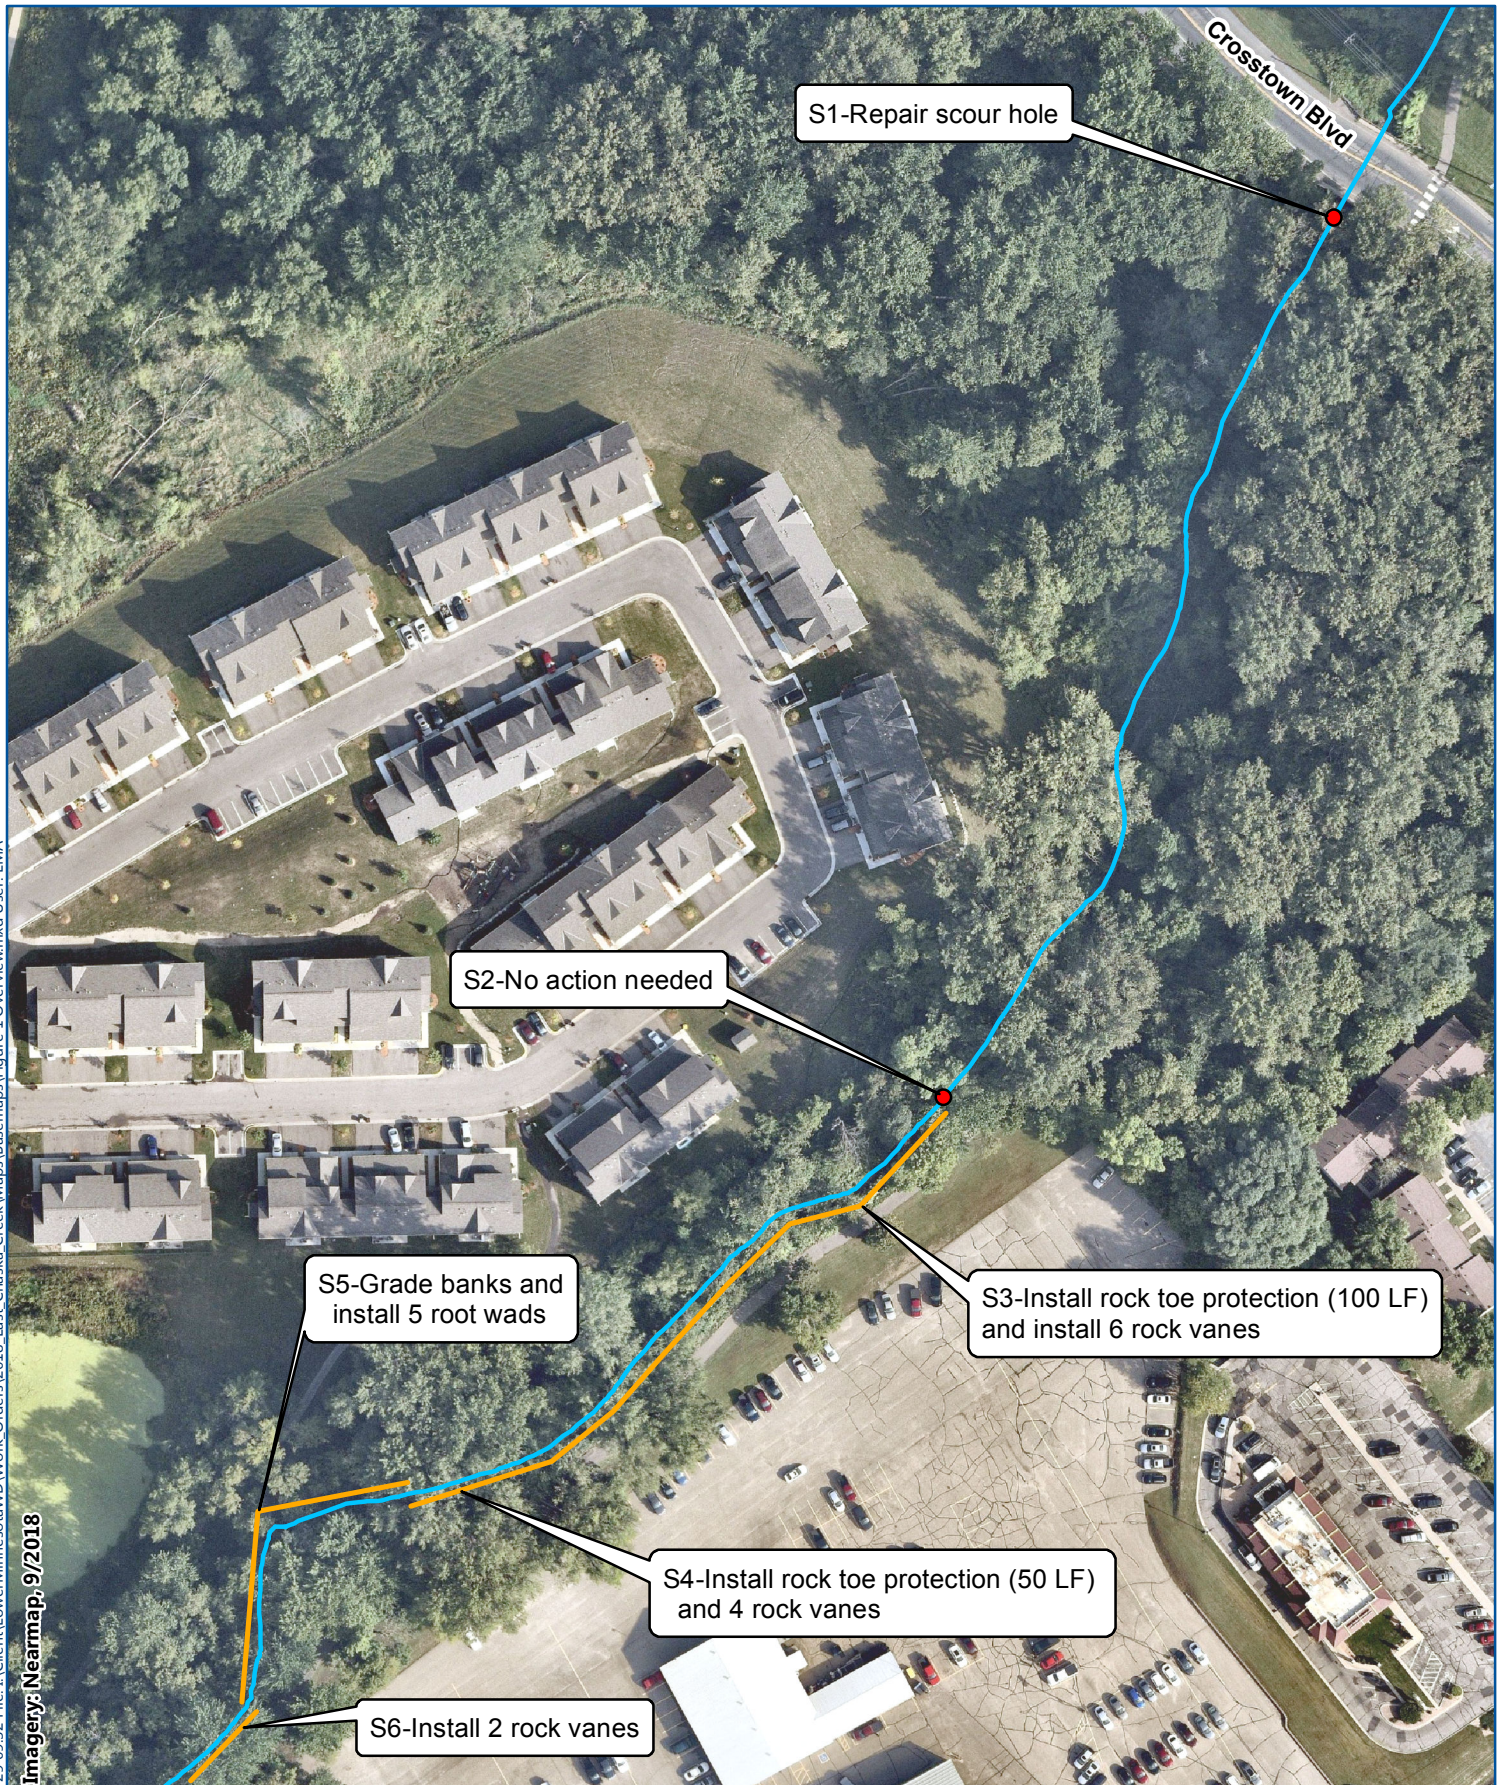
**RECOMMENDED  
CHANNEL STABILIZATION  
PROJECTS**  
East Chaska Creek Project  
Chaska, MN  
**FIGURE 2**

The channel under the Crosstown Boulevard Bridge is lined with concrete so it is wide and flat (Site S1 in Figure 2). The downstream end of the concrete lining is also above the existing channel bed, resulting in a drop of approximately one to two feet. It is possible that the channel downstream developed a headcut that created the drop at this location; however, the banks downstream of the bridge do not have a similar evidence of a headcut moving through the section of stream. In general, the banks are gradually sloping and appear to be at a reasonable height compared to the stream. If a headcut came through this section, the impacts of the headcut appear to have self-mitigated downstream of the bridge. Alternatively, it is also possible that the bridge was originally installed with an elevation drop at the downstream end.

There are multiple eroding banks within this reach (Sites S2 – S6, Figure 2) that threaten the City's paved trail located between the channel and the Lenzen Chevrolet parking lot. The creek appears to be developing point bars and a meandering pattern through this reach that is otherwise relatively straight. Given the man-made origins of the channel, the original channel may have been created too large for the flows it currently experiences in this location, so a smaller, meandering pattern appears to be developing within the larger channel.

After reviewing the site, Barr concurs that all of the erosion sites should be stabilized, and we concur with the recommendation to remove temporary asphalt repairs. The armoring and toe protection previously recommended would be effective. The previously recommended grade control structure (S2, Figure 2) can be eliminated because headcutting does not appear to be an issue within this reach.

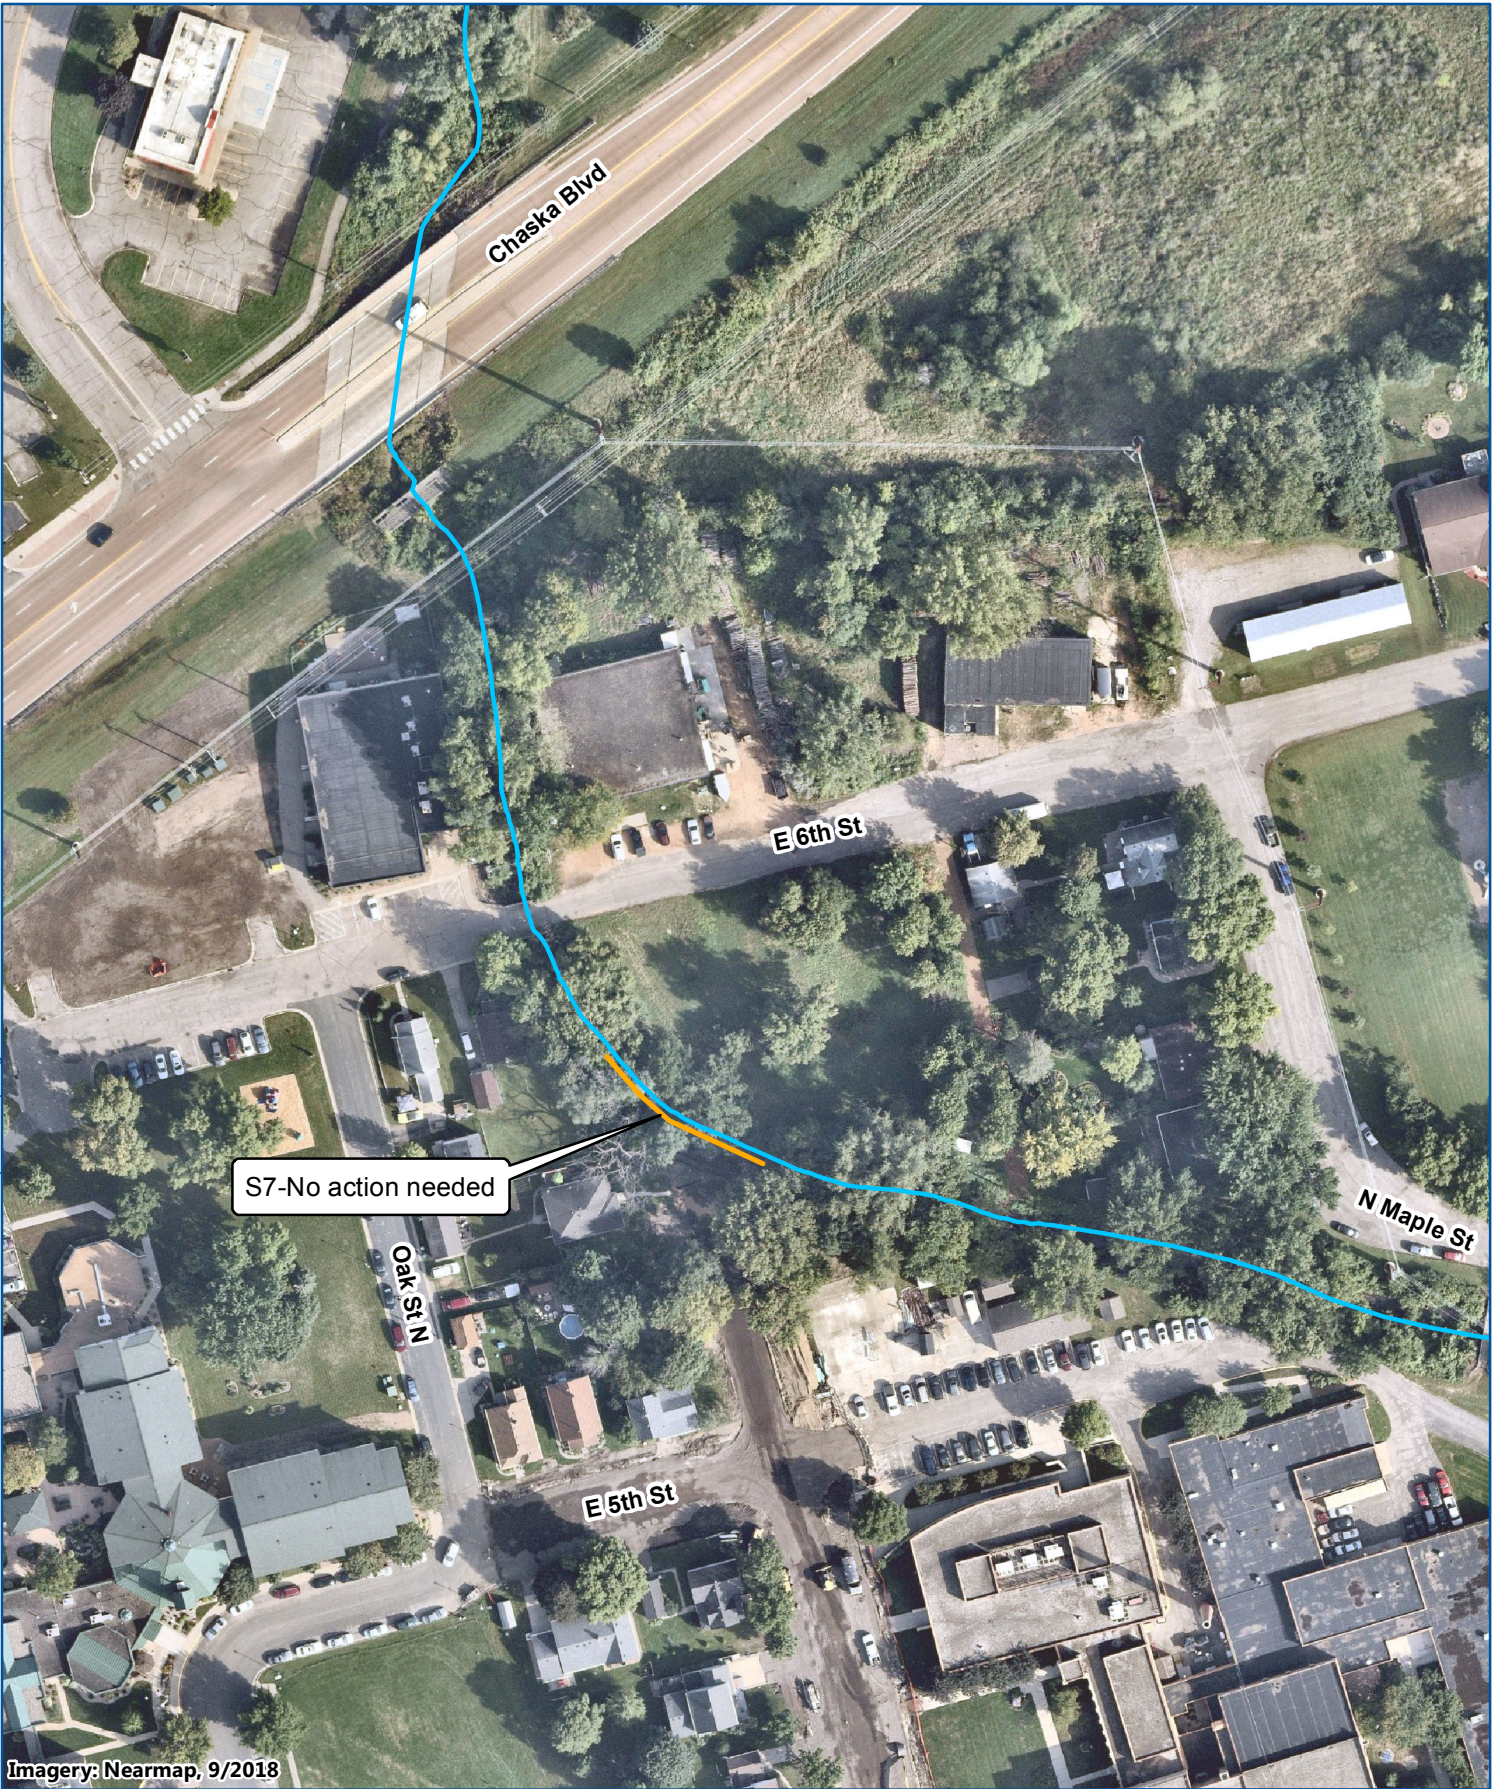
**RECOMMENDED  
 CHANNEL STABILIZATION  
 PROJECTS**  
 East Chaska Creek Project  
 Chaska, MN  
**FIGURE 3**

The original recommendation included installing toe protection for approximately 120 feet of the right bank (Figure 3). The 2018 assessment found that the City had recently completed some stabilization work

on this site, including grading and revegetating the bank. As a result, Barr recommends not completing additional stabilization work in this area.
