## 12.0 CITY OF MENDOTA

### 12.2 Field Survey Discussion

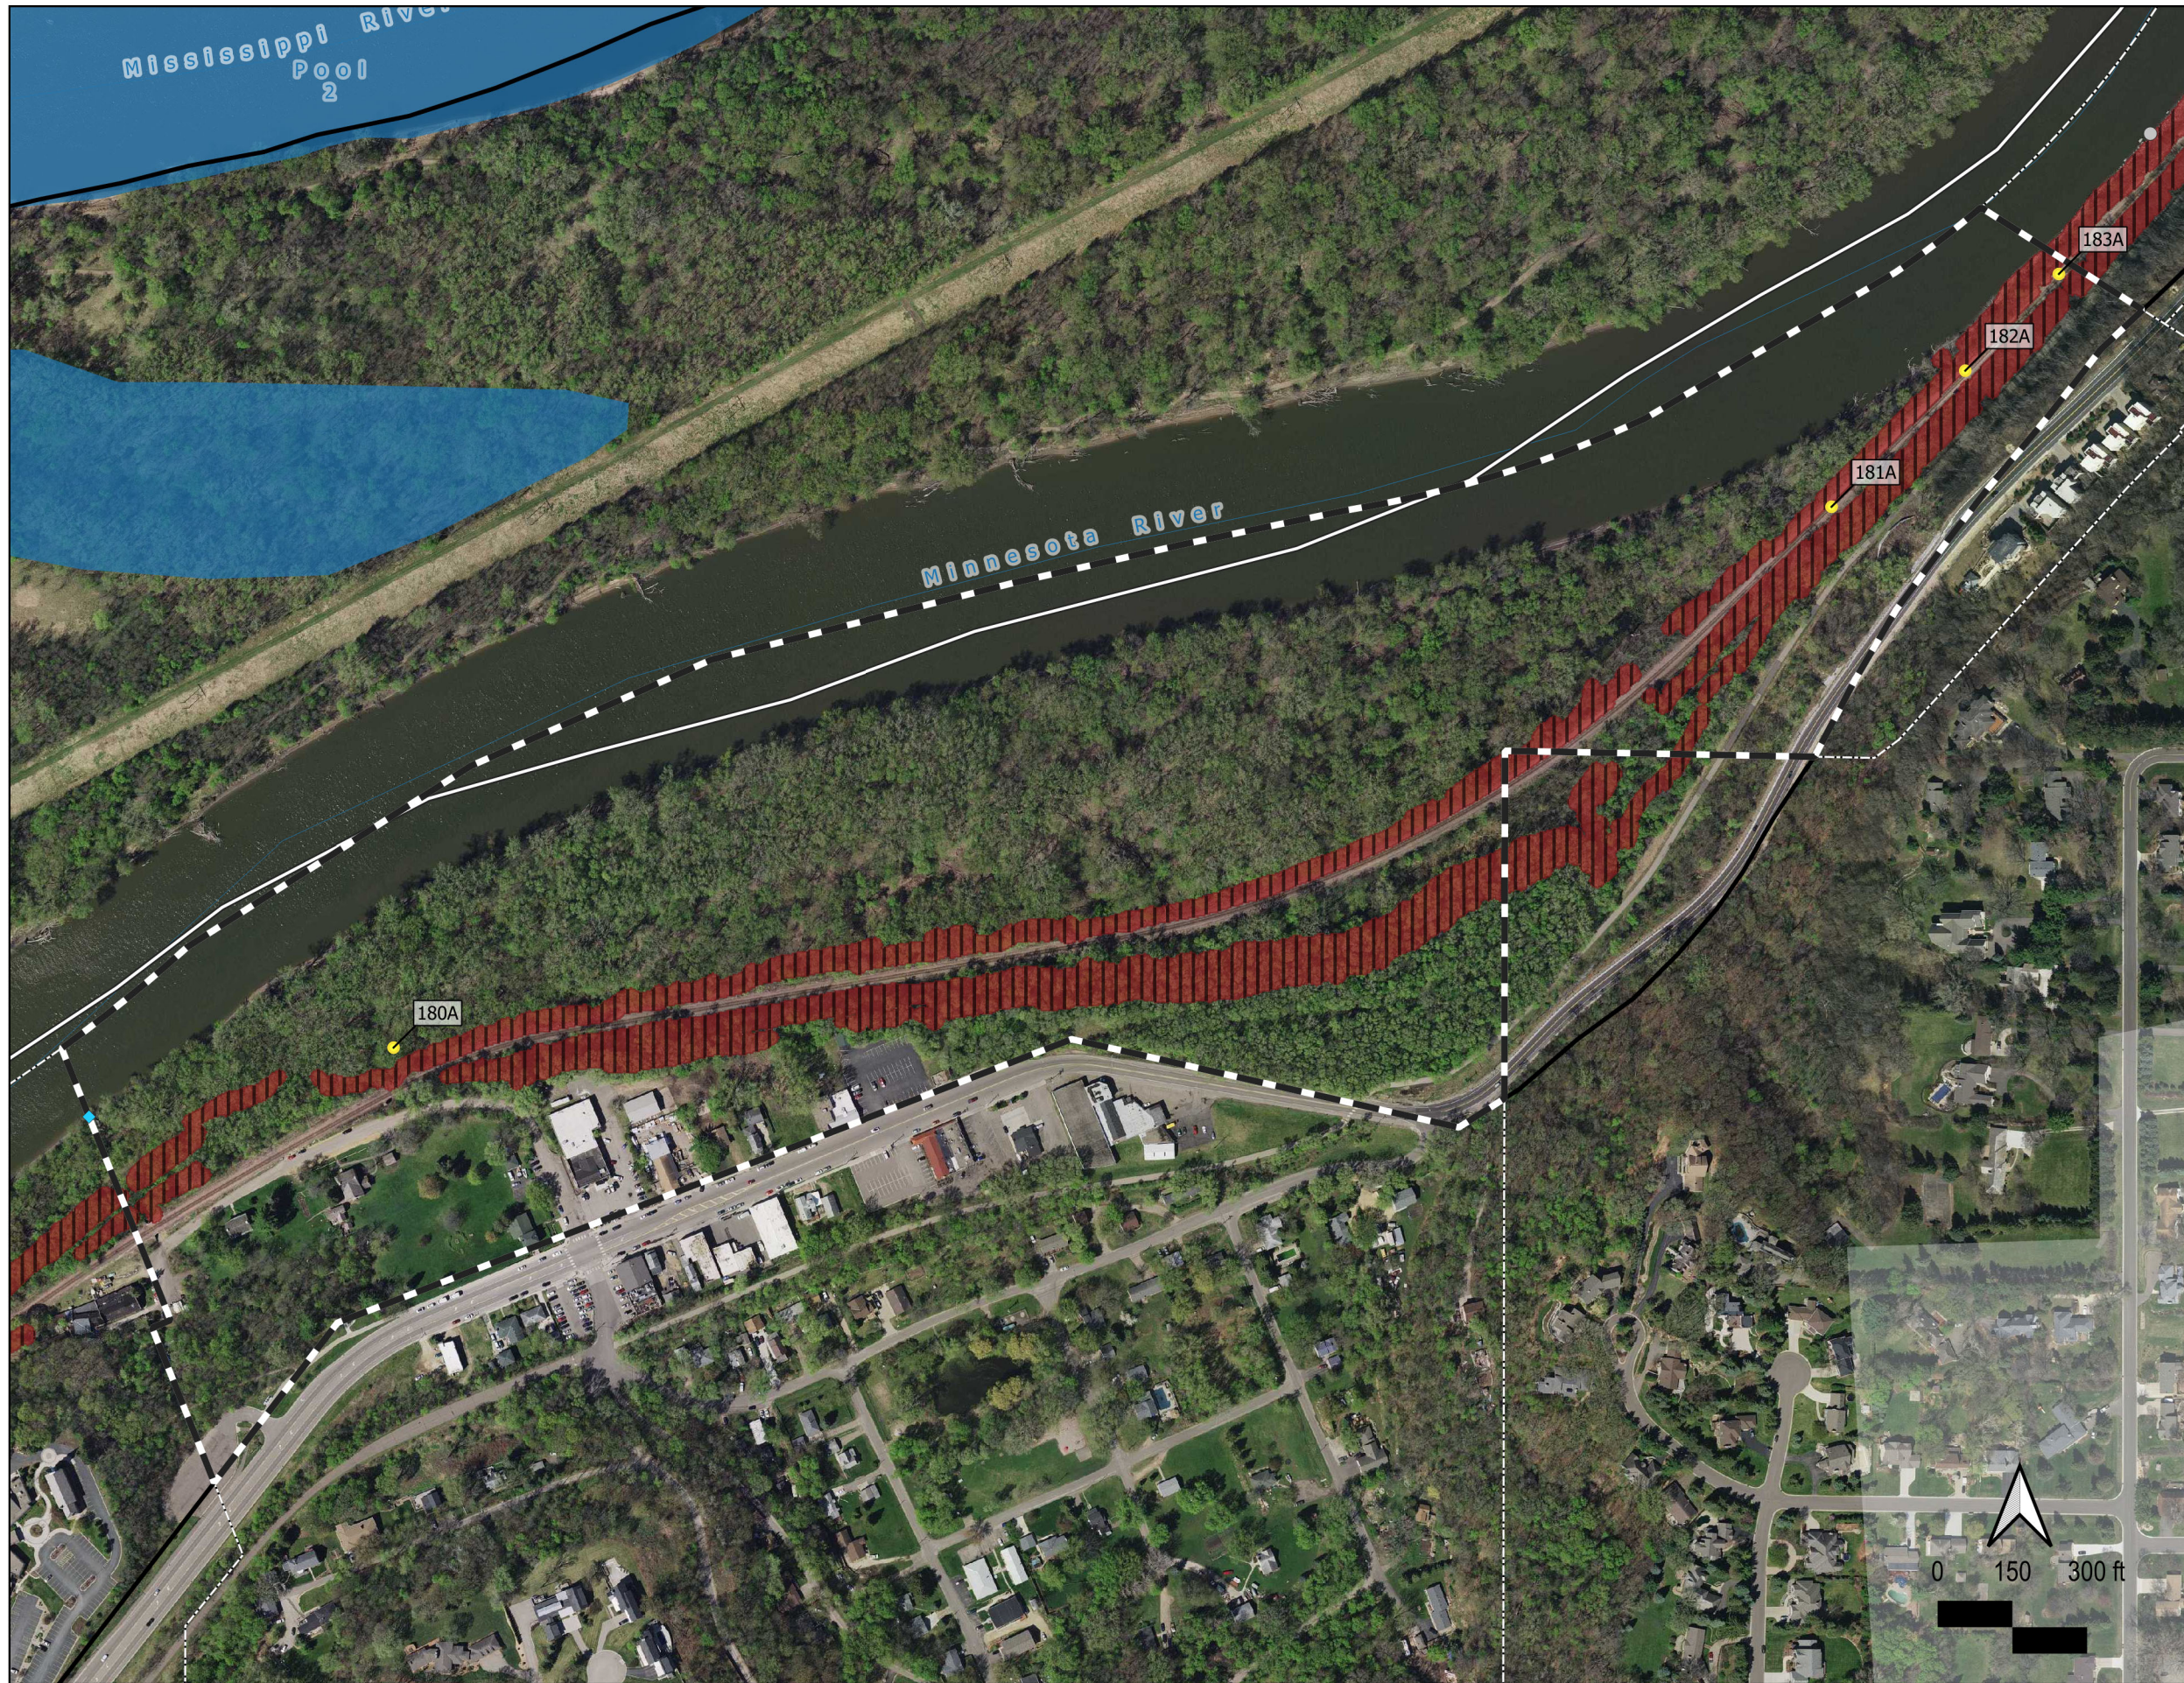
**Figure 116:  
Mendota 2008  
Inventory Locations**

The City of Mendota is located south of the Minnesota River in Dakota County, sandwiched between Lilydale and Mendota Heights. The 2008 Inventory identified four gullies within the City of Mendota ([Figure 116](#)).

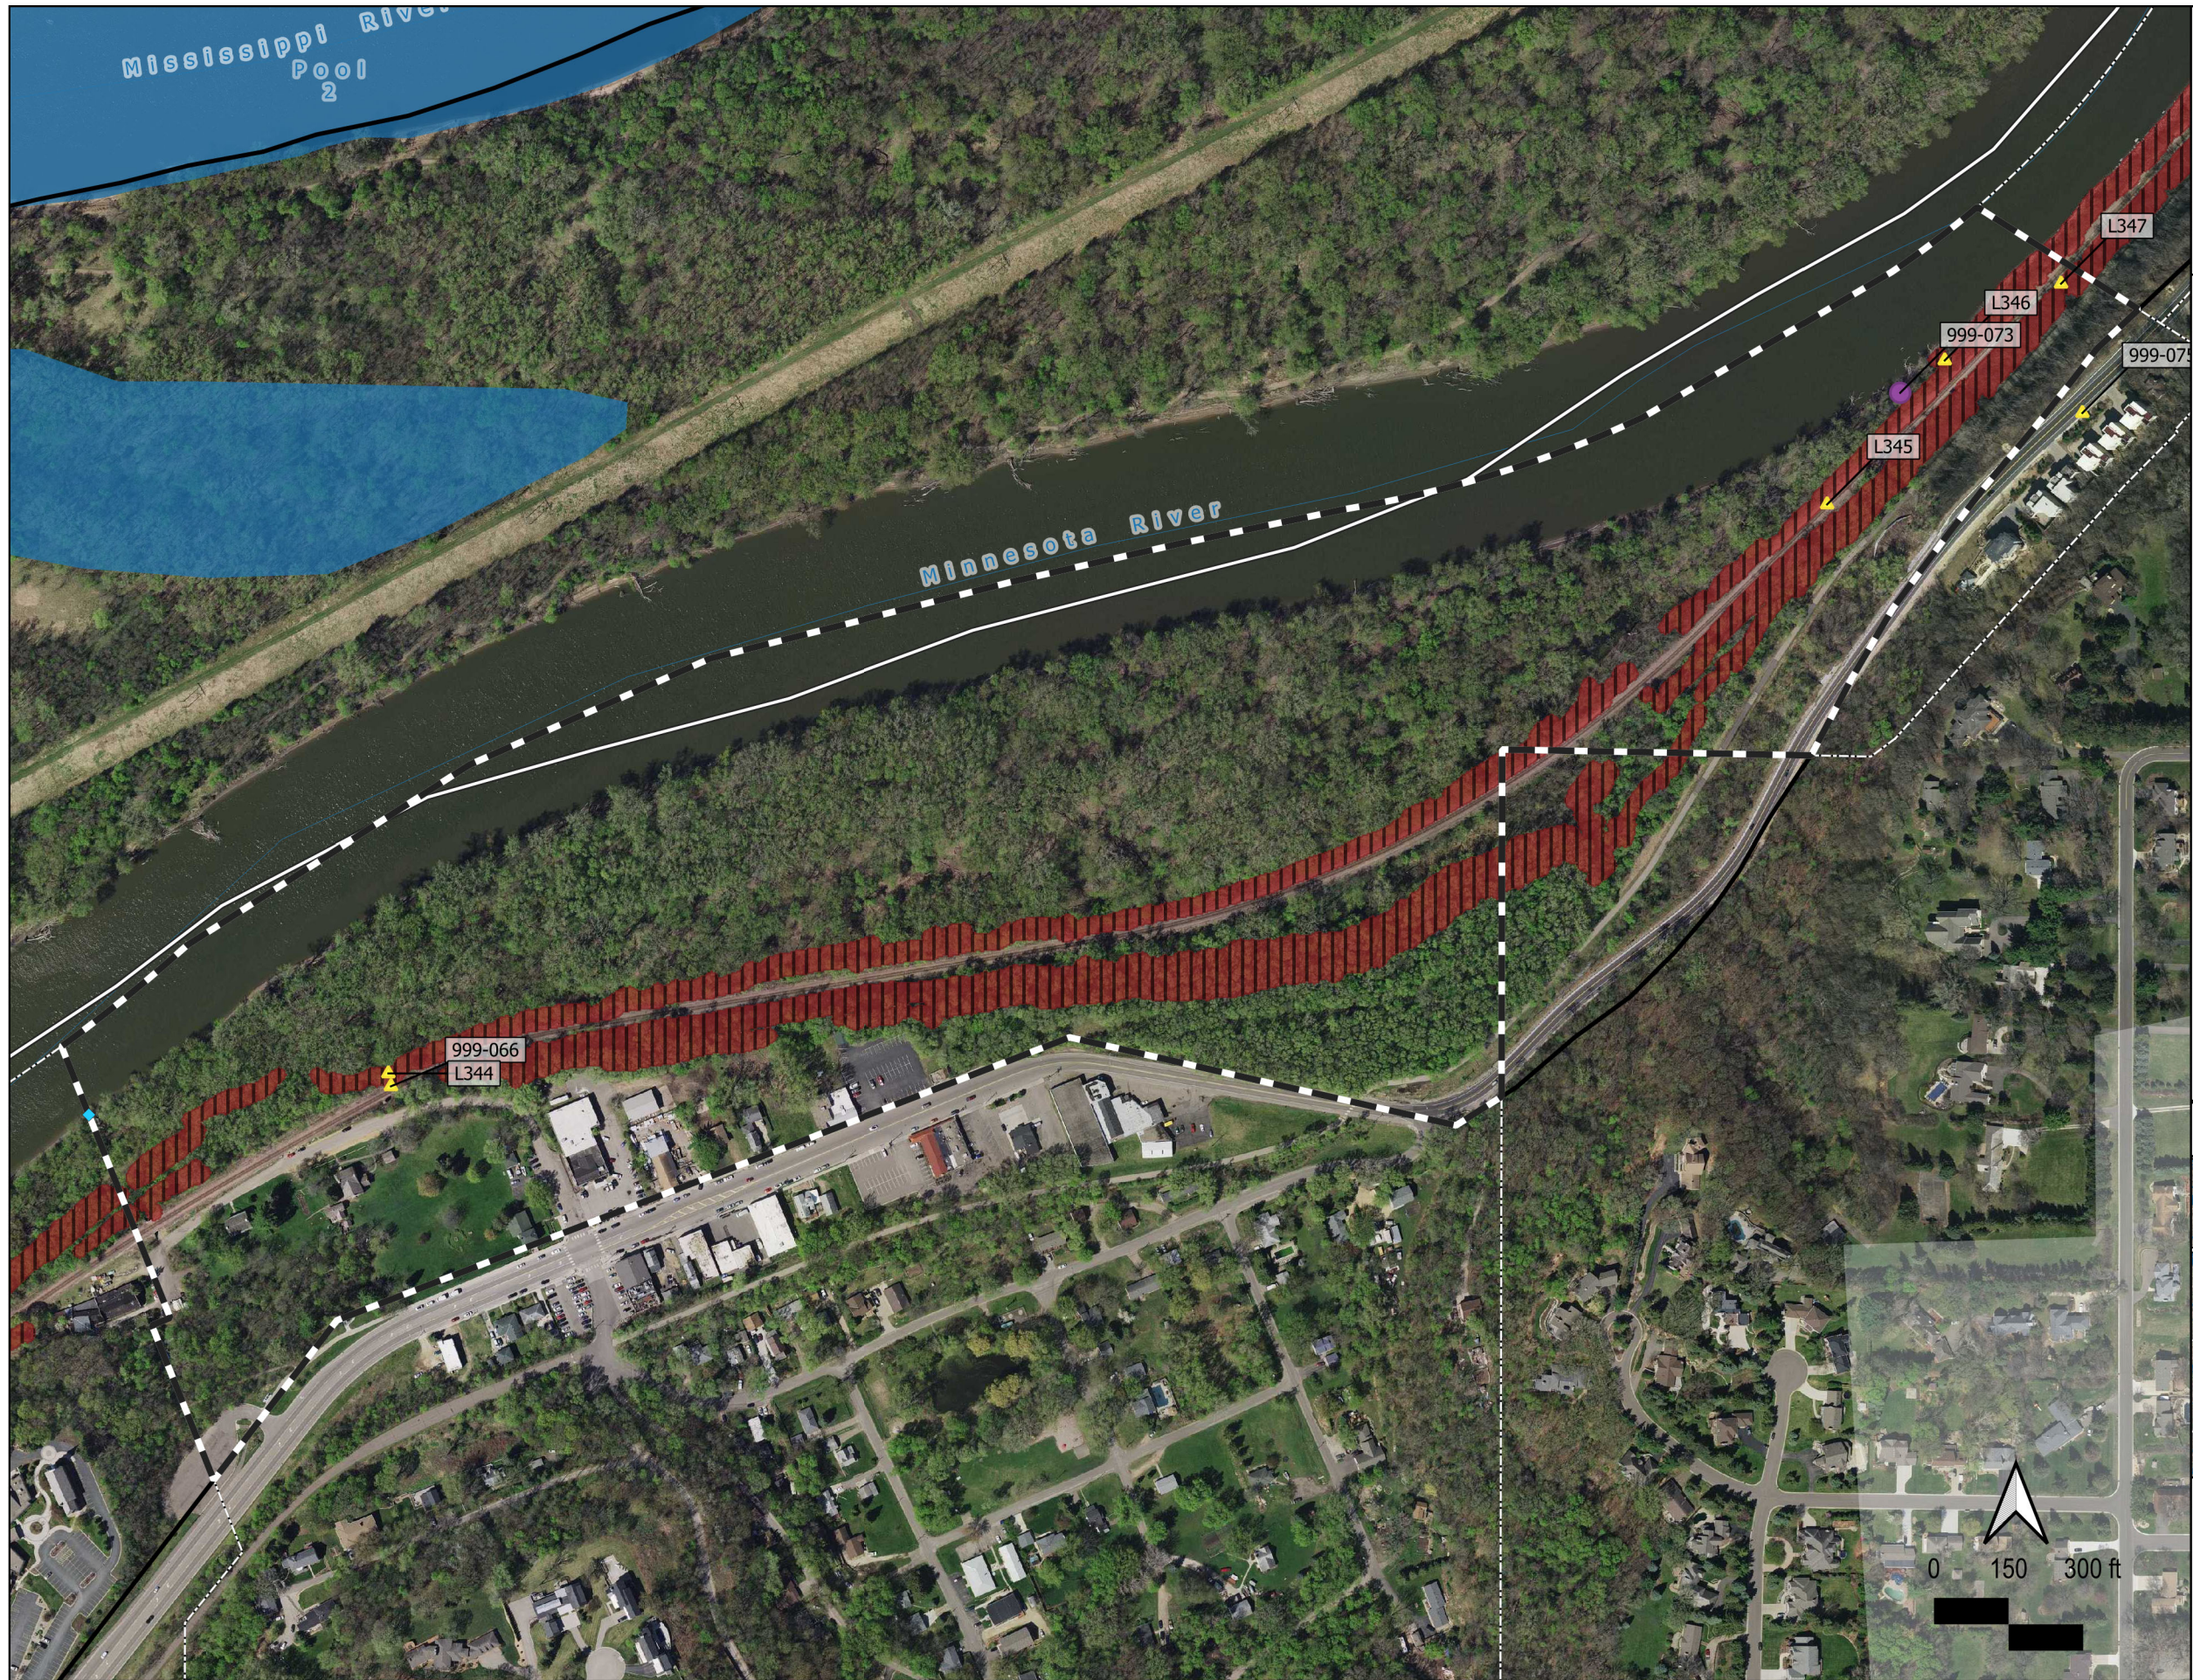
**Figure 117:  
Mendota 2020 Survey  
Locations**

The portions of Mendota within the LMRWD appeared to have the same type of terrain as Mendota Heights and Lilydale, but due to its small size, only five pipe outfalls and one gully were found within the city ([Figure 117](#)). One pipe could not be located, possibly as the result of heavy vegetation, but no other access difficulties arose in Mendota. No interactions with private property owners occurred.

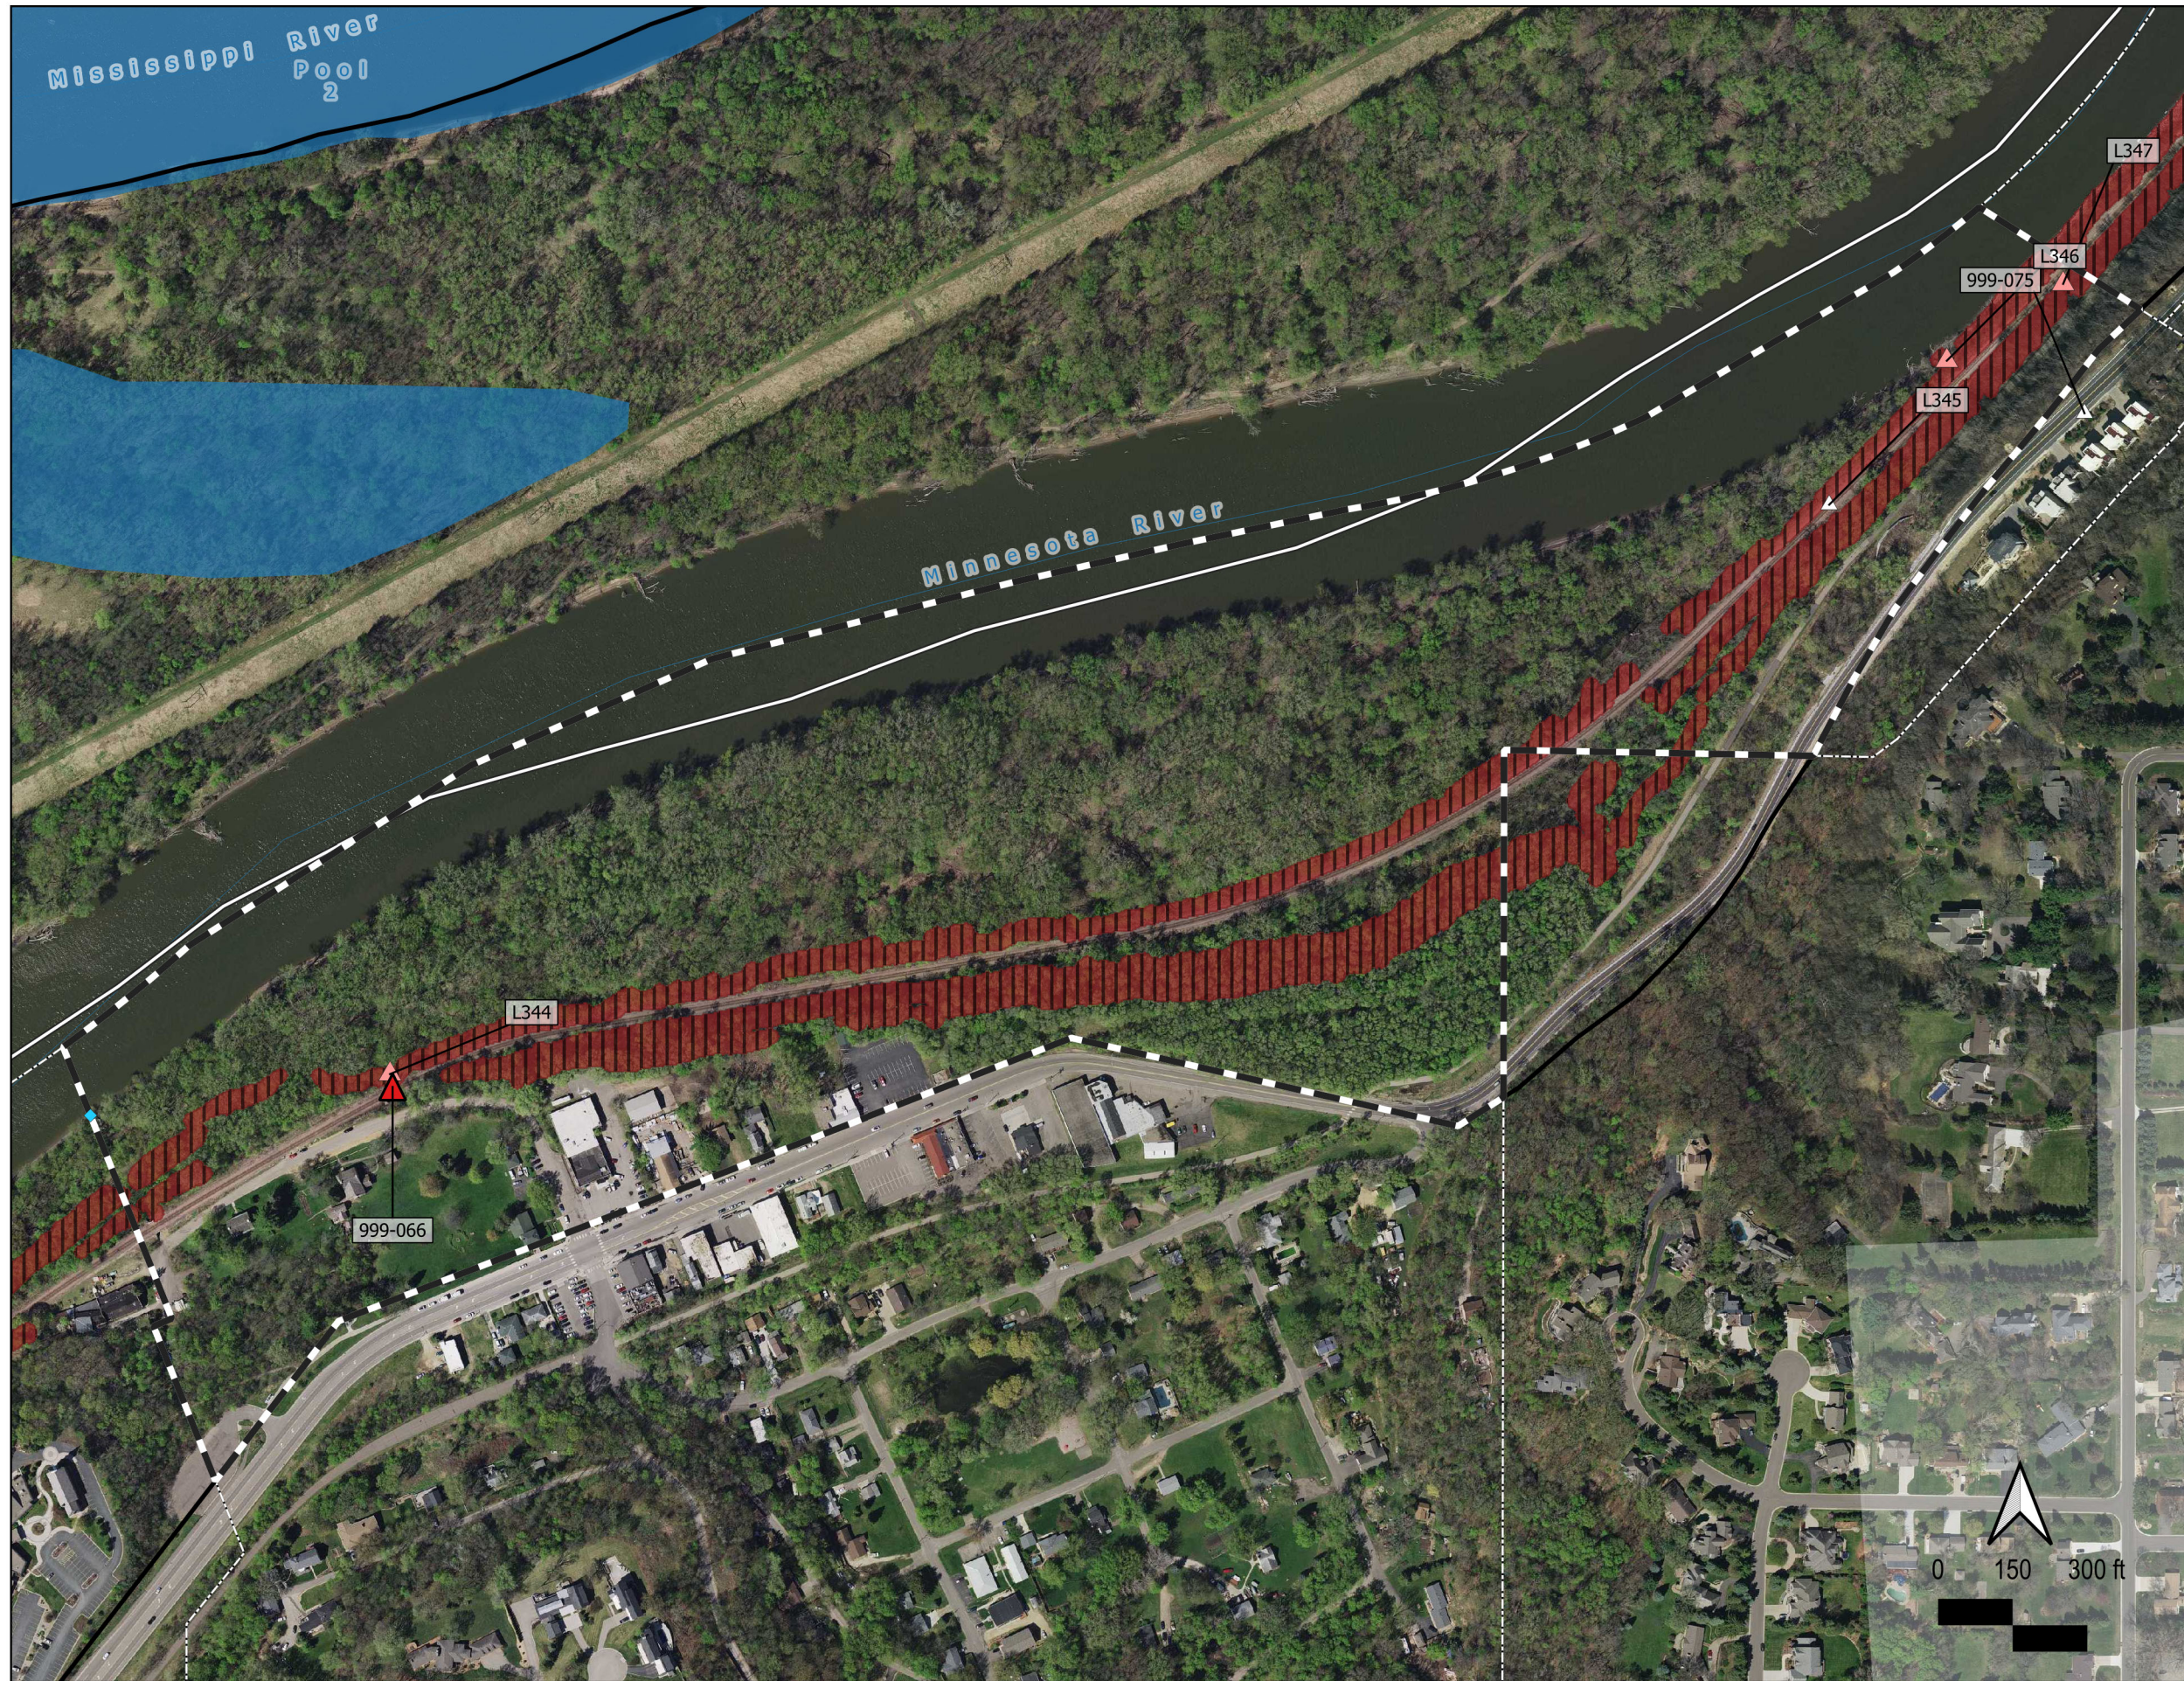
**Figure 118:  
Mendota 2020 Pipe  
Outfall Conditions**

With the exception of one new pipe along Highway 13, all pipe outfalls in Mendota were found along the railroad tracks ([Figure 118](#)). L347 is a pipe outfall consisting of a chute delivering water down from a pipe onto the limestone bluffs above the railroad and through another pipe beneath the railroad, where it then discharges into the Minnesota River.

Of the sites surveyed, only one gully (999-073) was surveyed, and it was in moderate condition with one pipe outfall requiring repair (999-076).

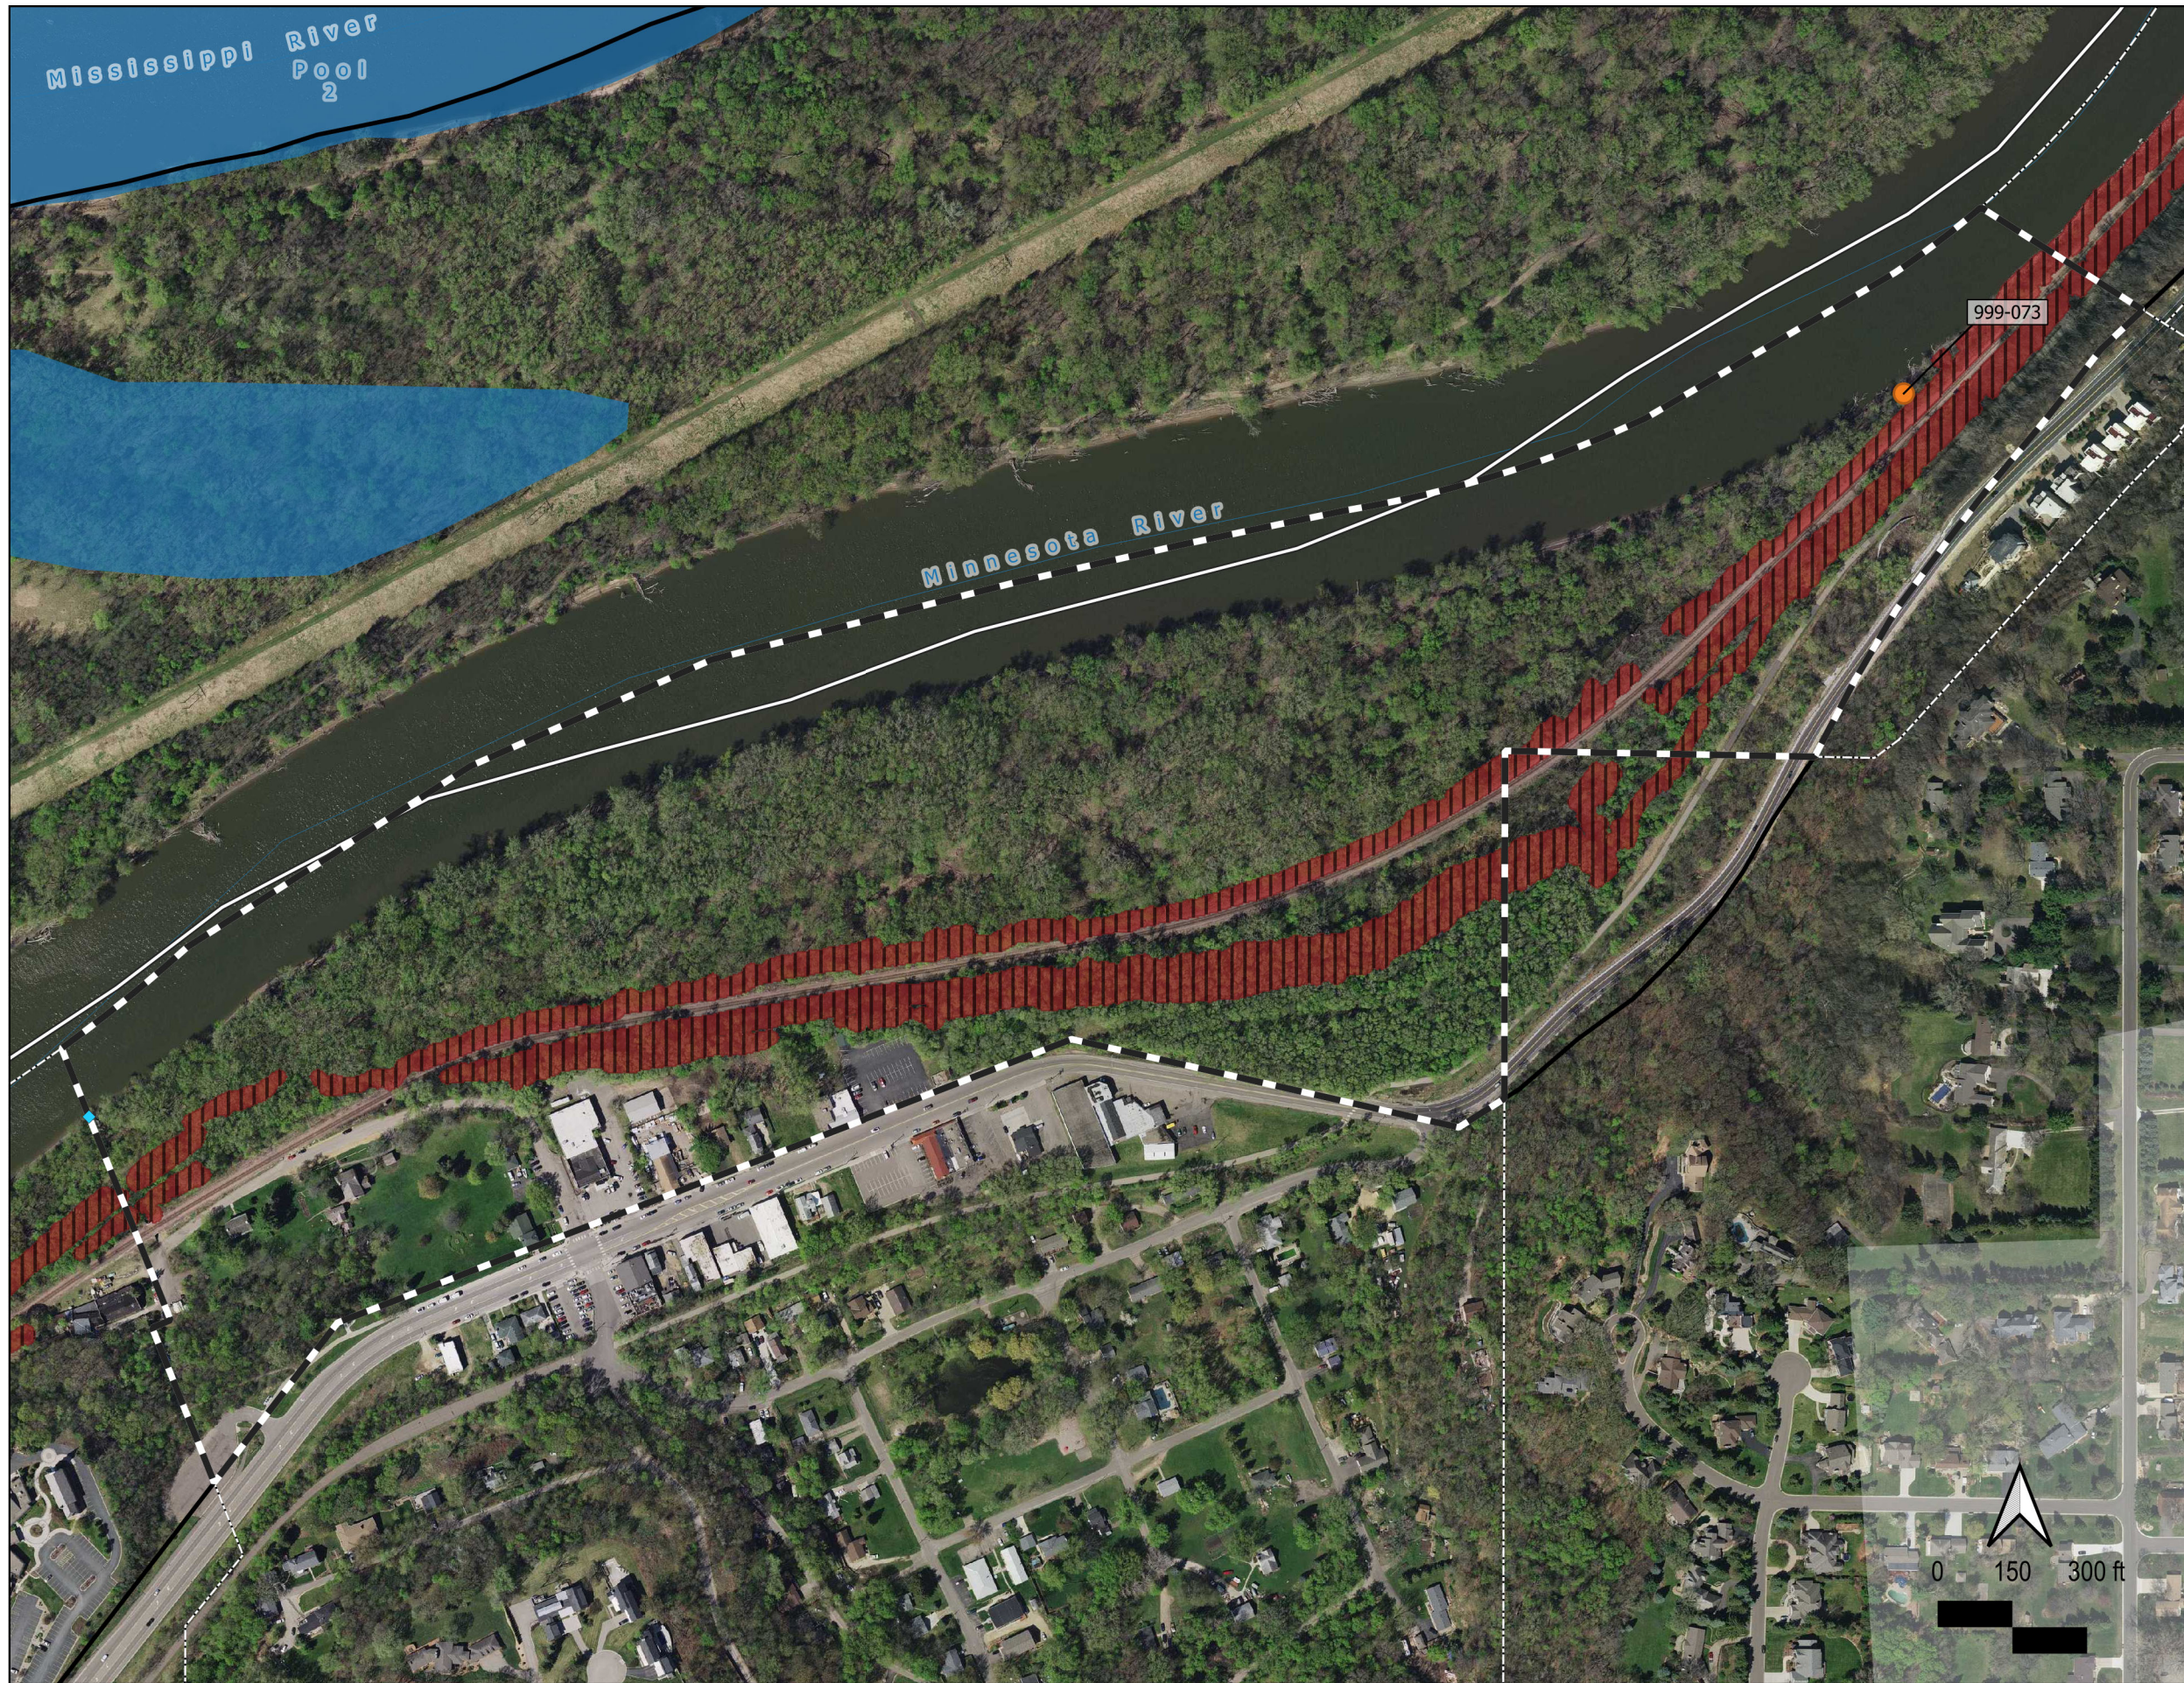
**Figure 119:  
Mendota 2020 Gully  
Conditions**

One gully (999-073) in Mendota was found to be a new feature ([Figure 119](#)). The gully fed right into the Minnesota River and showed signs of active erosion along the banks and head cut. Due to its depth and length, it was rated as having moderate erosion potential.
