LOWER MINNESOTA RIVER WATERSHED DISTRICT

Executive Summary for Action

Item 4. D. – Authorize final payment to Blackstone Construction

East Chaska Creek - Final Warranty Inspection

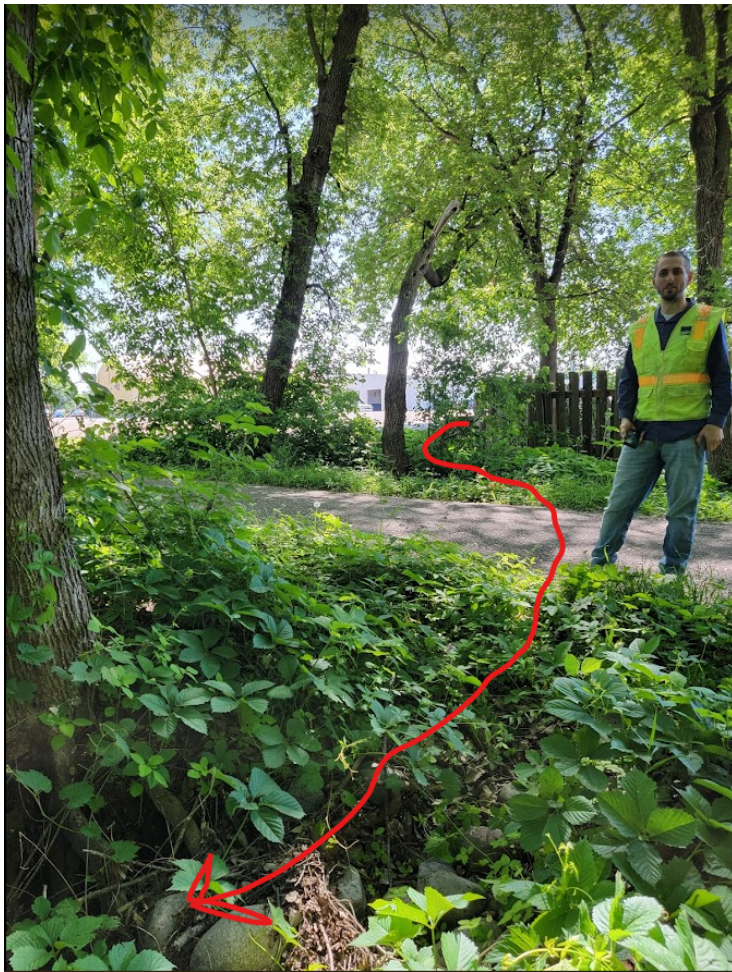
1. **Offsite Drainage and Erosion:** Stormwater runoff from the northwest corner of the Lenzen parking lot appears to be flowing over the trail and into the creek, which is causing some slope instability on the creek bank (see the photo below). The bank erosion does not appear to be caused by the creek or threatening the restoration, but may be more of a drainage improvement for Lenzen and the city to monitor and/or address. **Understood, I will forward the comment to Chaska Public Works to check periodically for changes in erosion/slope stability.**

- **Bank Stability:** Bank protection was in good shape with the exception of a small area near the downstream end of the project (see comment #1 above).

Figure 1. Approximate overflow/drainage path from Lenzen parking lot into East Chaska Creek.
