Savage Fen Stewardship Plan

**Lower Minnesota River Watershed District
Chaska, Minnesota**

**Young Environmental
Consulting Group, LLC**

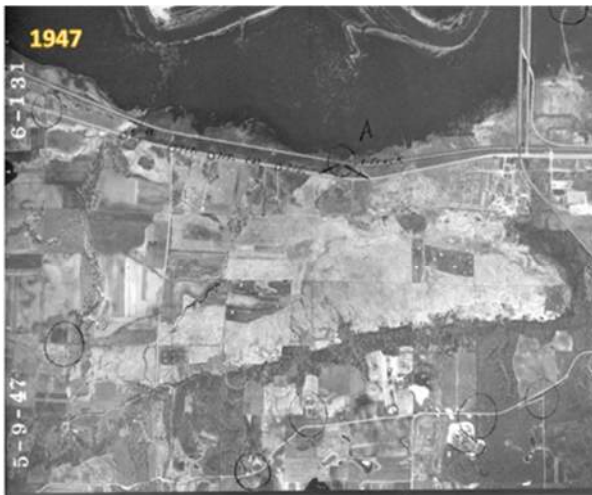
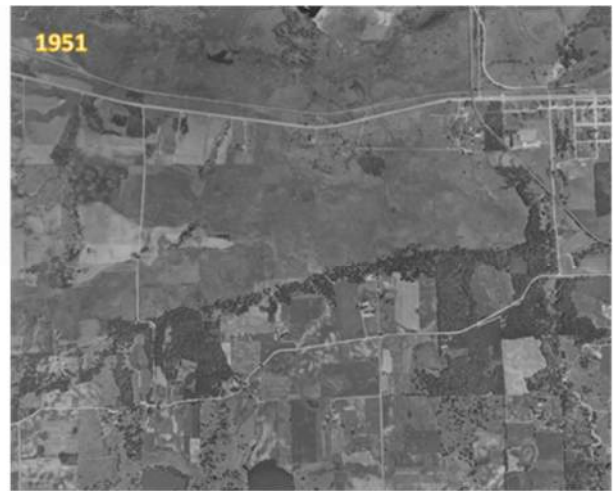
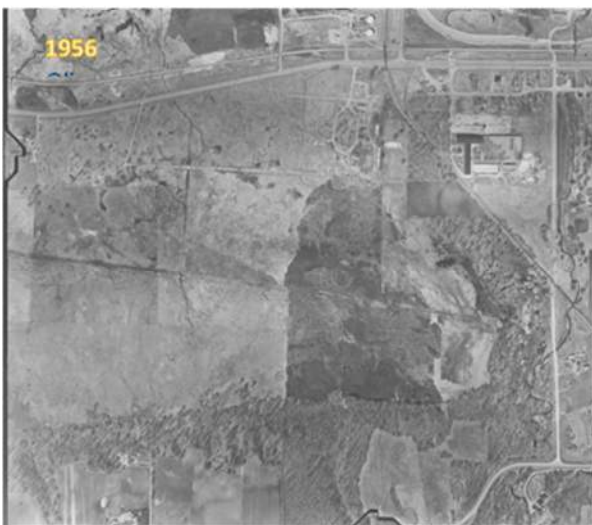
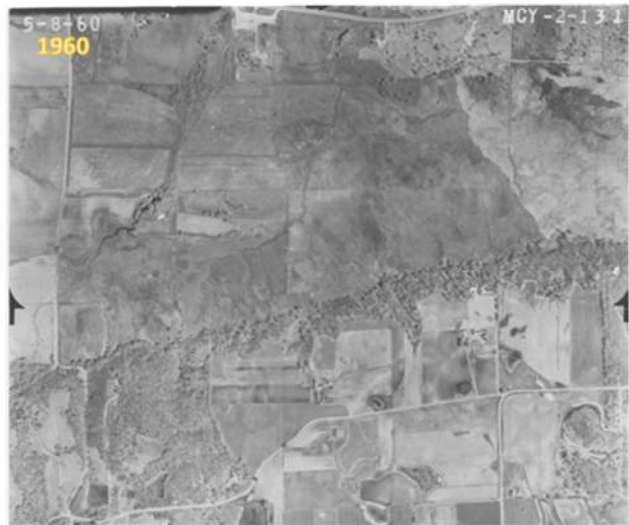
Aerial Photos of Savage Fen and the Surrounding Area Dated 1947, 1951, 1956, and 1960

Additional aerial photos are shown in the following figure. The image dated May 1947 shows a fen surface that appears lighter than much of the surrounding landscape. Many new and enhanced roadways are evident, especially to the north between the fen and Highway 13. Features that previously appeared as boarding houses have additional development nearby. It is difficult to distinguish between natural and human-caused marks on the fen that may be agricultural. There appears to be a ditch that drains part of the fen to the north. The presumed ditch is flanked by dark-hued polygonal features that have irregularly spaced light-hued objects that could be haystacks.

An image dated July 1951 shows a more sanguine perspective of the fen. The ditch is not as evident, and agricultural activities are less apparent. Leafed-out trees and other vegetation may be moderating features that might otherwise be in contrast.

The May 1956 image shows only the eastern part of the fen. The ditch is more evident, but agricultural activities are not. It is not known why the fen appears dark immediately south of the development, with a loop-shaped road. An approximately east–west line across the fen appears to have left a scar causing cracks or irregular trails in the land surface west of the drainage ditch. These marks may be associated with installation of a power line presently running across the fen.

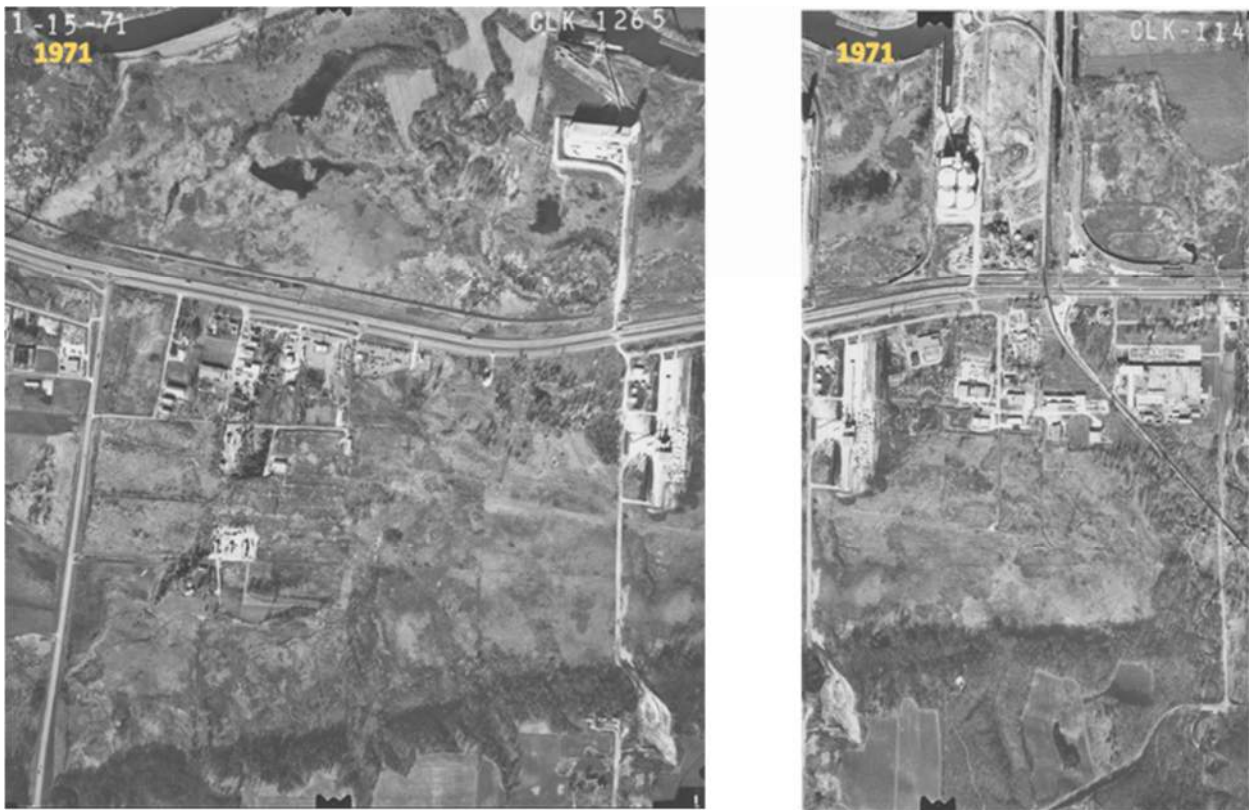
Aerial Photos of West and East Parts of Savage Fen and the Surrounding Area

Aerial photos of the east and west parts of Savage Fen taken in November 1971 are combined in the following figure. Development near Savage Fen had increased substantially when the image was taken. Agricultural fields to the west appear to have gone fallow and improved roadways provide access to nearby structures and other development. A north–south road has been established west of the ditch that leads up the bluff to the south and appears to lead to an excavation on the bluff. The road nearly connects with a road from the south and may represent the near completion of Dakota Avenue discussed in the Fens Gaps Analysis (Young Environmental, 2021).

The fen surface appears heterogeneous in the 1971 images compared to previous images. Streaks, scars, and irregularities that previously had been subtle appear starker and more evident. This could be the result of better contrast with improved image-capture technology or late season tones after the growing season, but it also might show that the fen is more stressed.
