# Geomorphic and Habitat Assessments of Trout Streams in the Lower Minnesota River Watershed District

August 2019

Prepared For: The Lower Minnesota River Watershed District

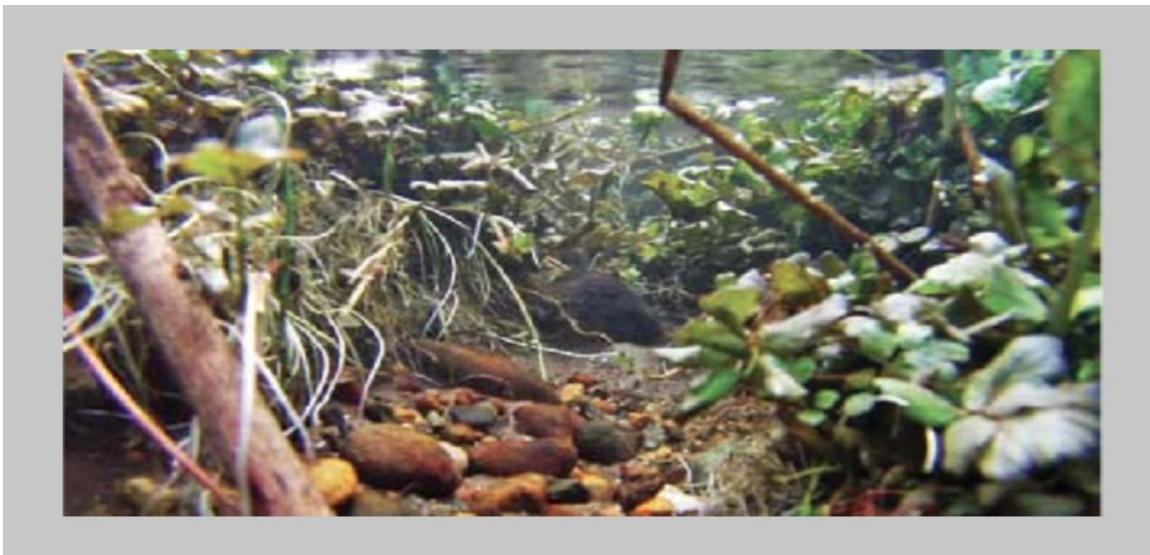
Figure A.3. Ike's Creek restoration (6/2/2012) taken by Tony Nelson of Twin Cities Trout Unlimited.

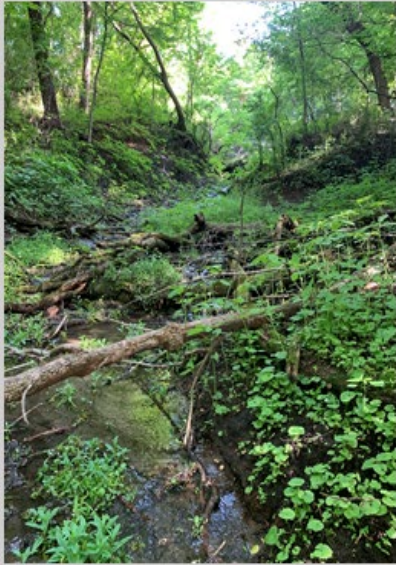
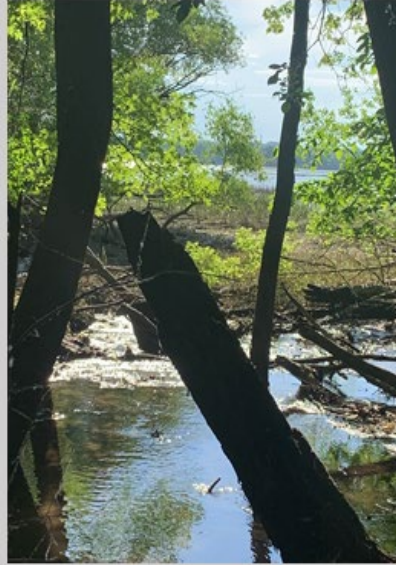
Figure F.1. Woody Debris. Erica Bock (July 2019).

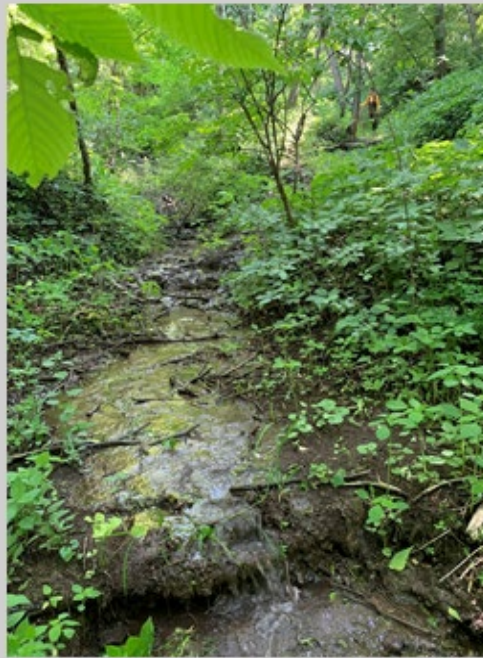
Figure F.2. Knick Points. Erica Bock (July 2019).
