<b>Gully ID:</b> 06:10-09:36	<p style="text-align: center;"><b>MAP</b></p>

<b>Date &amp; Time:</b> June 10, 2021 9:36 AM	
<b>Location:</b> Eagan	
<b>Weather:</b> Sunny <b>Storm/Rainfall Event in the Past 24 Hours?</b> No	
<b>GULLY INFORMATION</b>	
<b>Calculated Erosion Potential:</b>	Moderate
<b>Approximate Depth:</b>	3-Medium (3'-15')
<b>Approximate Bottom Width:</b>	1-Wide (>5')
<b>Approximate Gully Length:</b>	5-Long (>100')
<b>Condition of Gully Bottom:</b>	3-Some Vegetation
<b>Condition of Gully Banks:</b>	5-Bare Soil
<b>Gully Bank Angles:</b>	3-Mid-Range (45 to 90 degrees)
<b>Gully Shape:</b>	5-V-Shaped
<b>Gully Material:</b>	Silt/Clay

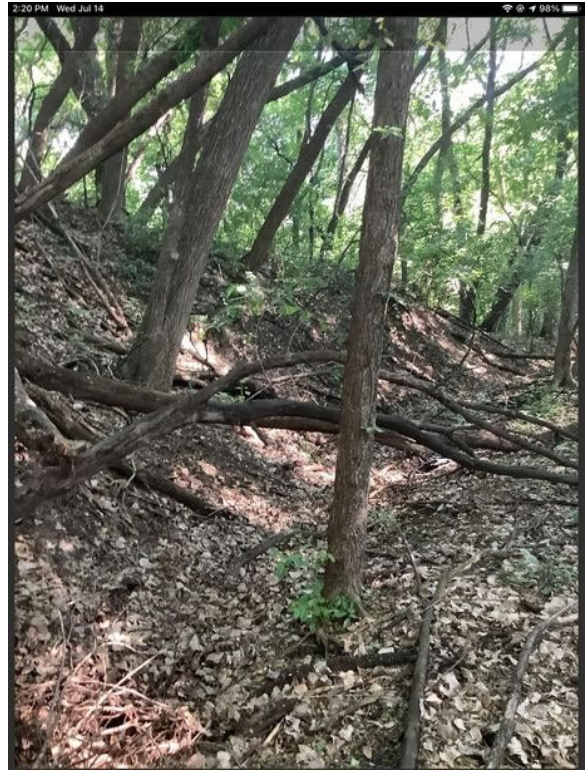
**Photo 2 Image**

Downstream view about 40 feet down the gully. Degradation and slumping worsens.

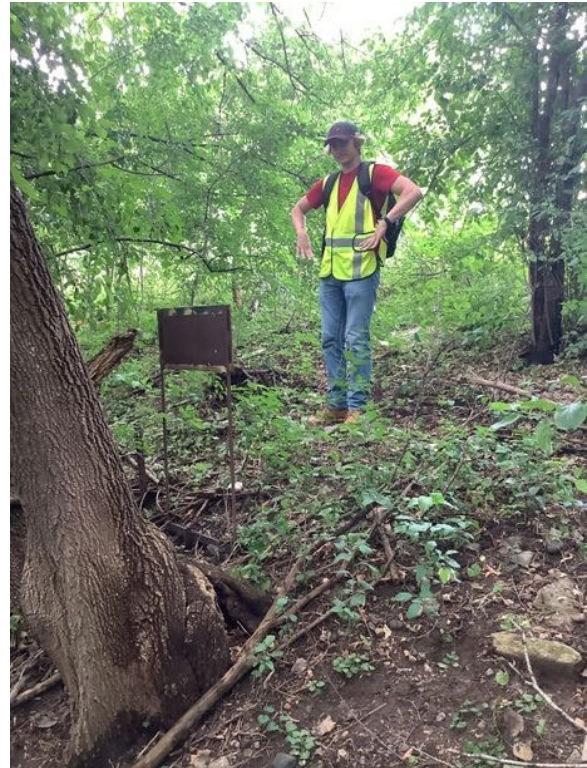
**Photo 2 Image**

Upstream view of right bank.

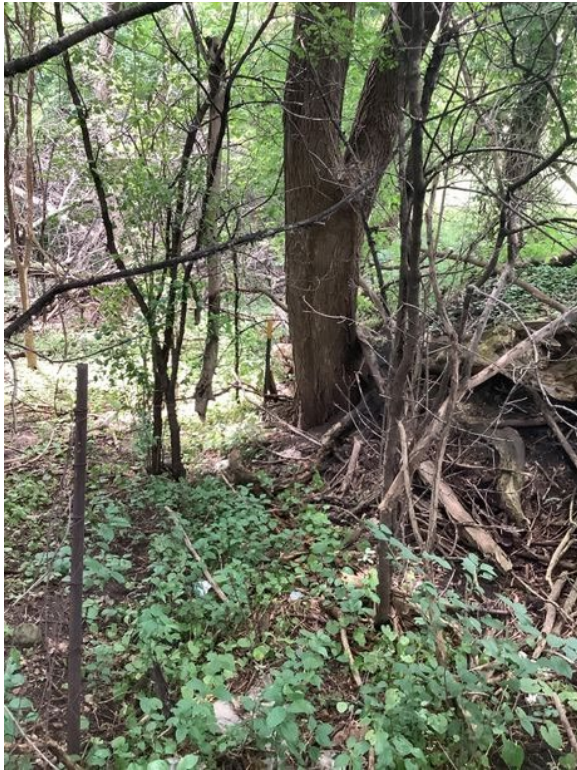
**Photo 3 Image**

Downstream view right bank.

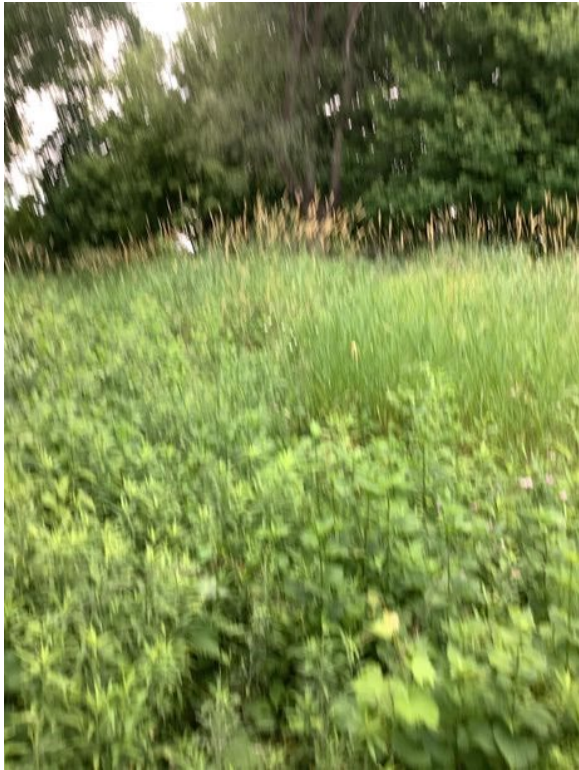
**Photo 3 Image**

Downstream view of right bank.

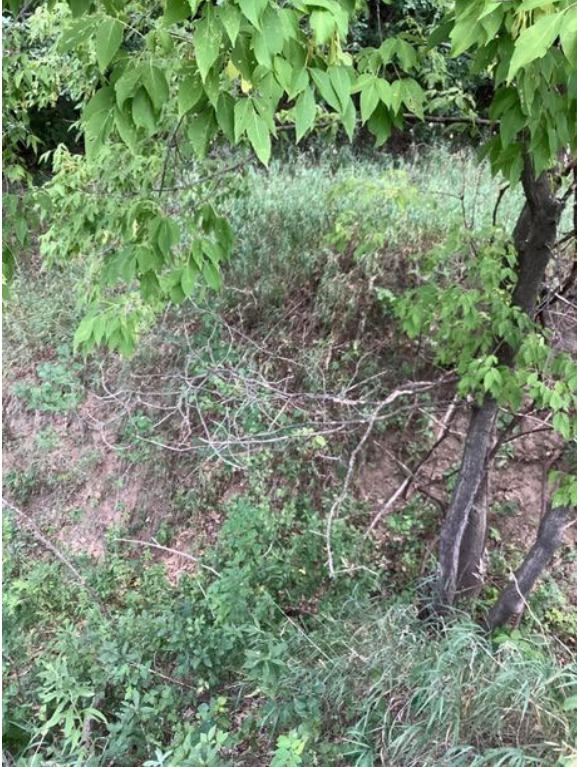
**Photo 3 Image**

Further downstream right bank

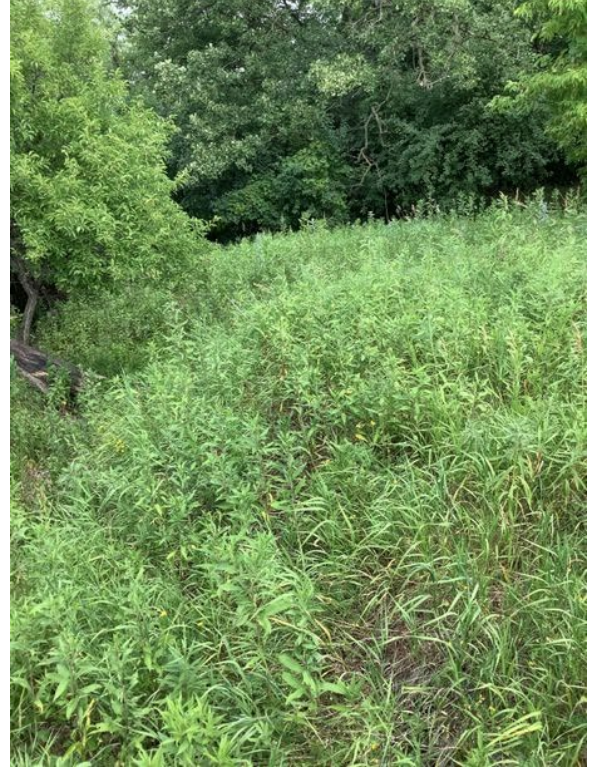
**Photo 2 Image**

Right bank

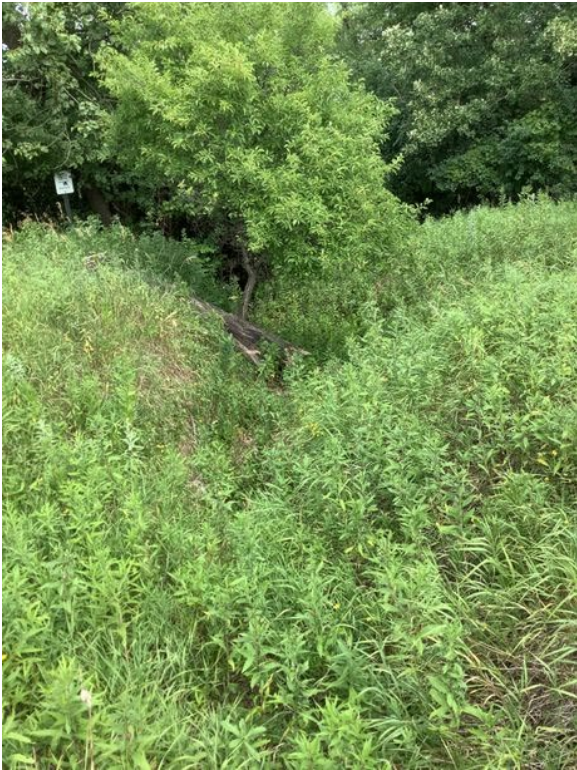
**Photo 3 Image**

Middle

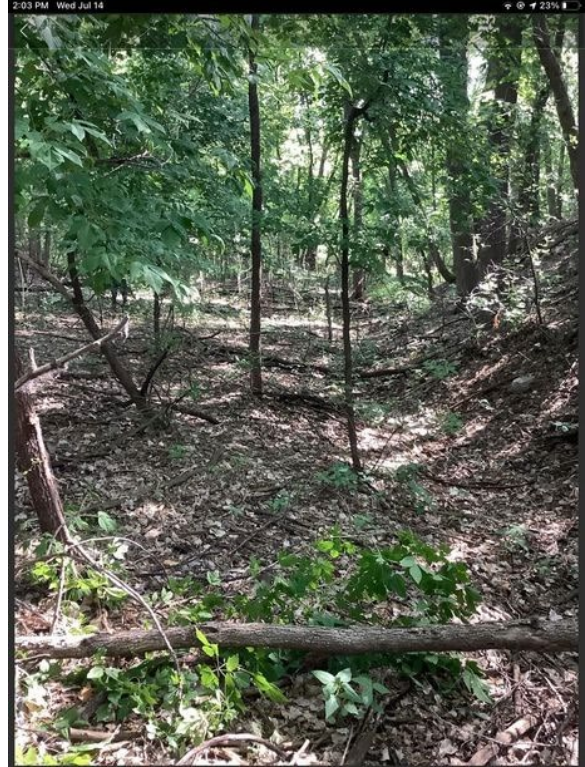
**Photo 2 Image**

Left Bank

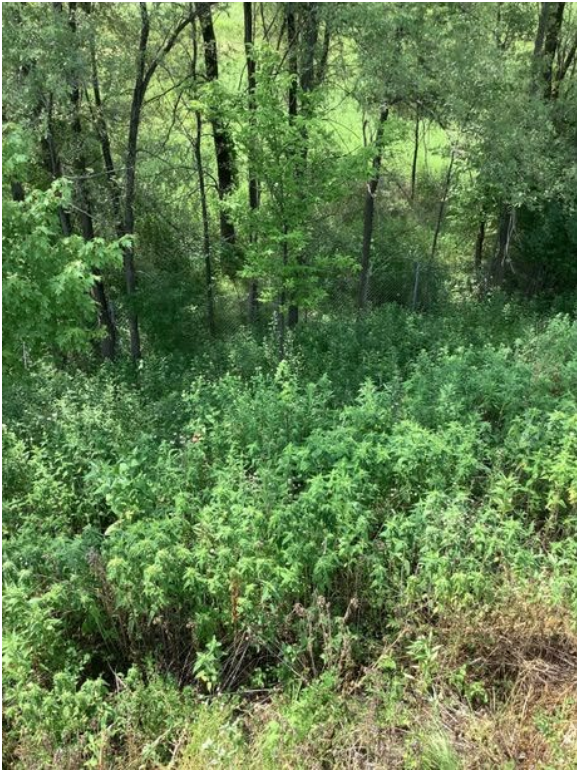
**Photo 3 Image**

View of gully bottom from right bank. There is a fence running through the middle of the bottom along the gully.

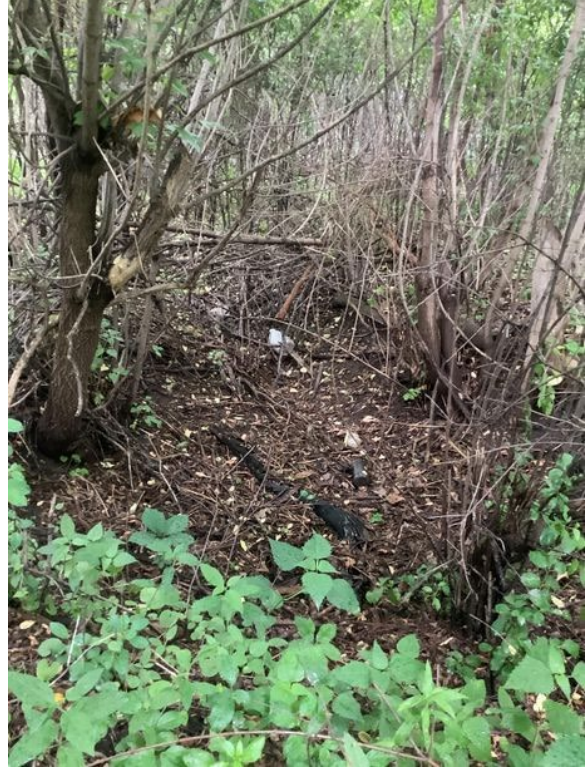
**Photo 2 Image**

Upstream view of gully

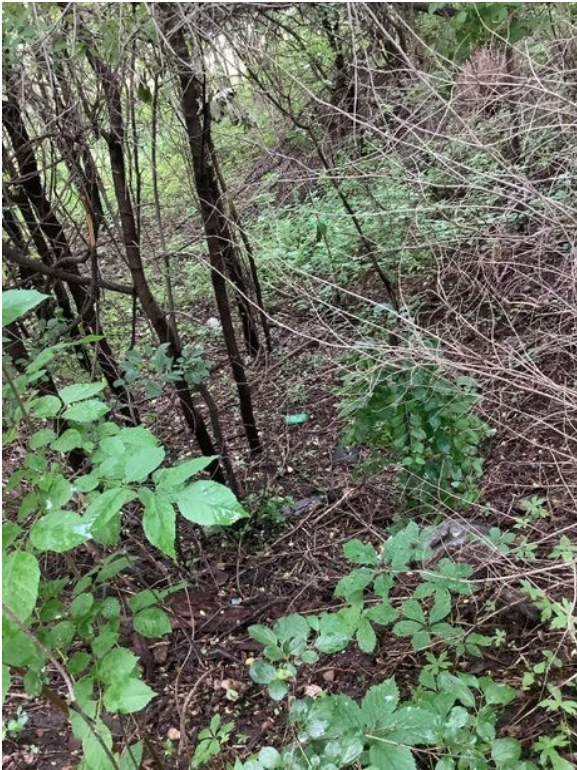
**Photo 3 Image**

Downstream view from left side.

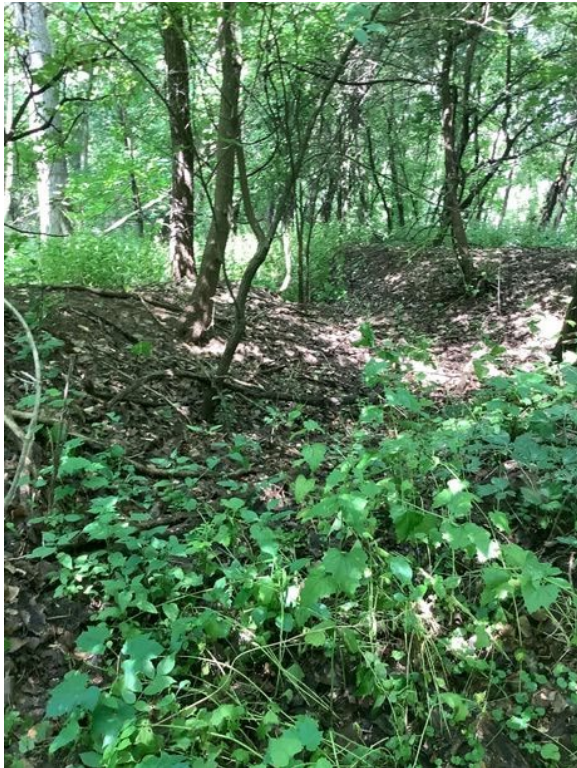
**Photo 3 Image**

Downstream view at turn. Area after turn had practically no vegetation for about 20 feet then it turns into heavy vegetation.

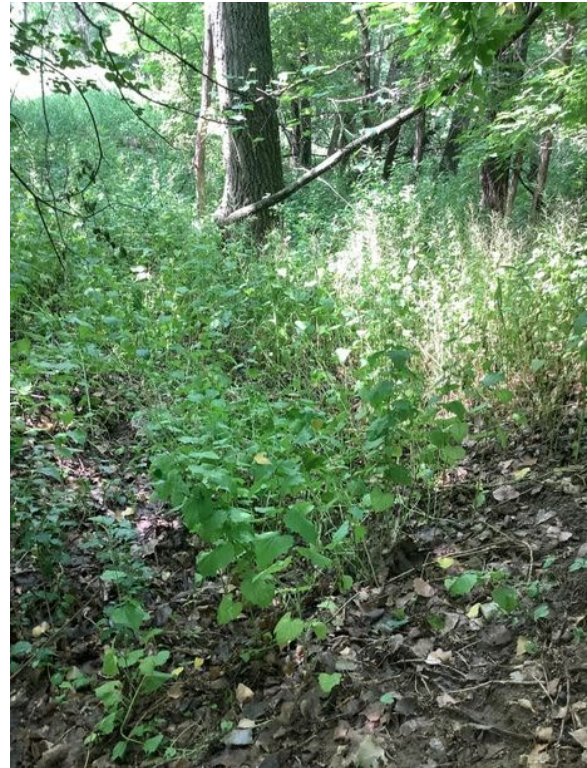
**Photo 4 Image**

Area where gully turns into heavy vegetation, this continues for about 30/40 feet until it connects to another gully downstream.

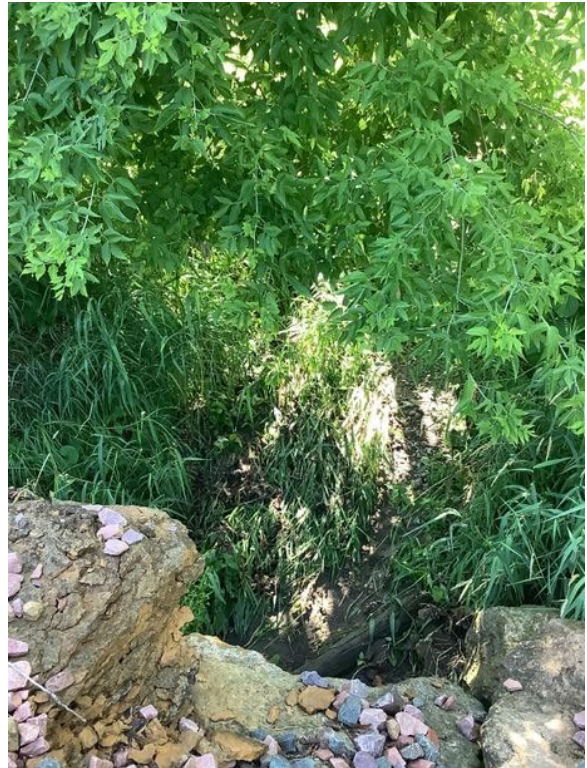
**Photo 4 Image**

Upstream view from other side of railroad tracks. No water was present in this part of the gully so the water must come from another pipe underground.

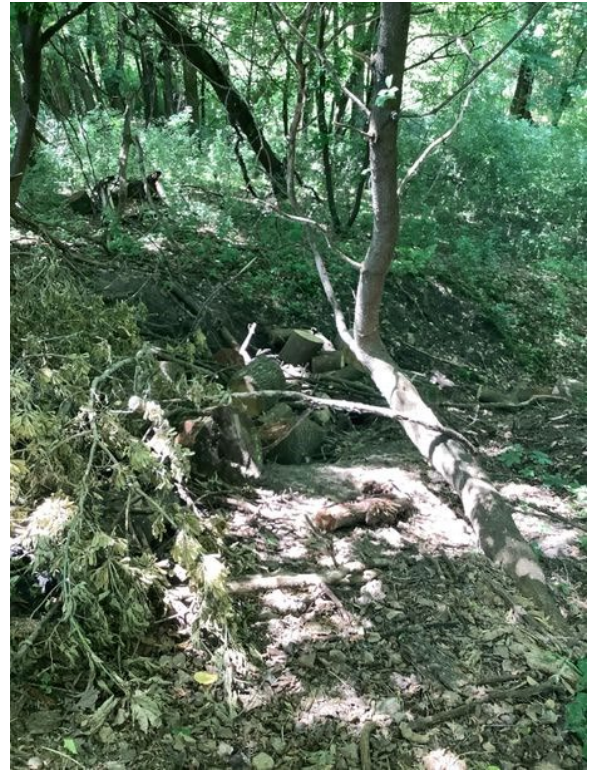
**Photo 2 Image**

Downstream view of head cut of gully filled with log chopping.

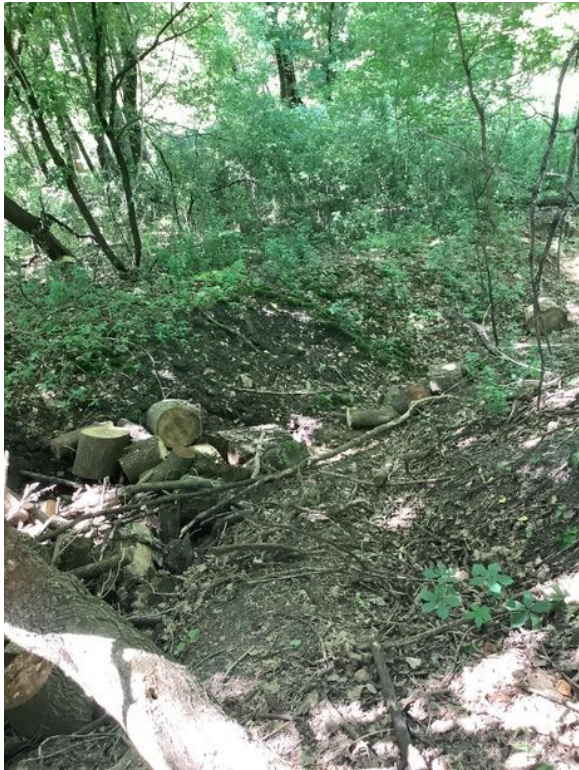
**Photo 3 Image**

Downstream view of entire gully

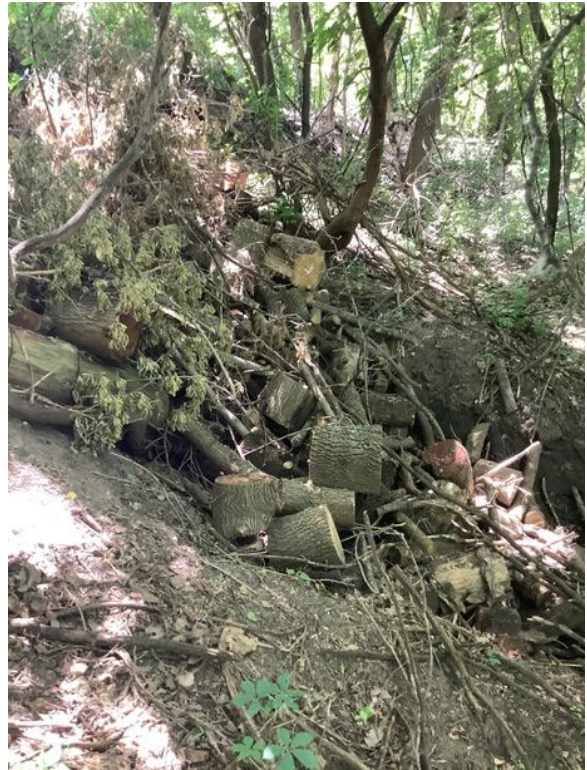
**Photo 4 Image**

Upstream view of yard waste thrown in gully to prevent erosion.

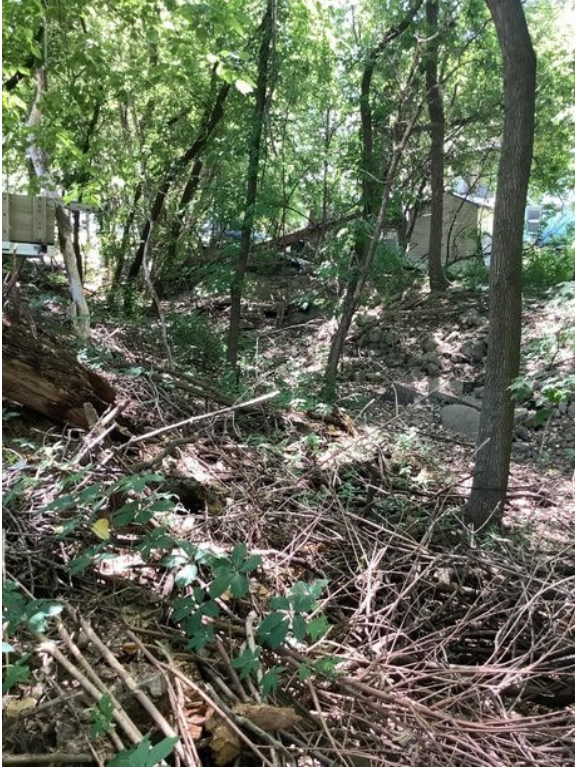
**Photo 1 Image**

Upstream view of gully from right bank.

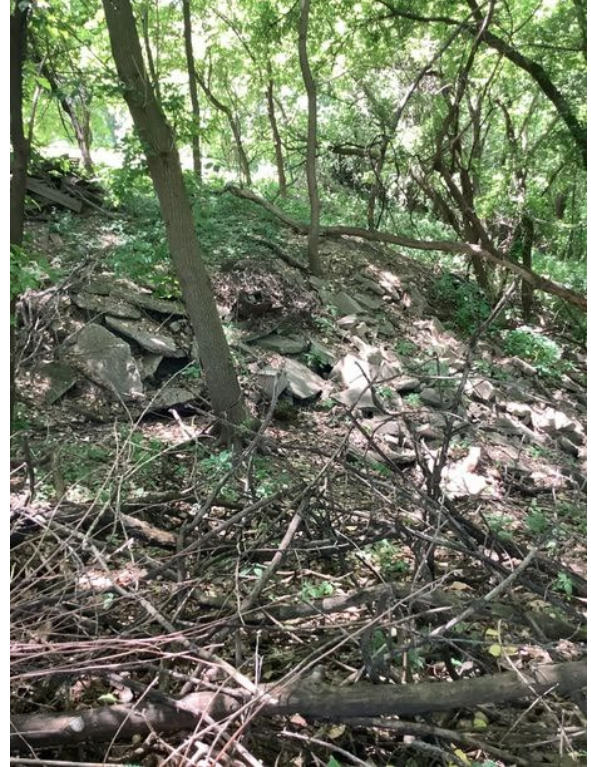
**Photo 2 Image**

View of concrete lining the left bank placed by resident to prevent erosion.

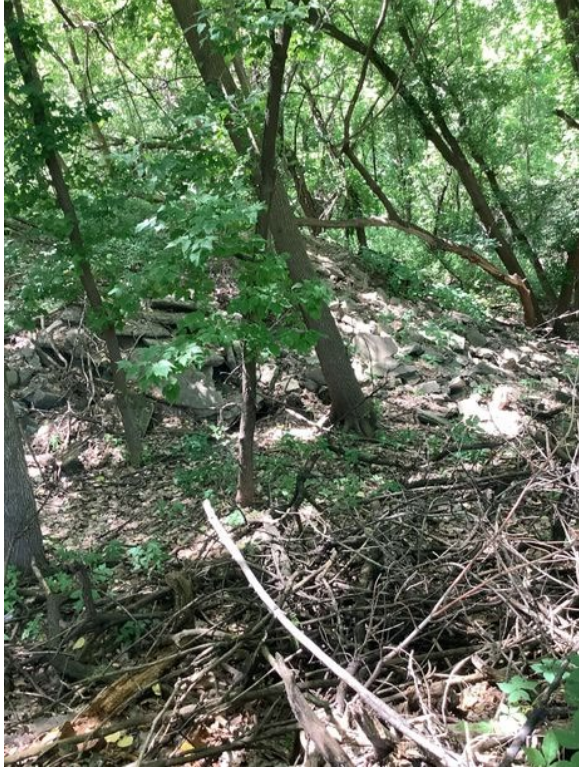
**Photo 3 Image**

Downstream view from left bank.

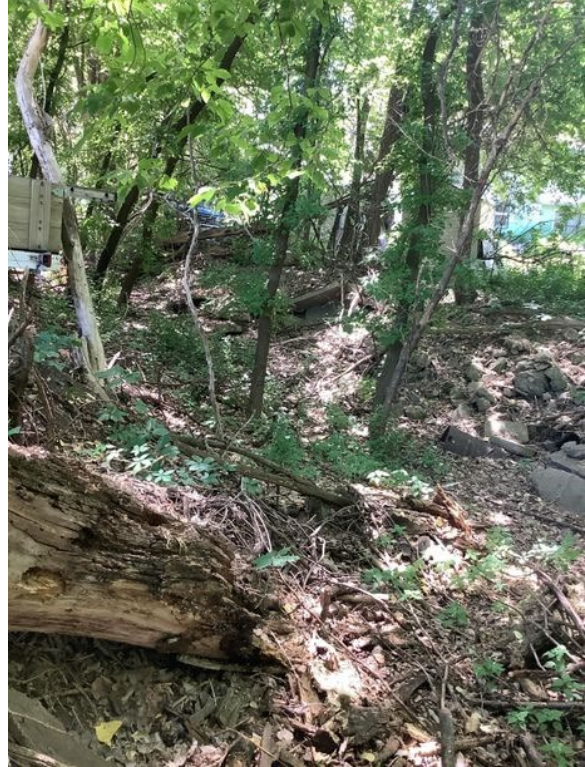
**Photo 4 Image**

Upstream view of gully from right bank.

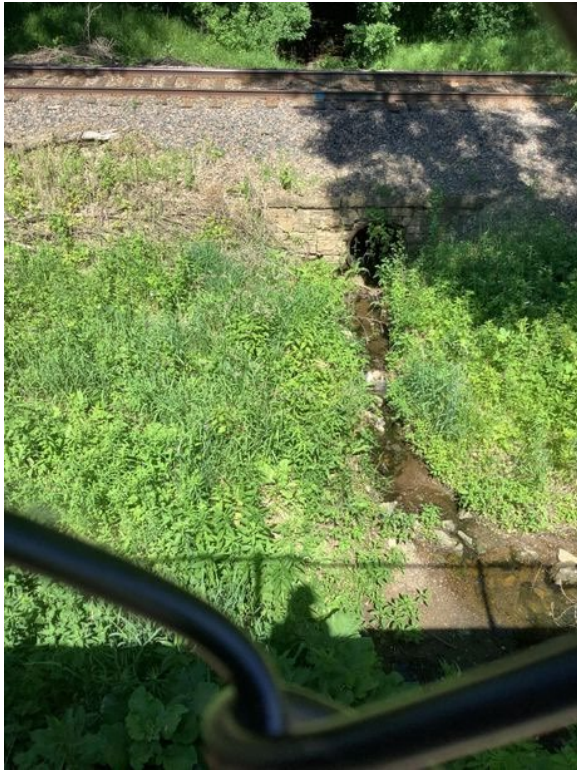
**Photo1**

**Pipe it feeds into**

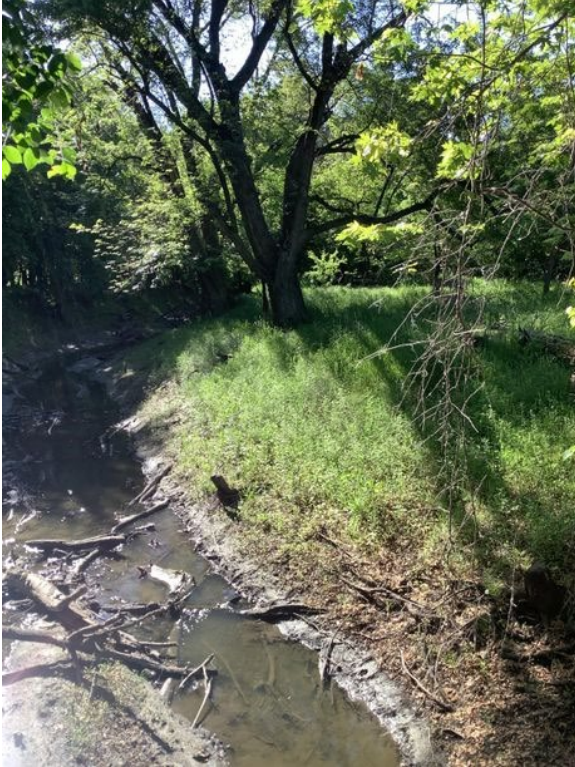
**Photo1**

**Upstream view of left bank.**

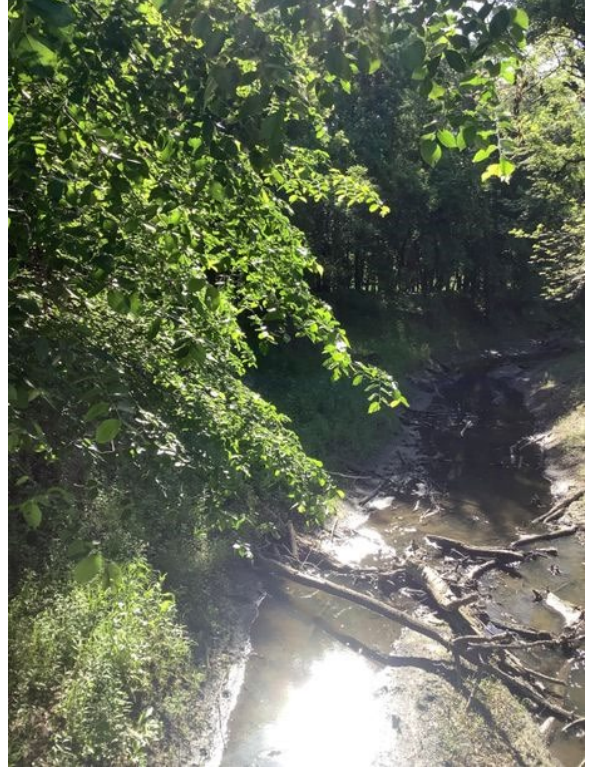
**Photo2**

**Upstream view of right bank.**

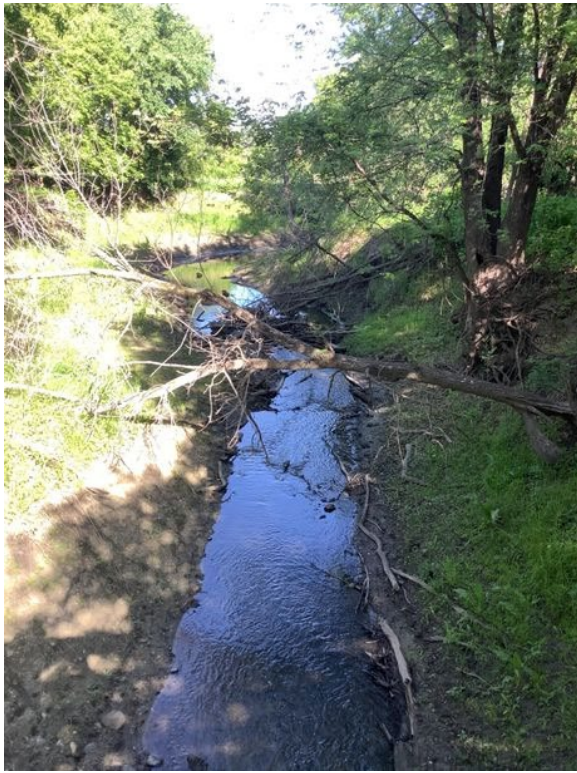
**Photo3**

**Downstream view of where gully meets previous gully.**

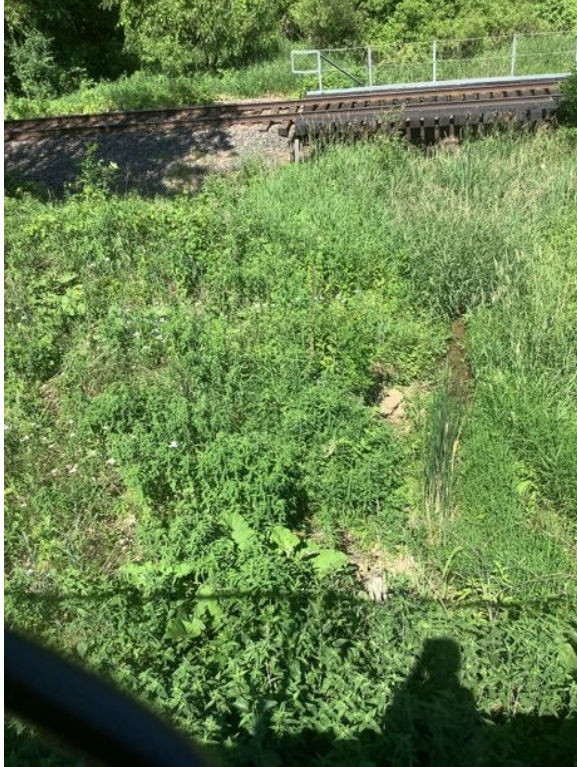
**Photo1**

**Downstream view from bridge.**

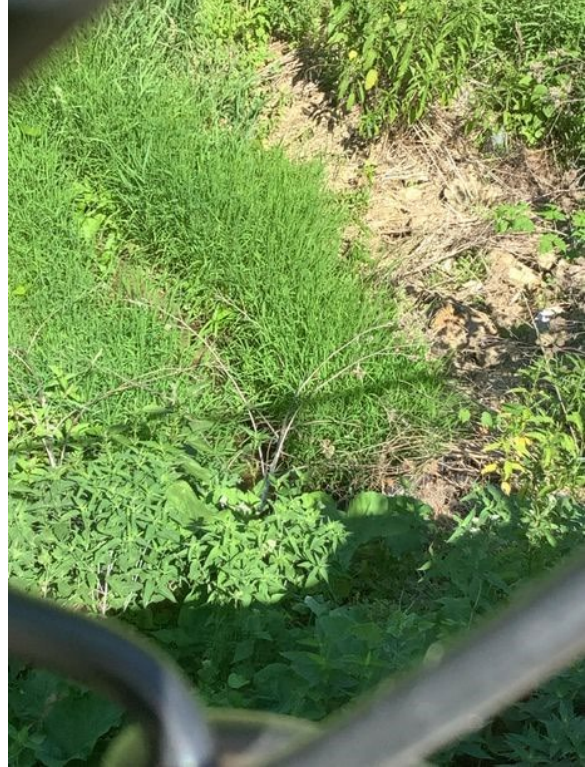
**Photo2**

**Downstream view from bridge of pipe.**

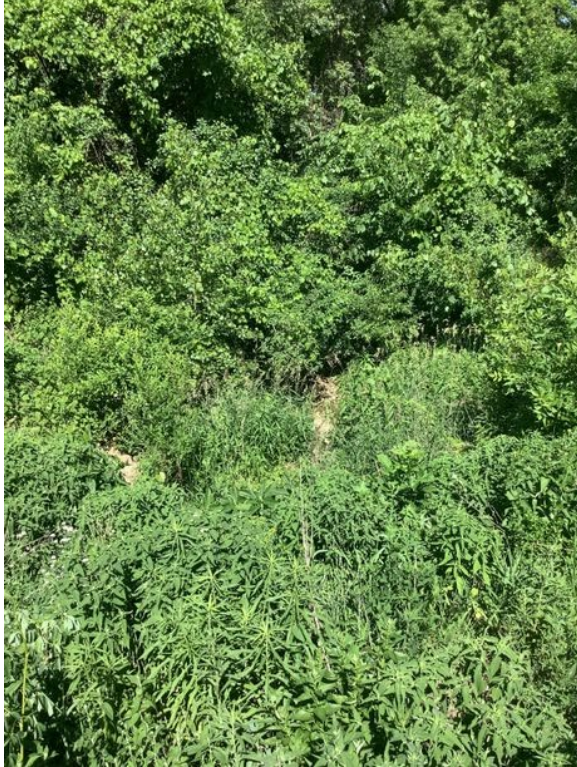
**Photo1**

**Downstream view of heavily vegetated gully from trail.**

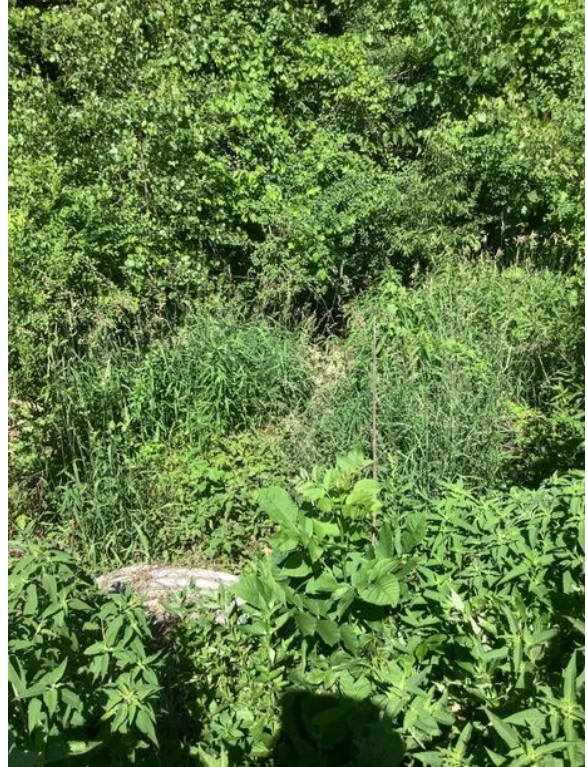
**Photo2**

**Downstream view from above pipe**

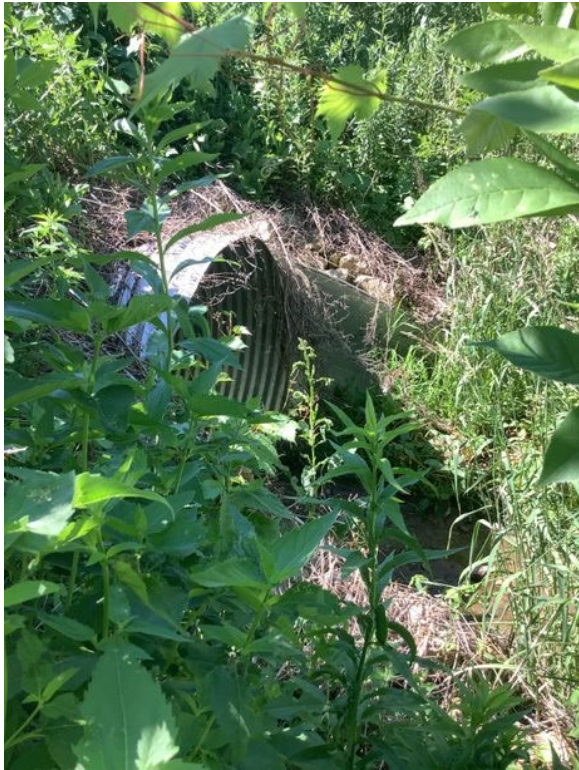
**Photo3**

**Upstream view of pipe from right bank.**

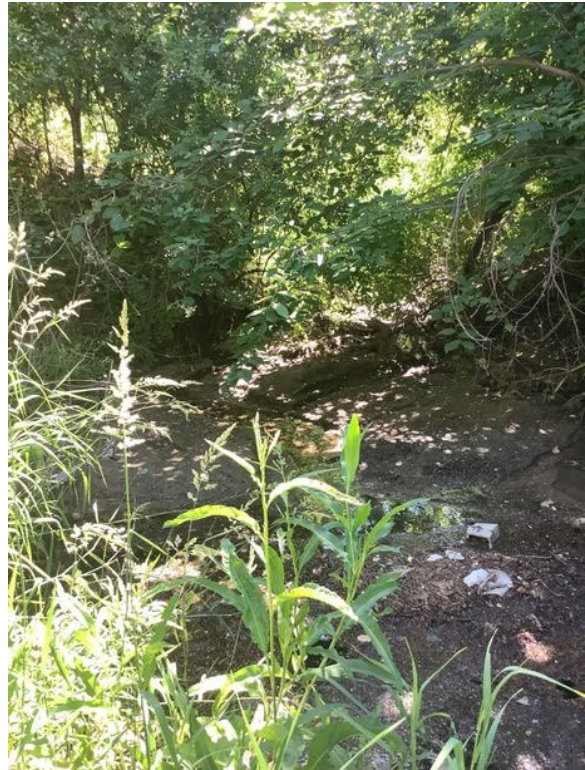
**Photo4**

**Upstream view from railroad tracks on north side of trail behind gully. Shows lots of degradation on the banks.**

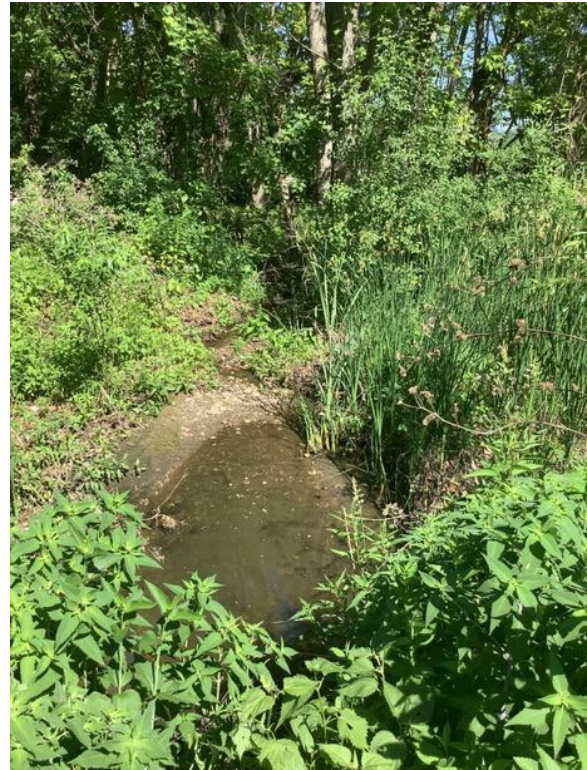
**Photo2**

**Downstream view of north side of trail of gully with stagnant water.**

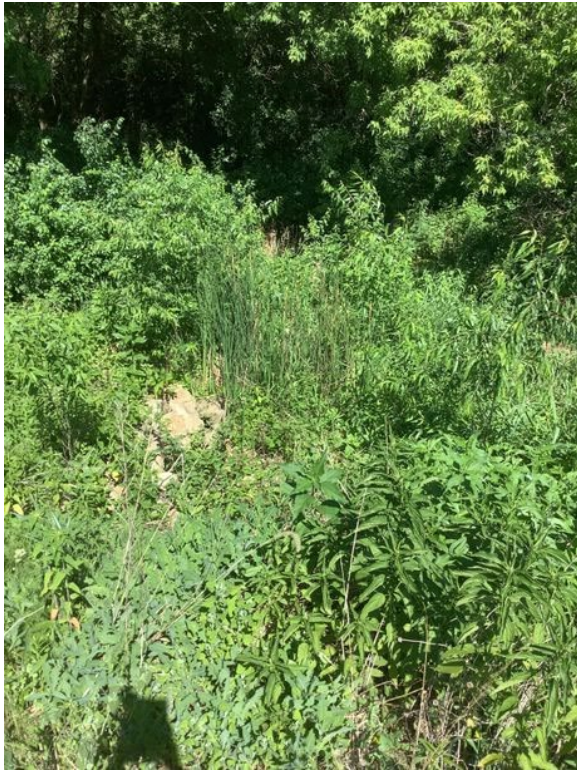
**Photo1**

**Downstream view of rocks outlining where the gully is located.**

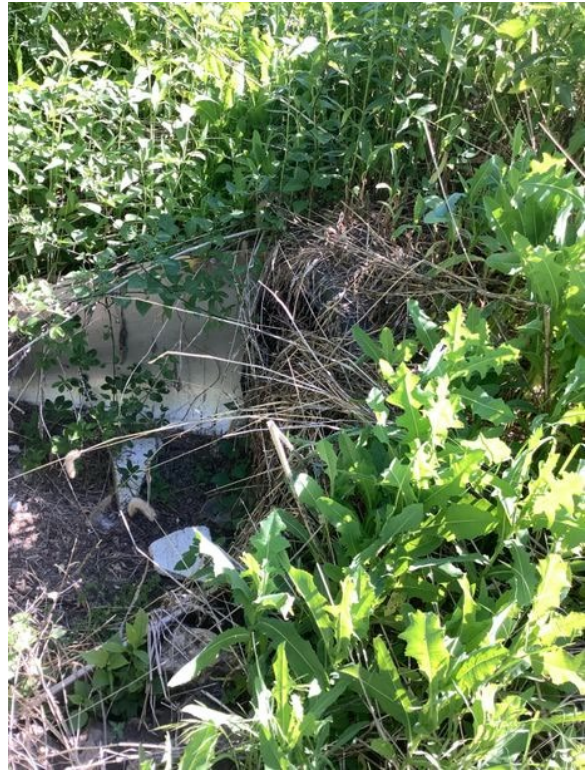
**Photo2**

**Upstream view of pipe.**

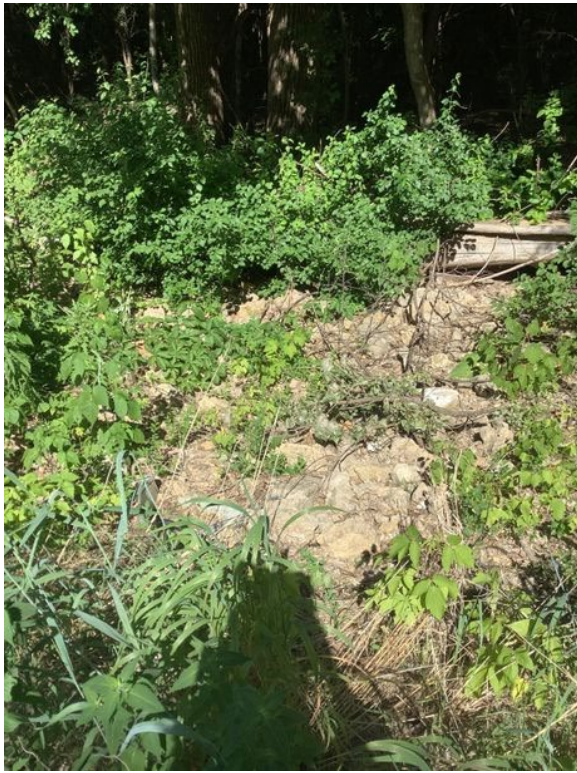
**Photo1**

**Downstream view of gully.**

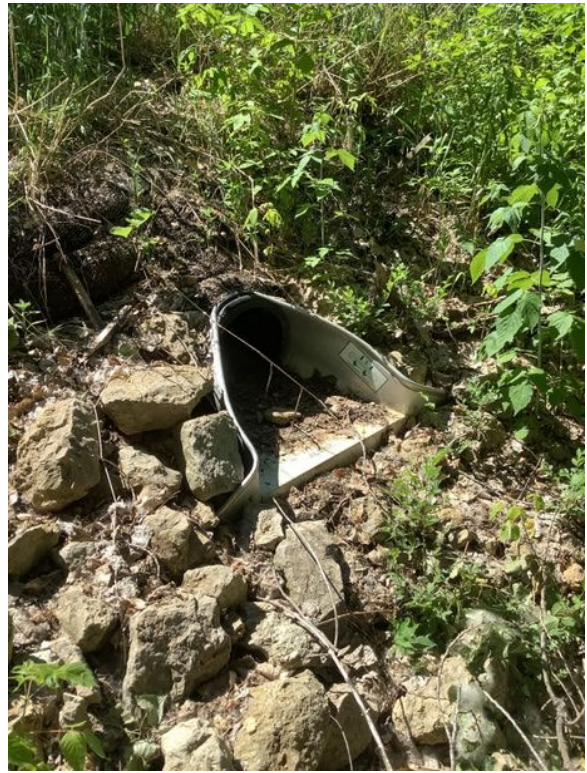
**Photo2**

**Upstream view of pipe.**

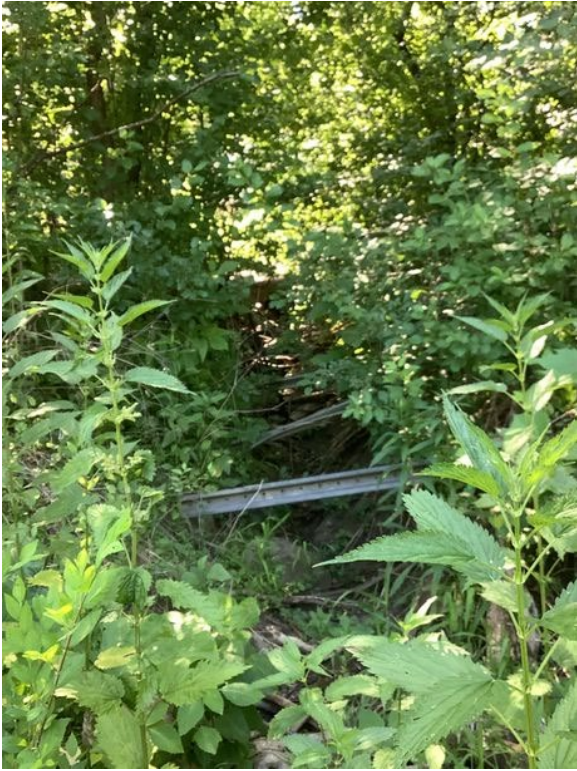
**Photo1**

**Upstream view of full gully.**

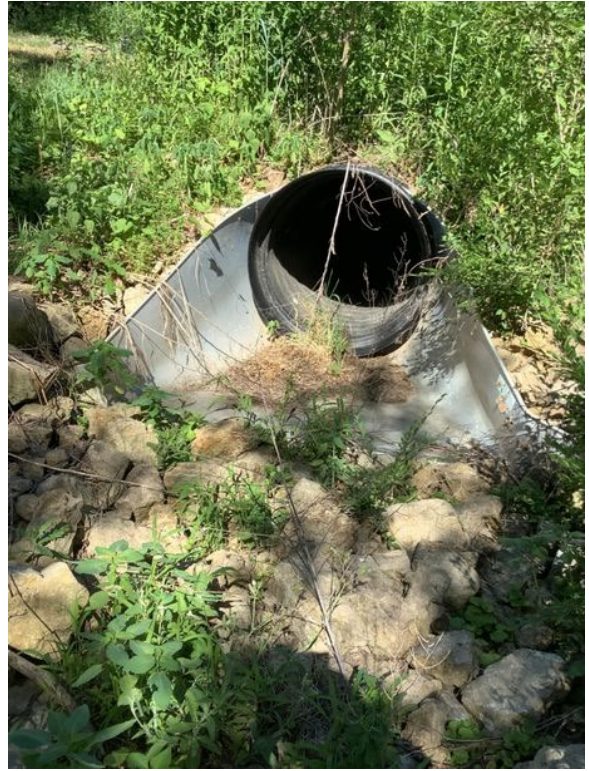
**Photo2**

**Downstream view of pipe and boulders.**

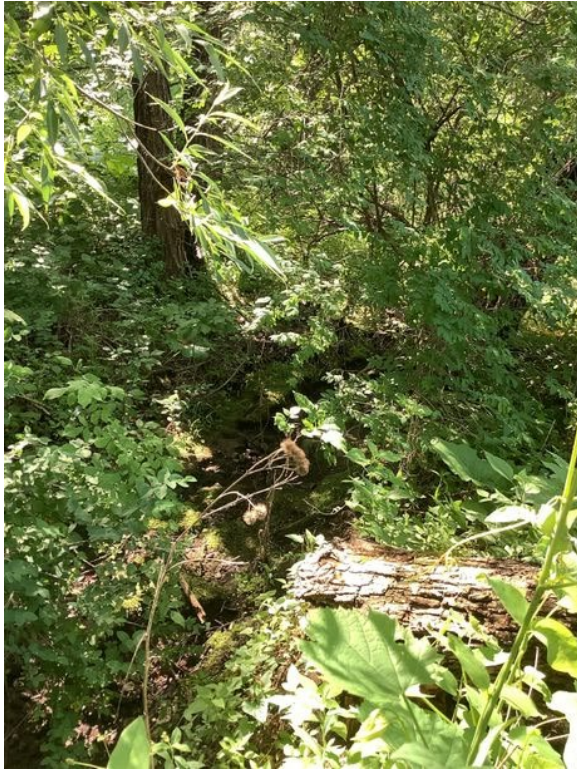
**Photo1**

**Upstream view of bottom of gully.**

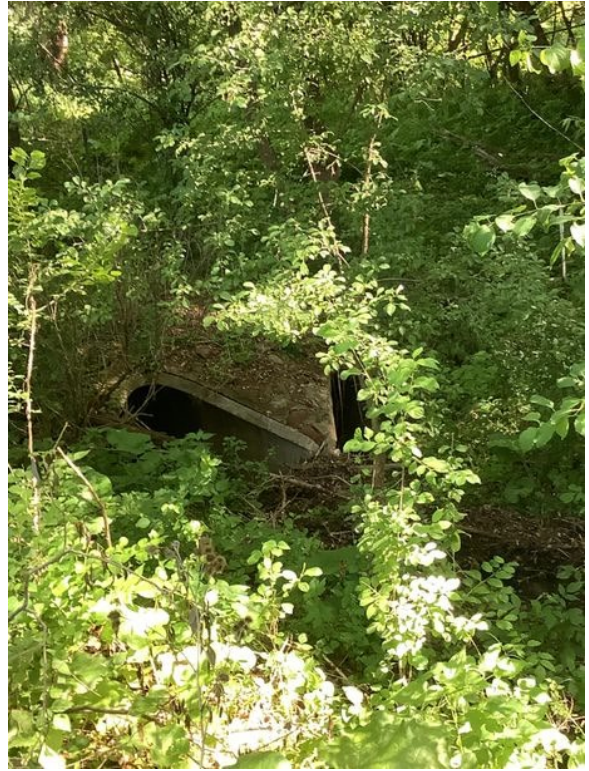
**Photo2**

**Downstream view of pipes at end of gully.**

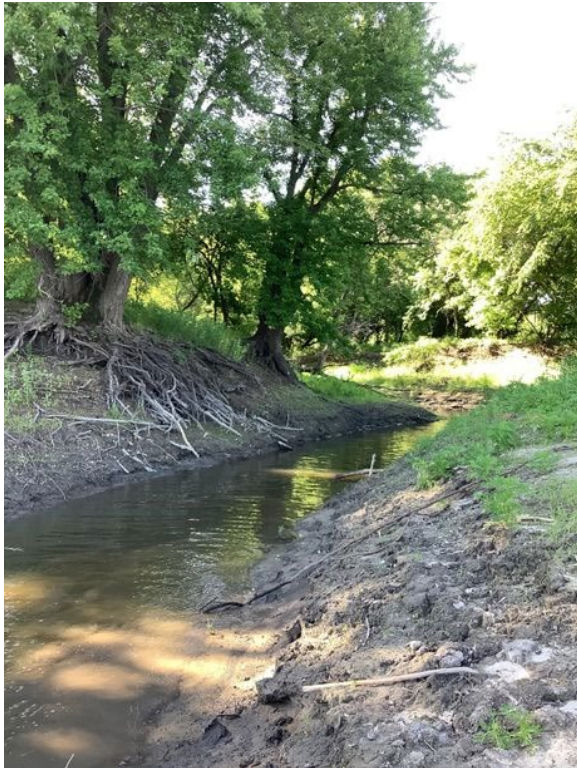
**Photo1**

<b>Seep:</b>	No	
<b>Stormwater Inputs:</b>	3-Constant high flow	
<b>Fallen Trees:</b>	No	
<b>Degradation:</b>		5-Severe
<b>Aggradation:</b>		3-Moderate
<b>Slumping:</b>		3-Moderate
<b>Additional Notes:</b>	Classification? High (x - 49) Notes/Comments: Stream running off of Minnesota river. Lack of vegetation on lower banks and large trees roots are very exposed.

**View of stream off river. Can see large tree with exposed roots on left bank and trees behind it Leaning over river.**

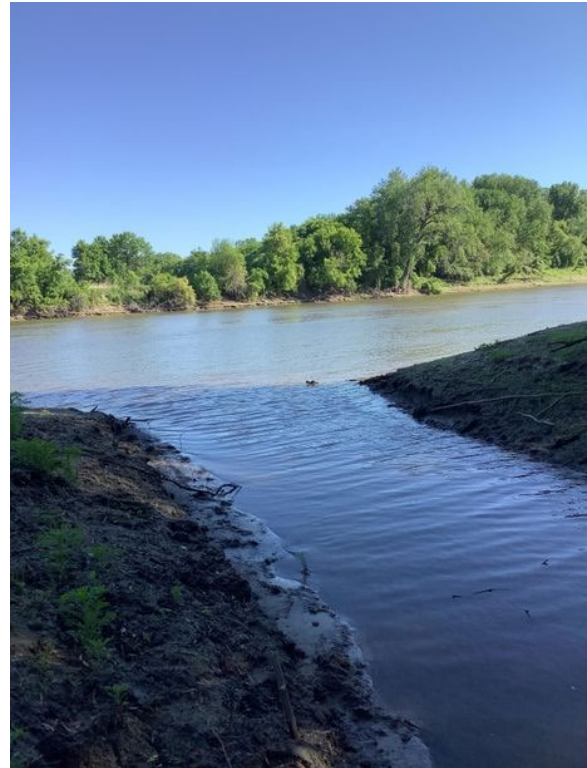
**Photo2**

**View from right bank upstream where the water flows into the gully from the Minnesota River and mixes with the stream**

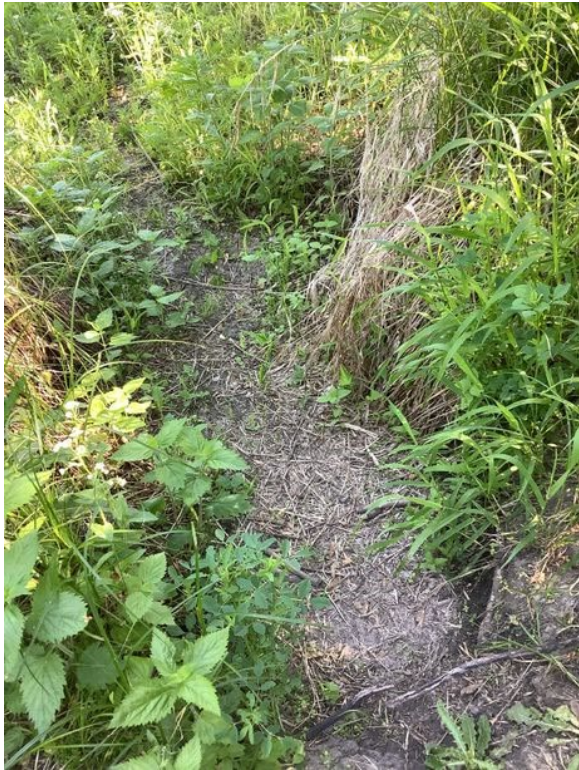
**Photo1**

<b>Seep:</b>	No	
<b>Stormwater Inputs:</b>	0-Not present	
<b>Fallen Trees:</b>	No	
<b>Degradation:</b>		3-Moderate
<b>Aggradation:</b>		0-No aggradation
<b>Slumping:</b>		0-No slumping
<b>Additional Notes:</b>	Classification? Moderate (x - x) Notes/Comments: Small gully near river, grass roots hanging from side. Little trail on other side of gully.

**View of entire gully**

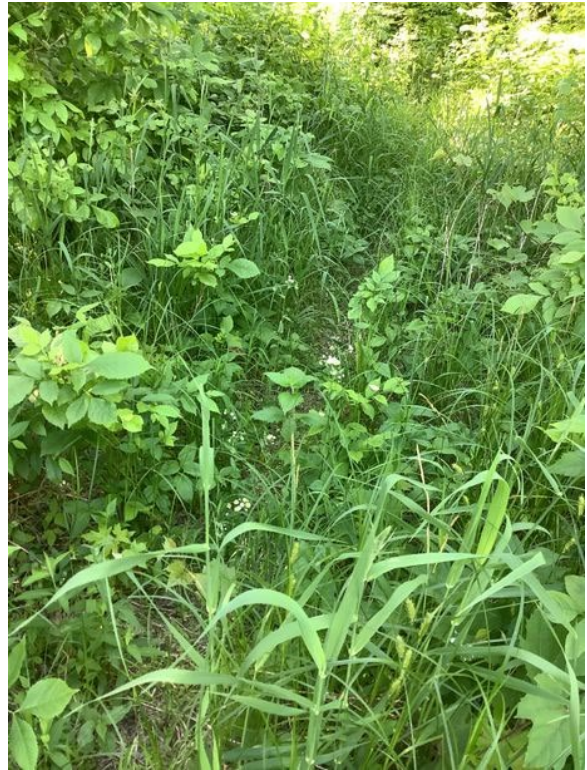
**Photo2**

**View of area upstream with less vegetation than surroundings**
