Gully ID: 07:19-11:55	MAP

Date & Time: July 19, 2021 11:55 AM	
Location: Savage	
Weather: Sunny Storm/Rainfall Event in the Past 24 Hours? No	
GULLY INFORMATION	
Calculated Erosion Potential:	High
Approximate Depth:	5-Deep (>15')
Approximate Bottom Width:	5-Narrow/V-Ditch
Approximate Gully Length:	5-Long (>100')
Condition of Gully Bottom:	5-Bare Soil
Condition of Gully Banks:	3-Some Vegetation
Gully Bank Angles:	5-Acute (<45 degrees or undercut)
Gully Shape:	5-V-Shaped
Gully Material:	Silt/Clay

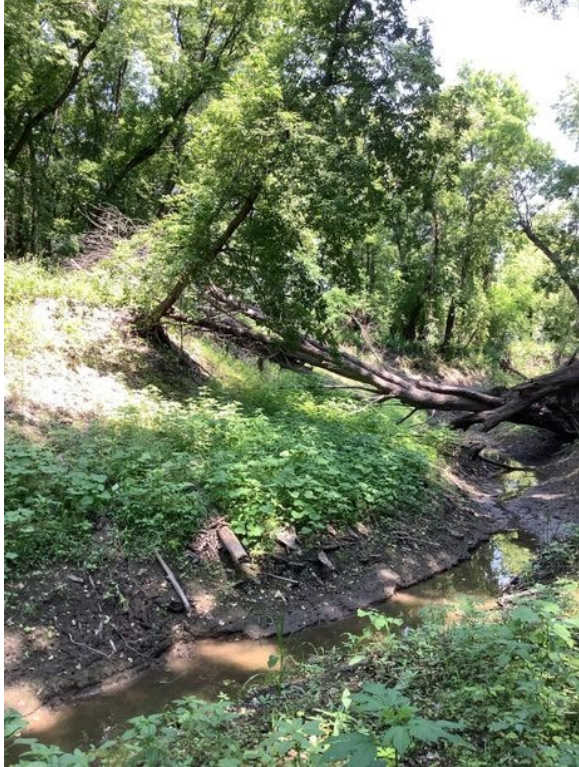
Photo 3 Image

Left bank

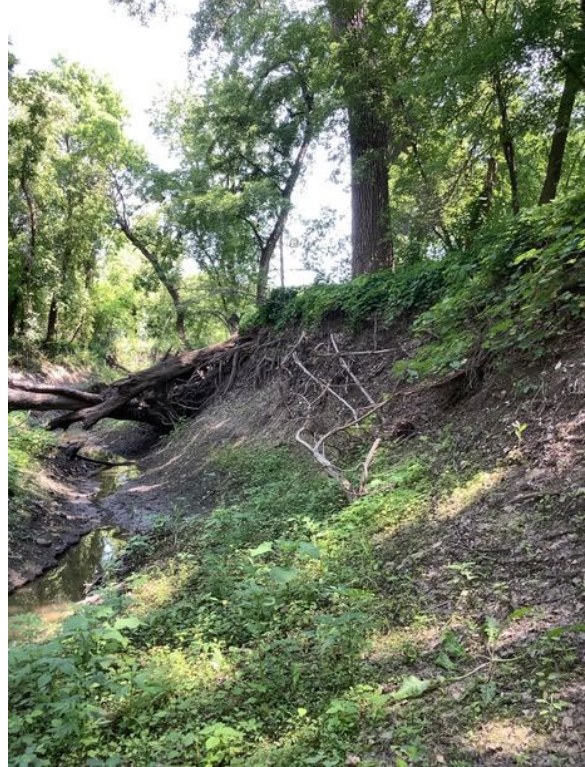
Photo 4 Image

Right bank

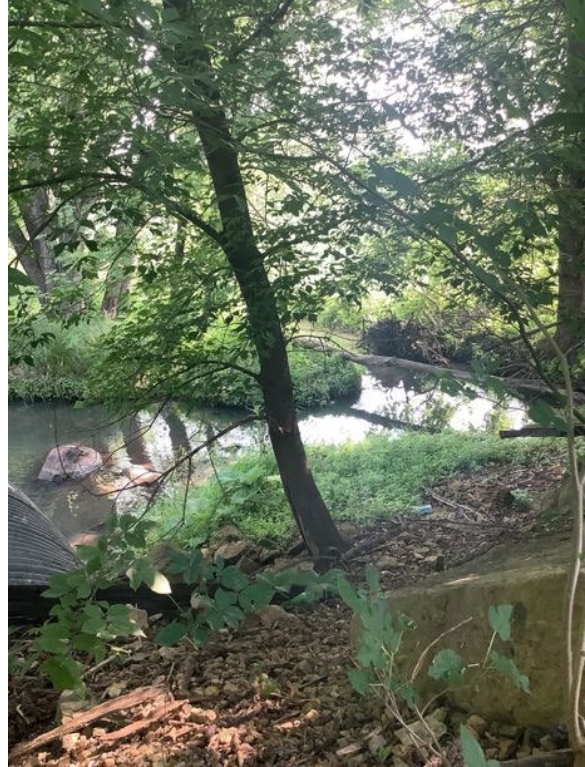
Photo 2 Image

Downstream view of winding gully.

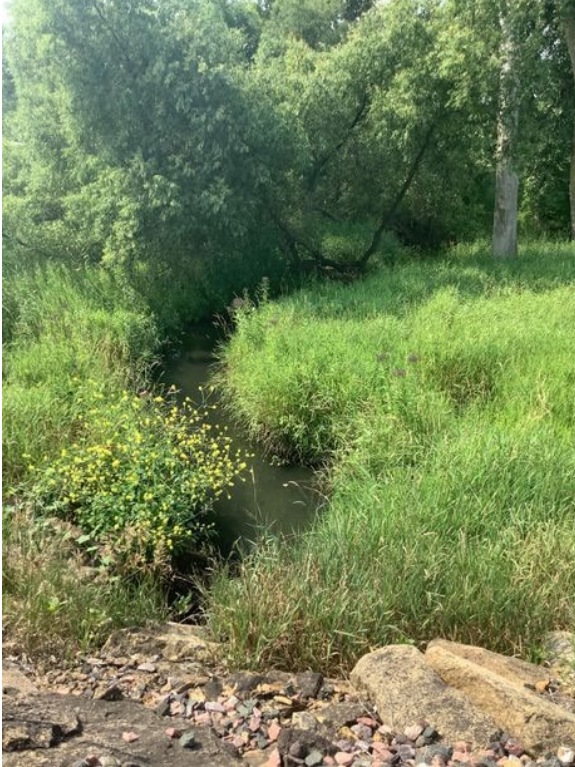
Photo 3 Image

Upstream view of gully on other side of railroad tracks.

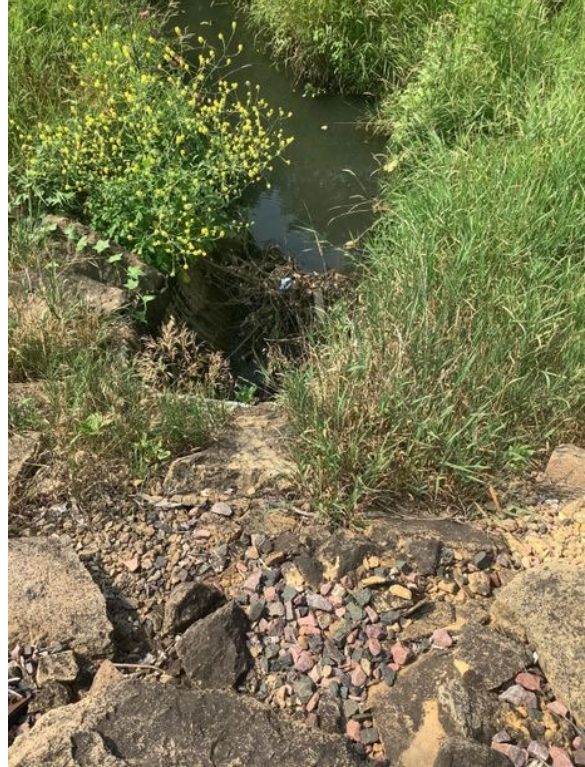
Photo 4 Image

Gully bottom of upstream pipe with lots of debris stuck before pipe.

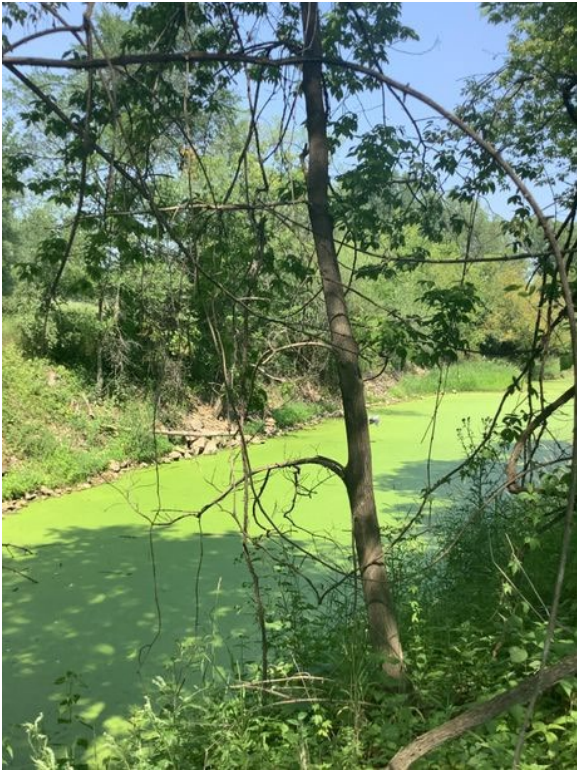
Photo 3 Image

Downstream view of degradation and leaning trees on the left bank.

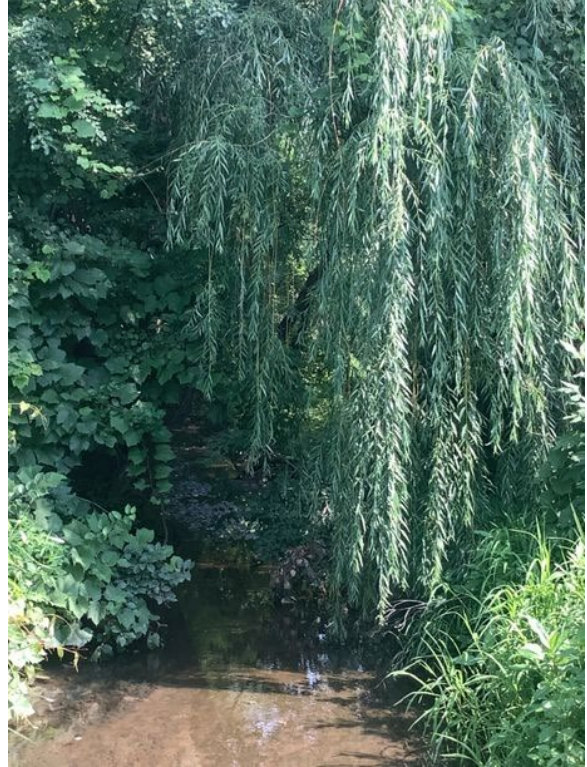
Photo 2 Image

Downstream view of leaning trees.

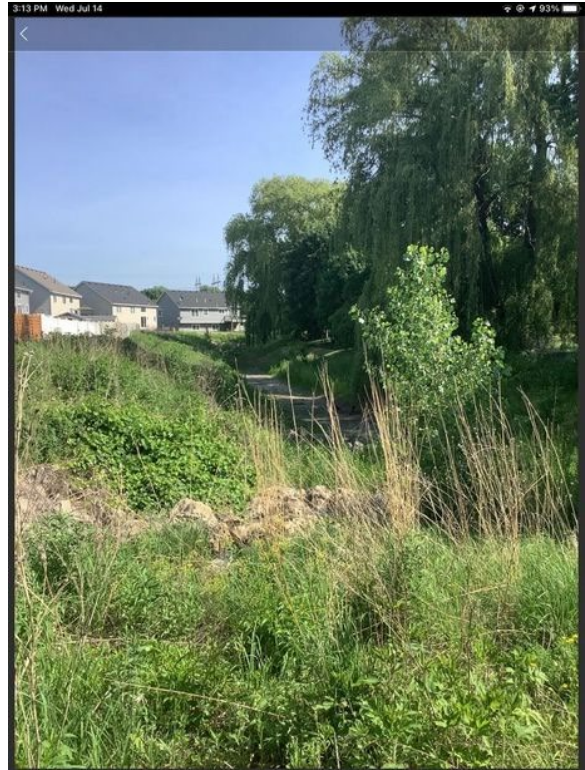
Photo 2 Image

Downstream view of the rest of the gully, the rocky area is where the pipe is located, at the end of the gully there is another drainage pipe.

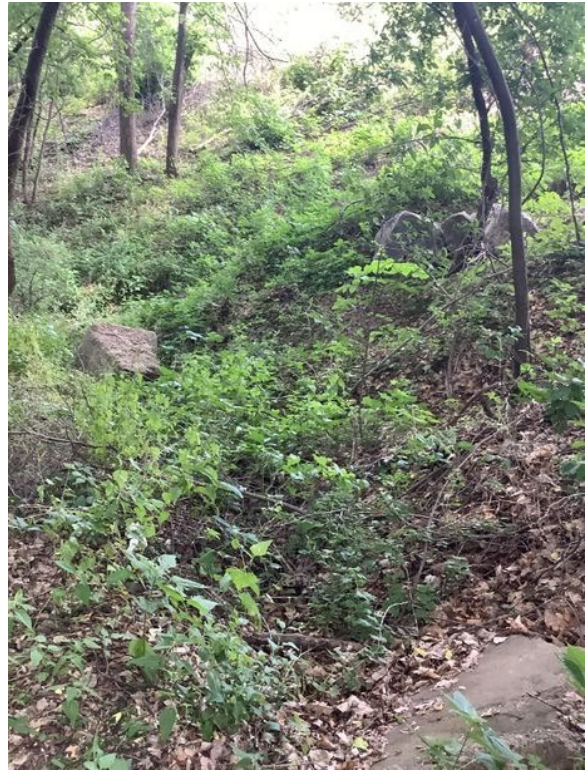
Photo 2 Image

Downstream view of right bank and large boulders on it.

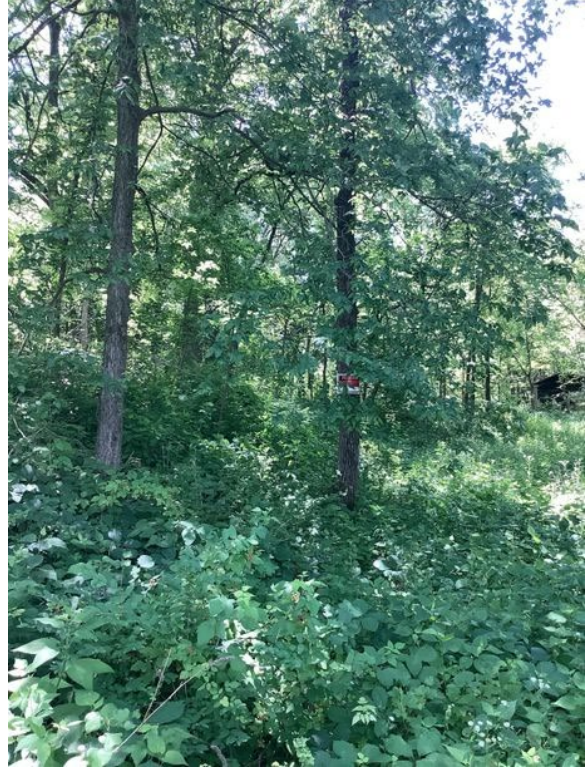
Photo 2 Image

Upstream view of right bank

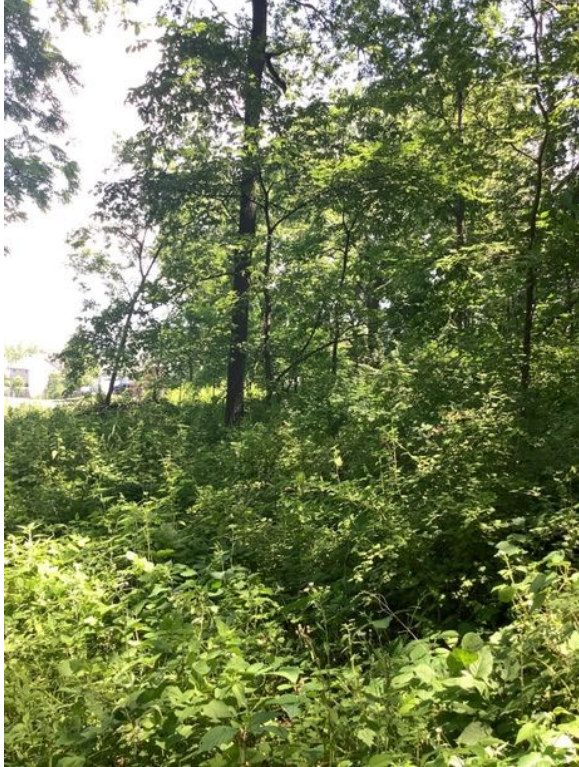
Photo 3 Image

Downstream view of right bank.

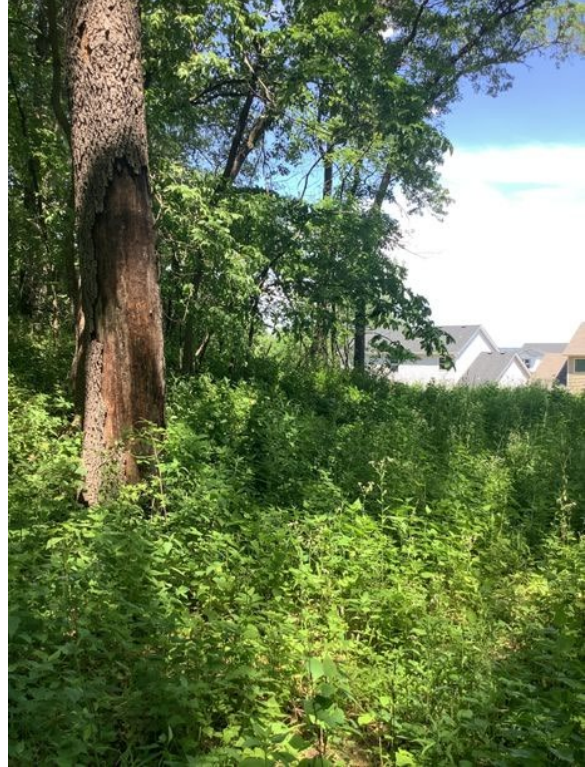
Photo 4 Image

Downstream view of left bank.

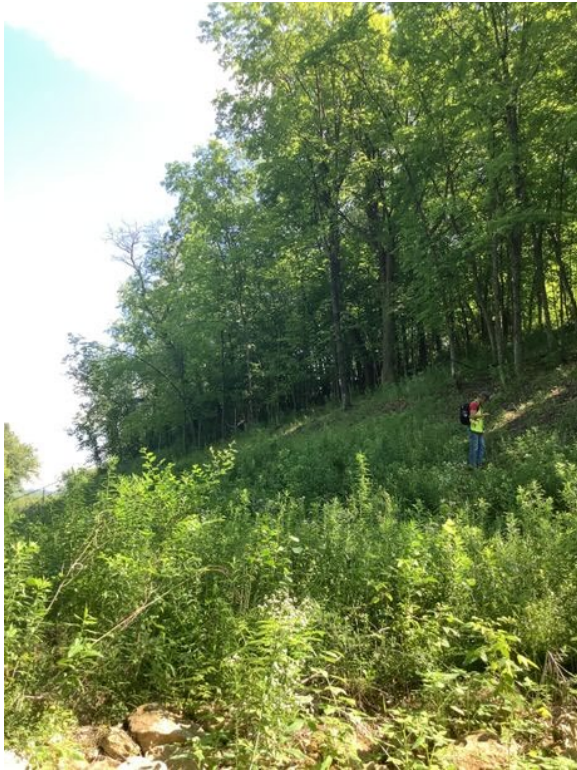
Photo 1 Image

Downstream view of right bank.

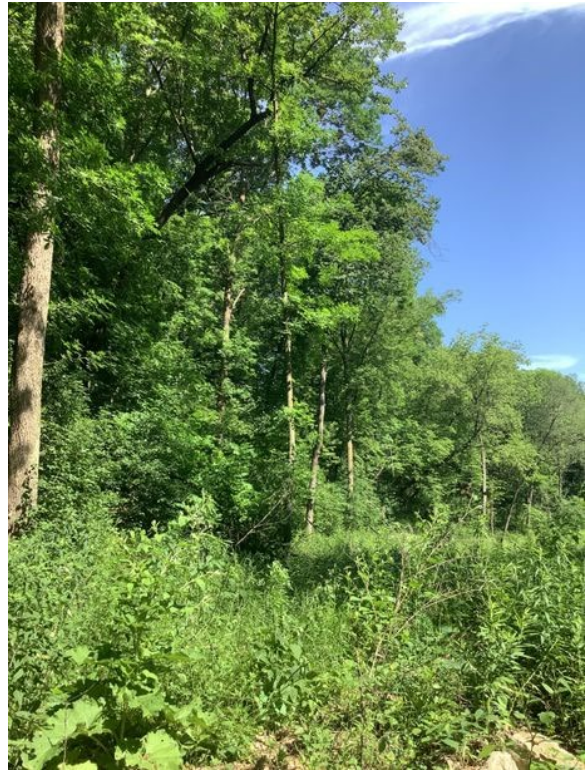
Photo 2 Image

Downstream view of left bank.

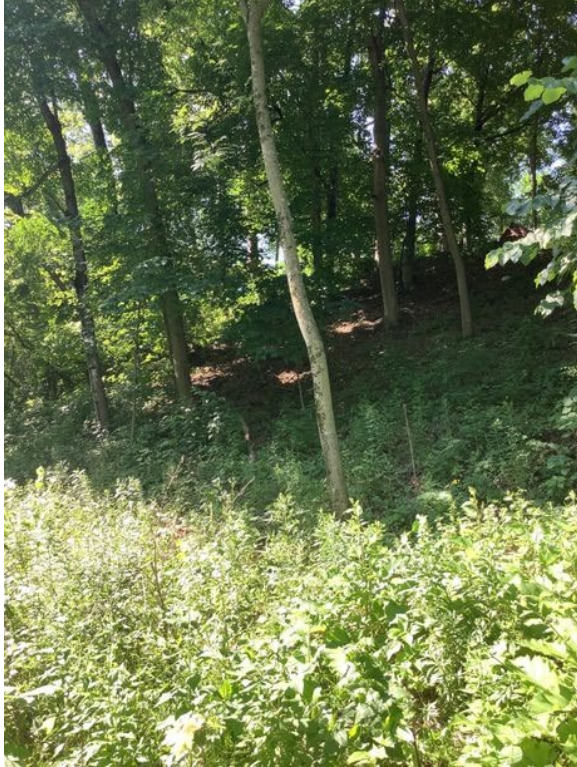
Photo 3 Image

Upstream view of left bank. This area is more bare and has more degradation.

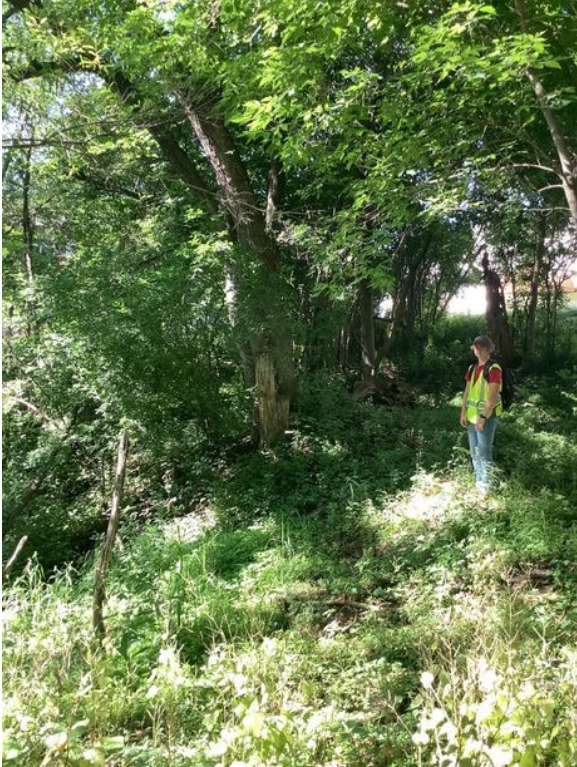
Photo 1 Image

Upstream view of left bank.

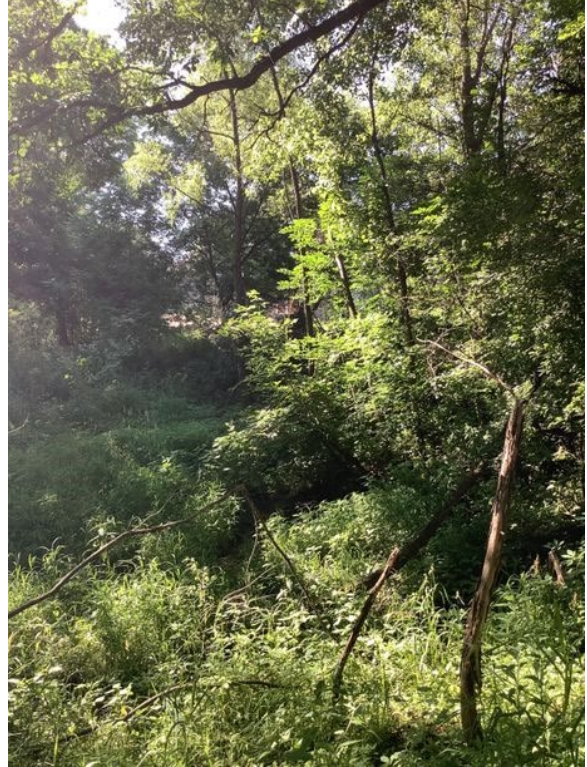
Photo 2 Image

Upstream view of right bank.

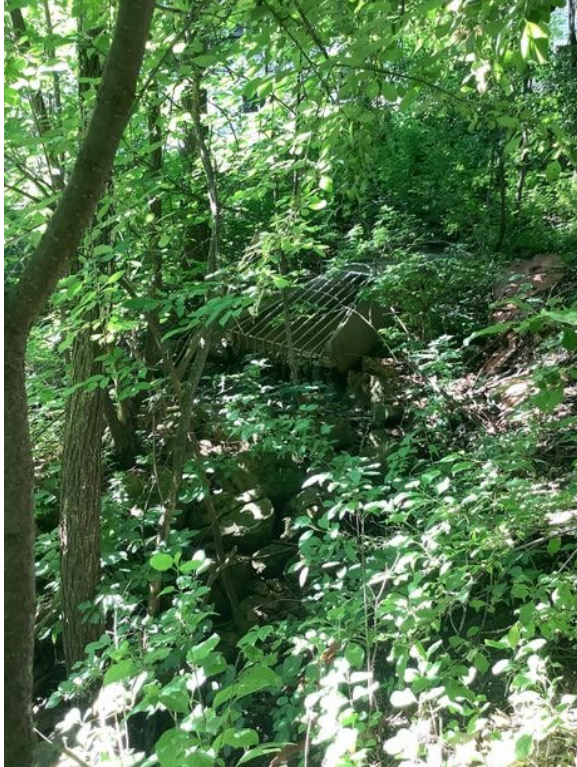
Photo 3 Image

Upstream view of pipe outfall. Pipe has armor in front of it.

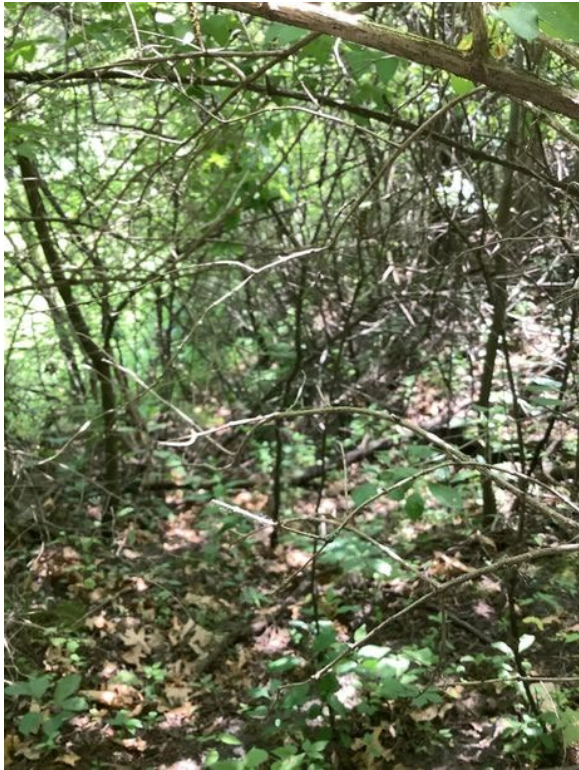
Photo1

Seep:	No	
Stormwater Inputs:	0-Not present	
Fallen Trees:	No	
Degradation:		3-Moderate
Aggradation:		0-No aggradation
Slumping:		3-Moderate
Additional Notes:	<p>Classification? High (x - 49)</p> <p>Notes/Comments: Gully leading into eagle creek. Steep and short with moderate vegetation. Some of the small trees growing on the banks look pistol shaped.</p>

View downstream of gully, kind of hard to see with vegetation blocking site.

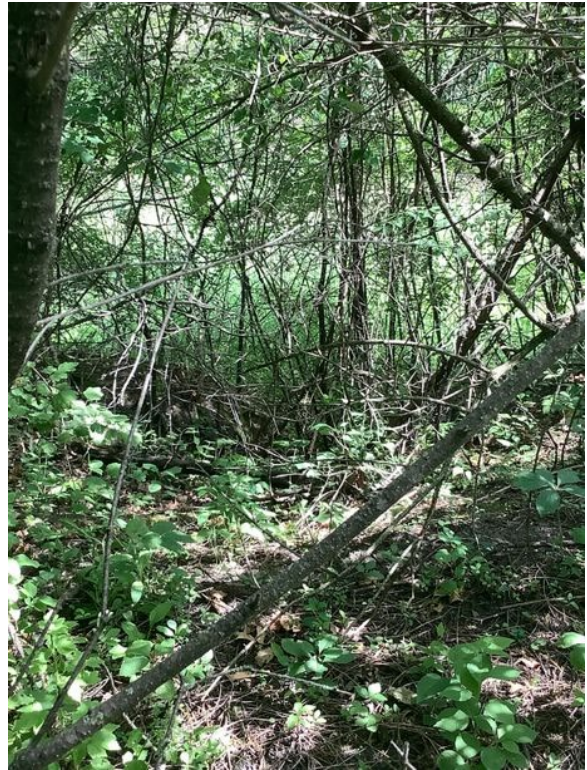
Photo2

Downstream view from left side.

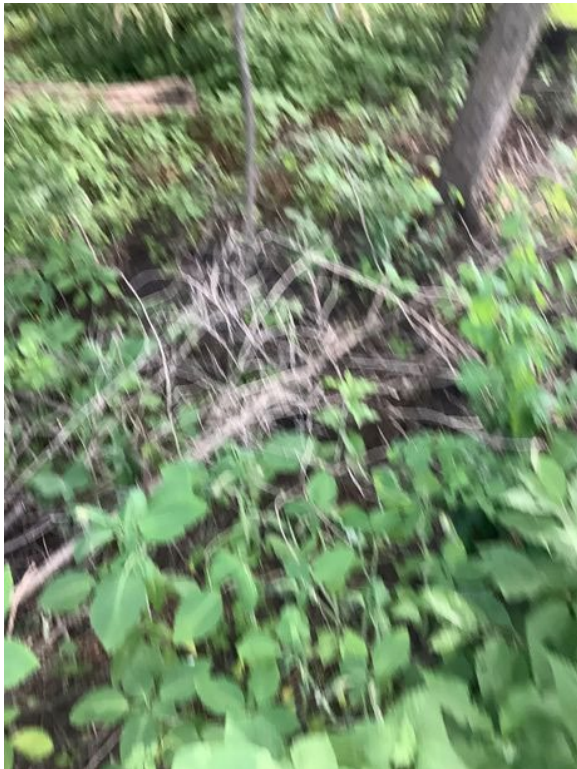
Photo1

Seep:	No	
Stormwater Inputs:	0-Not present	
Fallen Trees:	No	
Degradation:	3-Moderate	
Aggradation:	0-No aggradation	
Slumping:	0-No slumping	
Additional Notes:	Classification? Moderate (x - x) Notes/Comments: Short gully with what looks to be brush dumped in it. No visible vegetation on the banks or bottom, not ,UCB slumping, and moderate erosion

Downstream view of right bank.

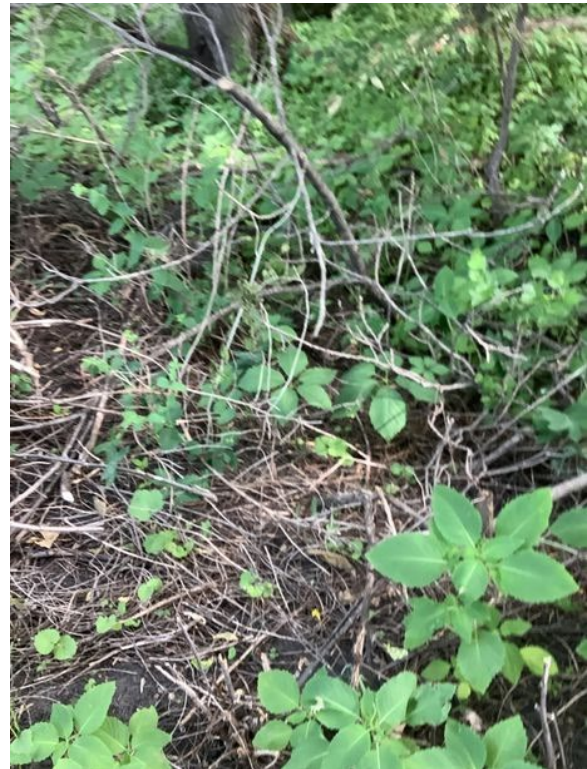
Photo2

Downstream view of left bank.

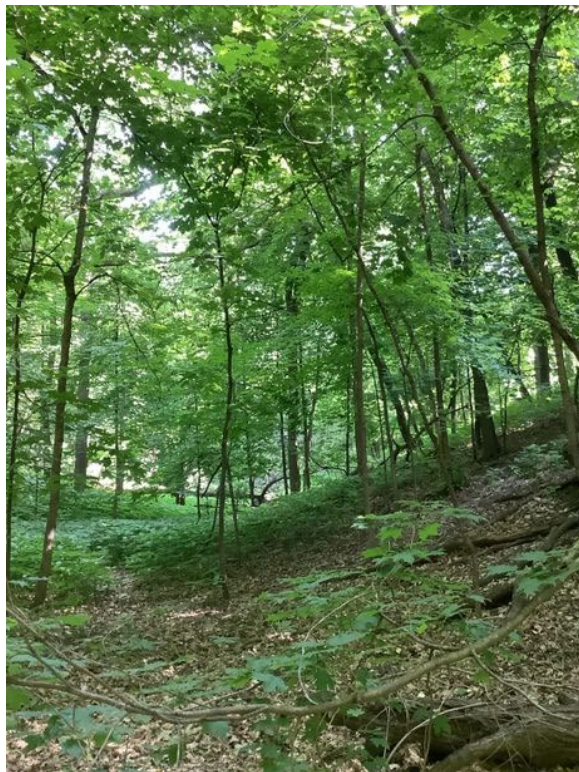
Photo1

Seep:	No	
Stormwater Inputs:	0-Not present	
Fallen Trees:	No	
Degradation:	1-Low	
Aggradation:	1-Low	
Slumping:	1-Low	
Additional Notes:	Classification? Low (4 - x) Notes/Comments: Large gully with heavy vegetation on banks and bottom. Minor slumping, and some signs on erosion

Downstream view of right bank.

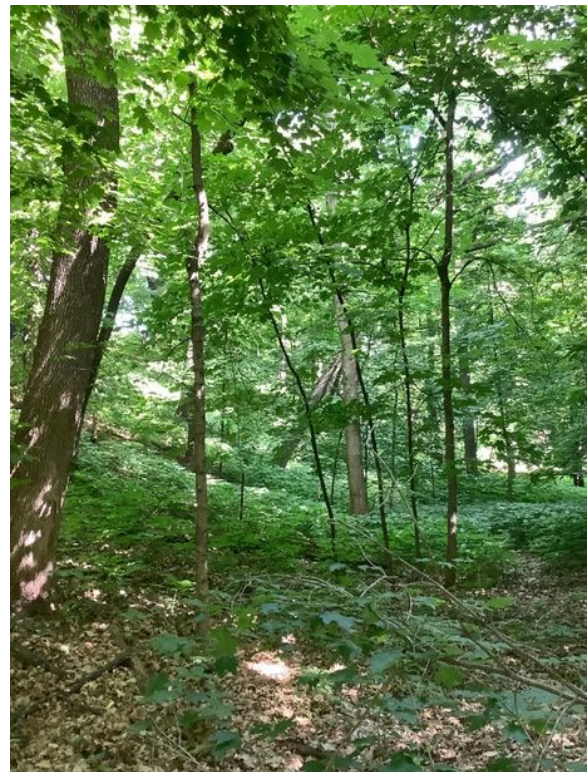
Photo2

Downstream view of left bank.

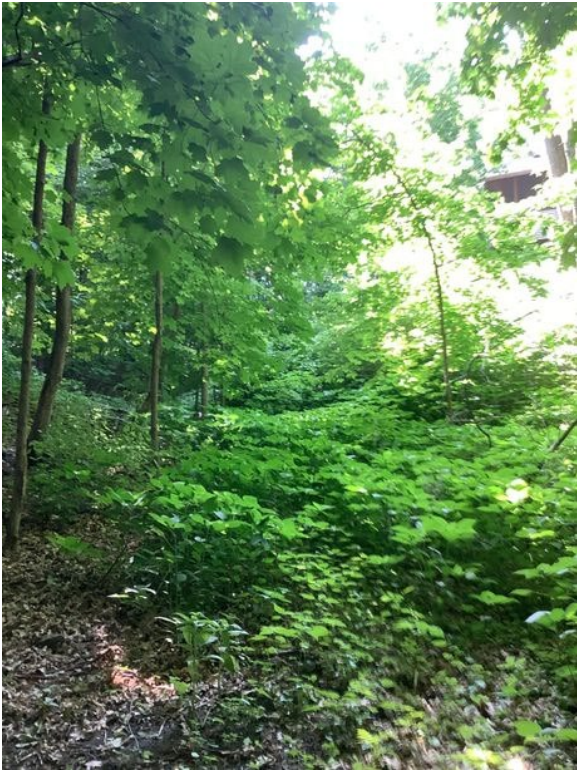
Photo3

Upstream view of gully.

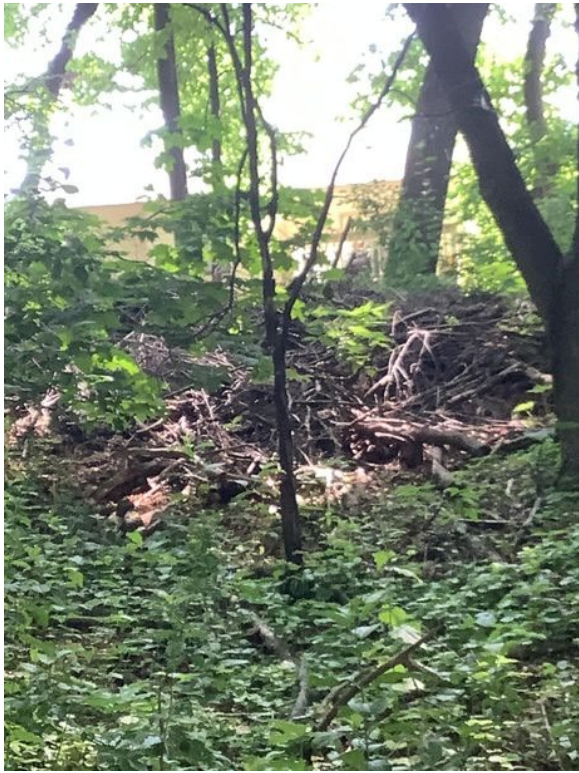
Photo3

Seep:	No	
Stormwater Inputs:	0-Not present	
Fallen Trees:	No	
Degradation:	1-Low	
Aggradation:	0-No aggradation	
Slumping:	0-No slumping	
Additional Notes:	Classification? Low (4 - x) Notes/Comments: Smaller gully with good amounts of vegetation on both the bottom and banks. Not much visible erosion, looks like somebody dumped brush at the top of gully

Upstream view of brush dumped in gully.

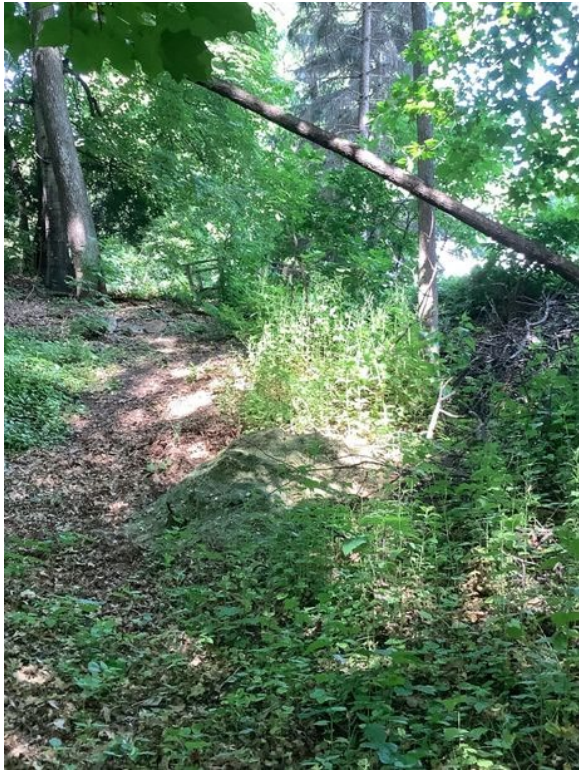
Photo1

Seep:	No
Stormwater Inputs:	0-Not present
Fallen Trees:	No
Degradation:	1-Low
Aggradation:	1-Low
Slumping:	3-Moderate
Additional Notes:	<p>Classification? Moderate (x - x)</p> <p>Notes/Comments: Medium sized gully with decent vegetation on the banks and bottom. Decent amount of tree slumping, and some visible degradation. looks like somebody dumped their lawn clippings down here</p>

Upstream view of left bank.

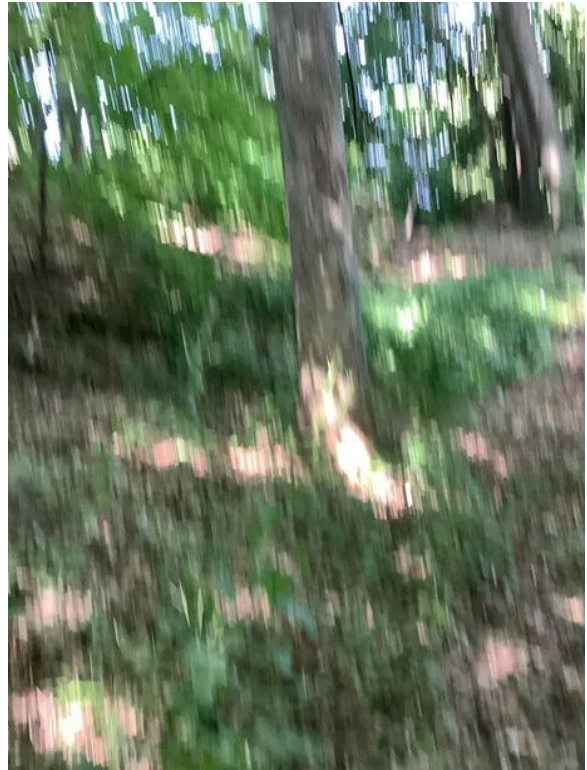
Photo2

Upstream view of right bank.

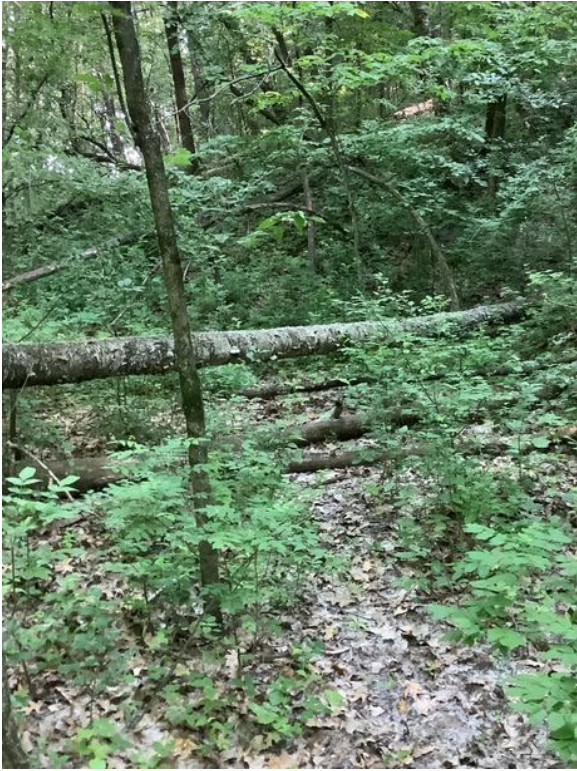
Photo3

Downstream view of fallen trees in middle of gully.

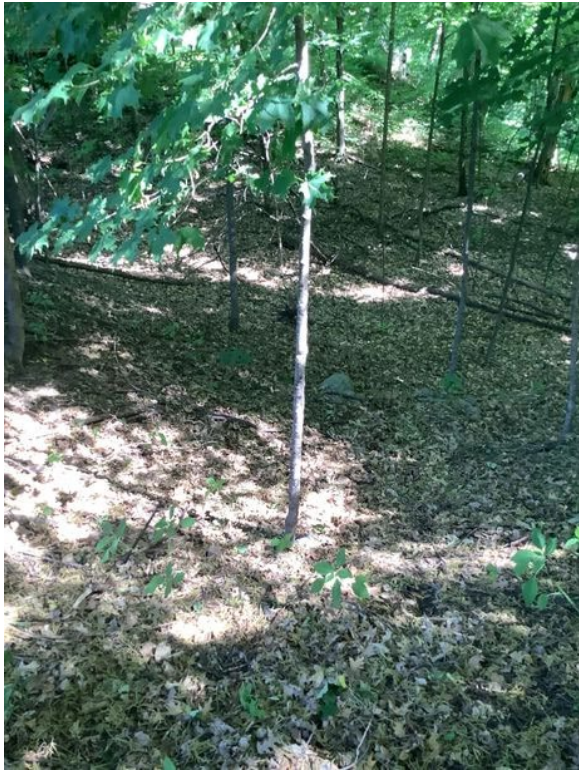
Photo1

Seep:	No
Stormwater Inputs:	0-Not present
Fallen Trees:	No
Degradation:	3-Moderate
Aggradation:	0-No aggradation
Slumping:	3-Moderate
Additional Notes:	<p>Classification? Moderate (x - x)</p> <p>Notes/Comments: Gully which connects to another gully to the left of it at the bottom and flows into a third large gully. Has very little vegetation and trees are starting to slump in</p>

Downstream center, wide so hard to see the banks.

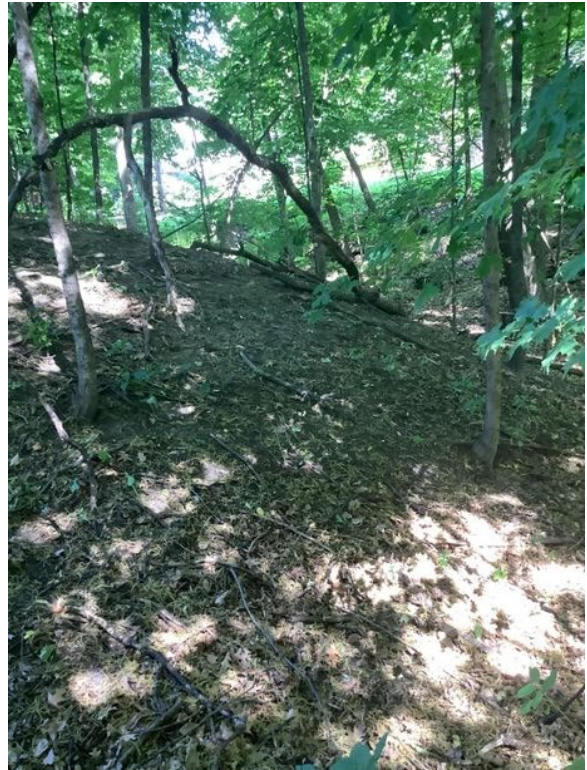
Photo2

Left bank, pistol trees are visible.

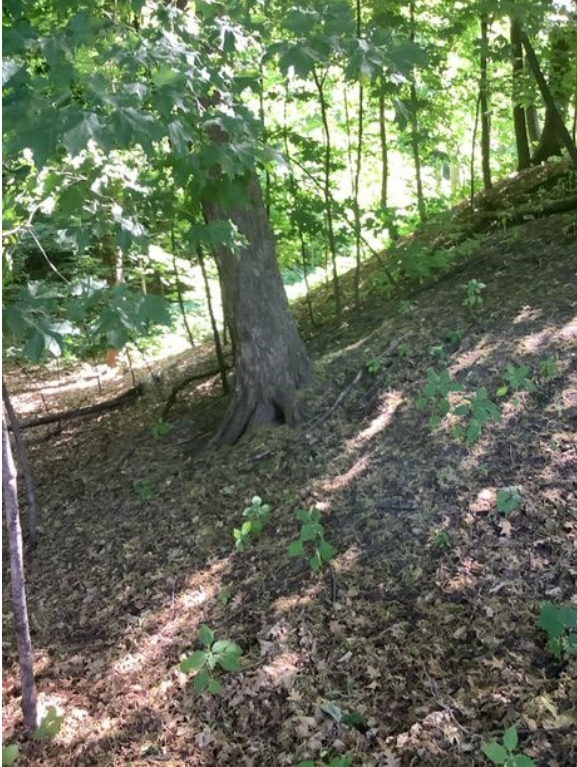
Photo3

Right bank, tree is beginning to lean in.

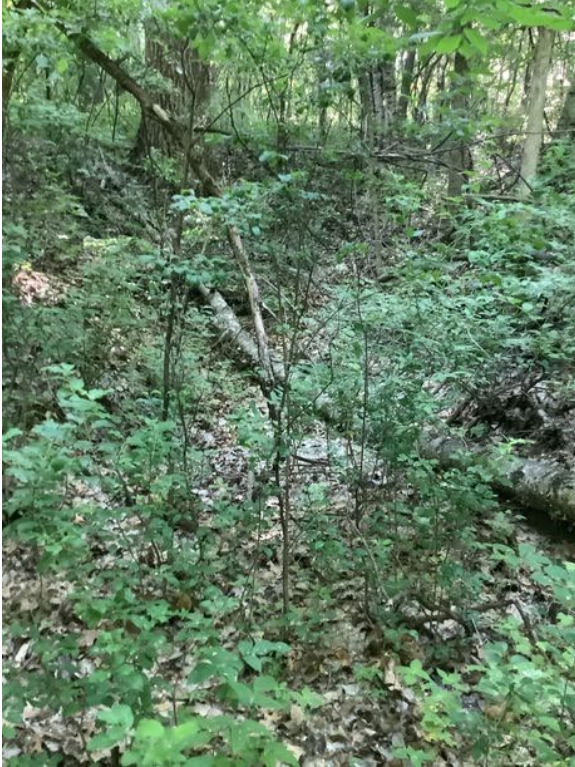
Photo1

Seep:	No	
Stormwater Inputs:	0-Not present	
Fallen Trees:	No	
Degradation:		3-Moderate
Aggradation:		0-No aggradation
Slumping:		1-Low
Additional Notes:	<p>Classification? Moderate (x - x)</p> <p>Notes/Comments: Steep and small gully. Fallen tree in center is not from gully, fell into gully from another area. Decent amount of vegetation. Runs into right bank of another potential gully.</p>

Upstream view of gully.
